**AVIATION INVESTIGATION REPORT
AIB-2013-0002**

**Onur Air
Airbus 300-605R, Registration TC-OAG
King Abdulaziz International Airport – Jeddah
Kingdom of Saudi Arabia**

**Abnormal Runway Contact (ARC) –
Nose Gear Retracted (SCF-NP)**

10th Jumada-II 1433 H – 01 May 2012 G

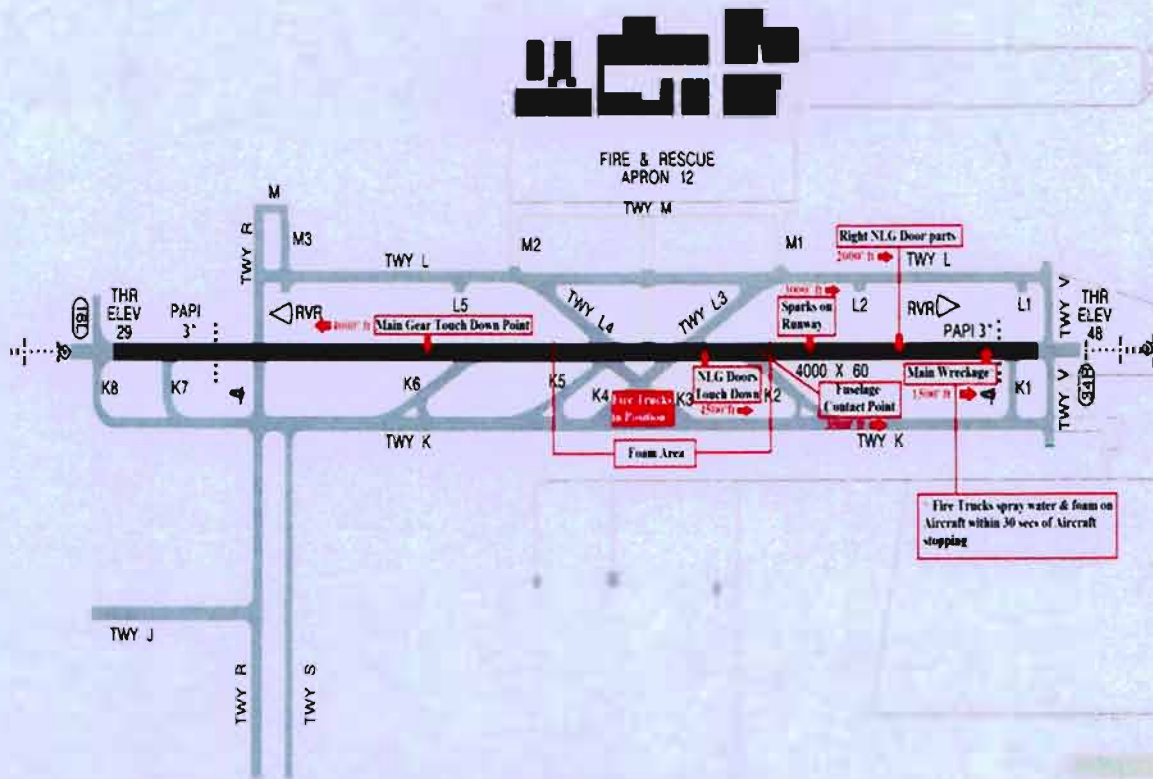
Figure 1: Runway 16L/34R with details of aircraft contact areas.

SVA 2865 was vectored over the Red Sea to lower the fuel load, thus reducing the landing weight. During this period, the Fire & Rescue Services (FRS) at Jeddah foamed a portion of runway 16 Left (16L) between taxiway Kilo 5 (K5) and K2 (Figure 1). The majority of the FRS vehicles were standing by at the junction of taxiways K4 and K3.

The aircraft landed on its main landing gear 4000 ft past the threshold of runway 16L (Figures 1 and 12). The nose of the aircraft was slowly lowered to the runway with the nose landing gear doors touching the runway within the foamed area 4500 ft from the end of runway 16L (Figure 2). The front of the fuselage then touched the runway within the last portion of foam, 3500 ft from the end of runway 16L. The nose area of the aircraft slid on the runway, where sparks were present until the aircraft came to a full stop 1500 ft prior to the end of runway 16L (Figure 14).

Approximately 30 minutes prior to the landing of SVA 2865, the FRS foamed the center portion of the runway between Taxiways K5 and K2 (Figures 1 and 12).

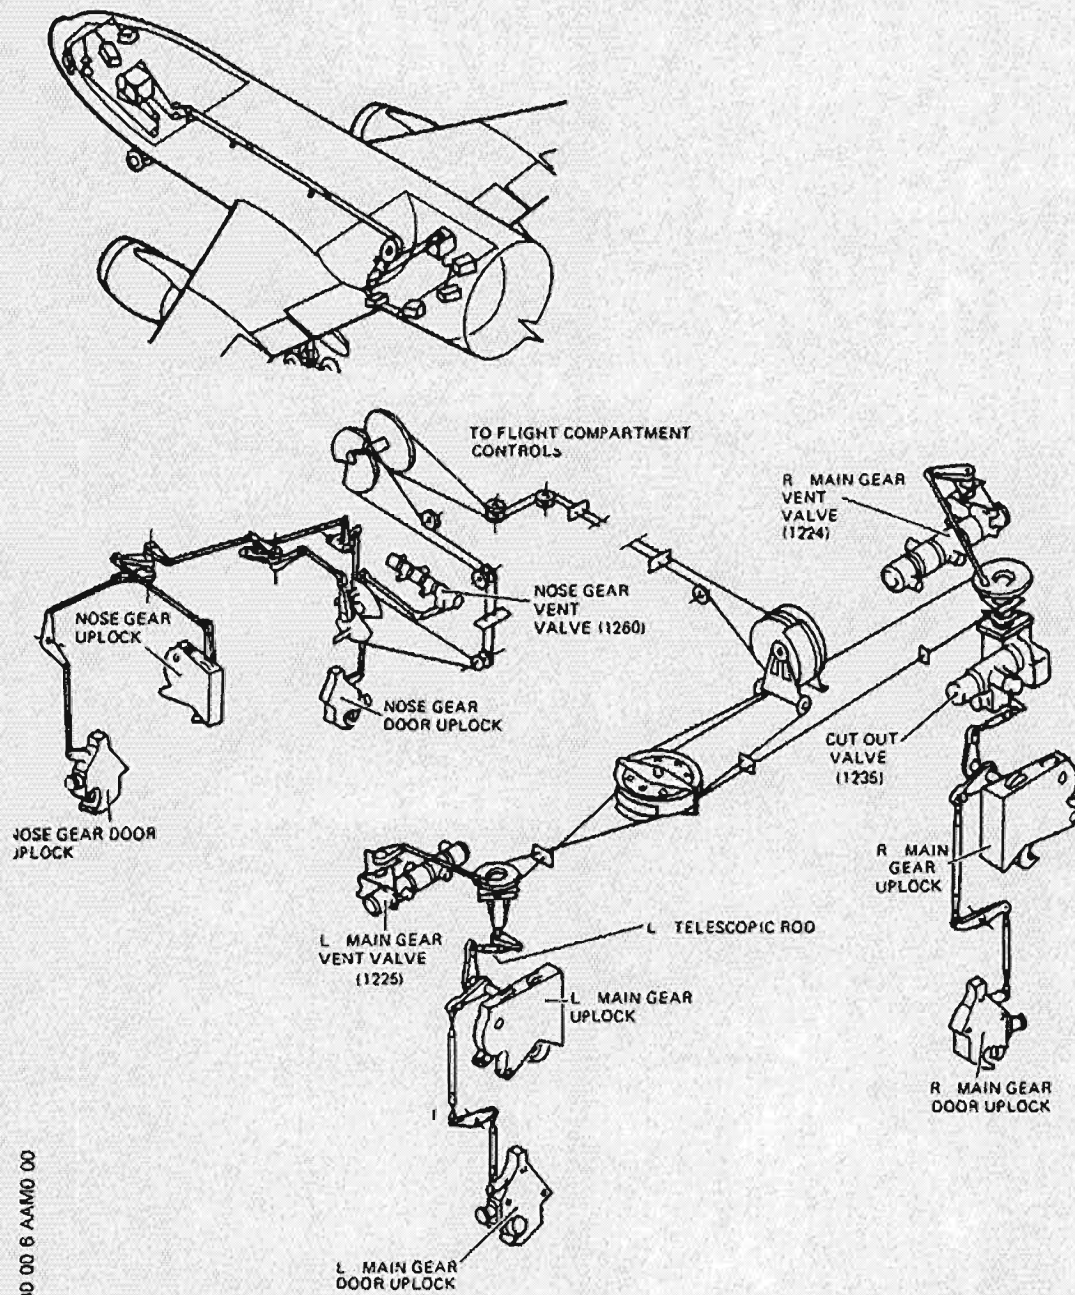
Figure 7: Schematic of Landing gear free fall system.

The aircraft has a gravity extension system for lowering the landing gear in case of hydraulic or electrical power supply failure (Figure 7). A hand crank is stowed in the right side console. A protected fitting is provided in the cockpit floor for insertion of the hand crank. A mechanical means for visual confirmation of the landing gear being down and locked are installed in each wing and through a viewing window located in the avionics compartment.

It was reported the Free Fall cables were below the specified cable tension. The under tension condition of the Free Fall cables could possibly result in the delay of the nose gear free falling by at least one (1) turn of the gravity extension hand crank. The flight crew indicated the free fall system operated as per the Flight Manual with no “hard points” noted when turning the gravity extension hand crank.

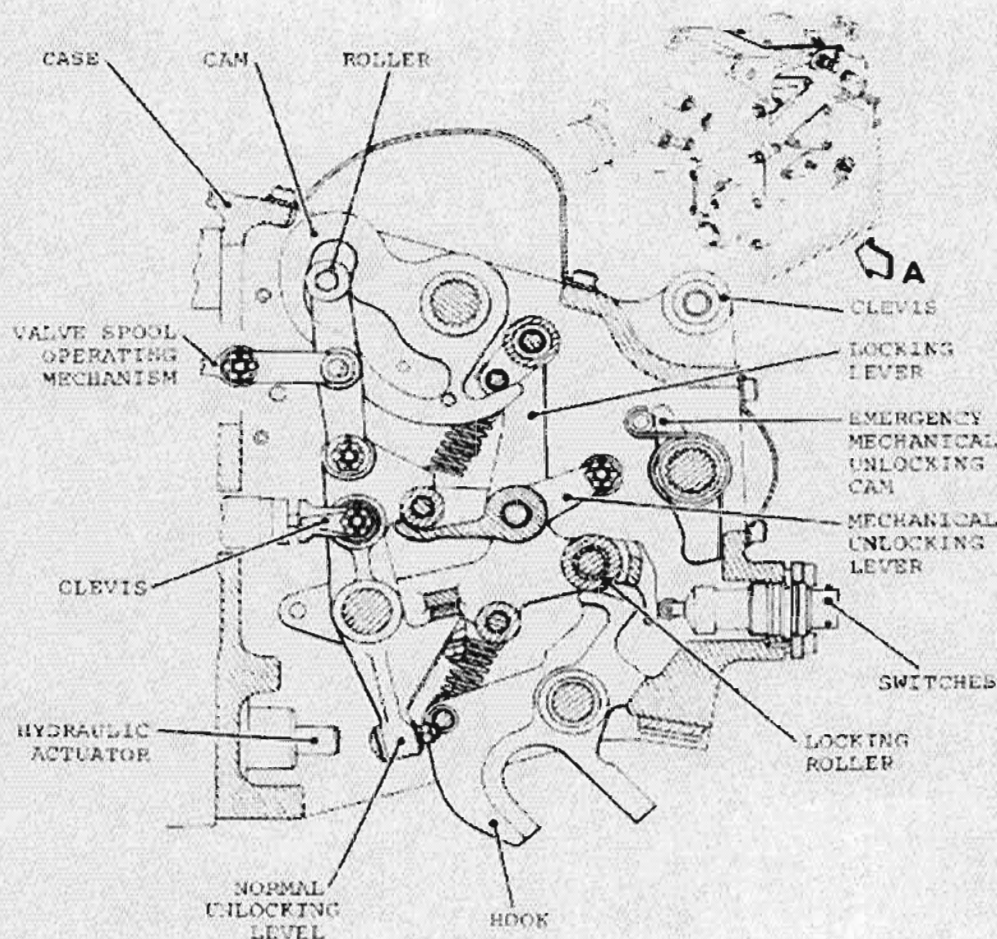
Figure 9: Diagram of NLG up-lock assembly

The NLG up-lock assembly contains two (2) sub-assemblies: the mechanical and the hydraulic assembly. The mechanical assembly includes the NLG up-lock case incorporating internal cams and levers and electrical switches (Figure 9).

- The cam includes a ramp and linkages which guide the roller to the sequence valve that incorporates a slide valve that hydraulically controls the movement and position of the landing gear doors;
- The NLG up-lock case also includes a locking lever which prevents the mechanical assembly from moving into the "unlocked" position. The hinge pin of the locking lever also has a normal mode unlocking lever that is controlled by the internal hydraulic actuating cylinder;
- Two NLG up-lock case springs actuate the lever which helps in the mechanical unlocking during emergency or free fall mode; and
- A cam for emergency mode mechanical unlocking is controlled by a lever control device located outside of the NLG up-lock assembly.
