**Aviation Safety Council**

**GE 235 Occurrence Investigation  
Factual Data Collection  
Group Report**

**July 02, 2015**

**ASC-FRP-15-07-001**

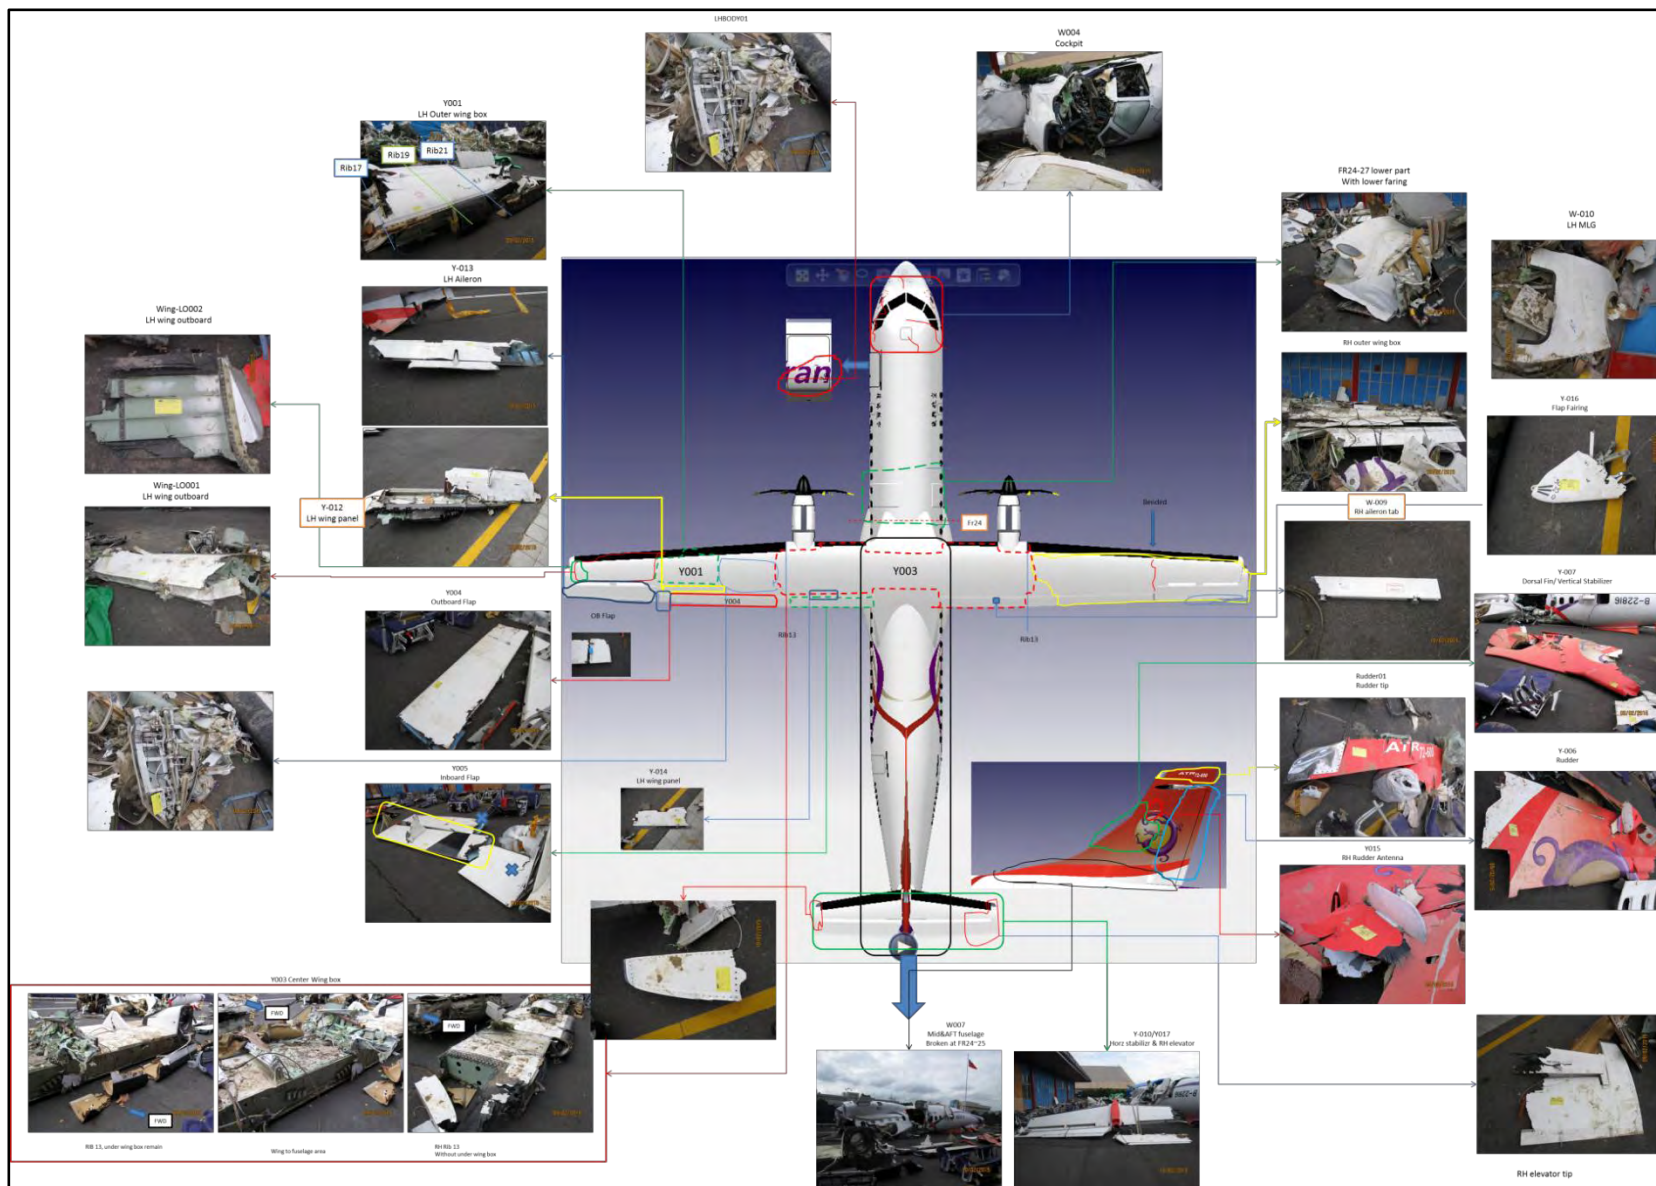
Figure 1.12-2 Recovered aircraft wreckage (1)

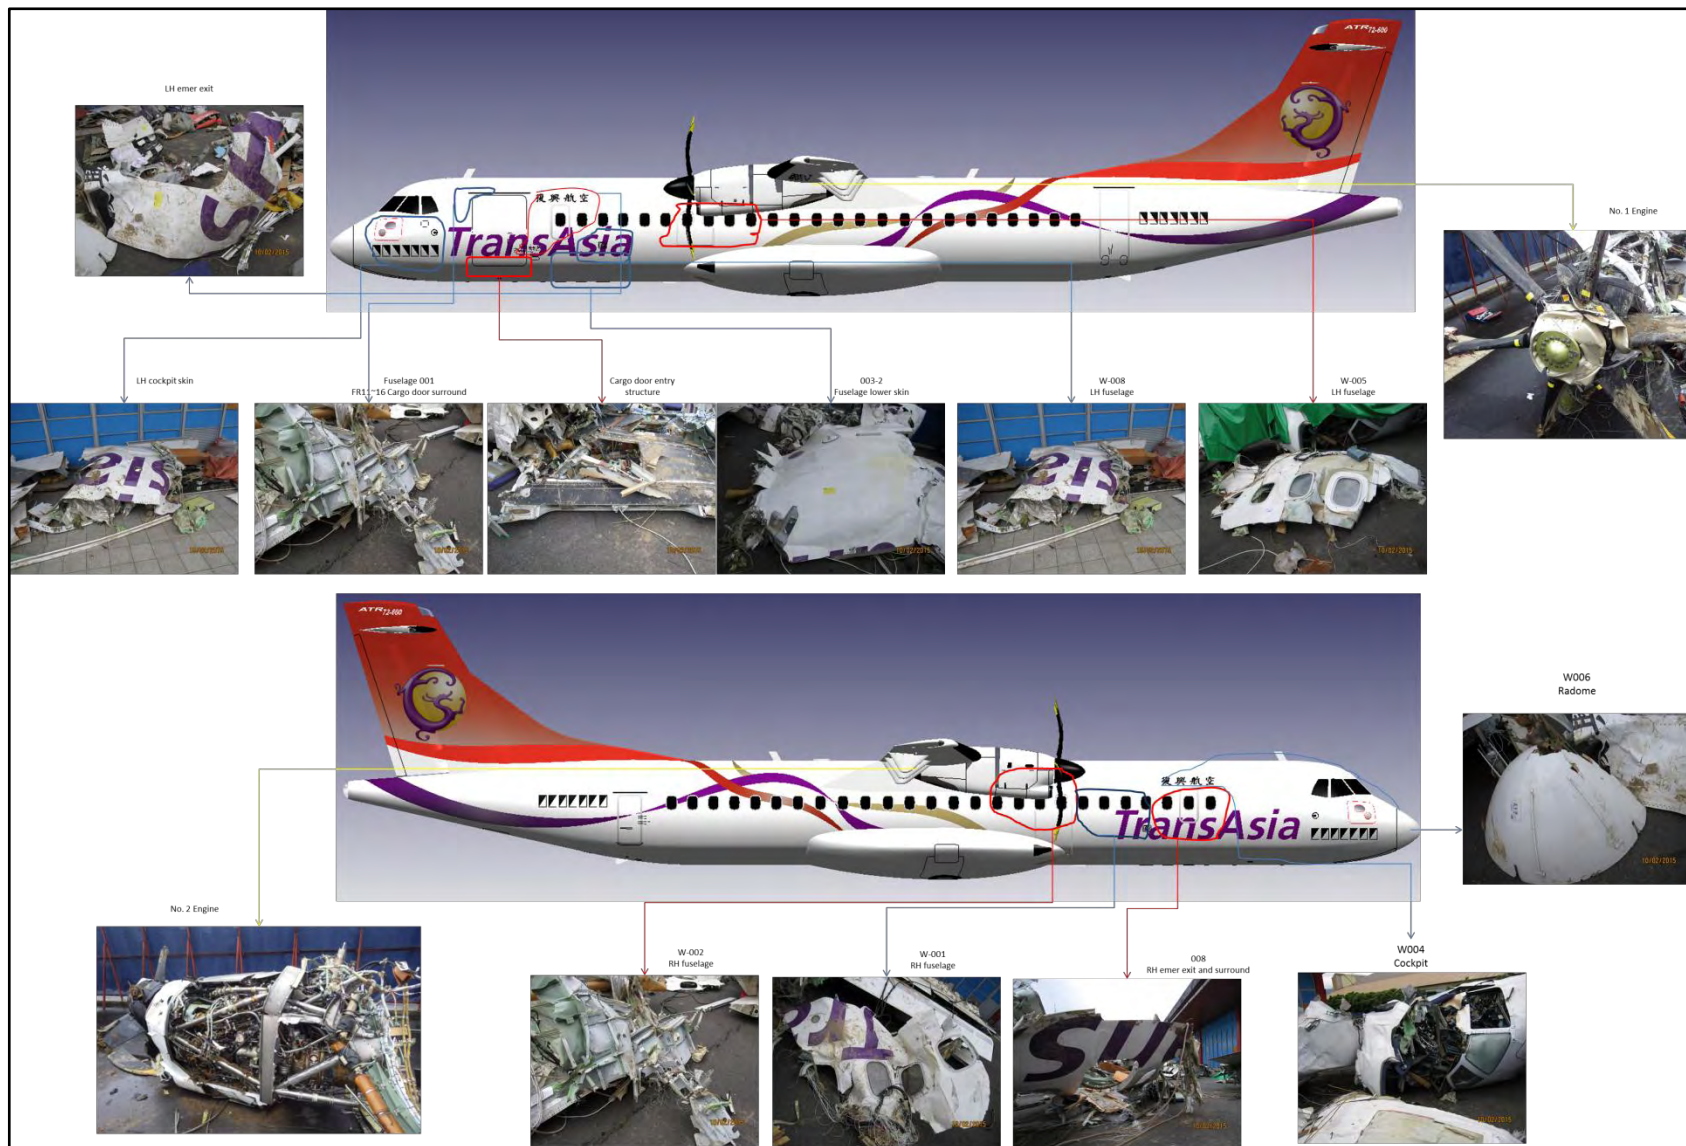
Figure 1.12-3 Recovered aircraft wreckages (2)

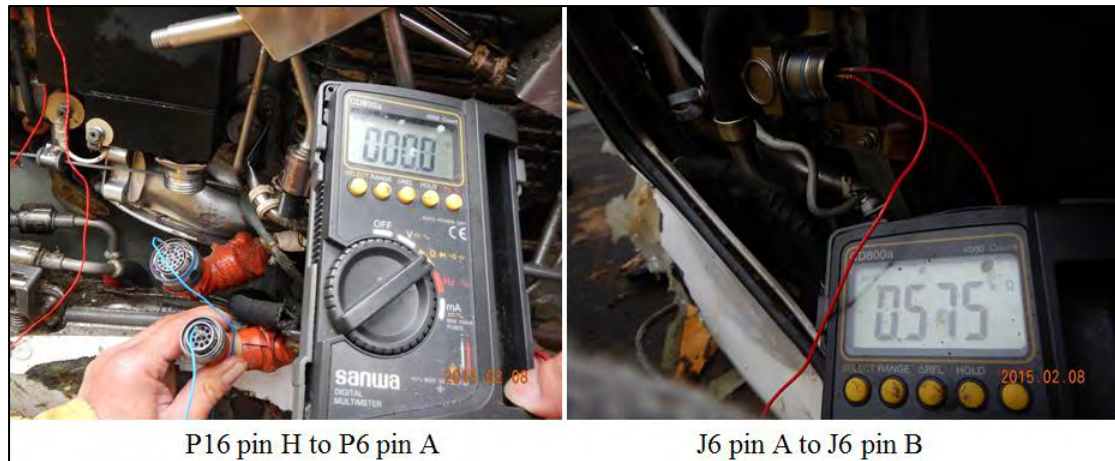
Figure 1.16-1 Continuity check of No. 2 AFU electrical circuit

<b>Point-A</b>	<b>Point-B</b>	<b>expected</b>	<b>result</b>
J6 pin A	J6 pin B	553-589 ohms	575 ohms
P16 pin H	P6 pin A	0-0.5 ohms	0 ohm
P16 pin J	P6 pin B	0-0.5 ohms	0 ohm
Insulation resistance (with reference to ground) of torque sensor No. 1 > 2 Mohms

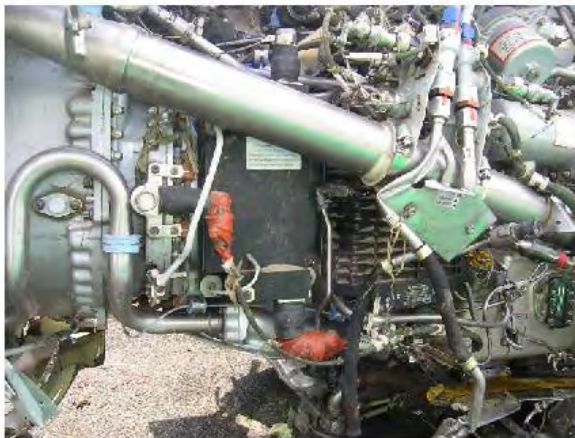
Photo No. 5

**Turbine Support Case:** Displayed no apparent impact damage. The fuel nozzle manifold was intact.

Compressor inlet case, autofeather unit and engine electronic control, in-situ.

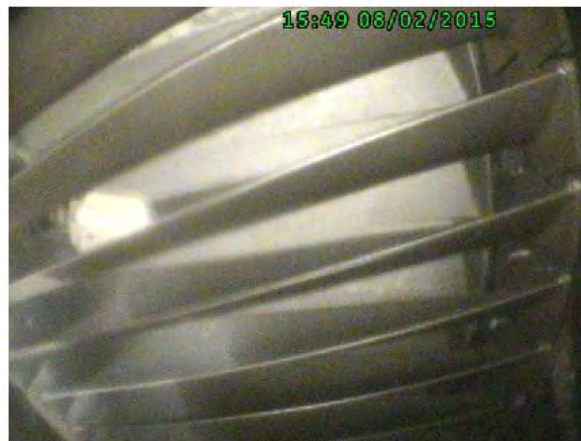
Photo No. 7  
First stage power turbine.

The turbine section components displayed no indications of any anomalies affecting normal operation, and all components observed showed normal running wear. All components showed water immersion damage. Please refer to photos No. 6 through 11.

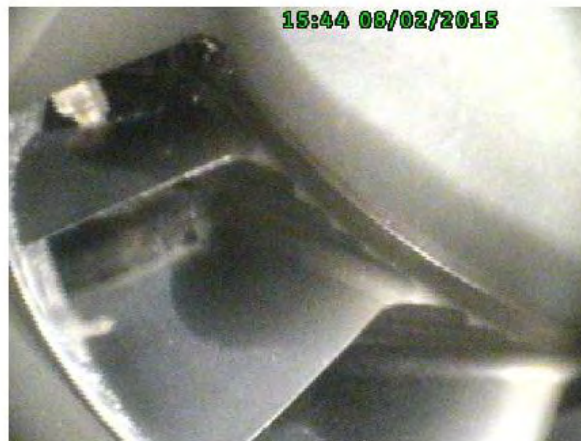
Photo No. 14  
High pressure impeller.

The compressor section components displayed no indications of any anomalies affecting normal operation, and all components observed showed normal running wear. All components showed water immersion damage. Please refer to photos No. 13 and 14.

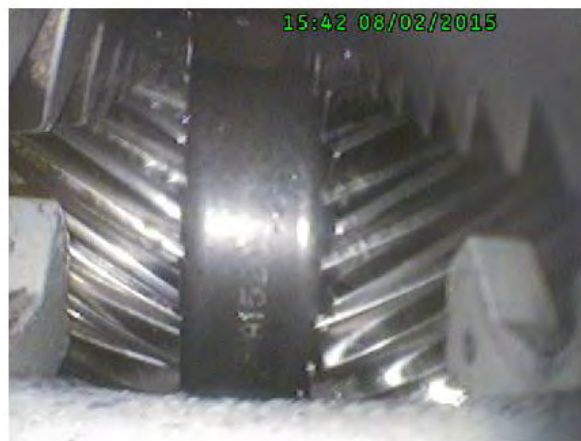
Photo No. 16  
Reduction gearbox helical input gearshaft and helical gear.

The reduction gearbox components displayed no indications of any anomalies affecting normal operation, and all components observed showed normal running wear. All components showed water immersion damage. Please refer to photos No. 15 through 17.

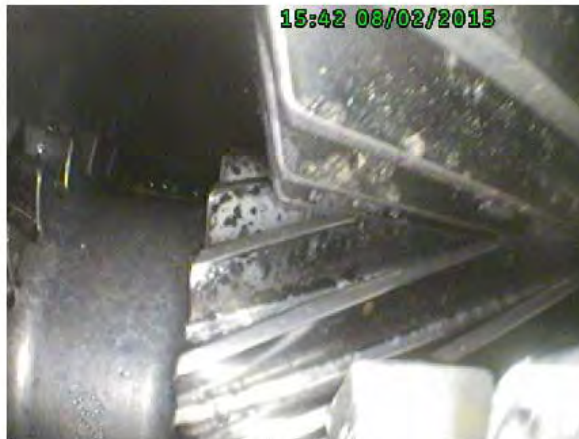
Photo No. 17

Reduction gearbox helical input gearshaft and helical gear.

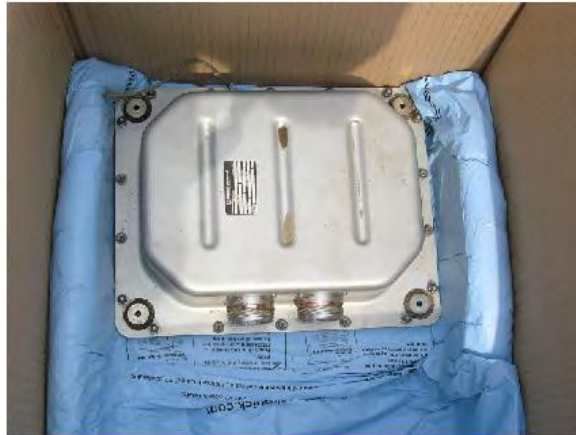
**Propeller Electronic Control:** Hamilton Sundstrand Model EPC100-1, P/N 816332-5-401, S/N 13070018. The unit was re-immersed in fresh water and packed sealed in water for shipping. Please refer to photos No. 18 and 19.

Photo No. 18  
Propeller Electronic Control.

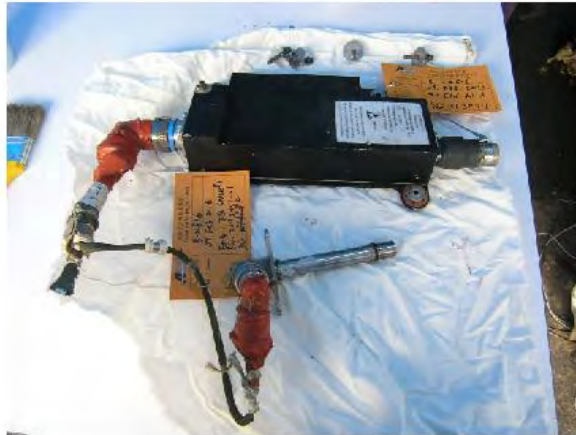
Photo No. 22  
Autofeather unit and torque sensor No. 1.

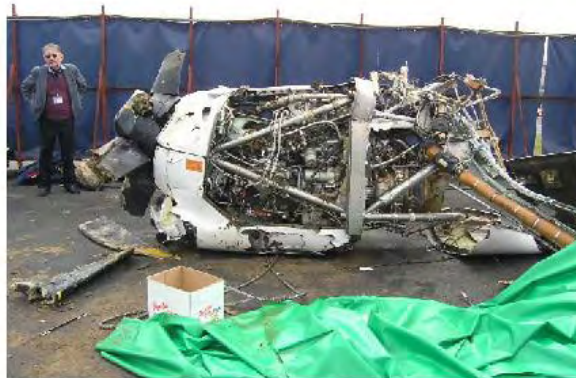
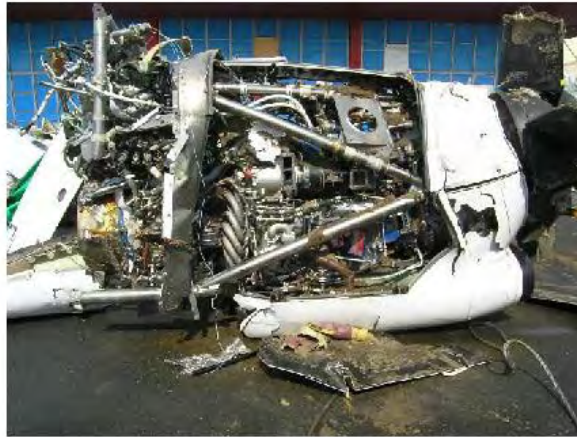
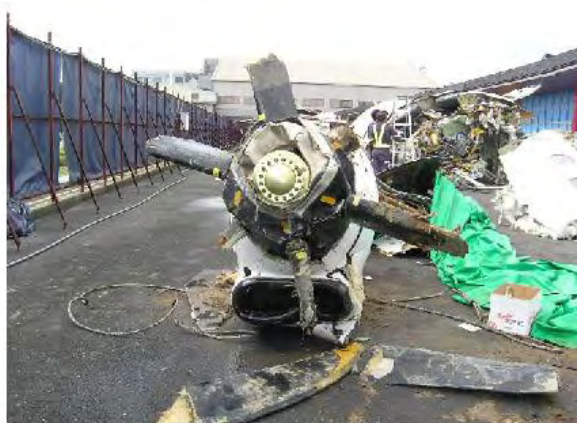
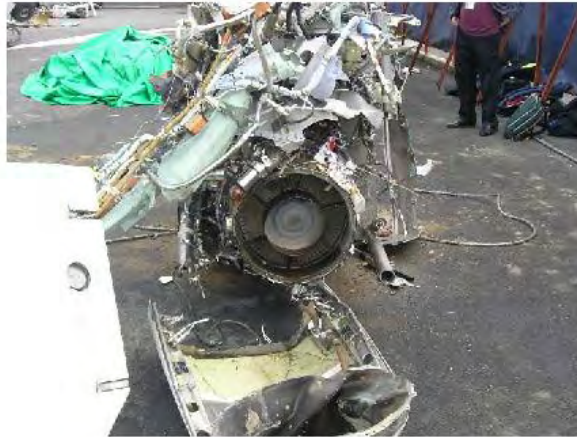
**Front Inlet Case:** The front inlet case was crushed and the reduction gearbox was forced aft and upward into the engine mount structure. The torque sensor No. 1 probe was deformed due to impact fracture of the inlet housing mounting boss. The autofeather unit lower canon plug boss was deformed by impact. The rest of the front inlet case mounted controls and accessories were in place and intact.

Please refer to photos No. 31 through 37, 55 and 58.

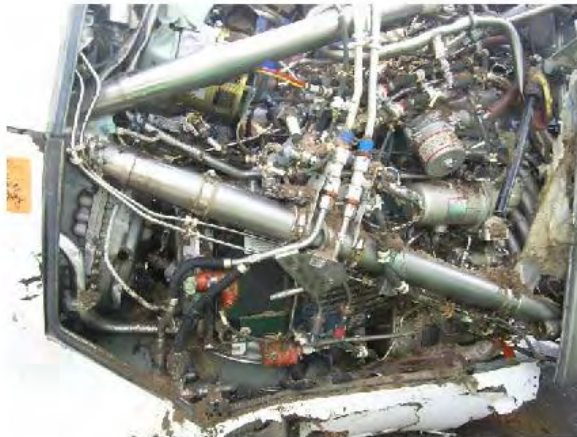
Photo No. 35  
Compressor inlet case. Autofeather unit and engine electronic control, in-situ.

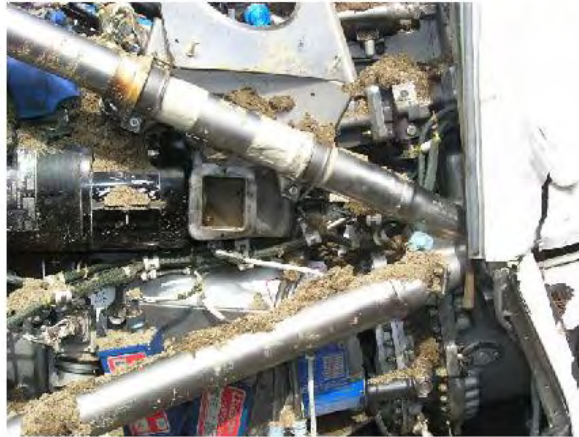
Photo No. 36  
Compressor inlet case, right hand side.

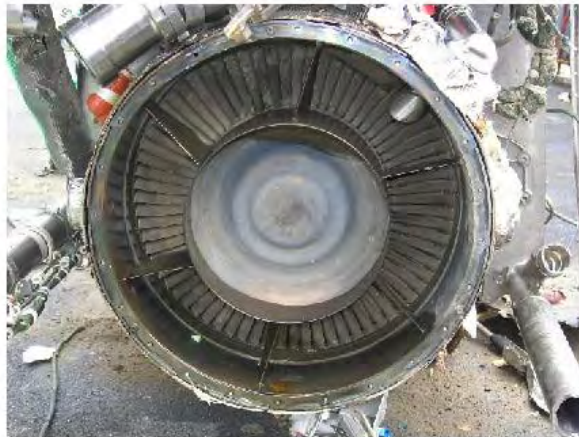
The engine was examined in the airframe nacelle as recovered. All quick engine change items and airframe nacelle to engine connections appeared to be intact, with water immersion damage. The propeller hub remained attached to the hub with the blade outer spans separated. The nacelle aft section and exhaust duct was separated.

Photo No. 37  
Exhaust duct and power turbines.

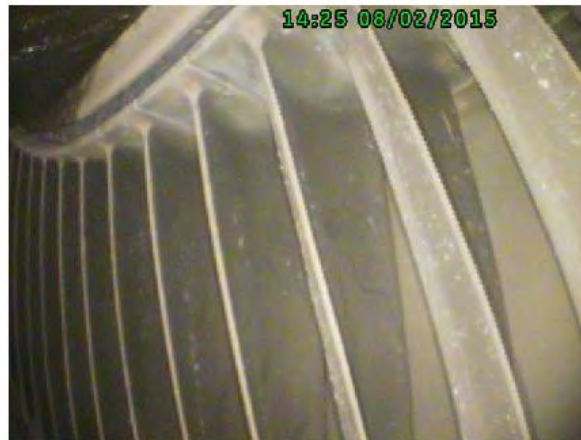
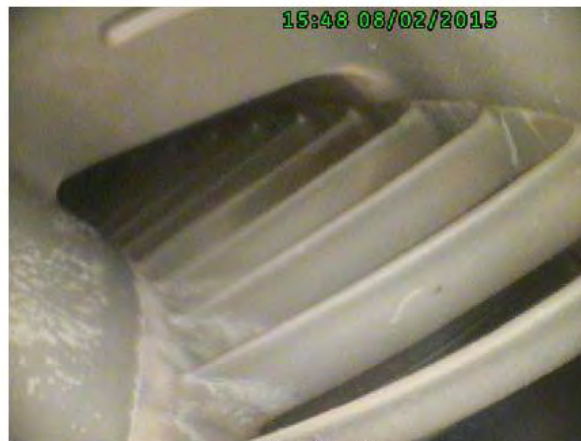
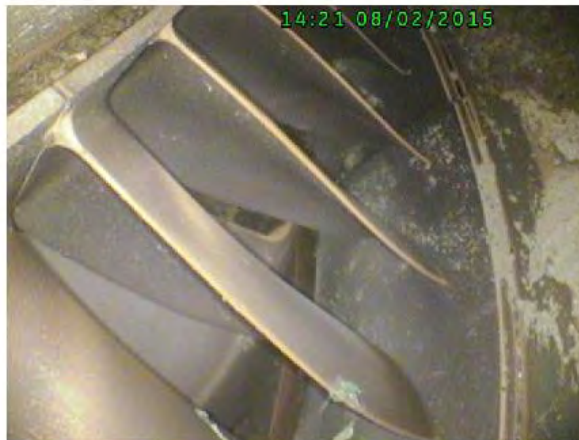
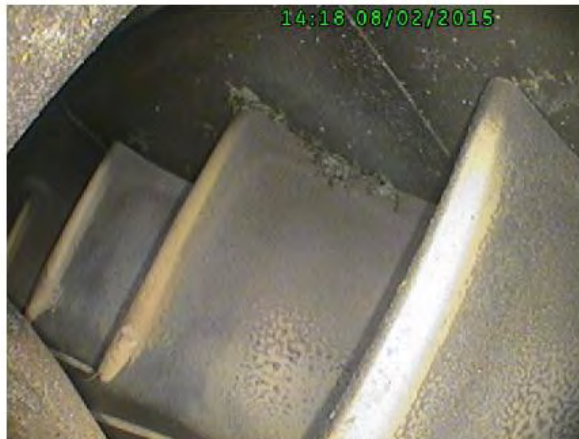
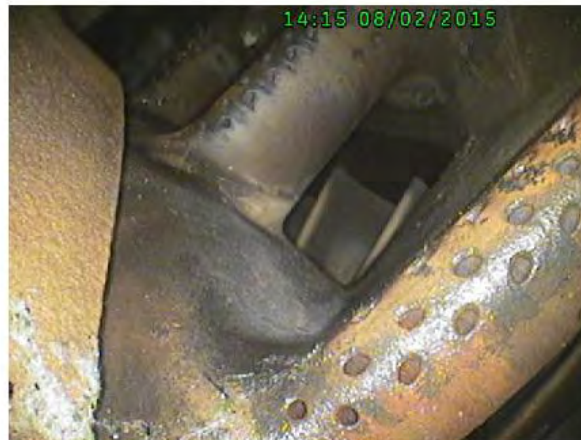
The turbine section components displayed no indications of any anomalies affecting normal operation, and all components observed showed normal running wear. All components showed water immersion damage. Please refer to photos No. 38 through 43.

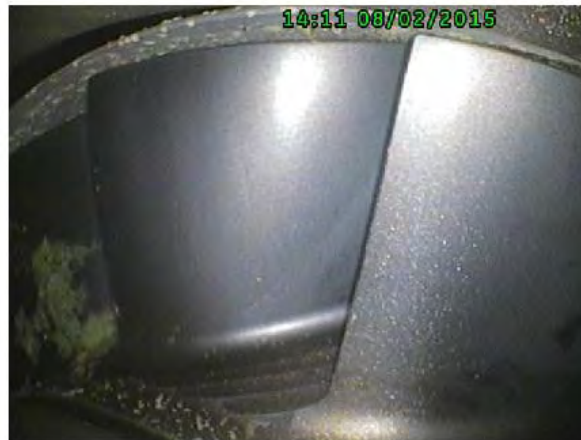
Photo No. 46  
High pressure impeller.

The compressor section components displayed no indications of any anomalies affecting normal operation, and all components observed showed normal running wear. All components showed water immersion damage. Please refer to photos No. 45 and 46.

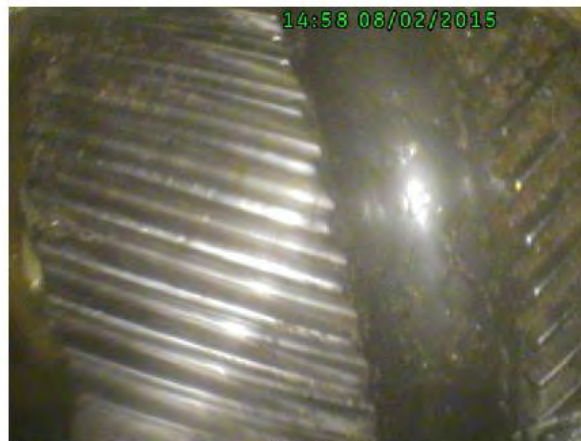
Photo No. 48  
Reduction gearbox helical gear, detail.

The reduction gearbox components displayed no indications of any anomalies affecting normal operation, and all components observed showed normal running wear. All components showed water immersion damage. Impact damage to the front inlet case prevented examination of the second stage spur gears. Please refer to photos No. 47 and 48.

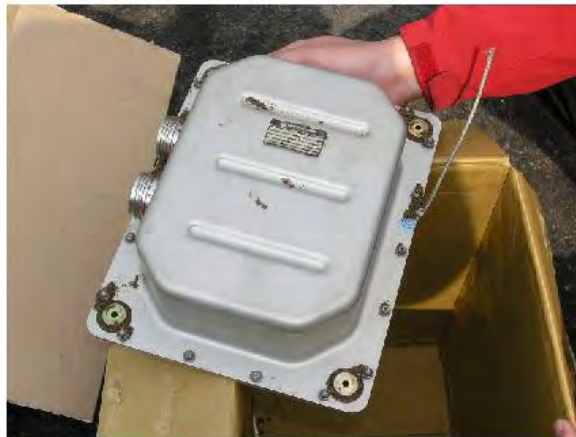
**Propeller Electronic Control:** Hamilton Sundstrand Model EPC100-1, P/N 816332-5-401, S/N 13080013. The unit was re-immersed in fresh water and packed sealed in water for shipping. Please refer to photos No. 49 and 50.

Photo No. 49  
Propeller Electronic Control.

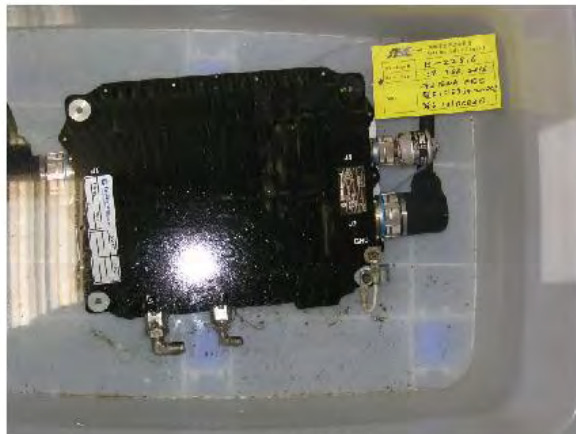
**Engine Electronic Control:** Hamilton Sundstrand Model EEC132-190, P/N 1012974-002, P&WC P/N 3373309-4, S/N 13100020. The unit was re-immersed in fresh water and packed sealed in water for shipping. Please refer to photos No. 51 and 52.

Photo No. 51  
Engine electronic control.

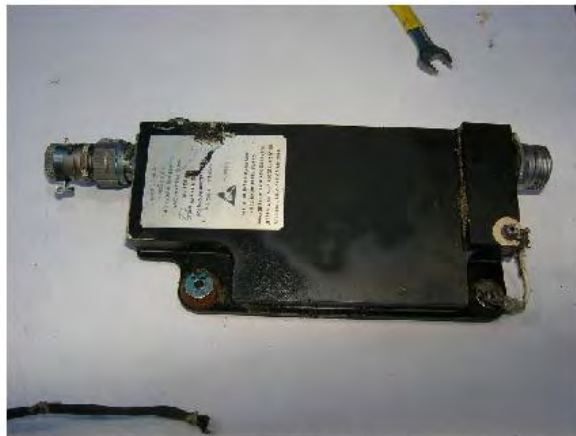
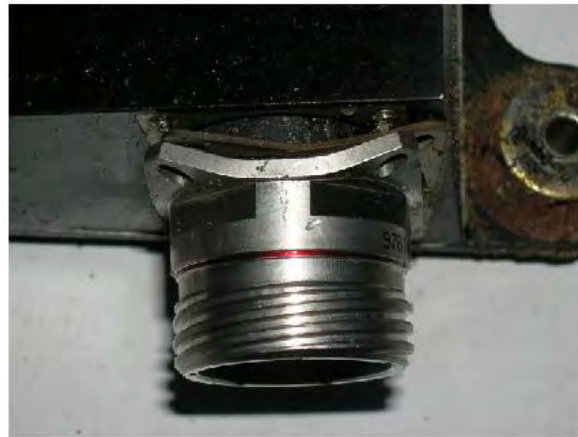
**Autofeather Unit:** Rosemont P/N 30048-0000-28 Rev D, P&WC P/N 3078166-01 S/N RT2362. The lower canon plug boss was deformed by impact. The unit was re-immersed in fresh water and packed sealed in water for shipping. Please refer to photos No. 53 through 55.

Photo No. 55  
Autofeather unit torque sensor canon plug fitting.

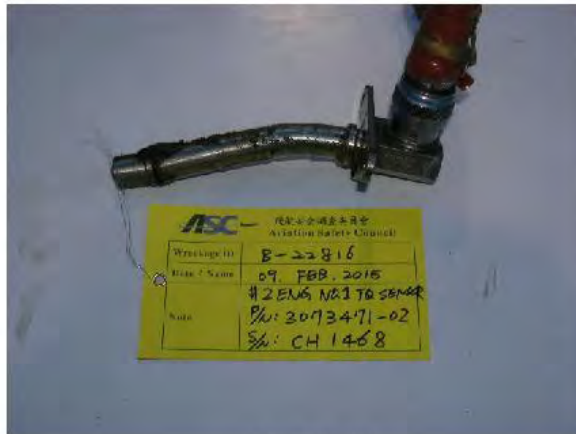
Photo No. 58  
Torque sensor No. 1.

**Torque Sensor No. 1:** P/N 3073471-01, S/N CH1468. Please refer to photo No. 58 and 59.

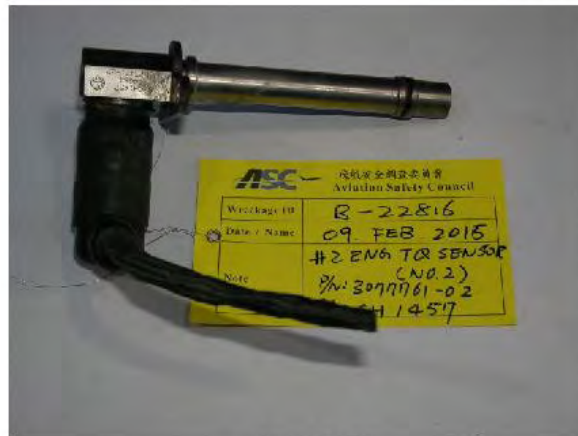
Photo No. 59  
Torque sensor No. 2.

**Torque Sensor No. 2:** P/N 3073471-02, S/N CH1457. Please refer to photo No. 59.

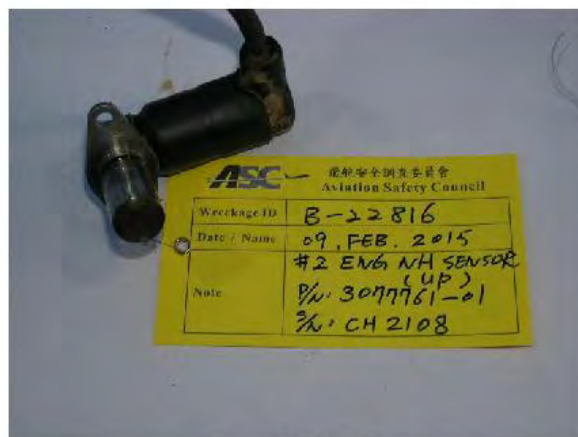
Photo No. 60  
Nh sensor upper.

Nh Sensor (upper): P/N 3077761-01, S/N CH2108. Please refer to photo No. 60.

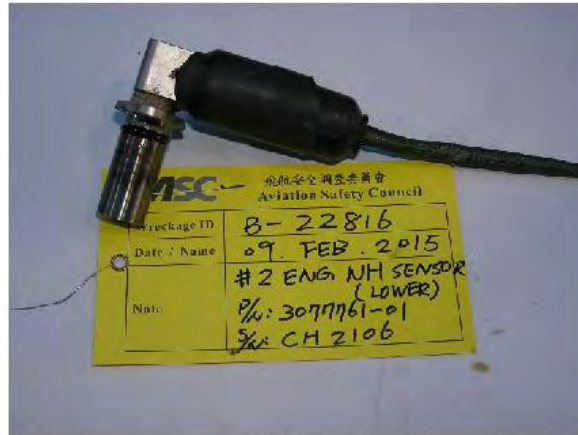
Photo No. 61  
Nh sensor lower.

Nh Sensor (lower): P/N 3077761-01, S/N CH2106. Please refer to photo No. 61.

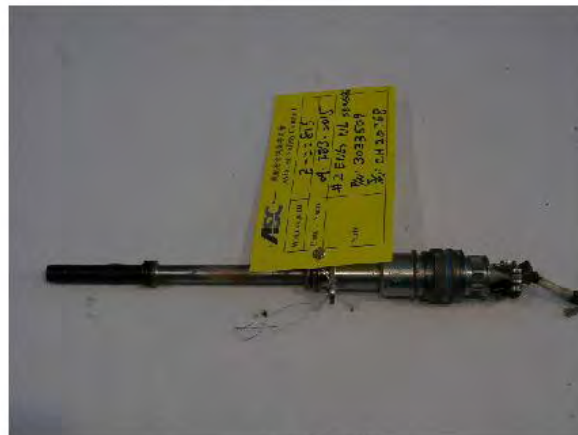
Photo No. 62  
NI sensor.

**NI Sensor:** P/N 3033509, S/N CH20768. Please refer to photo No. 62.

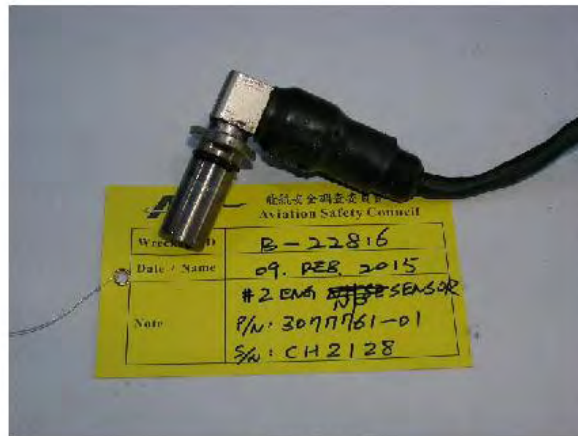
Photo No. 63  
Np sensor

**NP Sensor:** P/N3077761-01, S/N CH2128. Please refer to photo No. 63.

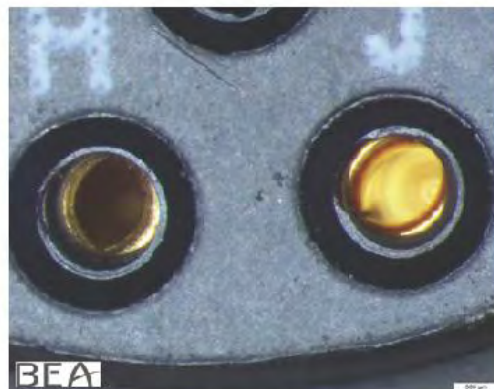
Figure 3: Pin H and J

The macroscopic examination showed a difference between the pin H of AFU connector on cable 2 and the other pins on this connector.

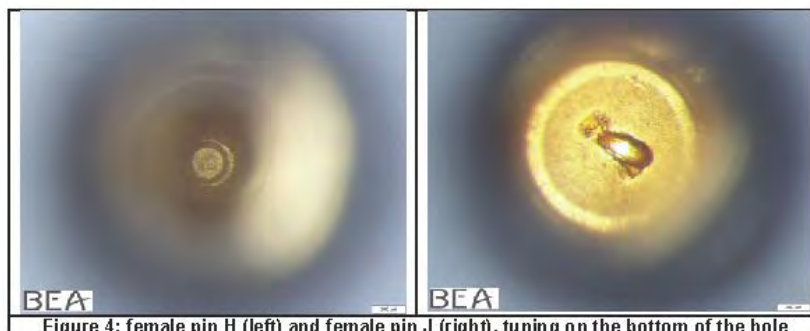
Figure 4: female pin H (left) and female pin J (right), tuning on the bottom of the hole

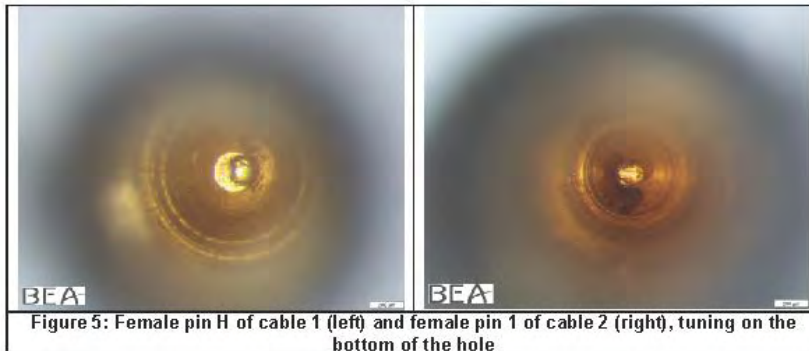
Pictures of the female pin H of cable 1 and the female pin 1 of TQ sensor (cable 2) were taken.

All these macroscopic views do not allow us to conclude.

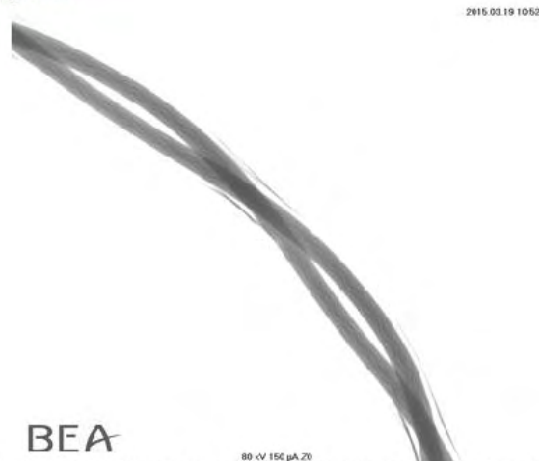
**Figure 6: typical RX picture of the cable between the 2 connectors**

Both cables RX examination provide the same result. No defect was detected on these cables.

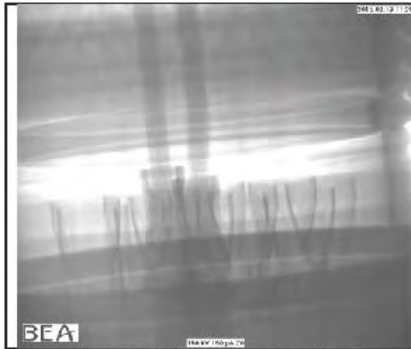
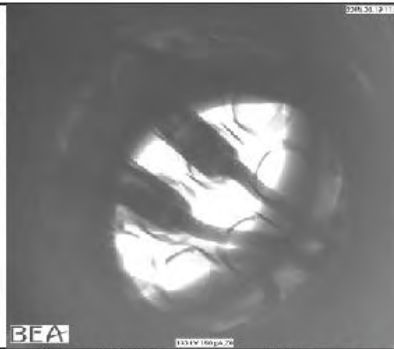
**Figure 9: TQ sensor connector**

**Figure 10: tilt view of the TQ sensor connector**

Only 2 female pins are connected to wires (pins 1 and 2). No trouble with these connections was detected by this examination. The other holes of the connector are empty.

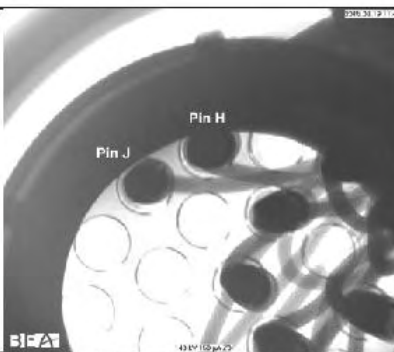
**Figure 11: AFU connector**

**Figure 12: view of the AFU connector**

Inside the AFU connector, 15 female pins are connected to wires. Their references are: A-B-E-F-H-J-N-P-R-S-U-W-a-b-c. No trouble with these connections is detected by this examination.  
The other holes of the connector are empty (references: C-D-G-K-L-M-T-V-X-Y-Z).

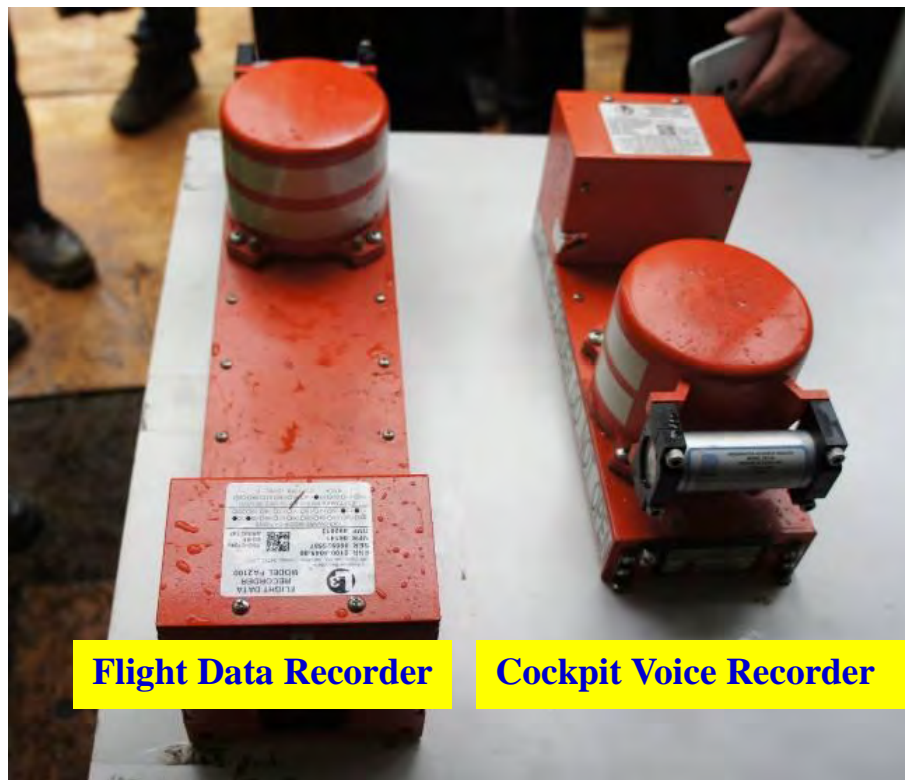
Both Cockpit Voice Recorder (CVR) and Flight Data Recorder (FDR) of the occurrence aircraft were recovered by ASC investigators in Keelung River (Figure 1.11-1) at 1605 hrs on Feb. 4th. Upon the first inspection by ASC investigators, it was found that there was no external damage on both recorders but immersed with water. The photo of CVR and FDR was shown in Figure 1.11-2.

Figure1.11-2 External view of Cockpit Voice Recorder and Flight Data Recorder

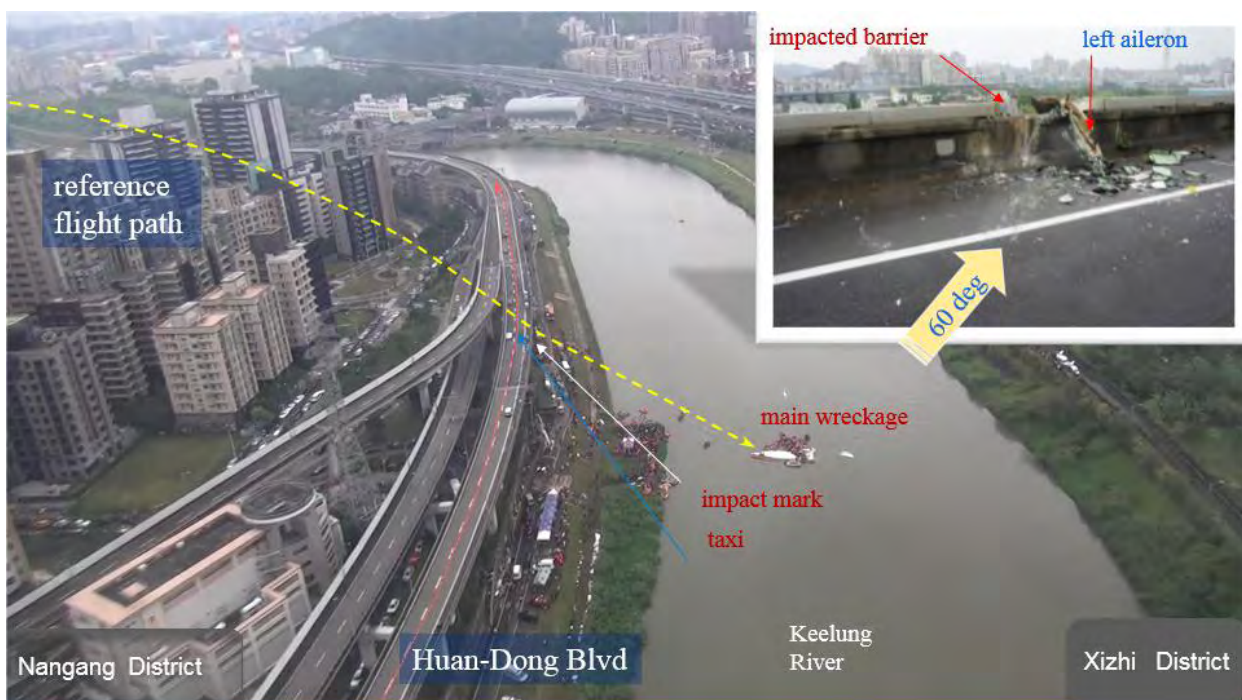
The impact mark made by GE235 indicated the aircraft impacted the Huan-Dong Blvd viaduct before crashing into Keelung River. Refer to Figure 1.12-1, there are several high buildings in the southern area of the Huan-Dong Blvd. Keelung River is at the north side of the Huan-Dong Blvd, and the water depth of the river is between one to two meters.

Figure 1.12-1 Aerial Photo of GE235 crash site

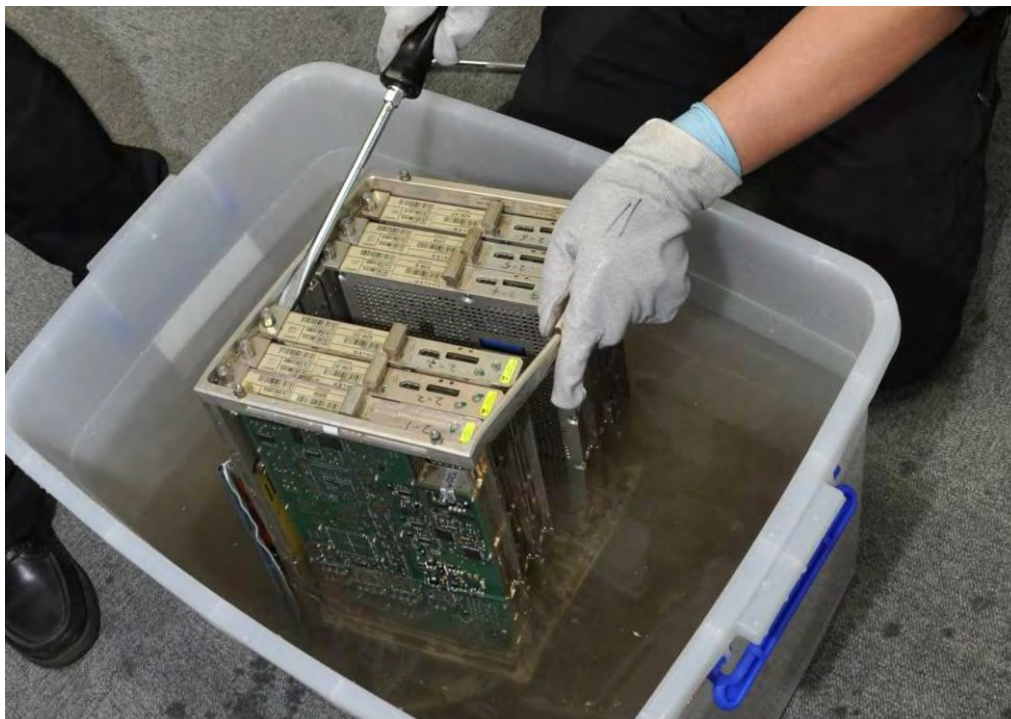
Because of the cockpit instrument panel was seriously deformed, investigators used electrical tools, such as grinder and drill, to remove these DUs. The external case of both MFC were slightly deformed. All PCBs were cleaned with water and removed from MFC before shipping to BEA, photo shown as Figure 1.16-1. Each device was tagged and photo documented into the wreckage database. Those devices were then packaged into water proof hard cases for shipping to BEA or TSB.

Figure 1.16-1 PCBs teardown from CAC rack

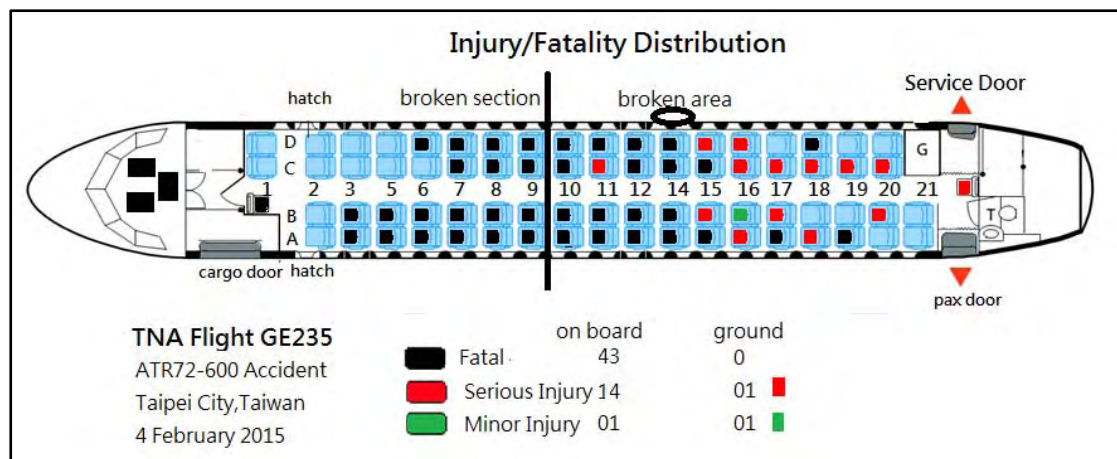
Figure 1.2-1 shows the cabin configuration with passenger injury and fatality distribution. The passenger seating positions were based on the airline seating plan and interviews with the surviving passengers.

Figure 1.2-1 Injury and fatality distribution

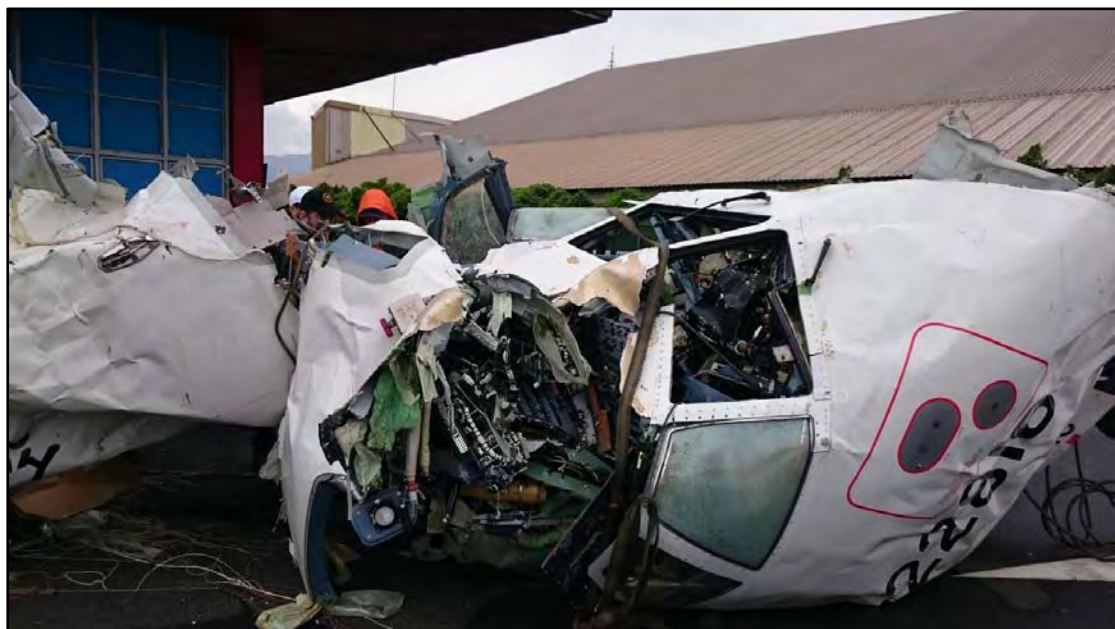
Forward fuselage area including cockpit suffered severe compression and damages due to the impact, as shown in Figure 1.3-1.

Figure 1.3-1 Wreckage on Cockpit

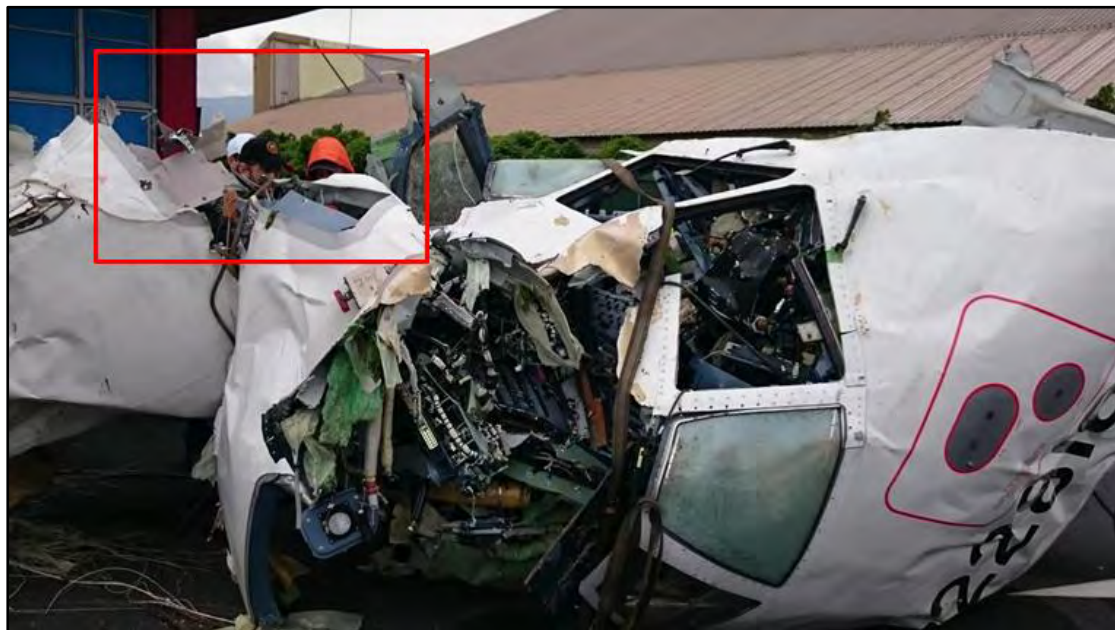
The frame that contains cockpit hatch door was severely damaged with the door missing, as shown in Figure 1.3-4. The actuator of cargo door was retracted. The cargo door was not opened before the impact; however afterward only door fitting remained connected to the actuator, as shown in Figure 1.3-5. Right hand side emergency door was dislocated from the door frame. The emergency door, with mounting hinges broken,

Figure 1.3-4 Cockpit and hatch door

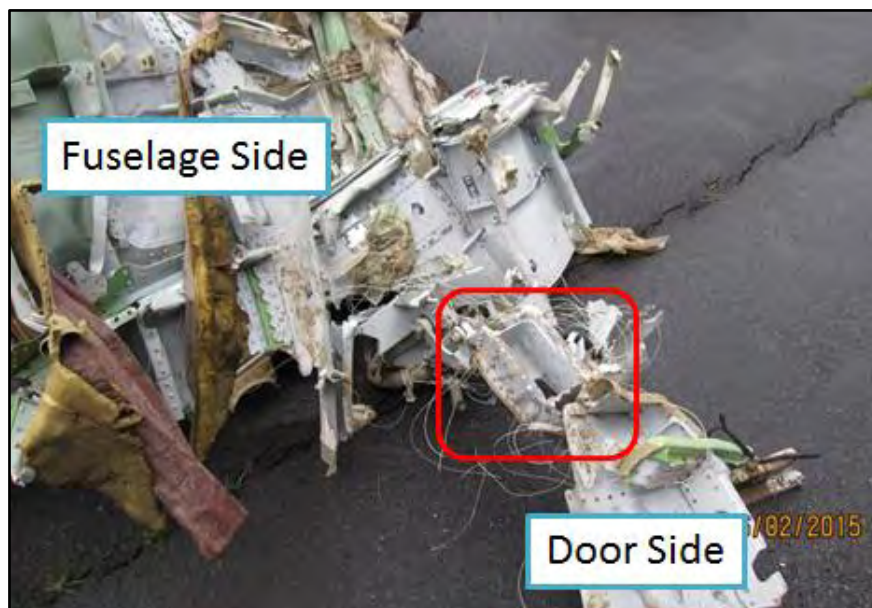
Figure 1.3-5 Cargo door

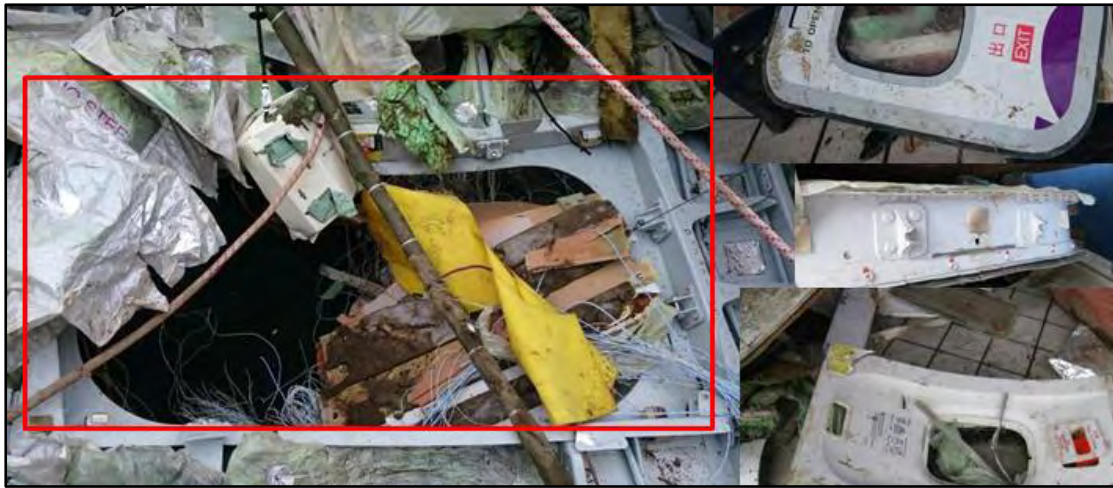
was considered being pushed into cabin during the impact, as shown in Figure 1.3-6. Left hand side emergency door broke into halves due to the impact. The fuselage side door frame could not be located due to severity of damages to the FWD airframe. According to broken hinge location, this door was pushed into cabin during the impact, as shown in Figure 1.3-7. Left hand side passenger door was closed and intact at the time of the accident. Both internal handle and external flap handle were pulled down to un-lock position, as shown in Figure 1.3-8. Right hand side service door was still functioning, and was opened during rescue operation, as shown in Figure 1.3-9.

Figure 1.3-6 RHS Emergency escape door

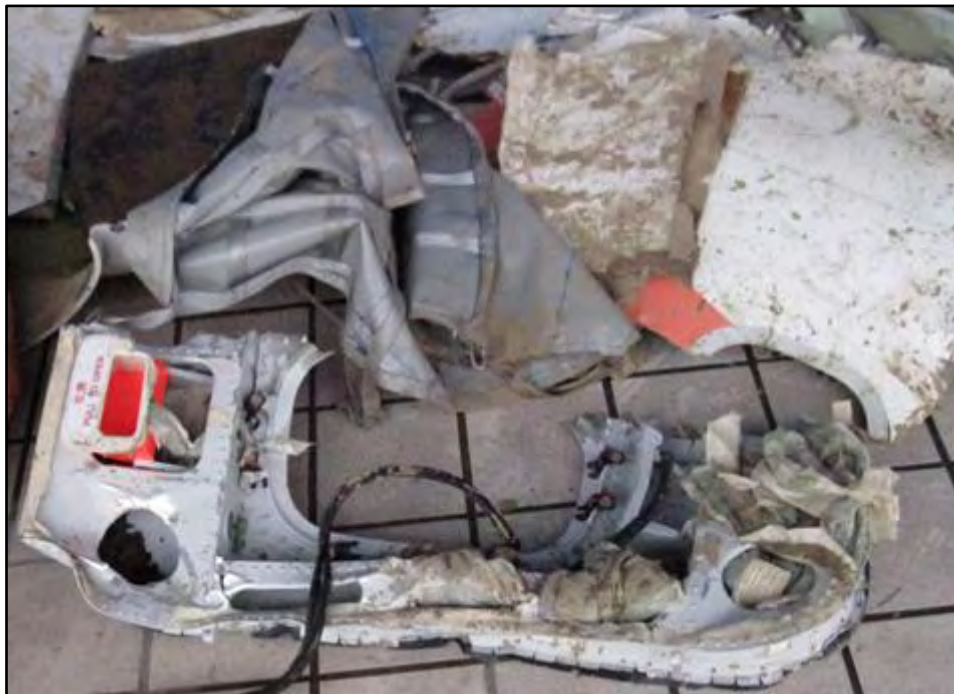
Figure 1.3-7 LHS Emergency escape door

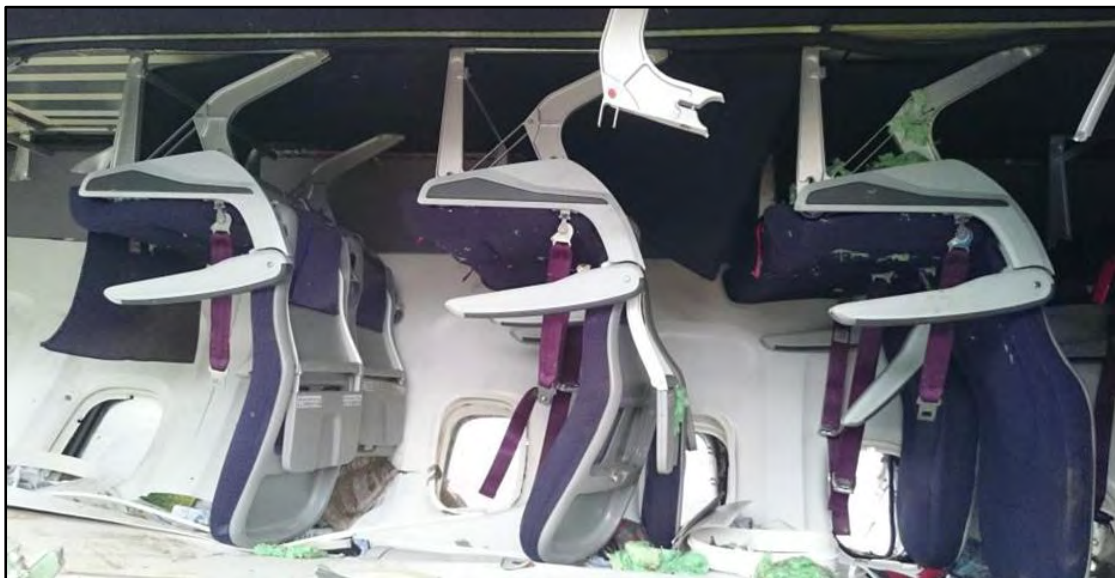
There were 8 sets (2 seats for 1 set) of passenger seats kept intact on seat tracks located in the aft fuselage, as shown in Figure 1.3-10. 28 sets of passenger seats were dislocated from their positions due to the impact (about 5 sets) or rescue effort (about 23 sets), as shown in Figure 1.3-11. Their original positions could not be identified.

Figure 1.3-10 Passenger seats intact on seat track
