**Aviation Safety Council**

**GE 235 Occurrence Investigation  
Factual Data Collection  
Group Report**

**July 02, 2015**

**ASC-FRP-15-07-001**

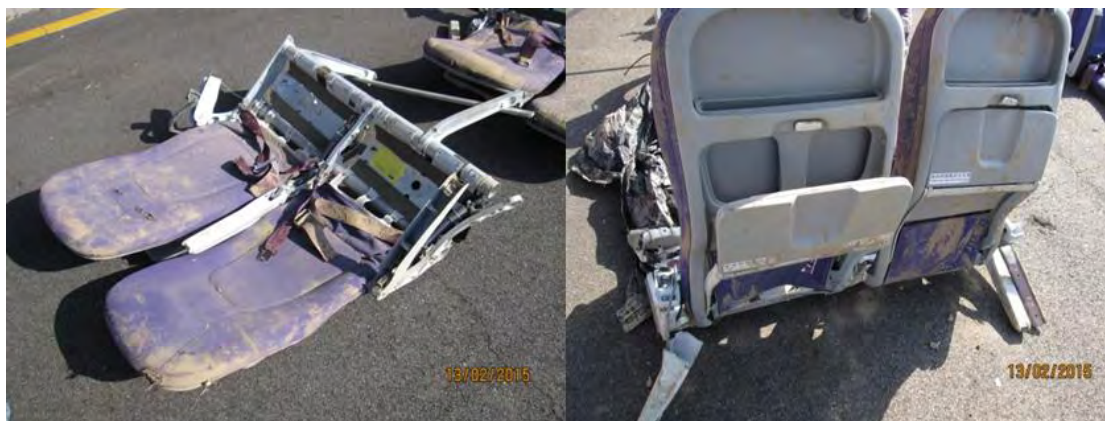
There were 8 sets (2 seats for 1 set) of passenger seats kept intact on seat tracks located in the aft fuselage, as shown in Figure 1.3-10. 28 sets of passenger seats were dislocated from their positions due to the impact (about 5 sets) or rescue effort (about 23 sets), as shown in Figure 1.3-11. Their original positions could not be identified.

Figure 1.3-11 Passenger seats dislocated from its position
