KNKT.14.12.29.04

# KOMITE NASIONAL KESELAMATAN TRANSPORTASI

Aircraft Accident Investigation Report

**PT. Indonesia Air Asia  
Airbus A320-216; PK-AXC  
Karimata Strait  
Coordinate 3°37'19"S - 109°42'41"E  
Republic of Indonesia  
28 December 2014**

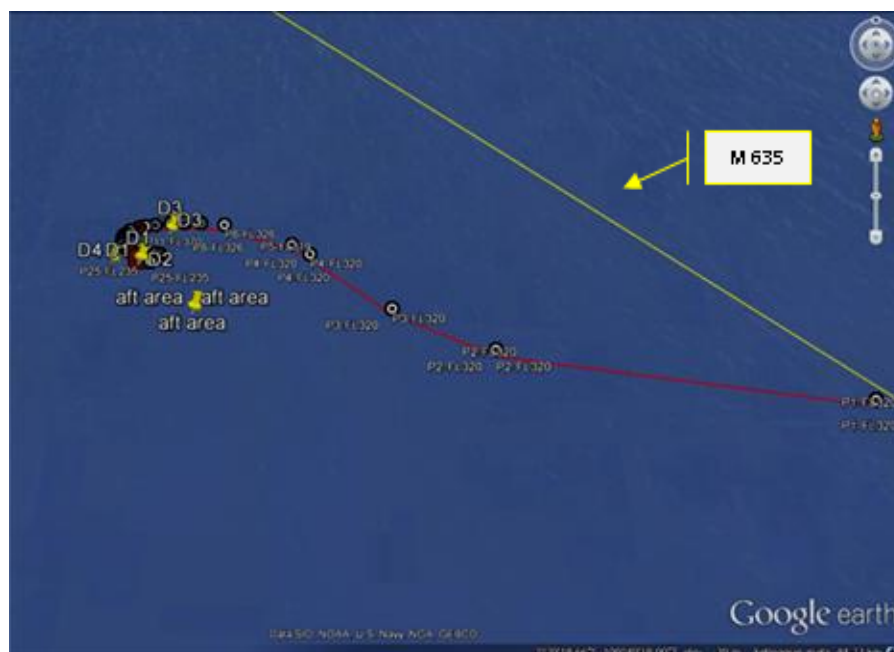
**Figure 17: Automatic Dependent Surveillance – Broadcast (ADS-B) data superimposed to Google earth**

Based on the Automatic Dependent Surveillance-Broadcast (ADS-B) data from the Air Traffic Control data superimposed to Google earth showed that the aircraft deviated to the left from the airway M635.

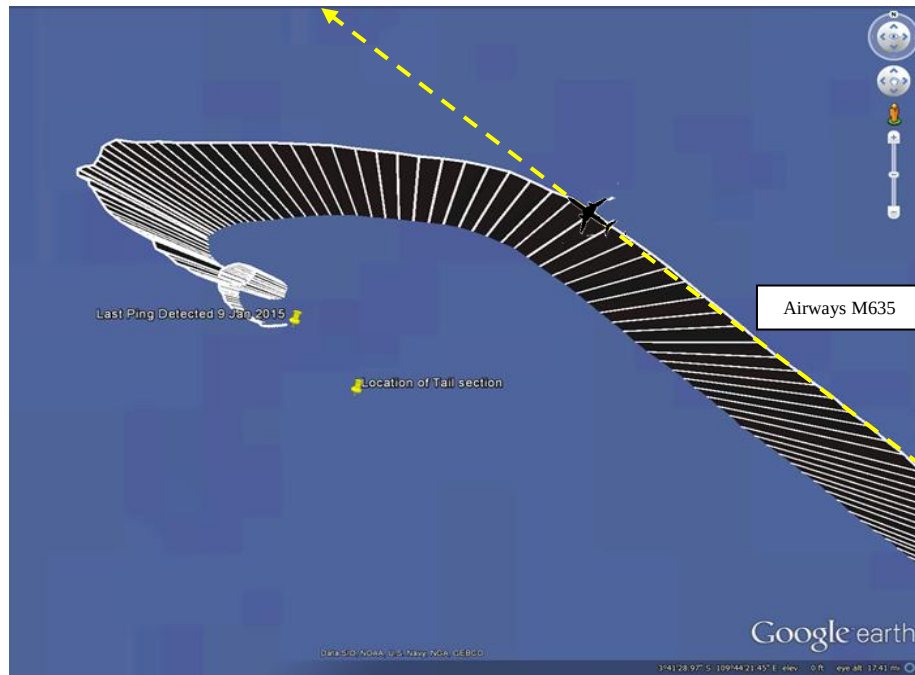
The FDR data showed that while the aircraft was cruising at an altitude of 32,000 feet in normal condition, the aircraft then deviated to the left from airway M635. The master caution triggered by both RTLU problems activated 4 times. The fifth master caution was related to the FAC 1 FAULT activating. The sixth master caution was triggered by the FAC 1+2 FAULT and followed by the autopilot and auto-thrust disengaged and flight control law reverted from Normal Law to Alternate Law.

Subsequently the aircraft entered a steep turn and climb, eventually reaching high angle of attack, the stall warning activated and continued until the end of the recording. The FDR and CVR recording ended at 2320:35 UTC.

**Figure 19: Flight path based on FDR data superimposed to the Google Earth**  
 Detail information of the FDR is shown on the following graphs.  
 Note: abbreviation of FDR parameter indication available in the list of abbreviation of FDR parameters.

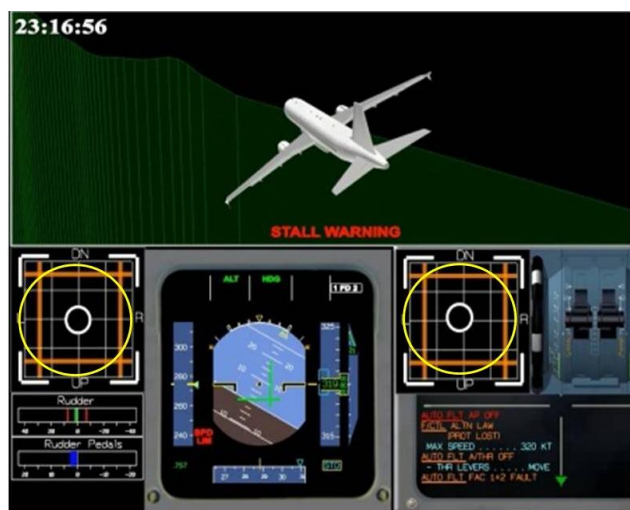
**Figure 26: The first aural Stall warning activated**

| Time (UTC) | From | To | Description |
|---|---|---|---|
| 23:16:56 | Warning | | Stall warning activated for 1 second |

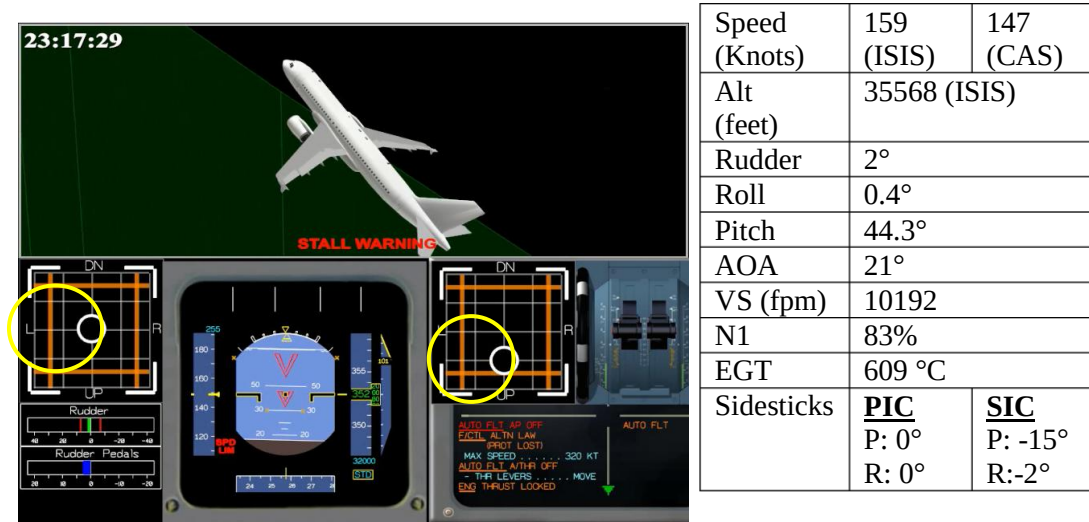
**Figure 27: The aircraft attitude at the highest pitch angle**

| Comment Reference | Reference chapter, page, paragraph | Commented extract | Reason for proposed change | Proposed amendment | Remarks |
|---|---|---|---|---|---|
| 56 | Selected significant events based on CVR and FDR (1.11.4), page 43, Figure 27 | <b>Figure 27: The aircraft attitude at the highest pitch angle.</b> | The time indicated on Figure 27 is 23:17:25 UTC, but in the FDR data, the highest pitch angle is at 2317:32 UTC. | The BEA suggests replacing the animation snapshot of Figure 27 with the equivalent one at 23:17:32 UTC and modifying the values in the associated table. | Accepted |

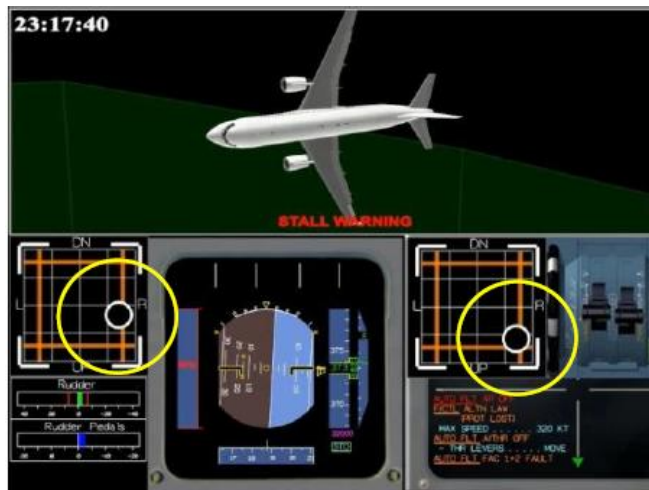
Figure 28: Aircraft in upset<sup>13</sup>situation

| Time (UTC) | From | To | Description |
|---|---|---|---|
| | | | The left side stick input continued until the end of recording. Dual input on the side sticks continued until the end of recording. |

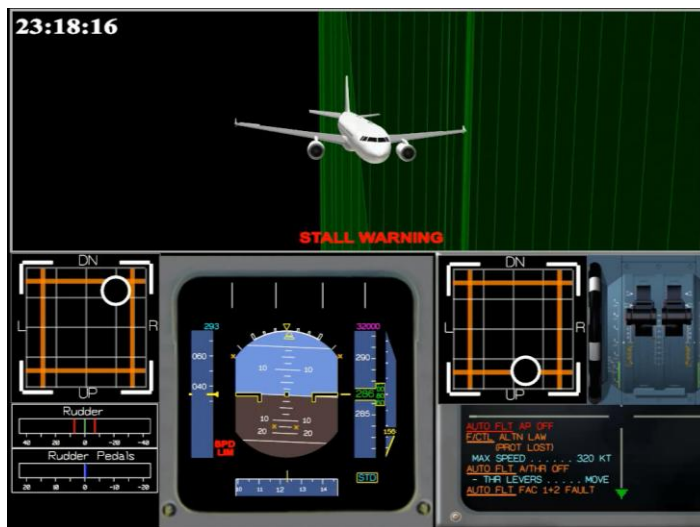
Figure 29: Attitude recovered

| Comment Reference | Reference chapter, page, paragraph | Commented extract | Reason for proposed change | Proposed amendment | Remarks |
|---|---|---|---|---|---|
| 57 | Selected significant | <b>Figure 29: Attitude recovered.</b> | The animation snapshot does not | The BEA suggests replacing the animation | Accepted |
