Steep Climb and Uncontrolled Descent During Takeoff  
National Air Cargo, Inc., dba National Airlines  
Boeing 747 400 BCF, N949CA  
Bagram, Afghanistan  
April 29, 2013

**Accident Report**

NTSB/AAR-15/01  
PB2015-104951

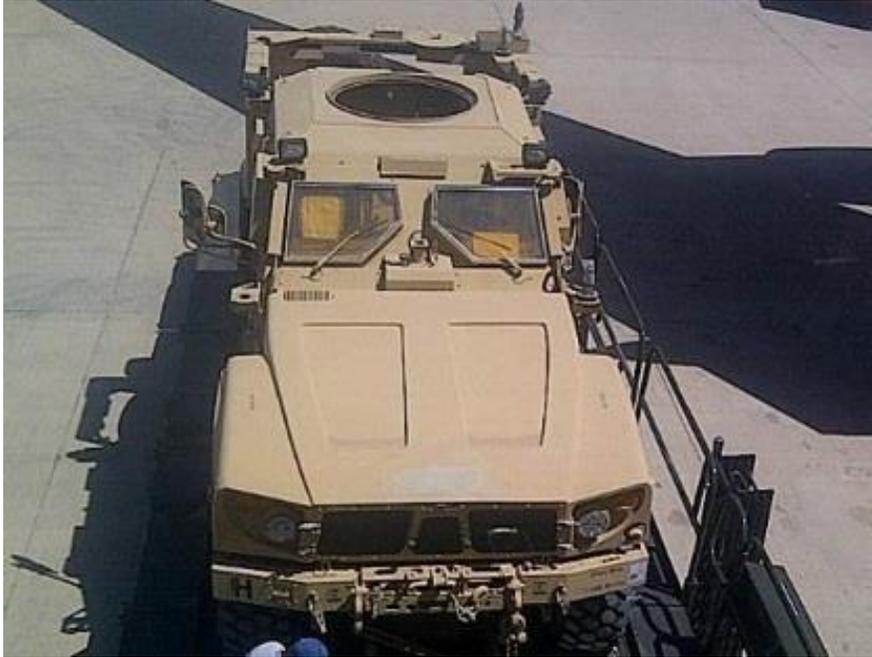
**Figure 1.** Photograph of one of two M-ATVs (secured by chains to its respective pallet) during loading onto the accident airplane via a side door aft of the left wing.

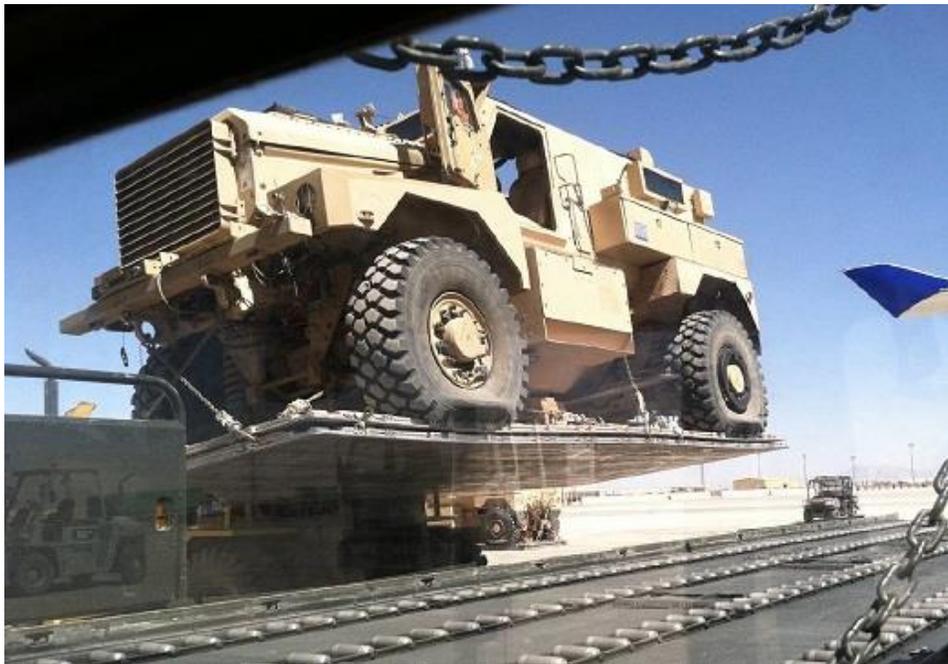
**Figure 2.** Photograph of one of three Cougars (secured by chains to its respective double-pallet platform) during loading onto the accident airplane via a side door aft of the left wing.

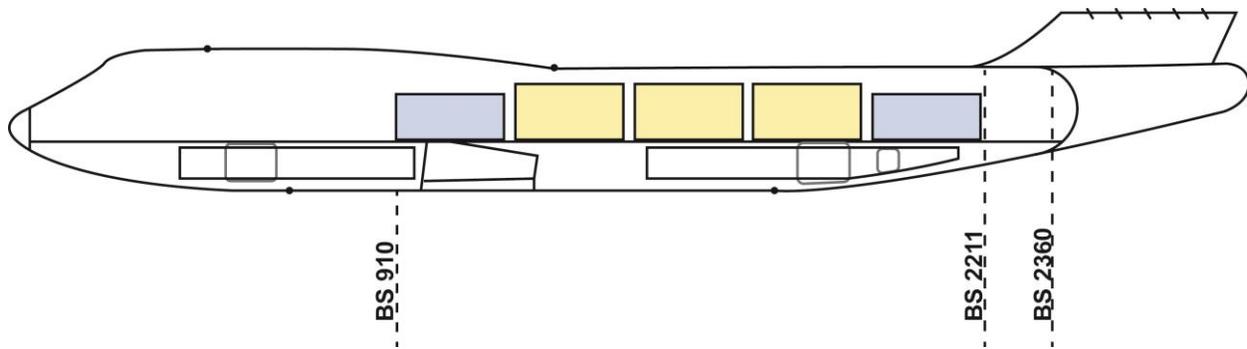
**Figure 3.** Diagram showing the loaded positions of the two M-ATVs (blue) and three Cougars (yellow) with respect to select airplane body station (BS) locations.

**Note:** All of the vehicles were loaded facing forward. All depicted locations are approximate. The back of the rear M-ATV was located about BS 2211, and the front of the forward M-ATV was about BS 910. BS 2360 corresponds with the location of the airplane's aft pressure bulkhead.<sup>6</sup>

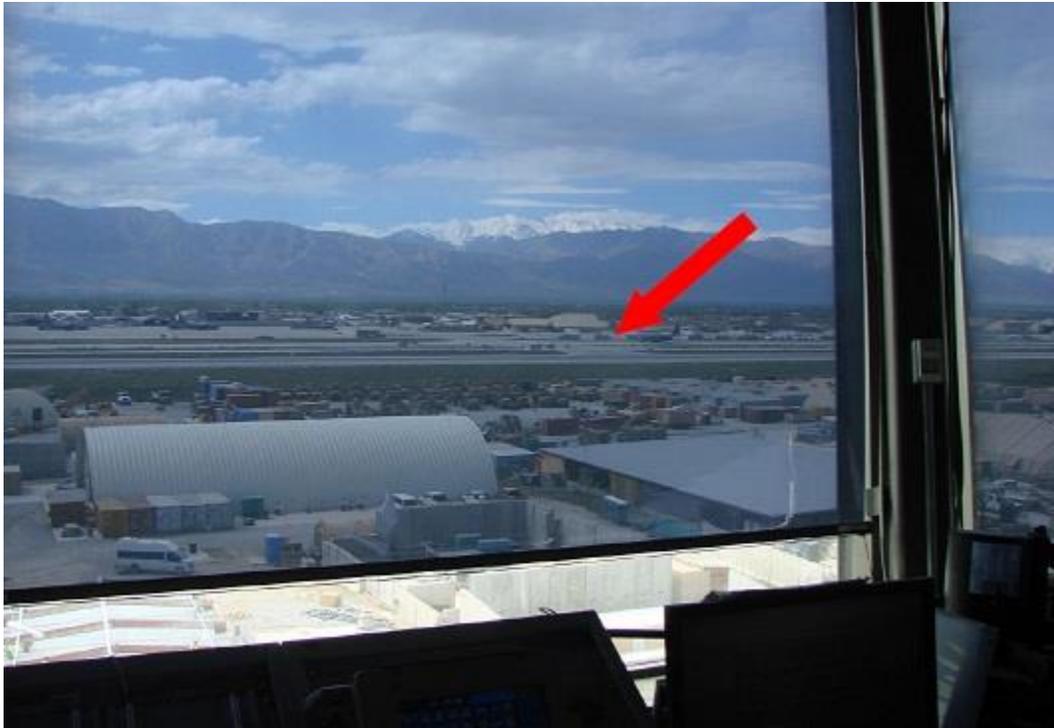
**Figure 4.** Photograph showing the view from the Bagram control tower looking west toward runway 3.

**Note:** The accident airplane departed to the north (from left to right). The red arrow indicates the location of the taxiway C intersection, near where the airplane reportedly rotated.

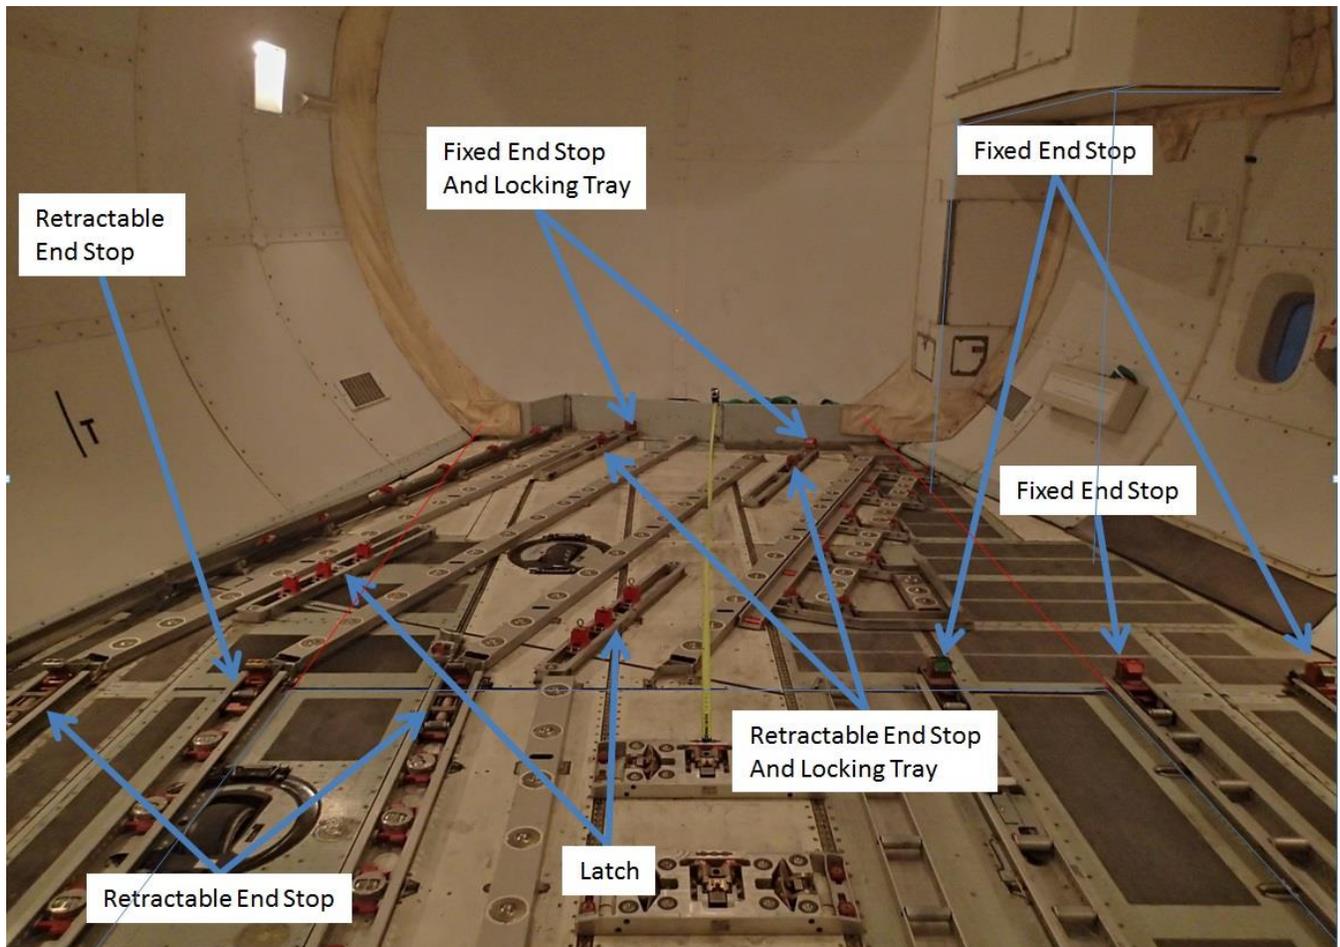
**Figure 6.** Photograph of a section of main deck flooring in the back of an exemplar airplane, looking aft.

**Note:** The locations of various fixed and retractable end stops and latches of the cargo handling system are noted with blue arrows. Note: The CVR and FDR shelf is in the upper right corner of the picture.

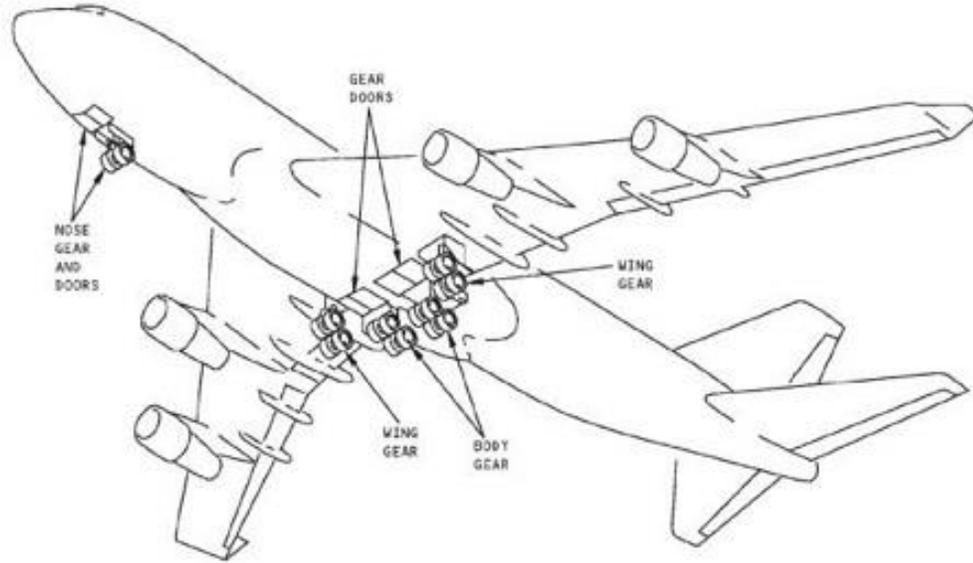
**Figure 14.** Diagram showing the respective locations of the nose, wing, and body landing gear on a Boeing 747-400 BCF.

The image study used Autodesk Softimage 2013 to compare the image data to a three-dimensional model of the airplane. The study found that, during the portions of the flight captured by one or more cameras, the airplane's left wing landing gear was not visible, consistent with it being in the retracted position. The right body landing gear, left body landing gear, and nose landing gear were visible (captured by one or more cameras), consistent with them being in the extended position. The study also found that the nose landing gear door was visibly protruding, consistent with the fully open position (see figure 15).

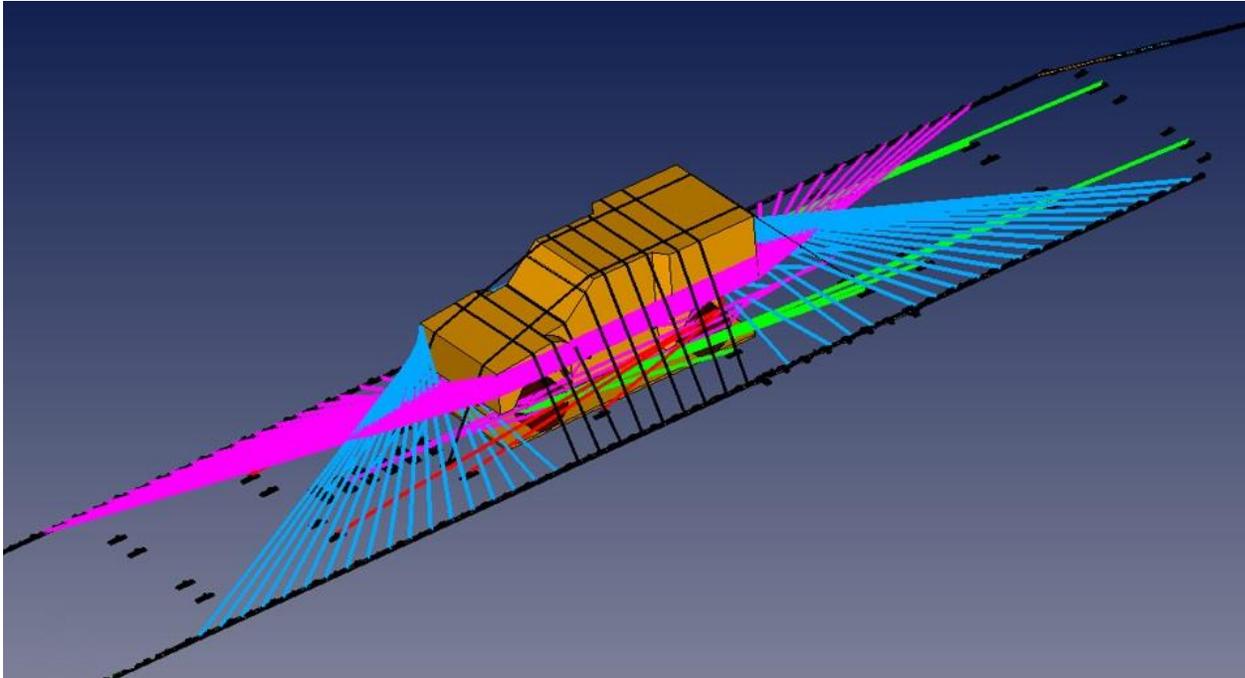
After the accident, both Boeing and Telair performed studies to determine if it was possible to transport centerline-loaded MRAP vehicles on pallets in compliance with the TRC requirements. In its study, Boeing determined that one centerline-loaded M-ATV on a G-code floating pallet could be transported in accordance with the guidelines in the Boeing and Telair weight and balance manuals. The study determined that, to meet the TRC requirement, the M-ATV must be positioned no farther forward than BS 1281, secured by 60 5,000-lb-rated tie-down straps, and be positioned aft of a specified quantity of frangible cargo in ULDs (see figure 16).

**Figure 16.** This line drawing provides an exemplar configuration showing how about 60 straps could secure a M-ATV to approved floor structures.

The study found that no centerline-loaded Cougars on G-code floating pallets could be secured and transported in the airplane in accordance with the weight and balance manual because the vehicle would have to be positioned aft of BS 1480 and would exceed the structural strength limitations of the main deck cargo floor in that area.
