**AIRCRAFT ACCIDENT REPORT 3/91**

**Air Accidents Investigation Branch**

**Report on the accident to  
Lockheed L1011-500, C-GAGI  
1 nm south east of Manchester,  
Cheshire on 11 December 1990**

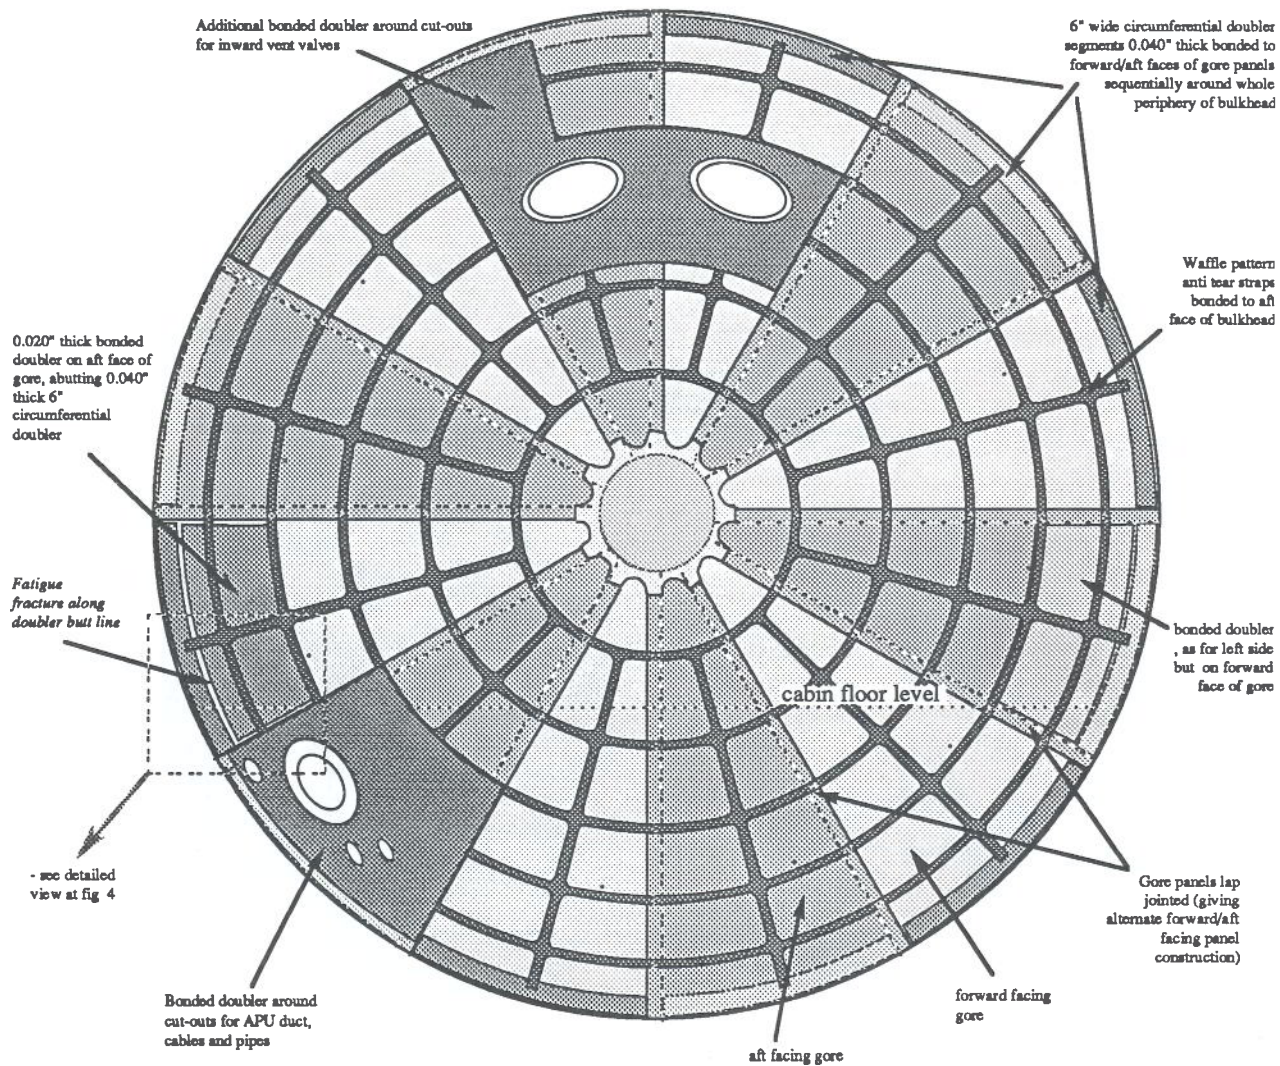
**Figure 2**  
**Rear pressure bulkhead constructional details**  
 Viewed from rear

Constructional details are shown in fig 2. The gore panels were lap jointed alternately on the forward and aft sides of the nominal membrane surface, producing a 'handed' form of construction. A series of radial and circumferential anti-tear straps, bonded in a typical 'waffle' pattern to the aft face of the bulkhead, subdivided each of the gore panels into ten elements of approximately rectangular shape.

Around the outer circumference of the bulkhead, adjacent to its attachment to the fuselage proper, were a series of 6 inch wide by 0.040 inch thick doublers bonded to the forward/aft surfaces of each gore panel, mirroring the constructional form of the gore panels proper, as indicated in fig 2. Additional doublers 0.020 inch thick were bonded to the 8-9 o'clock and 3-4 o'clock gore panels at cabin floor level, abutting the 6 inch wide circumferential doubler, and extending inboard to approximately the 1/3rd radius position (*ie* over the two outermost grid panels formed by the anti-tear straps). Because of the handed nature of the gore panel lap-joints, these doublers and the adjacent 6 inch wide edge doublers were on the aft face of the gore panel on the left hand side of the aircraft, and on the forward face on the right hand side.
