Aviation Occurrence Report Volume I

ASC-AOR-05-02-001

IN-FLIGHT BREAKUP OVER THE TAIWAN STRAIT

CHINA AIRLINES FLIGHT CI611

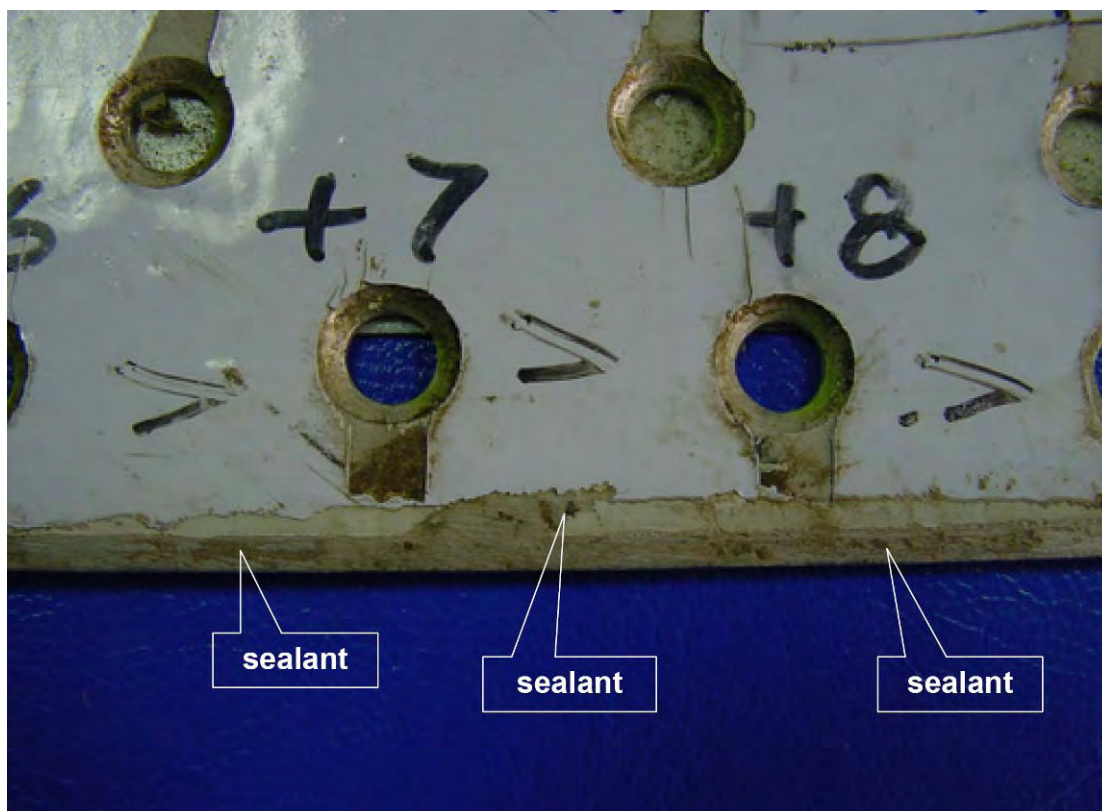
Figure 1.6-11 Paint removed from the doubler edge with sealant remaining

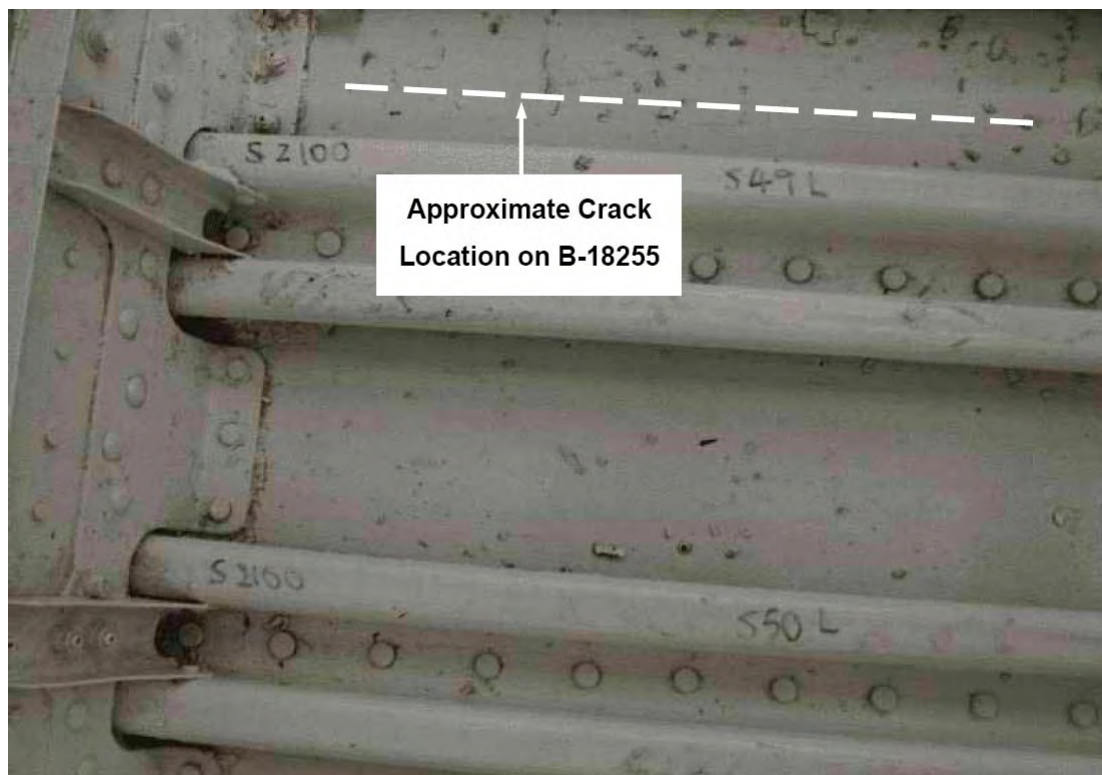
Figure 1.6-12 shows a B747-200 freighter bilge after cleaning. Figure 1.6-13 shows the bilge before corrosion inhibit compound and dust was removed from a B747-400 freighter. The stain on the lower lobe skin cover part of the paint. The bilge was covered with dirt and residue on two adjacent insulation blankets in the bulk cargo lower lobe bay.

Figure 1.6-12 A B747-200 aircraft bilge area with the CIC and dust removed

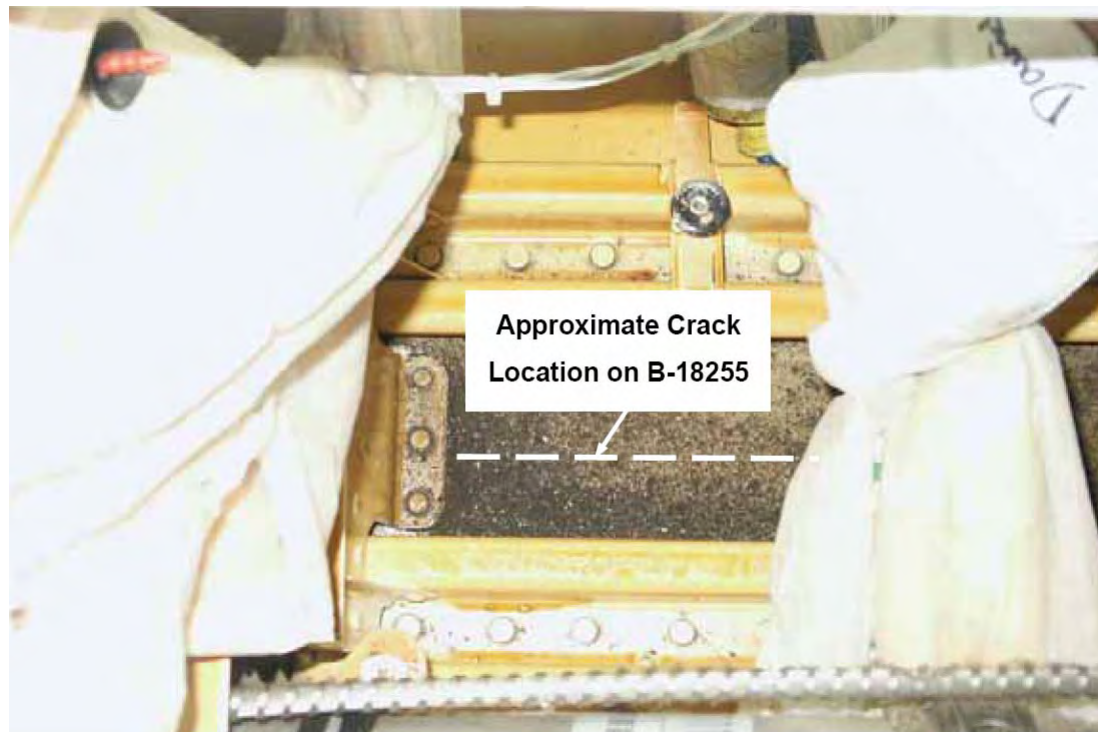
Figure 1.6-13 A B747-400 aircraft bilge area without removing CIC and dust

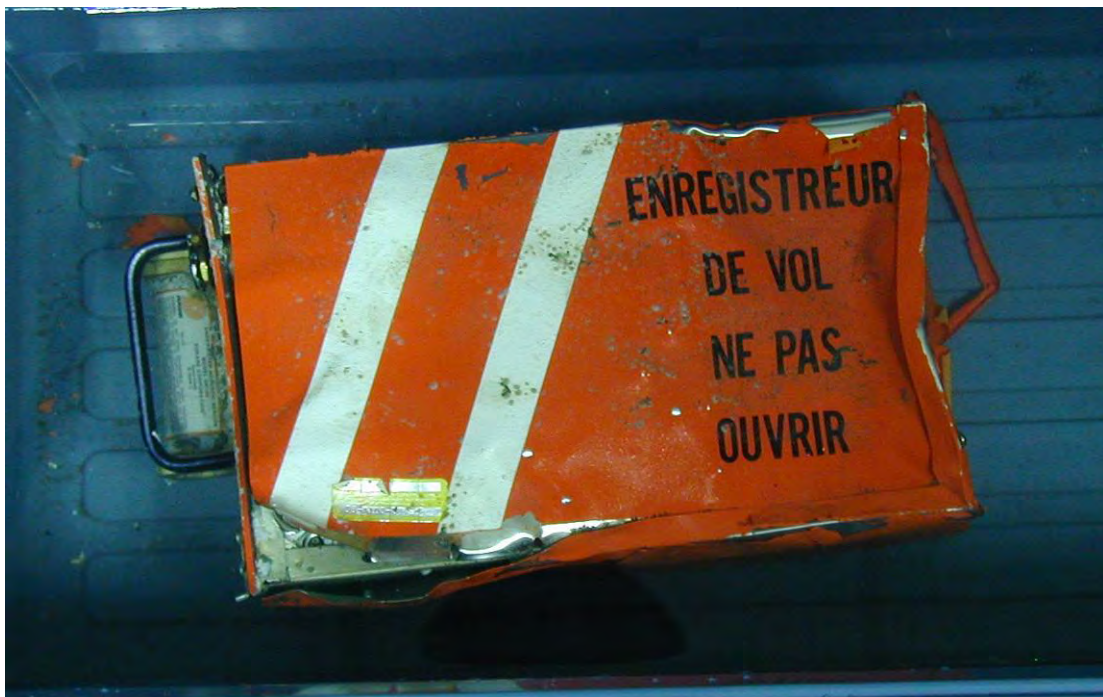
Figure 1.11-1 Damaged CVR in the water cooler

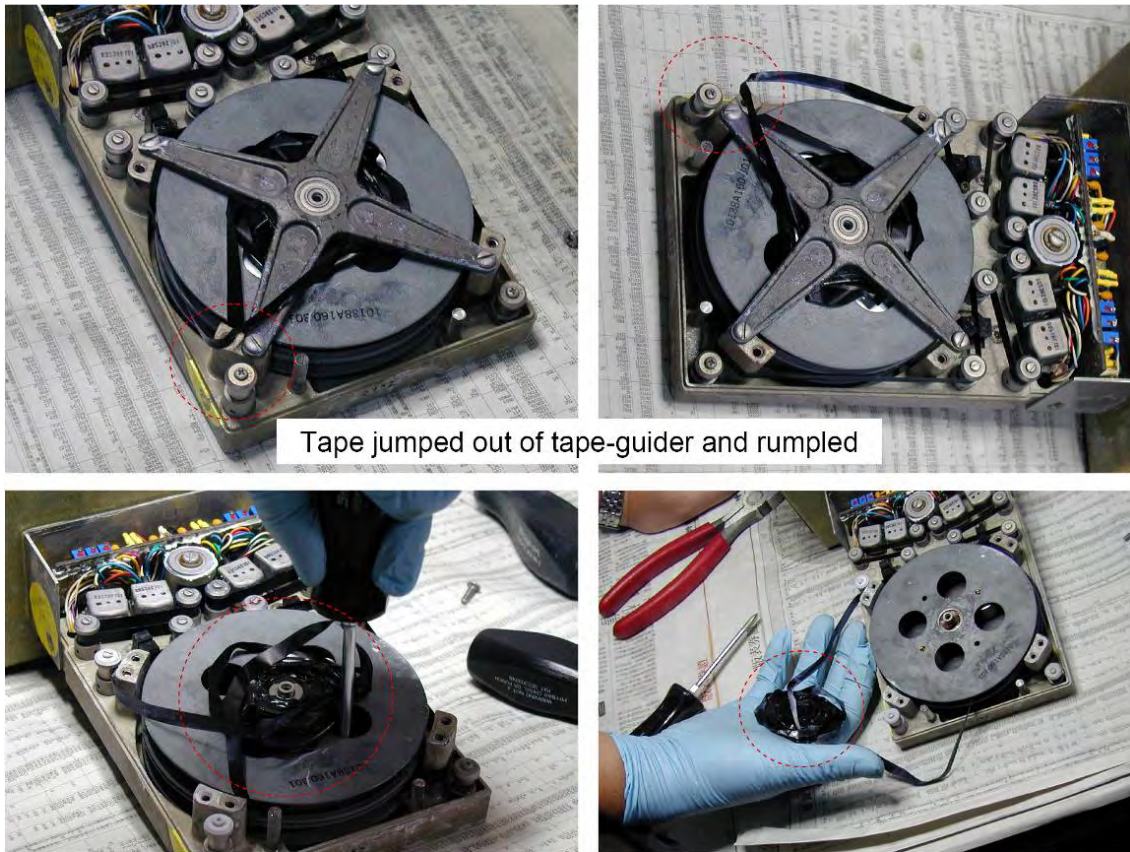
Upon arrival, the FDR enclosure was open immediately and the magnetic tape was found damaged. Pictures of the damaged FDR tape are shown in Figures 1.11-3 and 1.11-4. There are six crinkle marks on the tape.

Figure 1.11-3 Photographs of damaged magnetic tape

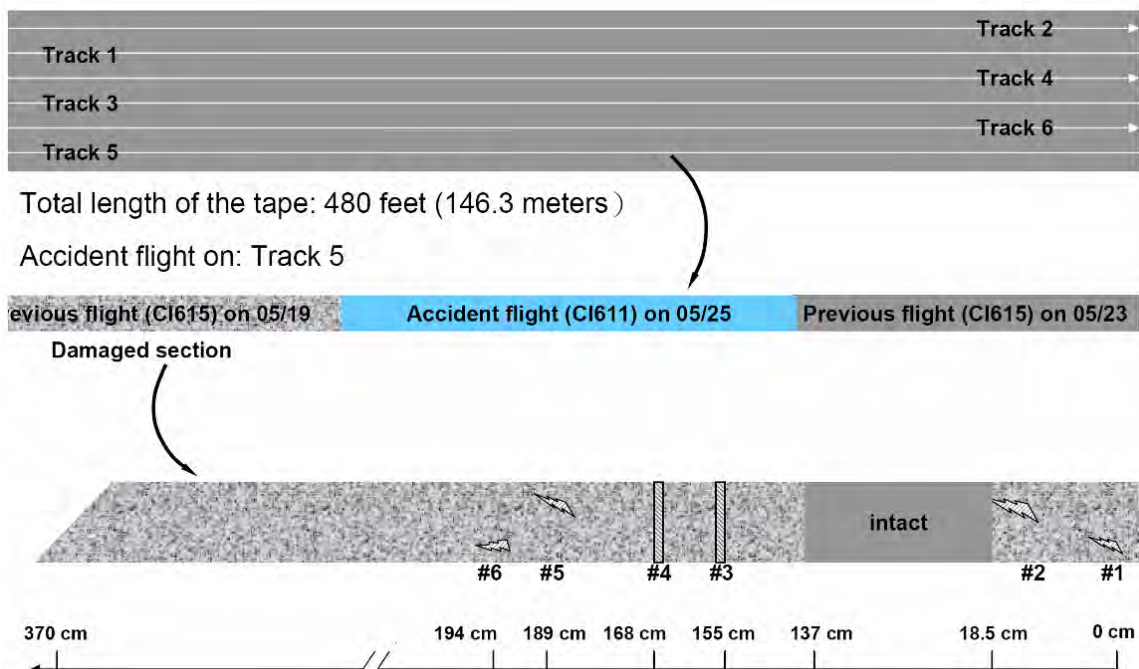
Figure 1.11-4 Sketch of damaged tape locations and conditions

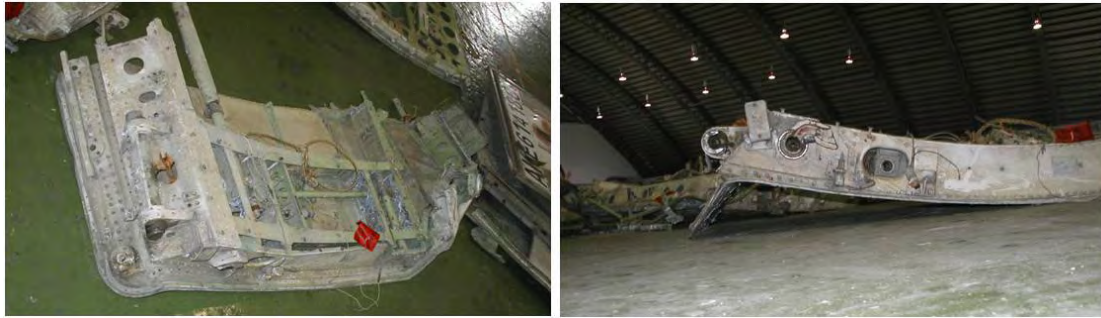
Figure 1.12-5

The lower aft portion of the door (item 2019 in Figure 1.12-5), including the aft pair of latches, was found separately. The lower portion of the door skin was bent

outboard approximately in 45 degrees. Examination of the hinge, latches, and the other mechanisms was consistent with the aft cargo door being closed at the time of the aircraft breakup.

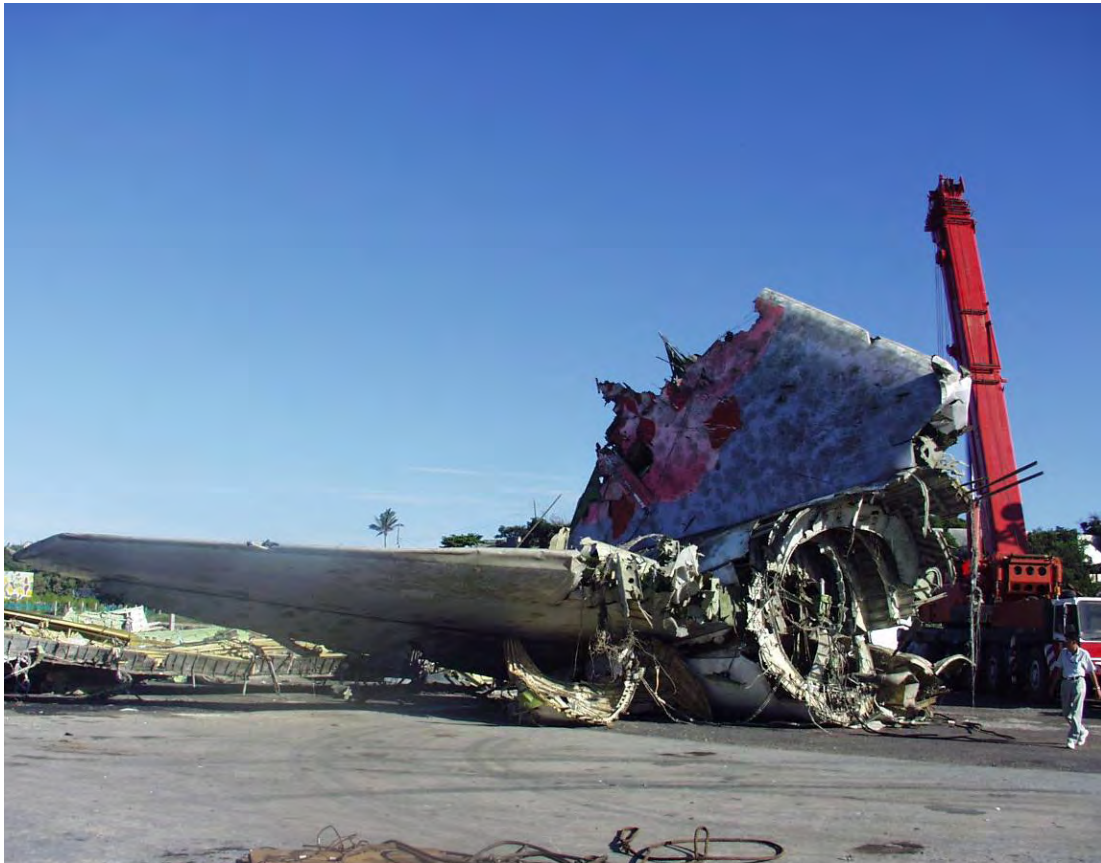
Figure 1.12-9 Item 630

The section 48 and empennage structure (the aft pressure bulkhead and all structure aft) was found in the red zone (Figure 1.12-8). The horizontal stabilizer, the majority of the skin/stringer/bulkhead structure, and the lower third of the vertical fin were found attached with very little damage (Item 630, Figure 1.12-9).

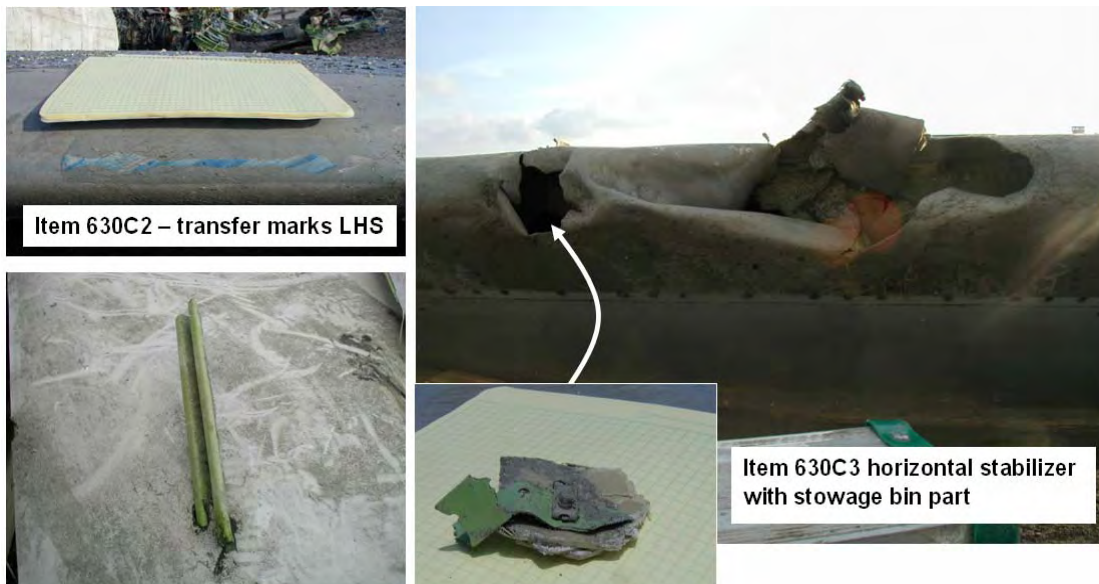
The right horizontal stabilizer (RHS) is considerably more damaged than the left horizontal stabilizer (LHS). The inboard portion of the RHS leading edge is deformed upwards. At the root of the RHS, the inboard 10 feet showed considerable impact damage along with upwards deformation of the compromised structure. A portion of seat support was found inside a puncture common to the lower surface of the LHS. A small segment of fuselage stringer was also found imbedded in the RHS elevator (Figure 1.12-10 left-down). A small fastener and shim from a stowage bin assembly were found inside a puncture common to the RHS leading edge (Figure 1.12-10 right).

Figure 1.12-10 A small segment of fuselage stringer imbedded in the RHS elevator (left-down). A small fastener and shim were found inside the RHS leading edge (right).

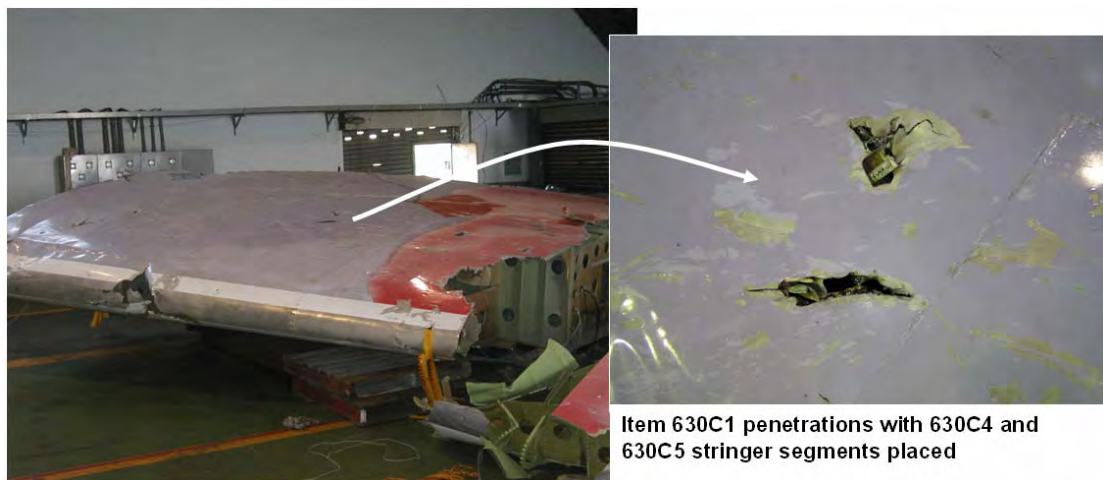
Figure 1.12-12 Item 630C1

The lower portion of the fin (item 630C1), the upper portion of the fin (item 2035), and several of the floating pieces (item 22) show similar evidence of impact damage on the right side.

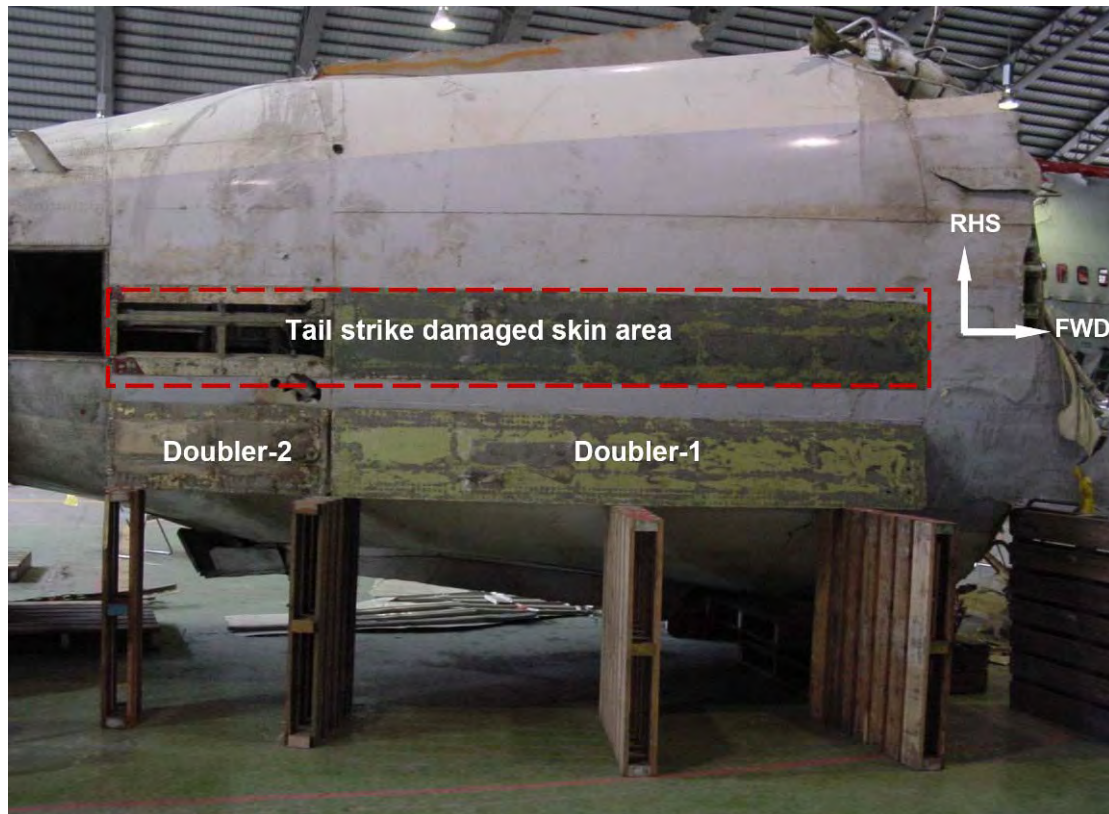
Figure 1.12-13 Doublers in section 48

The belly area of item 630 between STA 2484 to STA 2658 was examined, and two adjacent doublers were removed during wreckage examination as shown in Figure 1.12-13.

The B-18255 Aircraft Log Book stated the belly skin area between STA 2578 to STA 2638 had serious abrasion damage. Examination of the skin underneath the two doublers revealed that, skin underneath Doubler-1¹⁸ (STA 2484 to 2598) had damage consisting of fore to aft (longitudinal) scratching with the most severe scratching at the locations of skin stiffening members. The damaged area had not been cut out or removed (trimmed), however, blending was found over much of the repair surface. Skin beneath the Doubler-2 (STA 2598 to STA 2658) was cut out as shown in Figure 1.12-13.

and starts from STA 2535 with the length of 42 inches. No evidence of crack was identified in this region. There are dents at STA 2567 and STA 2610, which was the result of wreckage handling.

It was noted that the former topcoat, enamel and primer (original painting before the skin repair) remained on the skin covered by Dubler-2.

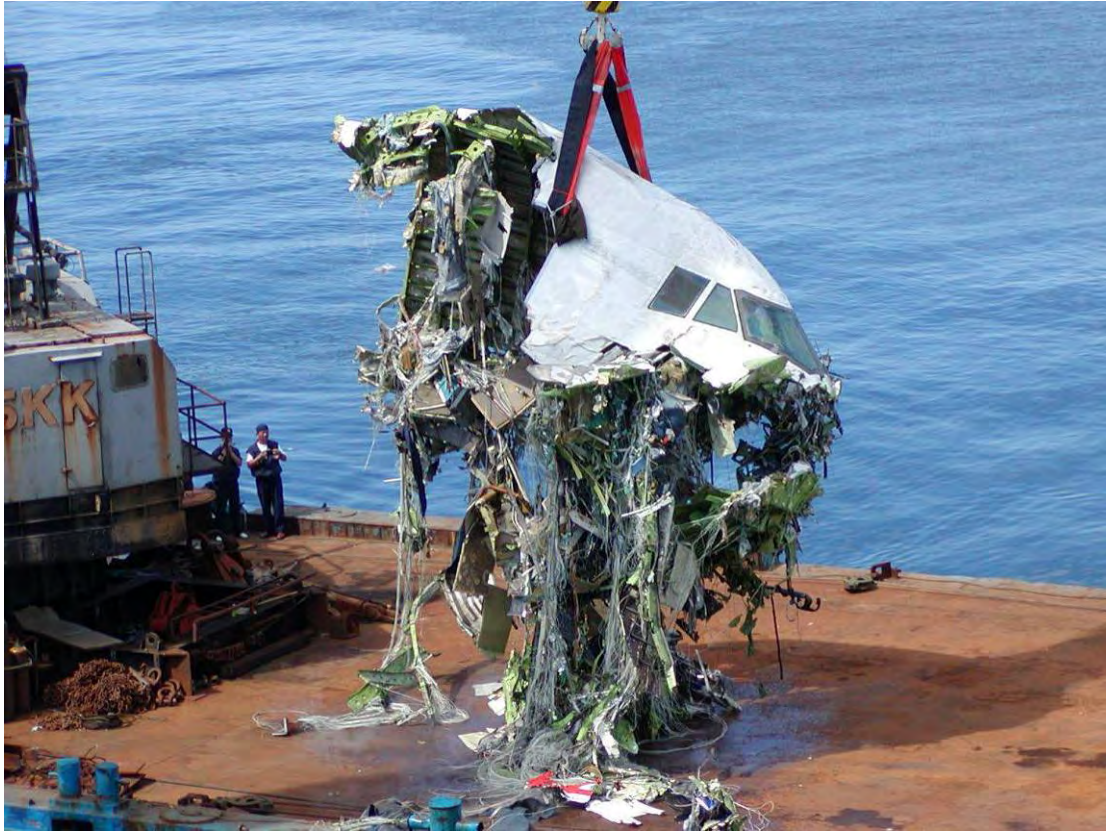
Figure 1.12-16 Cockpit section

The cockpit section was recovered relatively intact (Figure 1.12-16). The pilots' and the flight engineer's instrument panels remained attached to the cockpit section with wire bundles. The entire cockpit section was brought to the dock. Later, the cockpit section was lifted with a crane and the instrument panels were removed.

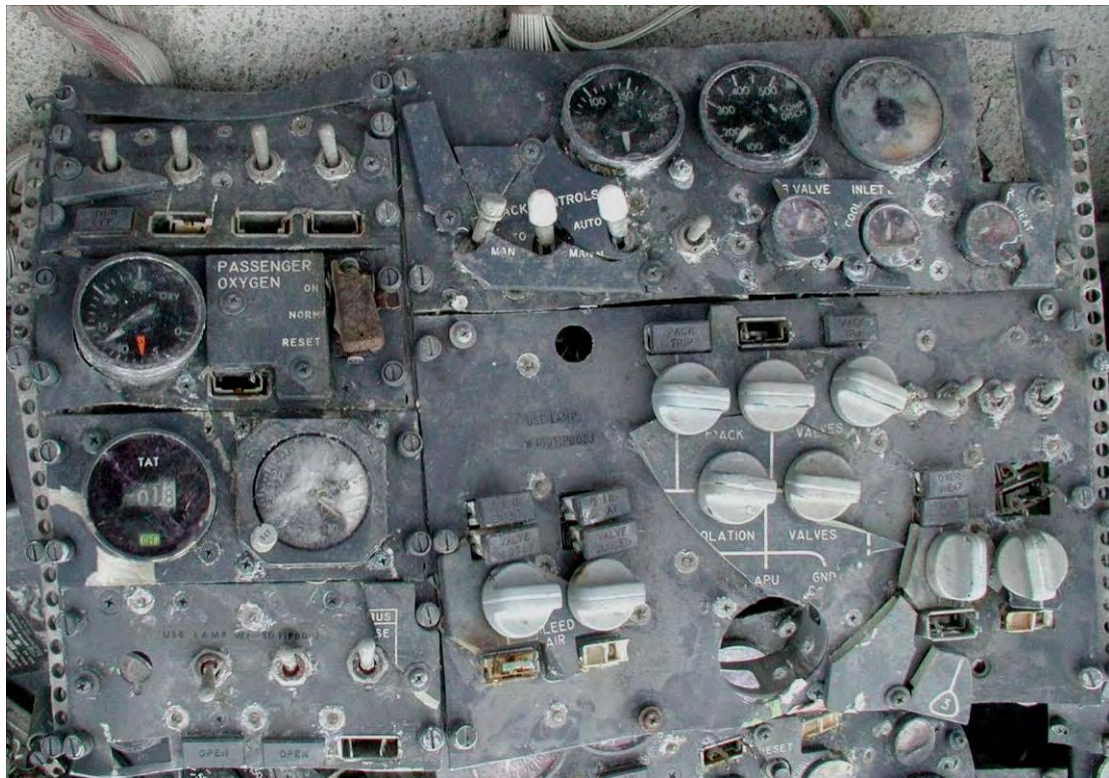
Figure 1.12-17 Flight engineer panel

Flight Engineer Panel is shown in Figure 1.12-17.

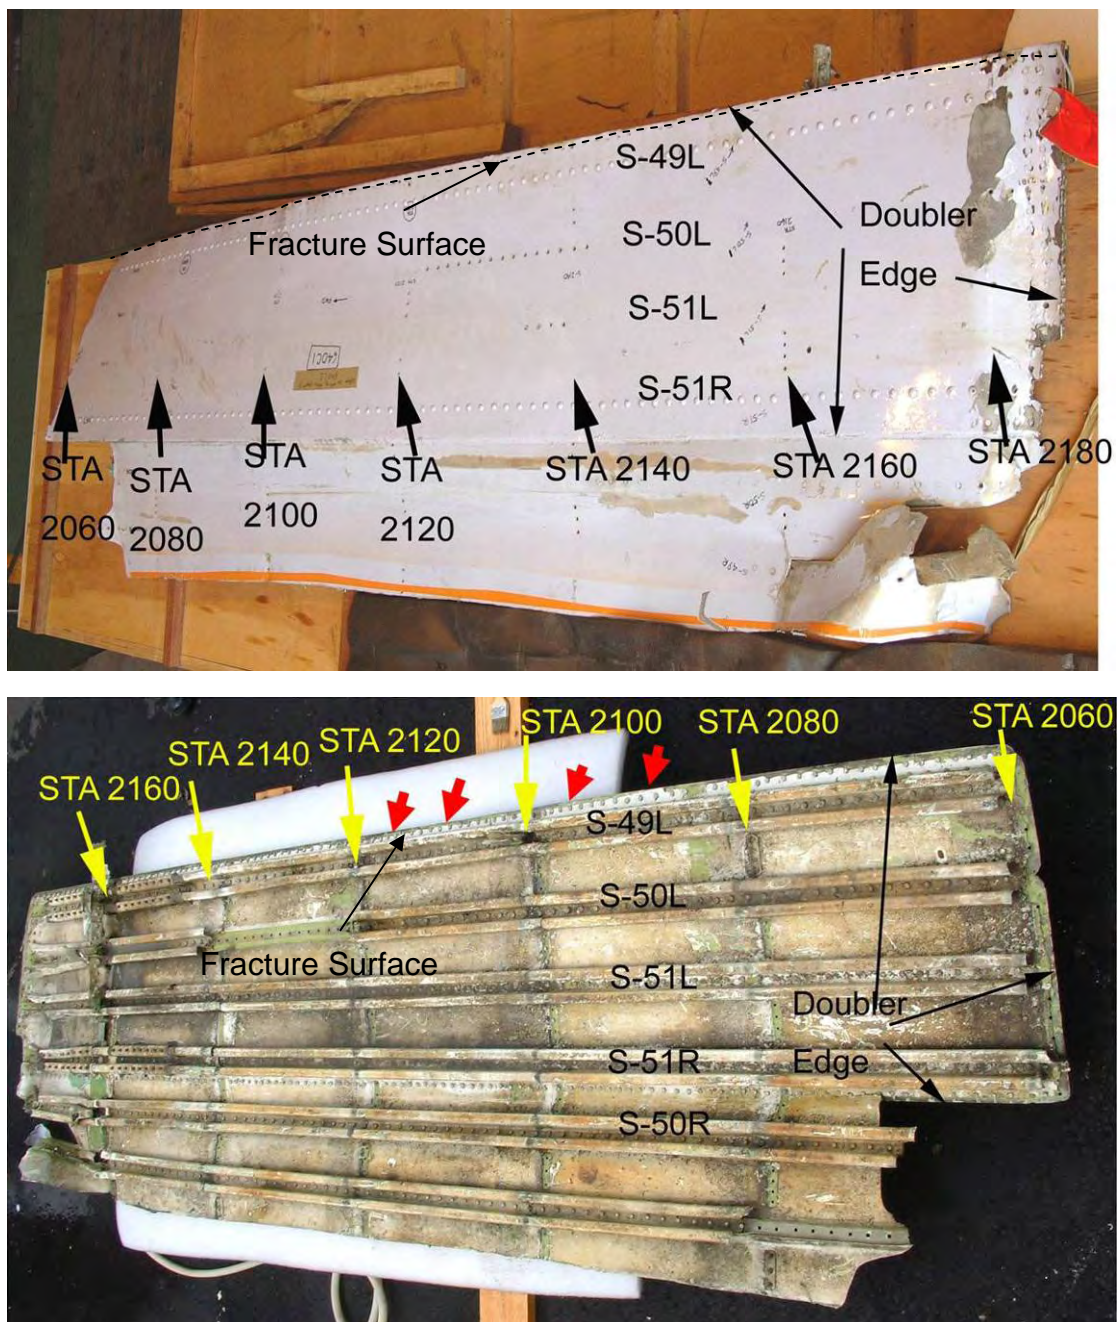
Figure 1.16-1 Exterior (up) and interior (down) of Item 640C1

Item 640C1 was a segment of Item 640 approximately from STA 2060 to 2180 and from S-49L to S-49R (Figure 1.16-1). A 23-inch wide, 125-inch long external repair doubler was attached to the skin by two rows of countersunk rivets around its periphery as well as by fasteners common to the stringer and shear tie locations. Universal head rivets were used at S-51R and S-49L while countersunk rivets were used at S-50L and S-51L.

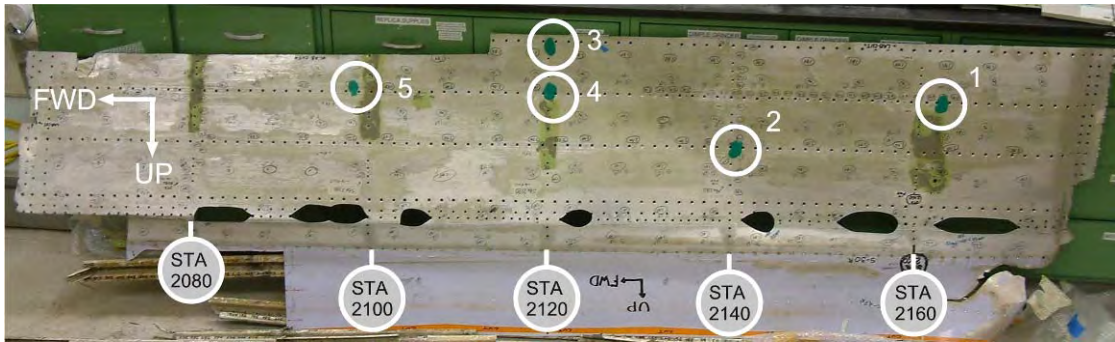
Figure 1.16-4 Locations chosen for scratch depth measurement

Five locations exhibiting major scratches on the repair faying surface of the skin as shown in Figure 1.16-4, were chosen for the examination of the scratch geometry and depth. The maximum scratch depth measured in each location is shown in Table 1.16-1.

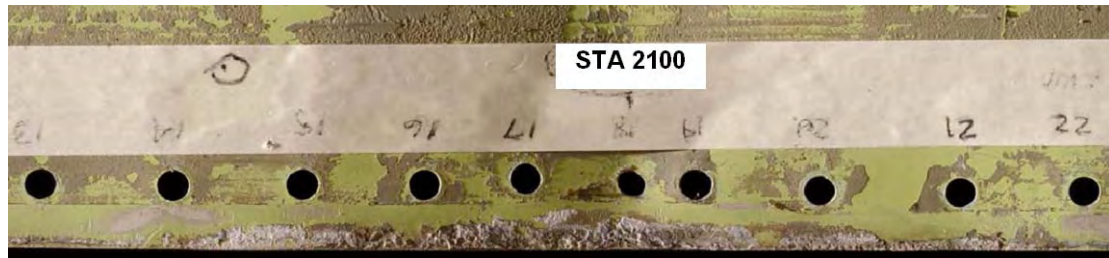
Figure 1.16-6 Light colored deposit on the faying surface of the repair

A light colored deposit was noted on the overhanging portion of the faying surface of the doubler above the fracture surface at S-49L as shown in Figure 1.16-6. Low power optical examination of this area revealed that this light colored deposit had a similar appearance to the light blue exterior paint applied to the doubler. Organic analysis utilizing Fourier Transform Infrared

Spectroscopy (FT-IR) of the deposit revealed that the spectra of the light colored deposit matches with the reference light blue exterior paint on the doubler (Figure 1.16-7).

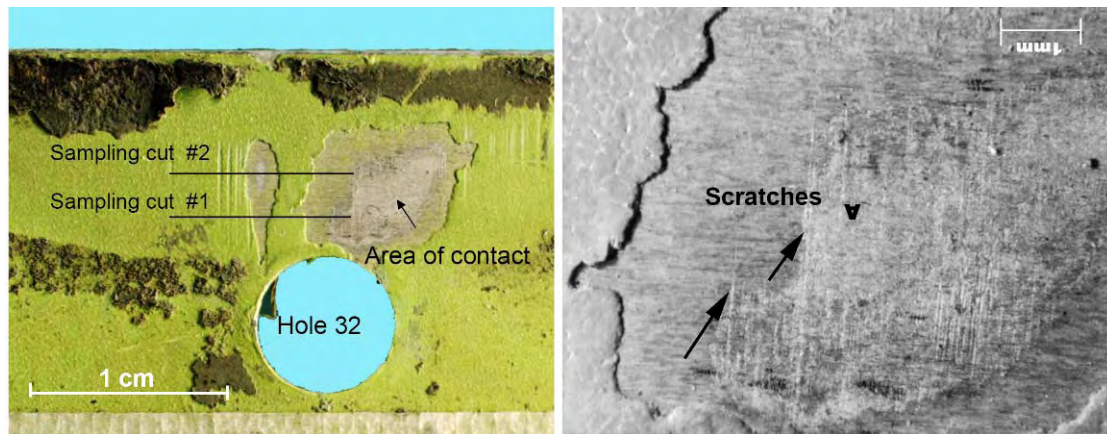
- The fretting marks observed from STA 2061 (hole +16) to STA 2132 (hole 49) are associated with most of the rivet locations. The most significant fretting damage was present between holes 8 and 43.
- The fretting marks near hole 32 and an optically magnified photograph of the area of contact is shown in Figure 1.16-9. It shows that the area of contact exhibits many colors and some hoop-wise scratches (marked by arrows).
- Two cross-section locations were chosen to characterize the area of contact. Figures 1.16-10 and Figure 1.16-11 show the metallographic photographs through the area marked by data sampling cut #1 and data sampling cut #2 respectively. It is observed that there was some material superimposed over the grooves of the scratches.

Figure 1.16-9 Area of contact near hole 32 showing the different colors (left) and scratches present (right)

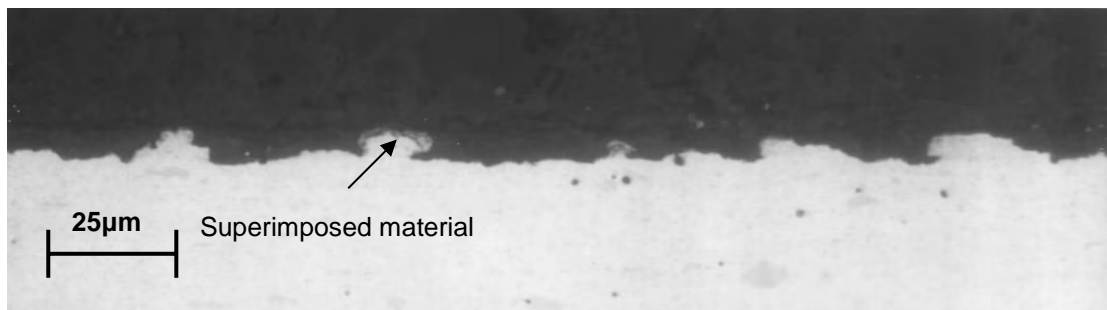
Figure 1.16-10 Metallographic photograph of the profiles marked by data sampling cut #1 in Figure 1.16-9

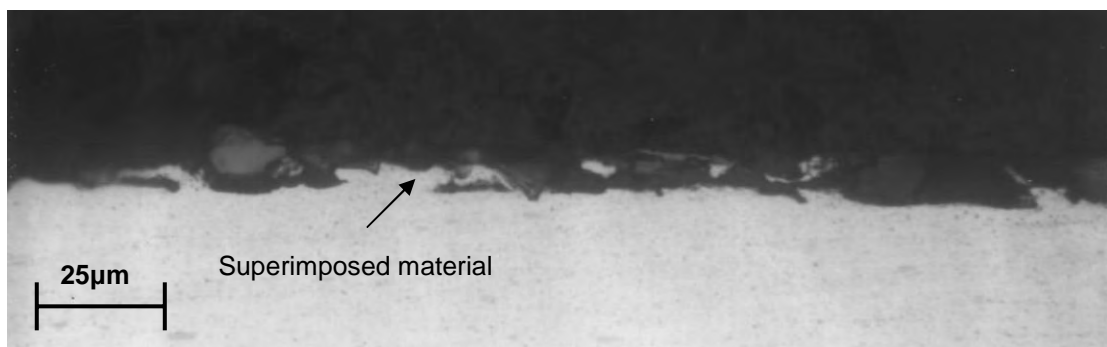
Figure 1.16-11 Metallographic photograph of the profiles marked by data sampling cut #2 in Figure 1.16-9

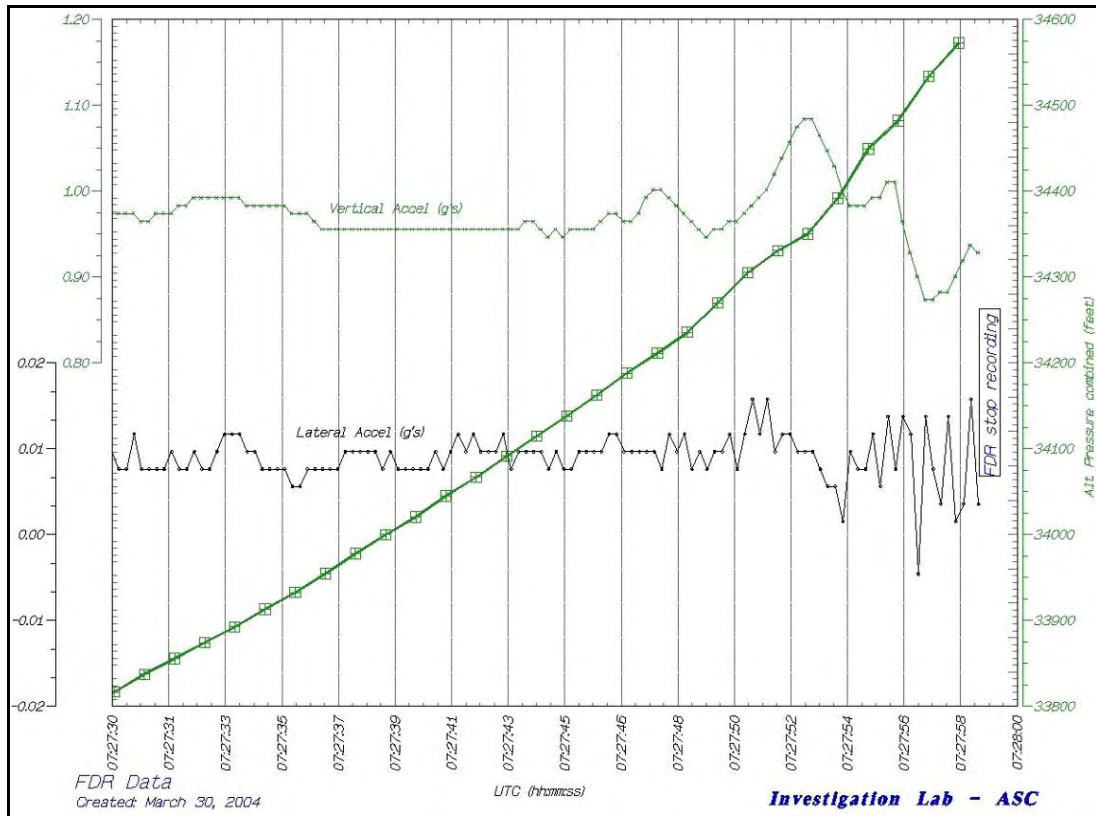
By carefully examining the acceleration data from the FDR, one can observe that 10 seconds prior to the loss of power of the flight recorders, there was a slow increase in both the vertical acceleration and lateral acceleration, as shown in Figure 2.1-1. By comparing the lateral acceleration parameter of the previous two flights of B-18255, before approaching its cruising altitude of 35,000 ft, similar oscillatory behaviors were found, as shown in Figure 2.1-2. Comparison was also made of the vertical acceleration parameter of CI611 and the two previous flights. A more pronounced increase in magnitude of the vertical acceleration was observed. These data led to the consideration that a preliminary breakup of the fuselage structure might have been in progress before the power loss of the FDR.

However, on Boeing 747 aircraft, the accelerometers are mounted along STA 1310, which is near the aircraft's center of gravity. These instruments measure accelerations of the aircraft associated with maneuvering, turbulence etc. They do not accurately measure the frequencies of vibrations that may pass through the fuselage. With the limited data available, the Safety Council could not determine what led to the slight increase in vertical acceleration prior to the break-up of the aircraft.

Figure 2.1-1 CI611 vertical and lateral acceleration data (last 30 seconds)

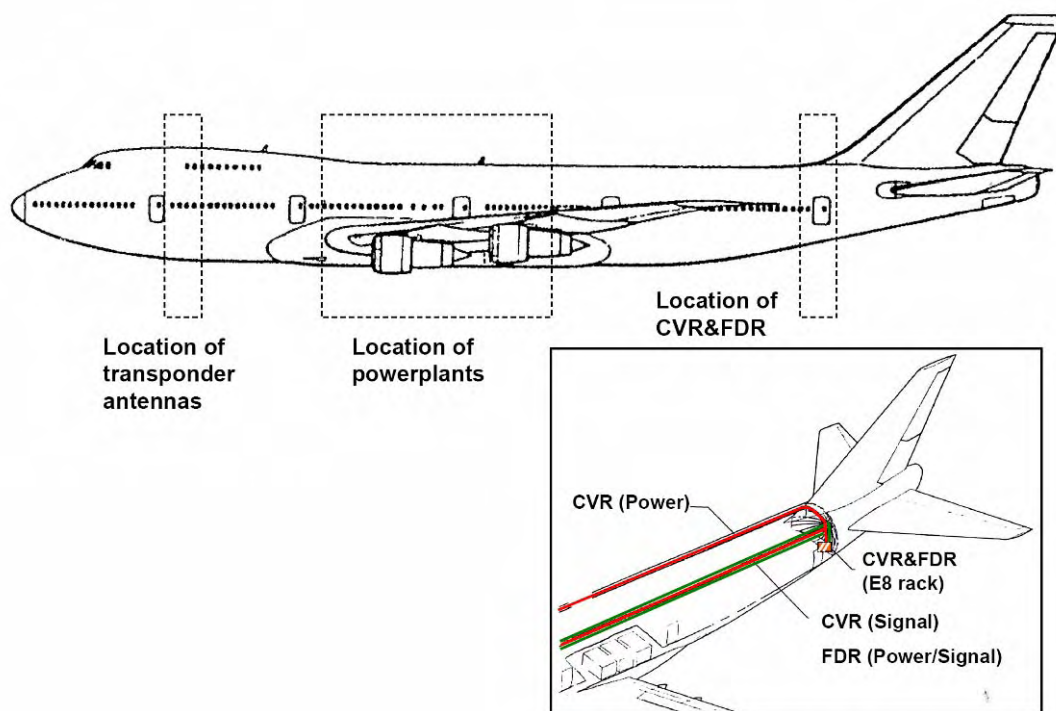
In addition, both recorders were located in the aft portion of the aircraft (above ceiling near to door 5L) and both transponder antennas were installed behind door 1 (Figure 2.2-1). The power of the CVR and FDR was interrupted simultaneously at 1527:59. However, the radar transponder continued to transmit for about 15 seconds longer. Therefore, the breakup should occur between the power plants and the recorders.

The Aviation Safety Council concludes that the loss of power to the CVR and FDR was the result of damage to electrical wires in the aft-pressurized fuselage area as the aircraft began to breakup. The forward portion of the aircraft continued to have power to the Mode-C transponder system for about an additional 15 seconds, before power to the transponder was interrupted.

Figure 2.2-1 Locations of flight recorders, transponder antennas, and power plants

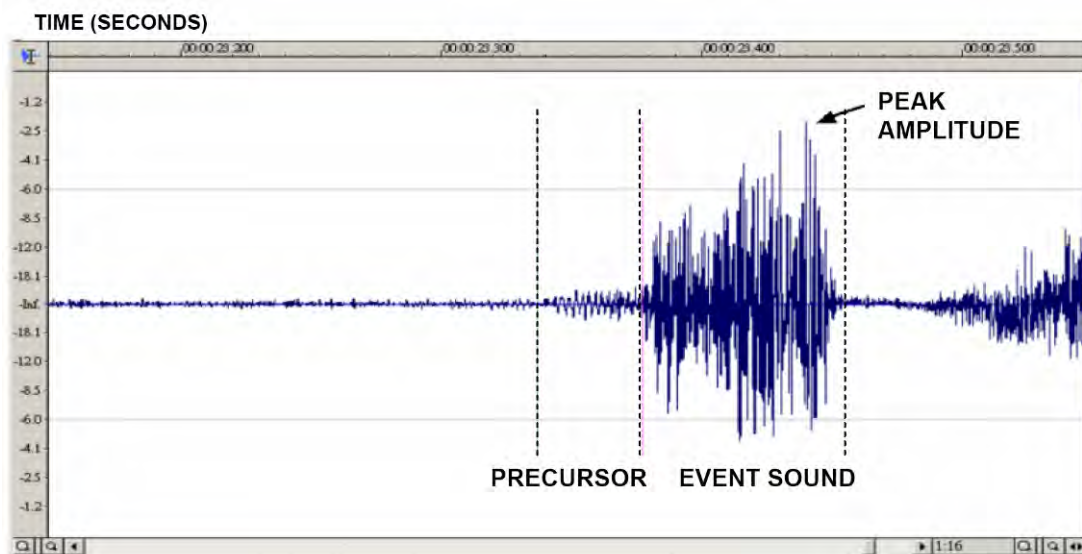
Based on different sound wave propagating speed via air and via the aircraft structure, the travel time of the sound wave from an event source via air or aircraft structure to reach a specific point on the aircraft are different, such time difference can be referred to as the precursor in the CVR recording. When the event source is away from cockpit, the arrival time of precursor to the CAM is always ahead of the event sound because the sound wave propagating speed in metal is much faster than in the air. Figure 2.2-2 shows the C1611 CVR recorded precursor and event sound signatures. By comparing both signatures can provide the possible propagation path of event sound.

Figure 2.2-2 Typical precursor and event sound signatures

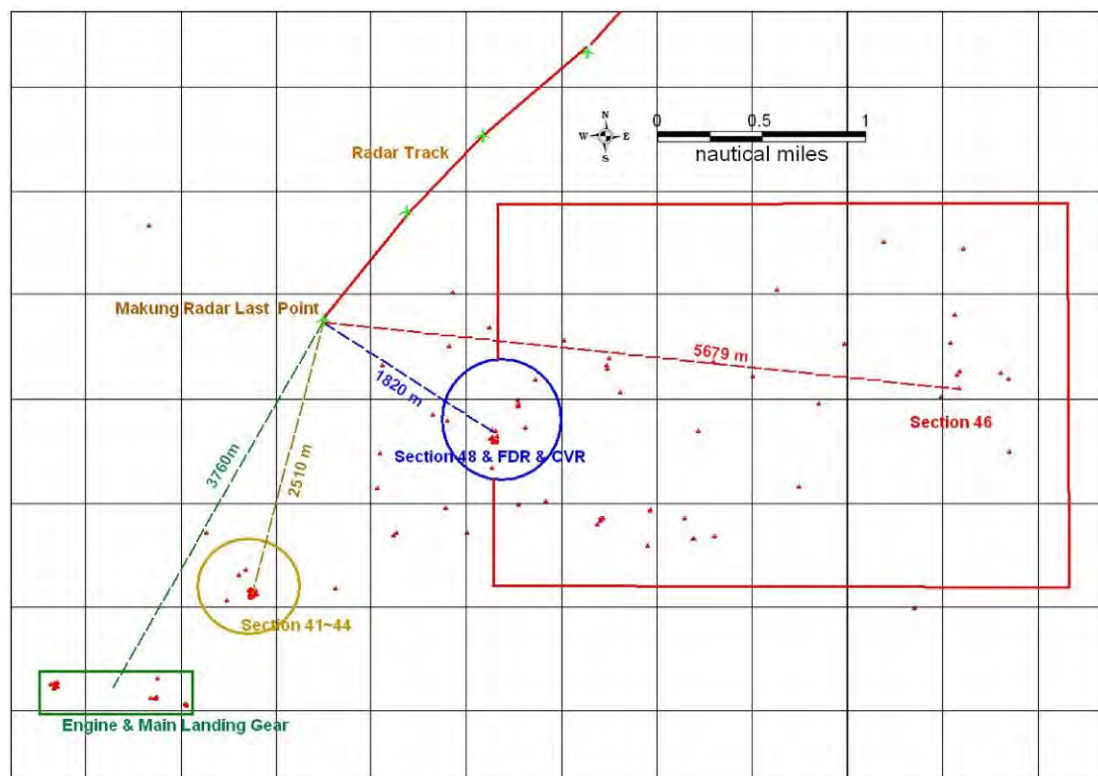
Figure 2.2-3 Relative location of the wreckage

Figure 2.2-3 shows the relative locations of the CI611 wreckage. The wreckage distribution pattern matches the four groups of aircraft wreckage detected by PSR.

The wreckage distribution data show that the distance between the tail (section 48 with lower portion of fin) and forward portion of fuselage (section 41-44) was 1.5 nautical miles. The distance between the tail and most eastbound wreckage (section 46), which was recovered under water, was 3 nautical miles.

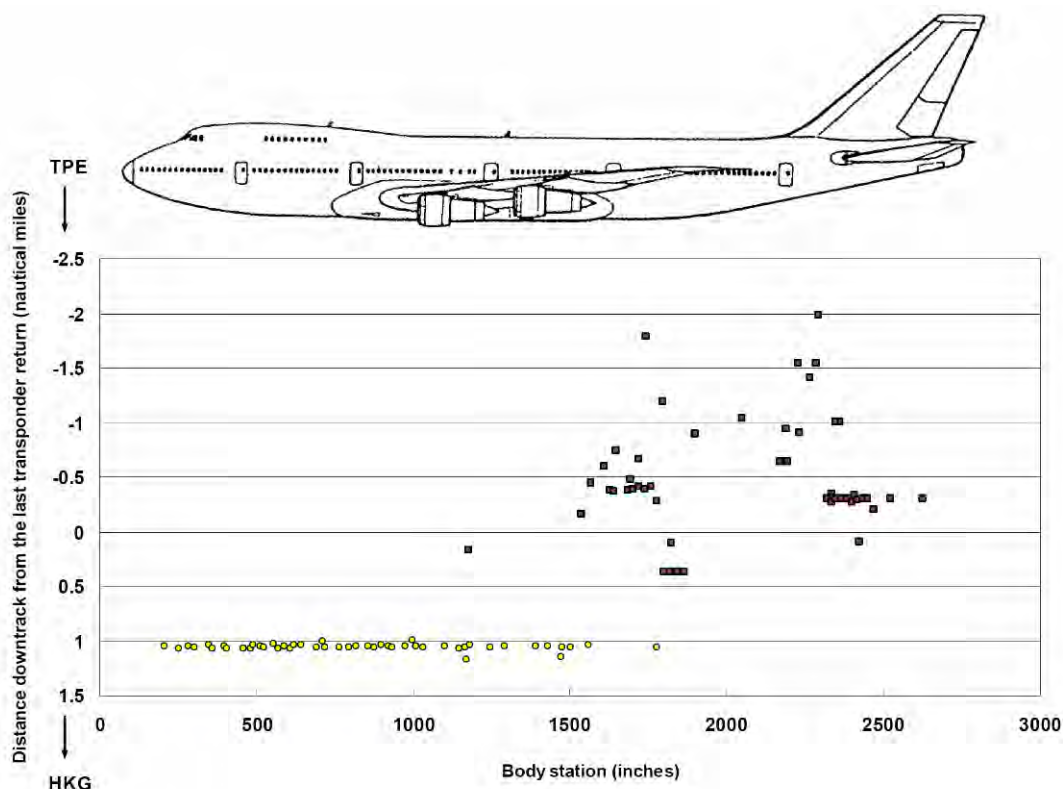
Figure 2.2-4 Wreckage distributions along the flight path

Hong Kong, which is shown in Figure 2.2-4. One can readily see that the wreckage pieces from the cockpit, engines, wings, all landing gears, and sections 41, 42, and 44 are distributed along a very concentrated segment while section 46, 48, and the tail empennage are spread widely.

The figure also shows a step jump from the forward portion of the aircraft to the aft sections. It shows that the fuselage section 46/48 structure aft of the aft wheel well bulkhead at STA 1480 was separated from the rest of the aircraft.

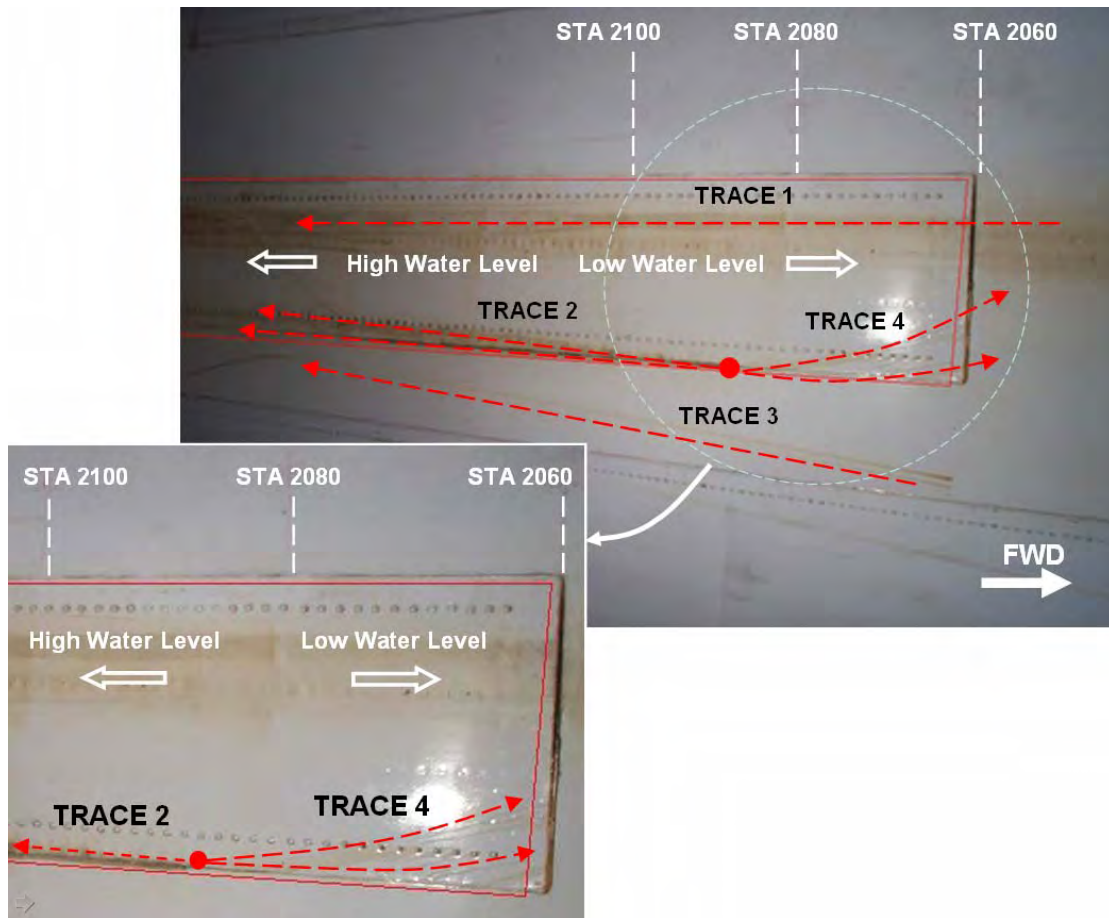
Figure 2.2-5 Comparison of Trace 1,2,3 (straight line) and 4 (curve)

The photograph was taken from underneath the aircraft looking up towards the fuselage. This area of the aircraft belly slopes upward towards the rear of the aircraft. When the aircraft is parked, the forward end of the doubler is closer to the ground than the aft end. There were several traces observed on the doubler and the skin around STA 2100. Traces 1, 2, and 3 are brown in color and straight toward the aft of the aircraft, suggesting that the traces were induced by the relative wind during flight. Trace 4 shows several curved lines of transparent condensate liquid that flowed from STA 2090 toward the forward (lower) end of the doubler, consistent with flow due to gravity when the aircraft was parked. The traces seen in the November 2001 photographs were not evident on the wreckage when it was recovered.

Traces 2 and 4 began at the same origin but went in different directions. It suggests that trace 2 occurred as the aircraft was in the air, but trace 4 occurred when the aircraft was on the ground. The darkness of the traces shows the accumulated time and quantity of the flow. The color of trace 2 is the darker, which suggests a larger quantity of flow escaped into the air stream in flight.

This phenomenon, discovered during the accident investigation upon examination of photographs of the 1980 repair doubler, showed that there was possibility hidden skin damage beneath the doubler in the vicinity of STA 2100, at the time when the photographs were taken.

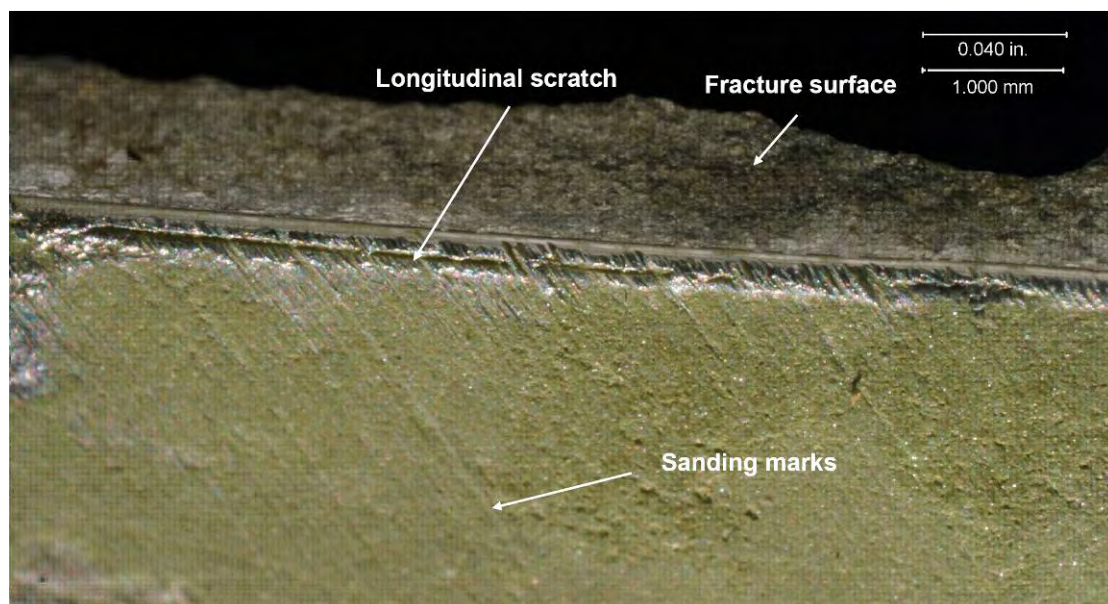
Figure 2.2-6 Fatigue crack originated from the scratch near hole 20

Photographs of the item 640 skin show that many longitudinal scratches (fore to aft) existed on the faying surface of the skin. An attempt to blend out of these scratches was also apparent from the rework sanding marks found on the repaired surfaces. Those scratches and sanding marks were consistent with the 1980 tail strike event of the accident aircraft.

The scratches caused discontinuity of the skin and stress concentration termed “stress risers.” The laboratory observations showed that the main fatigue crack and most of the MSD aft and forward were initiated from the scratches that existed at or just beyond the peripheral row of fasteners common to the repair doubler. Figure 2.2-6 shows the longitudinal scratch on the faying surface of the skin near hole 20 where fatigue crack initiation occurred from multiple origins.
