Aviation Occurrence Report Volume I

ASC-AOR-05-02-001

IN-FLIGHT BREAKUP OVER THE TAIWAN STRAIT

CHINA AIRLINES FLIGHT CI611

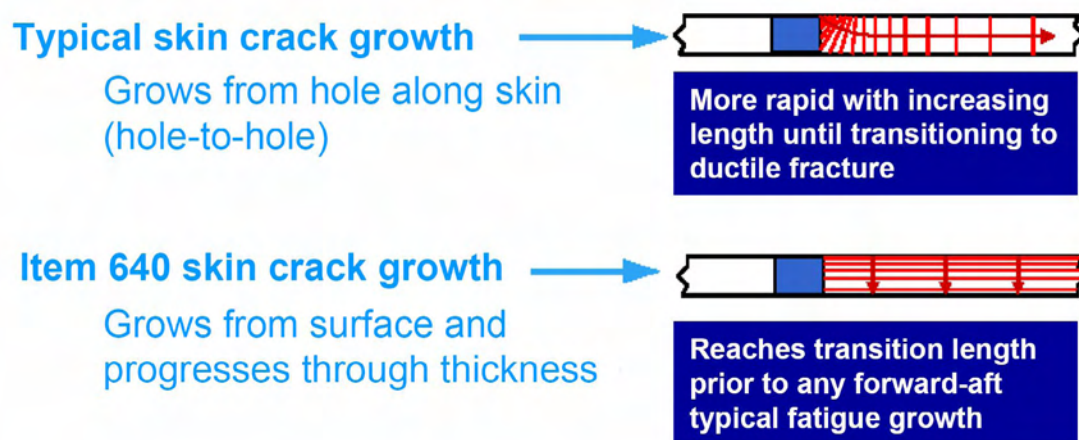
Figure 2.2-7 Cracking on Item 640 differs from typical fatigue crack

The fatigue crack pattern of Item 640 differs from traditional crack patterns. The standard cracking configuration assumes those cracks grow forward and/or aft

from hole to hole. But the crack configuration of Item 640 identified in the laboratories does not show any evidence of forward-aft striations within the flat-fracture fatigue areas. Instead, the crack growth pattern on Item 640 shows an increasing growth rate through thickness (Figure 2.2-7). This can be attributed to the cracks growing from many origins on the skin surface at the scratch locations and propagating inward. While the number of cycles required for the cracks to propagate through the skin thickness was determined as indicated in the BMT report, it was not possible to determine when in the aircraft history these particular cycles occurred. Thus, it was not possible to determine when the crack first penetrated the entire skin thickness.

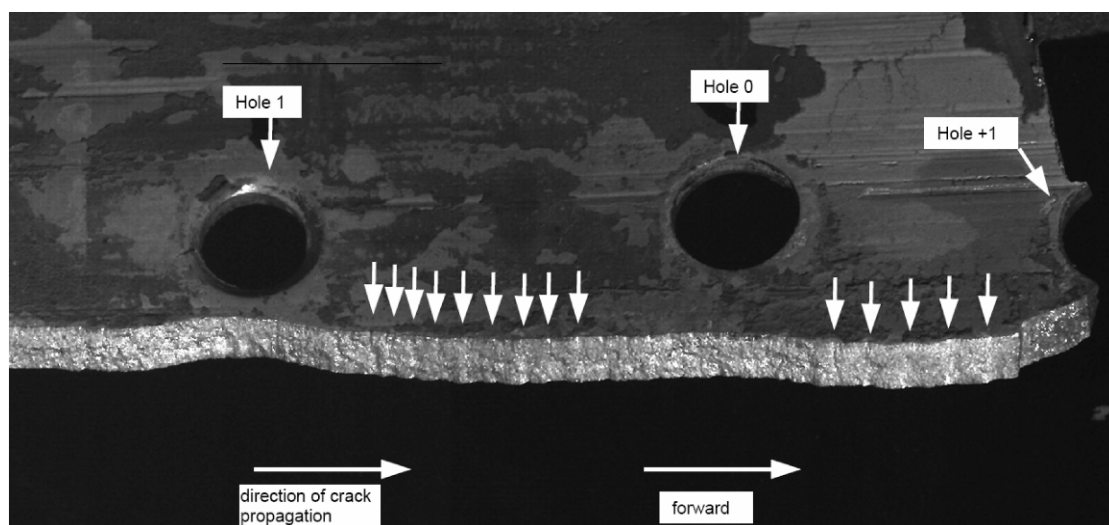
Figure 2.2-9 The regular spacing of cracking increments found on Item 640

The regular spacing of these marks as shown in Figure 2.2-9, is consistent with the application of constant magnitude stress cycles, or the pressurization cycles (once per flight cycle). These marks are more closely spaced near the flat-fracture fatigue area than away from the main fatigue area. These incremental crack growth indications were observed as far forward as approximately STA 2055 (outside the covert of the repair doubler) and as far aft as STA 2140 (hole 56).

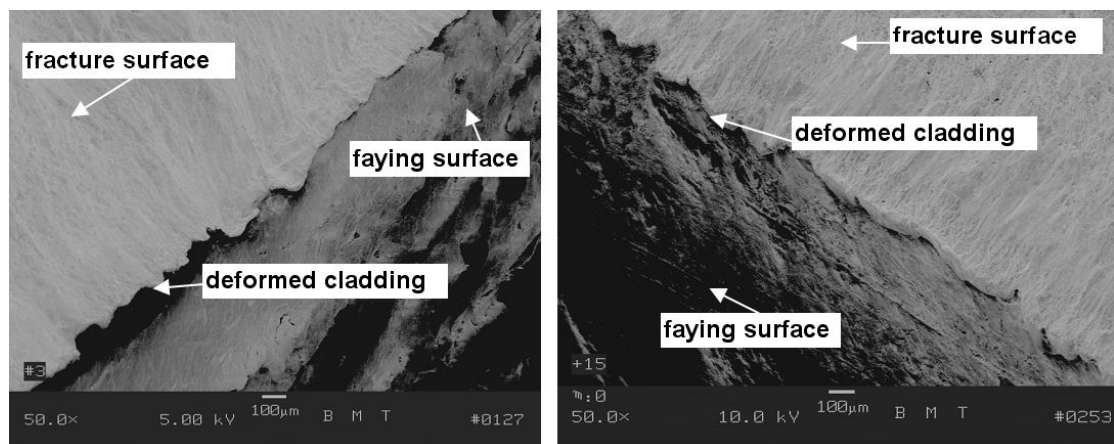
Figure 2.2-10 SEM photographs of the cladding near hole 3 (left) and +15 (right)

Cyclic rubbing of the fracture surface and associated compressive deformation of the cladding was observed along the faying surface shown in Figure 2.2-10 providing additional evidence of pre-existing crack. The cladding displayed compressive deformation due to cyclic crack closure as far forward as hole +17 and as far aft as hole 62. The remaining fracture aft of hole 62 displayed “necking”, which is typical of continuous tensile loading to ultimate tensile separation (Figure 2.2-11).

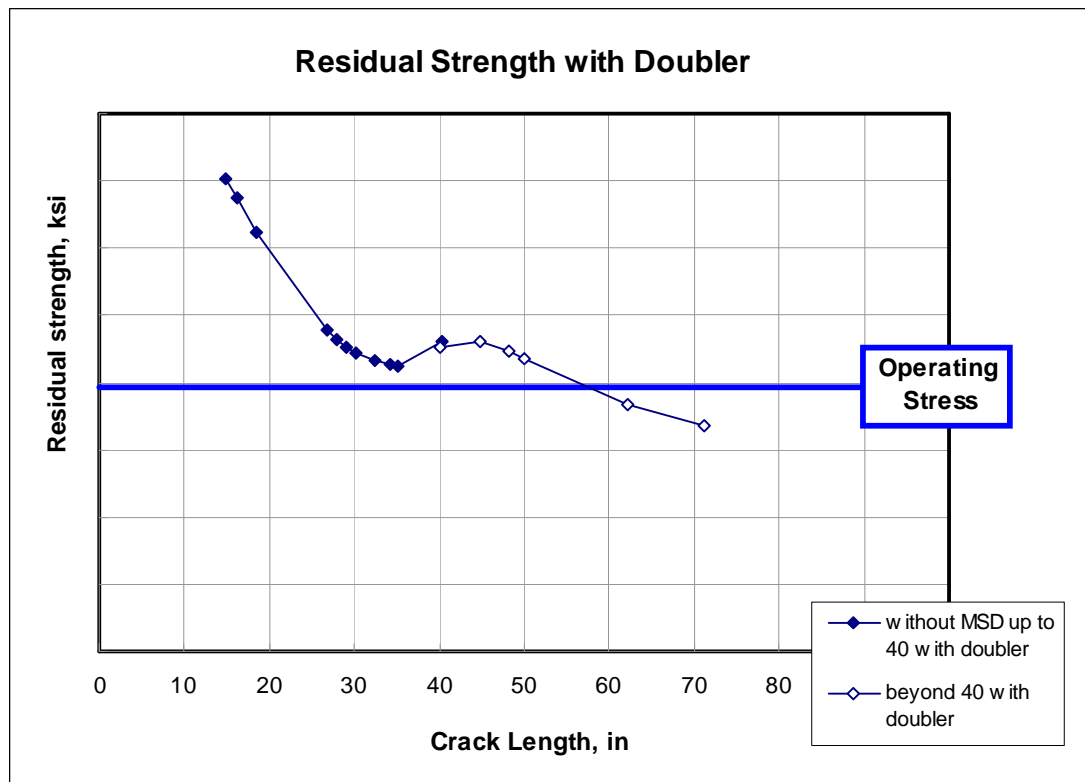
Figure 2.2-13 Residual strength of cracking

From the residual strength analysis discussed in section 2.5, when the crack was over 58 inches, the residual strength of the skin assembly would go below the operating stress (Figure 2.2-13), therefore caused the skin assembly beyond the capability limit under the application of normal operational loads.

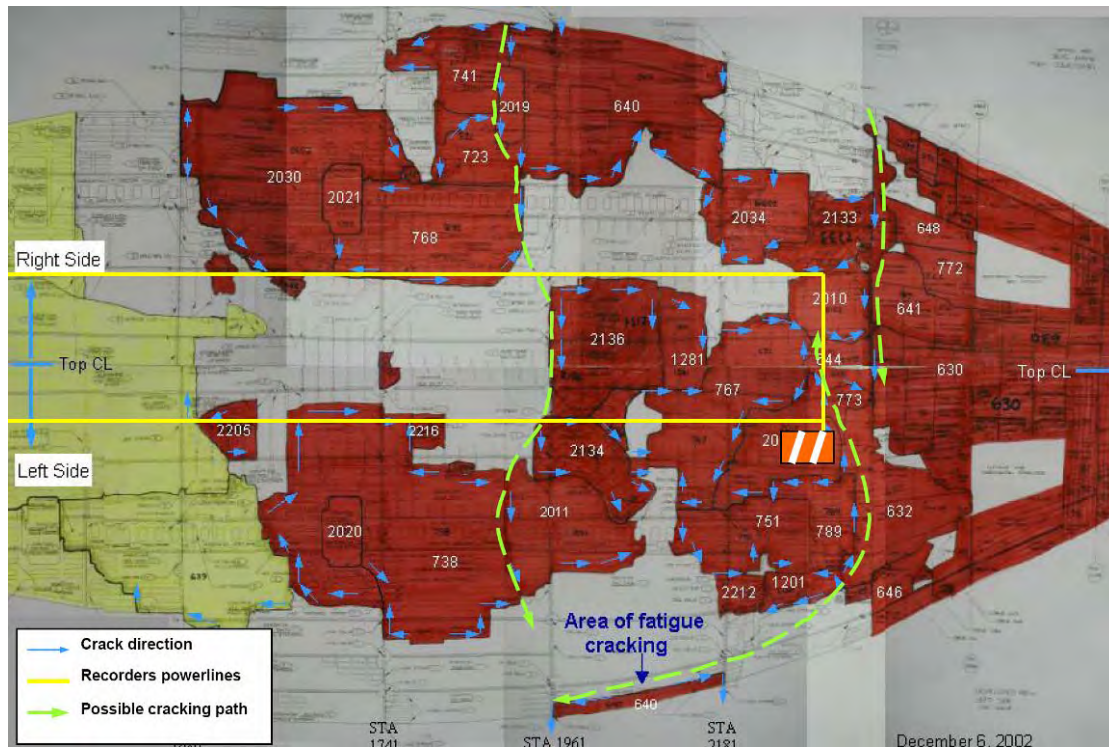
Figure 2.2-14 Directions of fracture propagation

Figure 2.2-14 shows the direction of the crack propagation on each piece of the wreckage in section 46. The methodology used to determine the direction of the cracking is described in Appendix 18. Once a portion of the structure failed, it could no longer sustain the integrity of the entire fuselage structure. The propagation pattern of the fracture is highly nonlinear and extremely dynamic. Without the recovery of all the wreckage pieces, it was nearly impossible to draw a conclusive break-up sequence of the aircraft. Therefore, the following observation only provides one possibility for the cracking to link together accordingly and formed a possible propagating sequence.

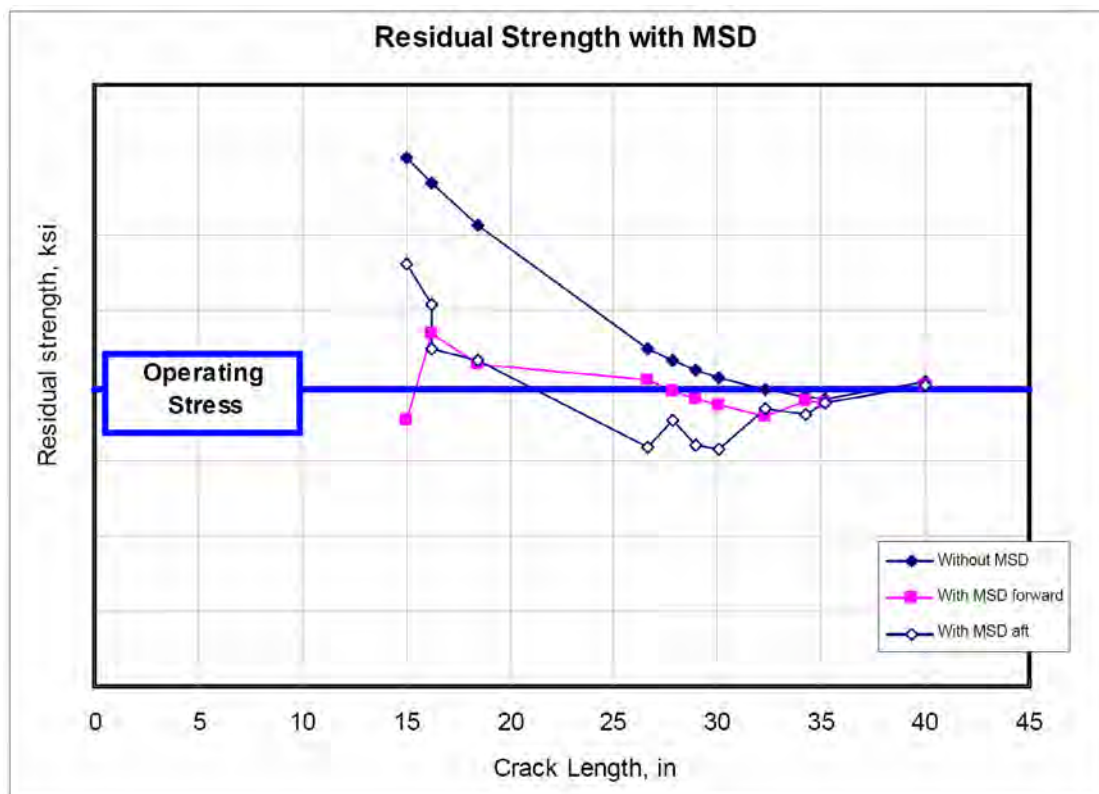
Figure 2.5-4 The residual strength of the crack length up to 40 inches

The reduction factors were calculated for the forward and afterward MSD adjacent to the leading crack. The leading crack would link to the MSD hence yield a relatively lower strength and then a new leading crack formed. The result of the final calculation was shown in Figure 2.5-4.

The upper curve of the Figure 2.5-4 shows the capability of the discontinued skin assembly without MSD. The lower two curves represent the residual strength capability of the skin assembly reduced by MSD effect within the two-bay region. These two curves indicated that the fatigue cracks identified in the two bay region should begin linking together as an overall crack length of 21 inches formed. For Item 640, once the crack grew to 35 inches, the MSD is no longer a factor in the residual strength capability, and then only the upper curve (without MSD) should be considered. Noted that at a two bay length (40 inches), the calculated residual strength capability and the operating stress are essentially equivalent.

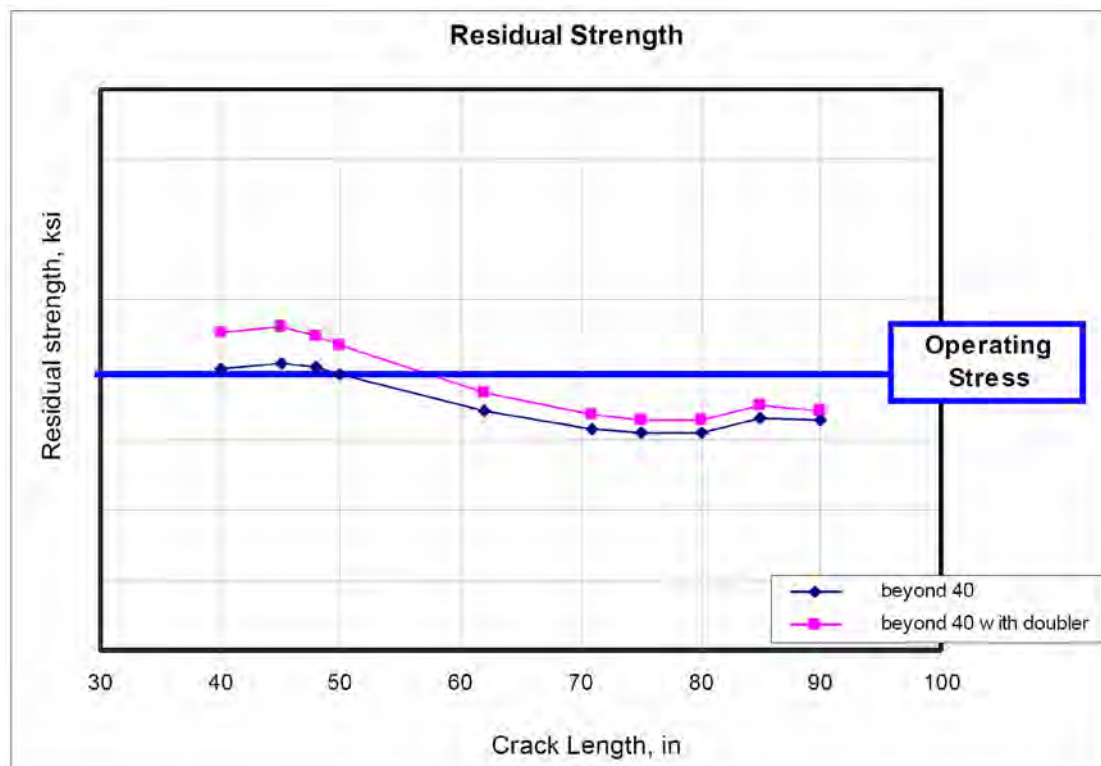
Figure 2.5-7 The residual strength of the extents of the crack up to 90 inches

The nonlinear FEM was also used to assist in determining the values for the residual strength beyond two bays (40 inches) of skin damage. Figure 2.5-7 represents a comprehensive residual strength analysis for the skin assembly, showing the calculated capability of the skin for cracks extending beyond 40 inches. This analysis includes both the basic residual strength for a cracked panel and the increased residual strength with the installation of the repair doubler. It can be seen that the influence of the repair doubler is less pronounced toward the extents of the pre-existing crack. This is primarily due to the inability of the repair doubler to sustain beam loads around the cracked area as the crack starts to approach the ends of the repair doubler.

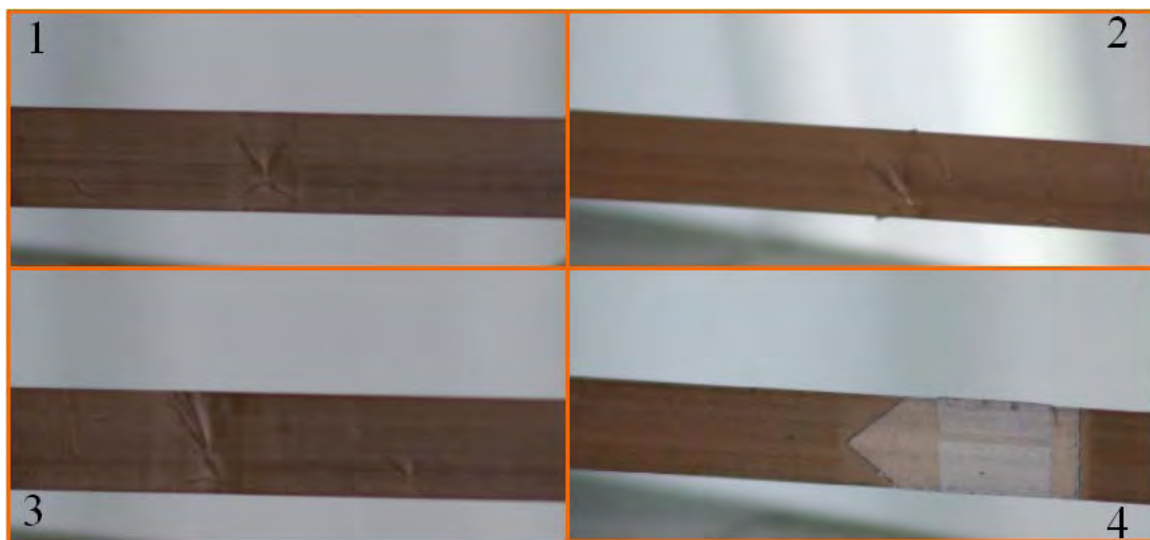
Figure 2.6-1 Damaged and spliced tape areas

Eight unidentified sounds were attributed to the tape damage and one with no signal was attributed to the tape splicing. Figure 2.6-1 frame #1 to #3 shows the typical tape damage and frame #4 shows the spliced area. Several sounds were identified as possible sounds from a toggle switch, or other switches. Because of high noise background, sounds from switches are difficult to be identified, such as momentary switch, switch movements, keyboard entries on the INS panel, switch on the audio selector panel, etc. Some unidentified sounds are likely the sound of crew motions but they might not be directly related to any operational action. Table 2.6-2 lists the unidentified sounds and their associated possible events.

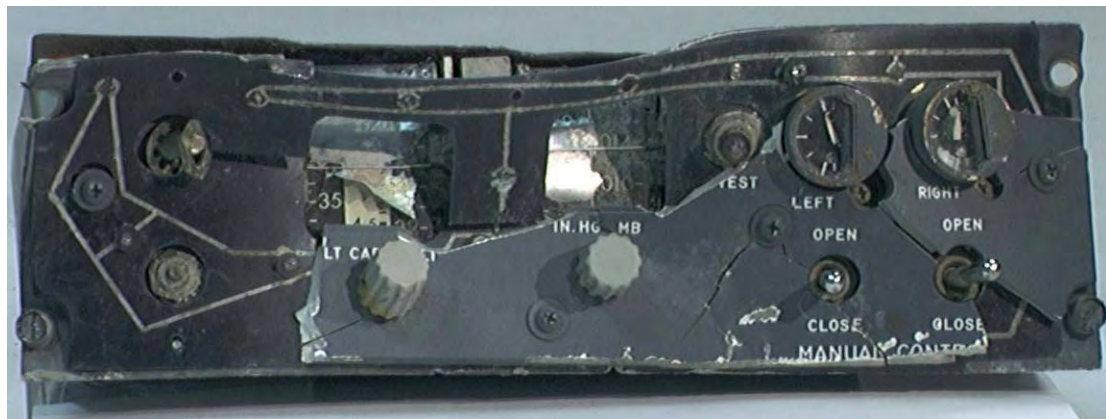
Figure 2.7-1 Cabin pressure control selector panel

Based on the examination, the Cabin Pressure Control Selector Panel (shown in Figure 2.7-1) is deformed, delaminated and fractured. The examination and test results show that the mode switch was in the “MAN” (manual) position.

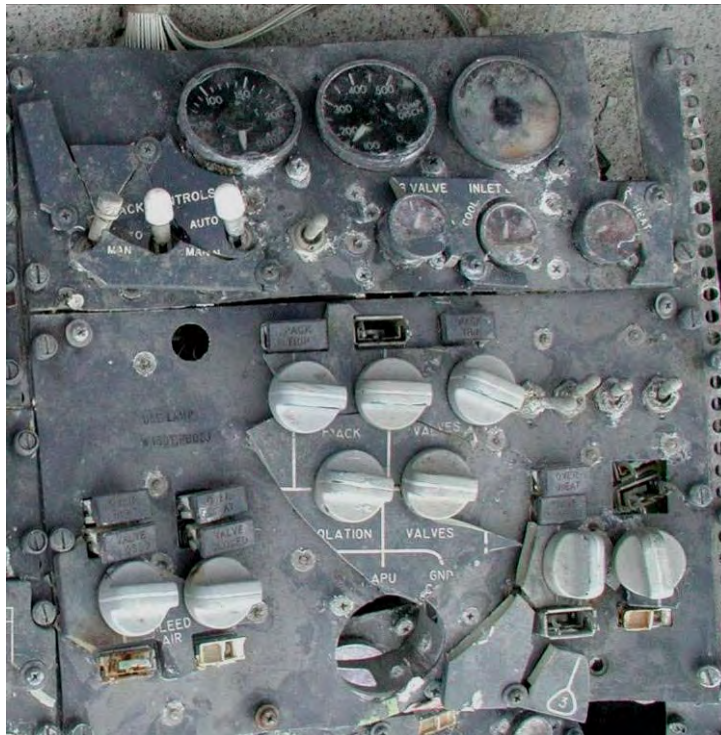
Figure 2.7-2 Air conditioning panel

Examinations and test results of the panel revealed that the bleed air valve switches for engines number 1 and 2 were found in the “Close” position. The bleed air switches for engines number 3 and 4 were found in the “Open” position. The Boeing 747-200 Airplane Operations Manual “Final Cockpit Preparation” and “Engine Starting” checklists specify that all four engine bleed valve switches be placed in the “Open” position, after engine start and normal flight.

One possible reason for the flight crew to place the bleed-air valves switches to “close” position would be due to the pressurization system malfunction. The CM-3 might also unintentionally have turned the two engine bleeds off in distress or disorientation when the occurrence happened.

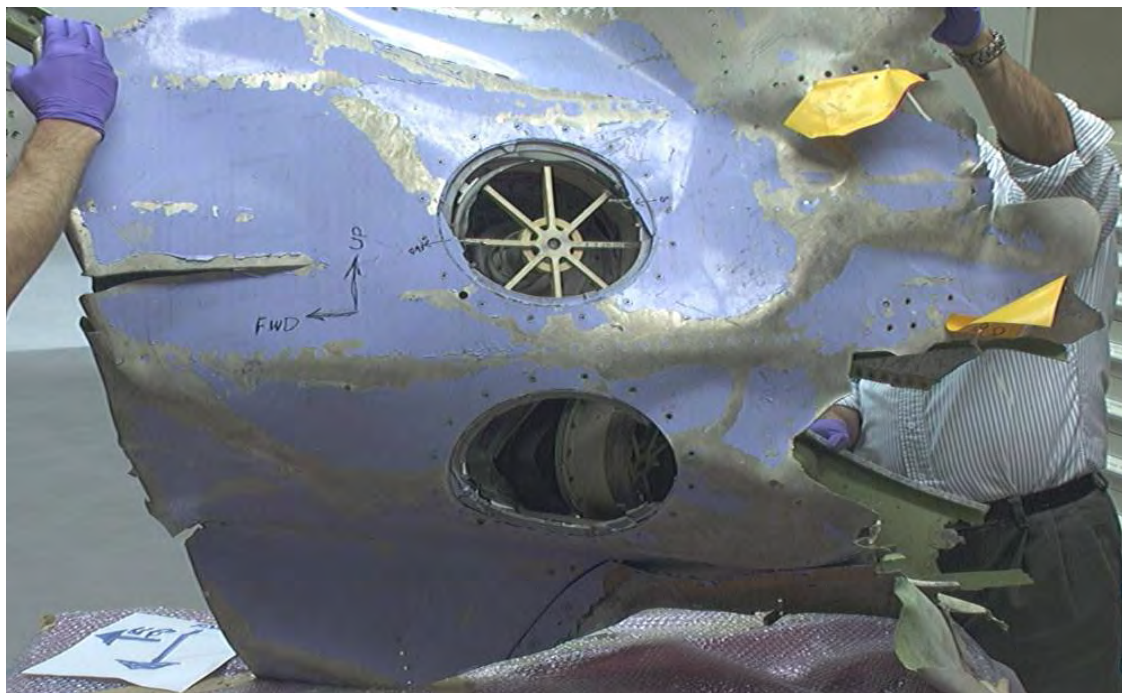
Figure 2.7-3 Pressure relief valves.

Two cabin pressurization relief valves are installed to relieve excessive pressure in the cabin. Both valves were recovered as shown in Figure 2.7-3. All flapper (blowout) doors (upper and lower for both valves) and some hinge pins are missing. The Lower Pressure Relief Valve was no longer attached to the structure. The structure between the upper and lower valves was buckled outward.

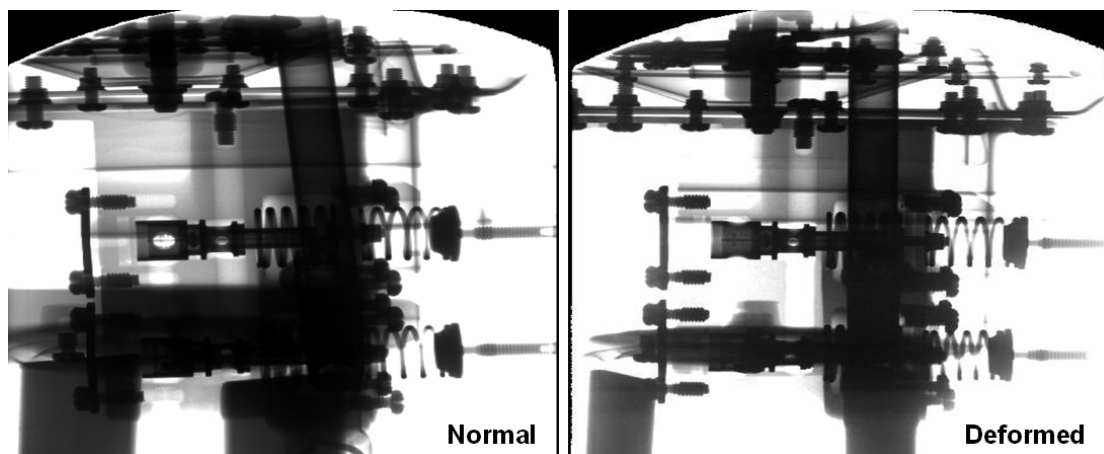
Figure 2.7-6 X-ray check results

X-Ray on the upper relief valve control switch was conducted. The results show that the control sensor assemblies were deformed from their original setting as shown in Figure 2.7-6.

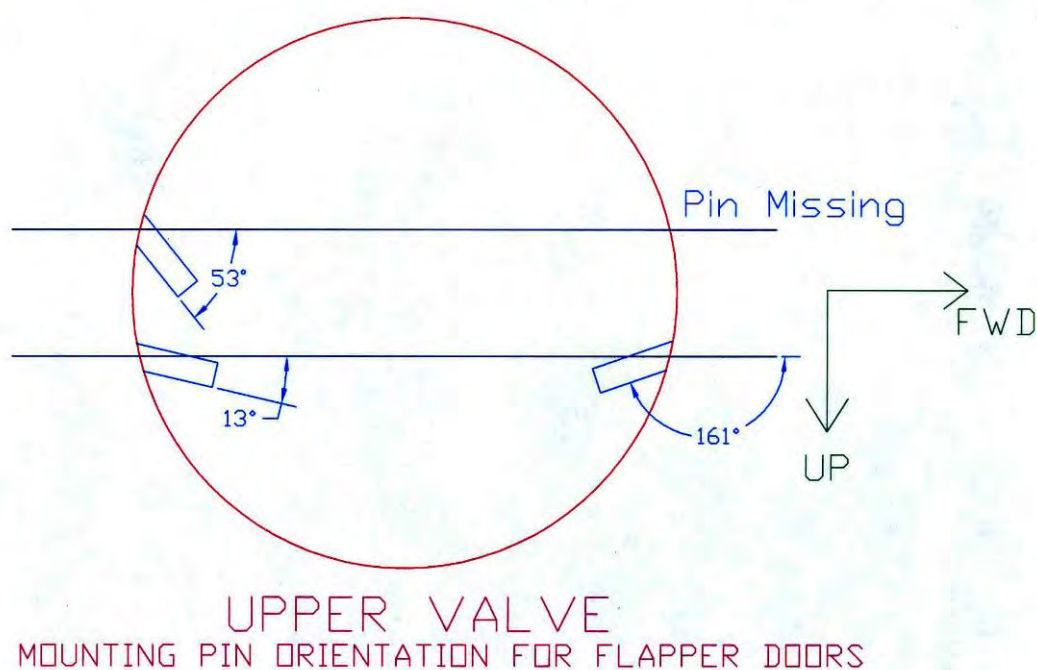
Figure 2.7-7 Upper flapper doors pins measurement results

The measurement of pin angles was performed using a flat reference plane (outer skin of aircraft); using two imaginary reference lines running between the centerlines of the pin mounting holes (upper fwd to upper aft) & (lower fwd to lower aft). All angular measurements were based from these two imaginary lines as shown in Figure 2.7-7. Results of the measurements are:

Upper aft pin was approximate 13° ; Upper fwd pin was approximate 161° ; Lower aft pin was approximate 53°

The wreckage examination results show that the upper pressure relief valves had been deformed inward, the flapper doors were missing and the three out of four existing shear pins were bent-in, but moveable. It could be that outside-in forces crushed the relief valve and damaged the flapper doors and the web gate. Those three pins of item 275 were still attached to the shear pins and are parallel to the relief valves housings (aircraft fuselage skin) that might indicate the valve doors was open before the water impact. However, based on the test results, the Safety Council could not conclude whether the door was open prior to the water impact.

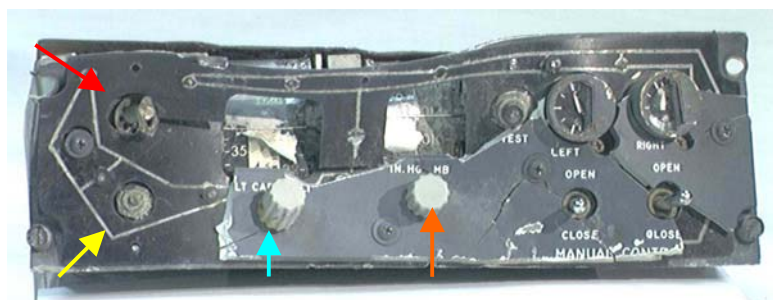
Figure 7: Flight Engineer's Cabin Pressure Control Selector Panel - (front view)

- **OUTFLOW VALVES** position indicators are both showing needle positions slightly below 9 O'clock (upon initial observations prior to taking photograph, fig. # 7).

- Continuity tests suggest setting was in manual (**MAN**) select mode, not **AUTO**.
- Confirmed wire continuity from J3 connector to rotary switch (S1)
- Initial visual inspection of the (S1) rotary **MODE SELECT** switch (reference, Figure 7) could not confirm switch setting because the shaft was bent (therefore inconclusive).
- X-ray of rotary switch (S1) could not verify **MODE SELECT** switch setting due to indistinguishable internal details.
- Disassembly of **MODE SELECT** rotary switch confirmed switch was set in manual (**MAN**) setting (Figure 14).

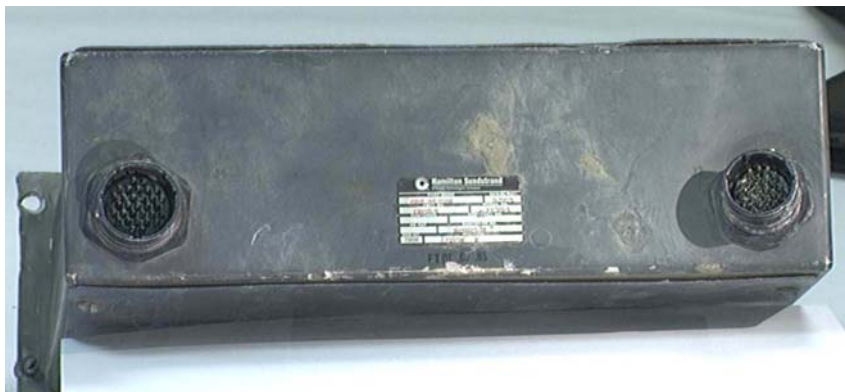
Figure 8: Flight Engineer's Cabin Pressure Control Selector Panel - (back view)

- J3 connector (right) misaligned due to deformation of rear chassis. Both connector (J3 and J4) pins are intact.
- Both connectors show contamination around multiple connector pins.

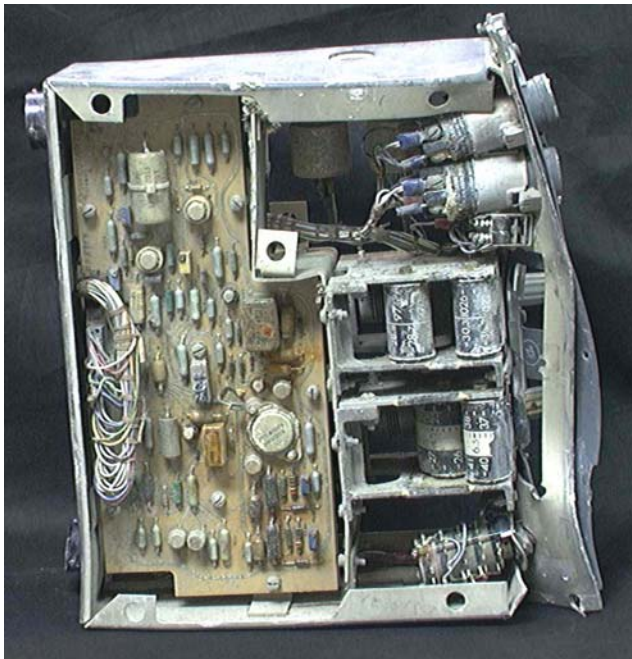
Figure 9: Flight Engineer's Cabin Pressure Control Selector Panel - (top view)

- Deformation of the face of the chassis.
- Broken spot welds and separation of face of chassis (lower right).
- Sedimentary deposits deposited throughout unit.
- Corrosion noted in multiple locations on multiple components.
- Slight deformation of rear chassis panel at the J3 plug (lower left).
- Flight **ALTITUDE** selection tape delaminated and partly missing.

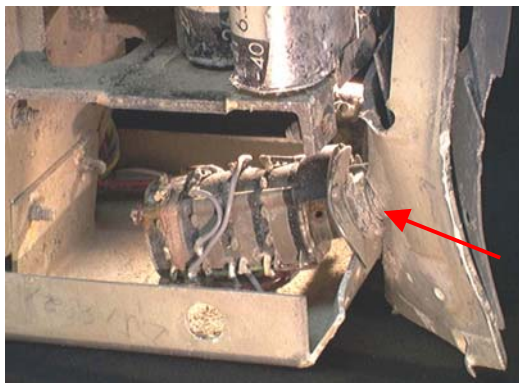
Figure 10: **MODE SELECT** Rotary Switch

- Rotary switch shaft slightly separated from front of chassis.

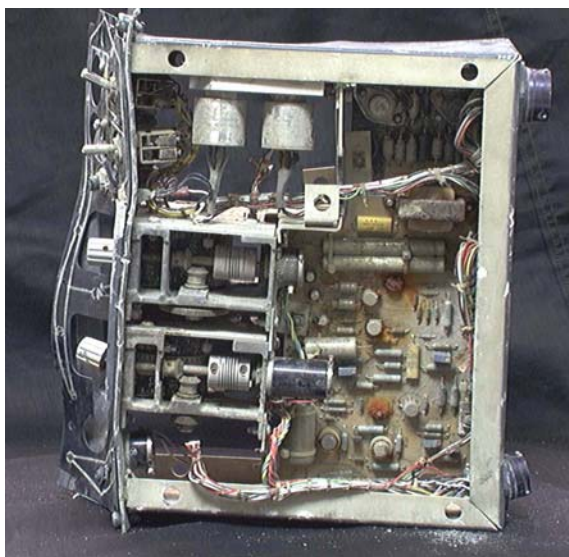
Figure 11: Flight Engineer's Cabin Pressure Control Selector Panel – (bottom view)

- Deformation of the face of the chassis.
- Sedimentary deposits deposited throughout unit.
- Corrosion noted in multiple locations on multiple components.

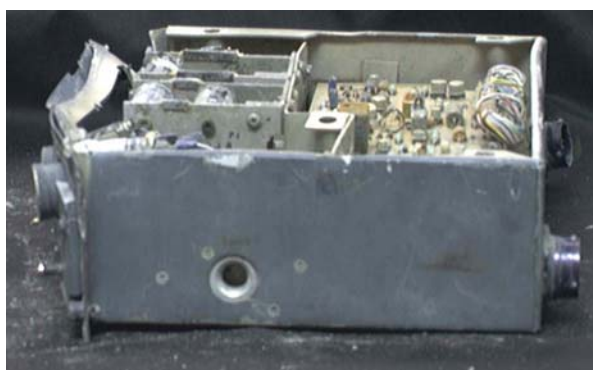
Figure 12: Flight Engineer's Cabin Pressure Control Selector Panel – (side view - cabin pressure port side).

- Deposits noted inside the sensor port.

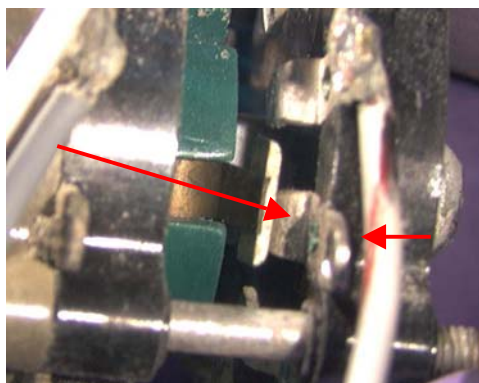
Figure 14: Panel, **MODE SELECT** Rotary Switch

- Internal contact position verification (manual).

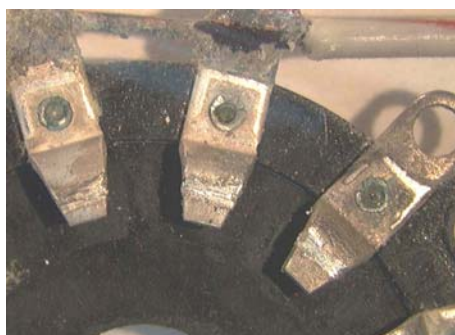
Figure 15: **MODE SELECT** Rotary Switch, Stationary contacts, deck 3, #1-2-3 (left to right).

- Contacts of rotary switch (S1), deck 3, #1-2-3, Wear marks on contacts appear to be normal.

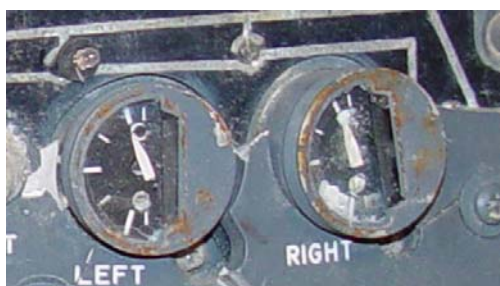
Figure 16: Panel, **OUTFLOW VALVES** Indicators.

- Internal surface of glass face: small surface anomaly observed as viewed from exterior.
- Case removed to inspect glass from inside. What appeared to be an anomaly on the inner side of glass was actually a debris deposit.
- No impact indications from needle impact were noted.

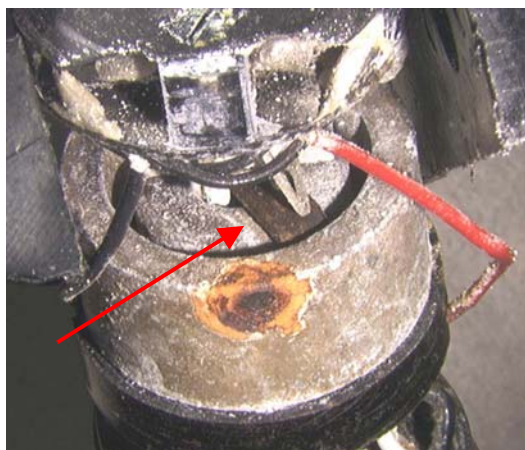
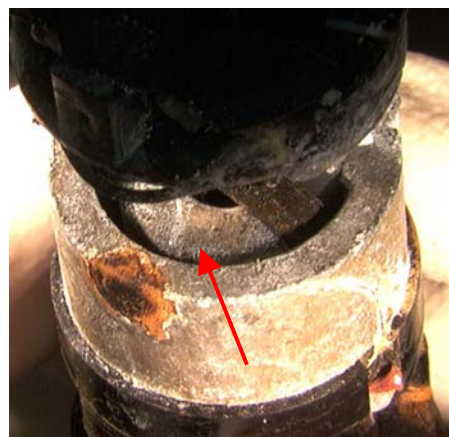
Figure 17: LEFT, OUTFLOW VALVES
Position Indicator witness mark

Figure 18: LEFT, OUTFLOW VALVES
Position Indicator showing witness mark after moving armature.

- Moving armature/needle, mounting tab corresponds to a witness mark on underlying base. This position corresponds to needle positioned at approximately 25% open. The armature was moved from its location in Figure 17 to display the “witness” pattern underneath the movable armature, shown in Figure 18.

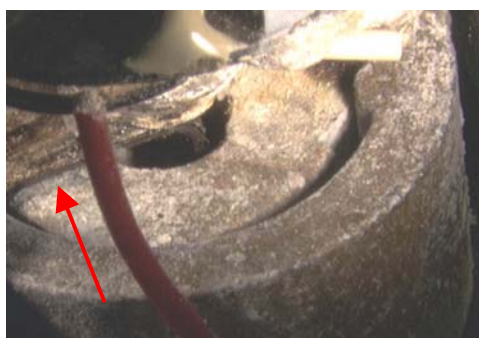
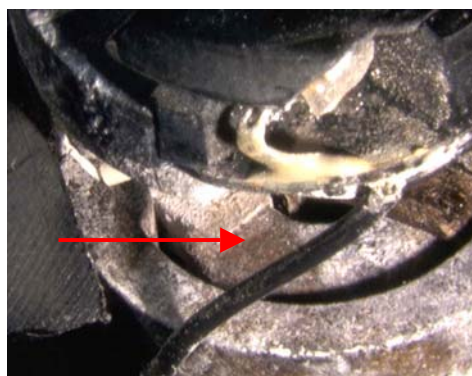
Figure 19: RIGHT, OUTFLOW VALVES
Indicator; armature is over witness mark.

Figure 20: RIGHT, OUTFLOW VALVES
Indicator; armature moved to show witness mark.

- Armature/wiper member corresponds to witness marks on base at two places (at both extreme ends of possible needle movement). It was inconclusive as to the exact corresponding location of needle position.
- Both **LEFT** and **RIGHT, OUTFLOW VALVES** Indicators' needles were detached from armature/needle mounting tabs and loose within the housings.

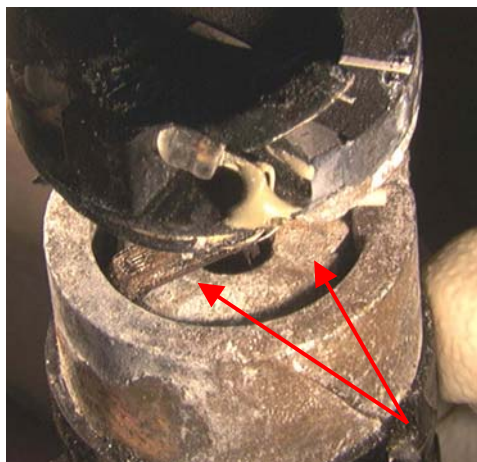
Figure 21: RIGHT, OUTFLOW VALVES

- There appeared to be two “witness” marks on the underlying base of this indicator. The one on the left appeared to be more distinct than the one on the right.

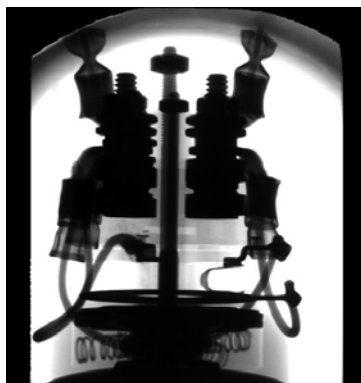
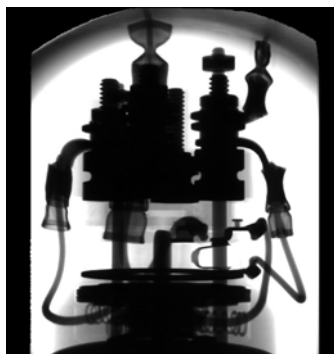
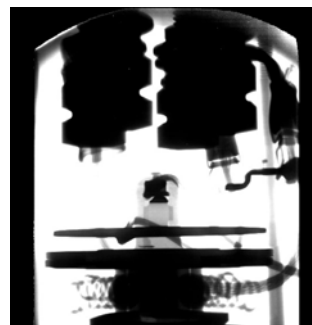
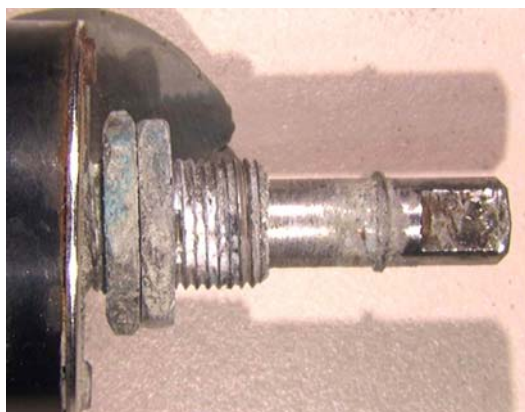
Figures 25a, 25b, 25c: X-rays of Pack Valve Switch #1

- Corrosion on all metallic parts
- Shaft can be pulled easily from switch body.
- Shaft is slightly bent relative to body.
- All wiring is intact, but no continuity.
- Terminals are significantly corroded.
- No cracking is apparent in the switch body.
- X-ray confirms that the valve-closed electrical contacts are aligned with each other.
- After removal of the switch, it was noted that the indexing ring tab to shaft was sheared or corroded away.

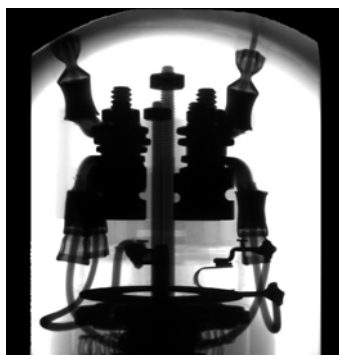
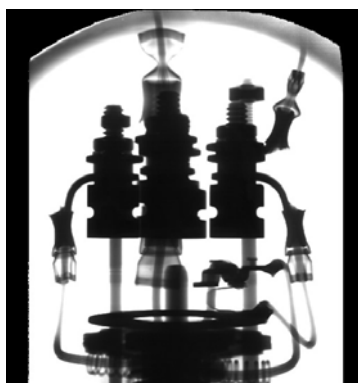
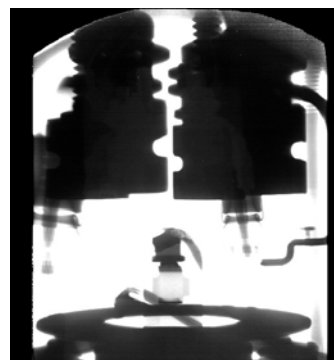
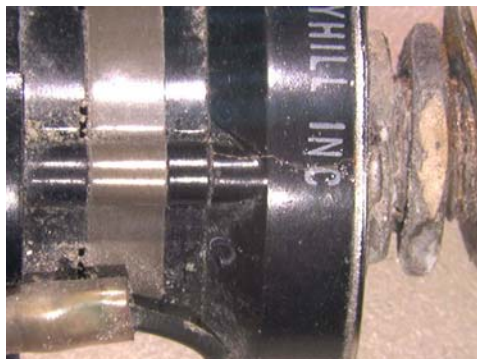
Figures 27a, 27b, 27c: X-rays of Pack Valve Switch #2

Figure 28: Detail view of switch #2, cracks in the body.

- Corrosion on all metallic parts
- Minor cracking of the switch body.
- No continuity could be attained.
- All external wiring appears intact.
- X-ray confirms that the valve-closed electrical contacts are aligned with each other.

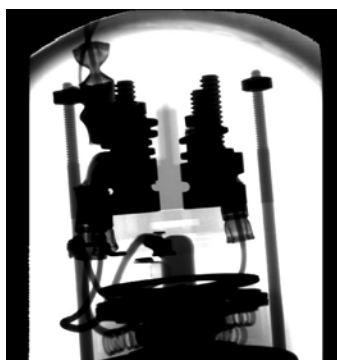
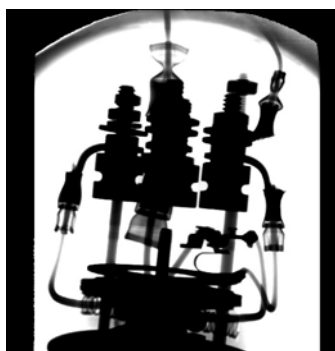
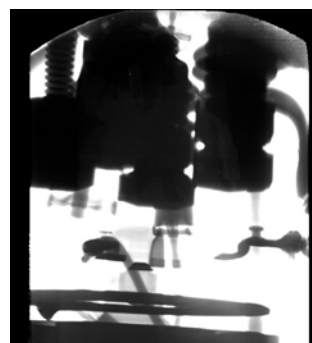
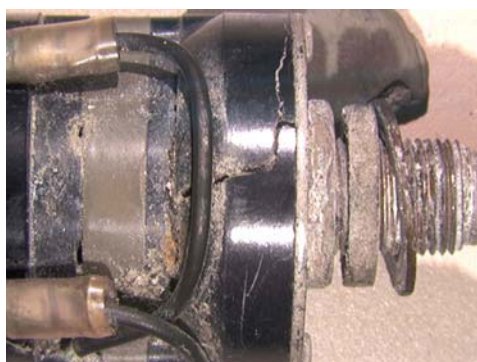
Figures 29A, 29B, 29C: X-rays of Pack Valve Switch #3

Figure 30: Switch #3 body crack detail

- Corrosion on all metallic parts
- Severe cracking of the switch body.
- No continuity could be attained.
- All external wiring appears intact.
- X-ray shows that the valve-closed electrical contacts are not aligned with each other. Misalignment approximately 10 degrees. The switch knob was not in the full closed position.

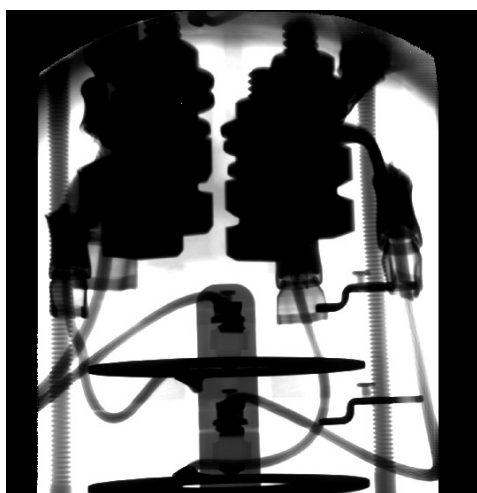
Figure 32: X-ray of Bleed Air Valve
Switch #1.

- X-ray confirms that both sets of active electrical contacts are aligned with each other.

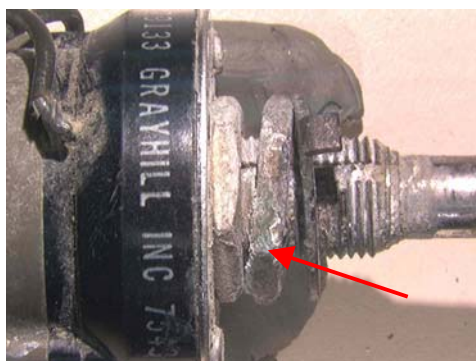
Figure 33: Bleed Air Switch #1

- Displaced nut
- Knob in OFF position
- Rear mounting nut has been displaced.
- Corrosion on all metallic parts

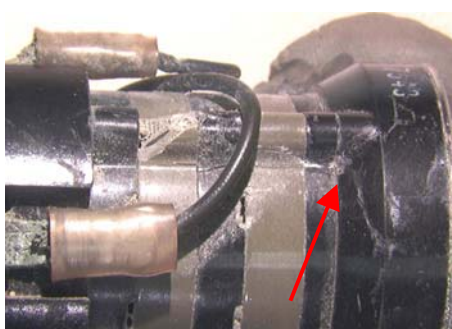
Figure 34: Bleed Air Switch #1.

- Minor cracking of housing is apparent.
- Crack detail.
- No continuity could be attained.
- All external wiring appears intact.

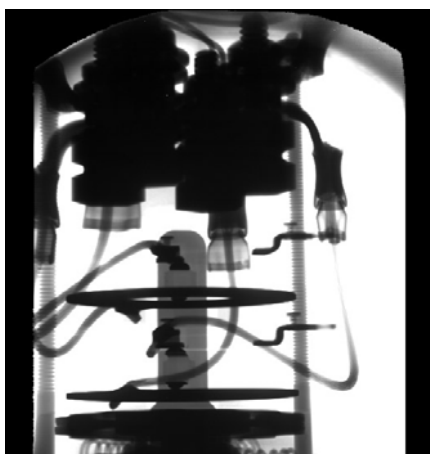
Figure 35: X-ray of Bleed Air Valve Switch #2.

- X-ray confirms that both sets of active electrical contacts are aligned with each other.

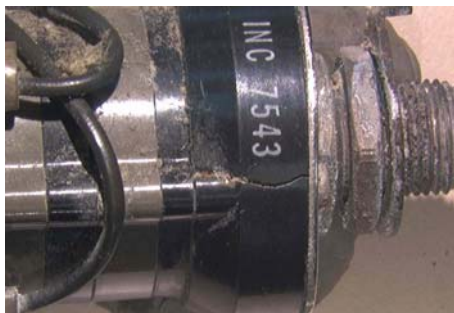
Figure 36: **BLEED AIR** switch 2.

- Minor cracking of housing apparent.
- Detail of cracks.
- No continuity could be attained.
- All external wiring appears intact.
- Knob in OFF position
- Corrosion on all metallic parts

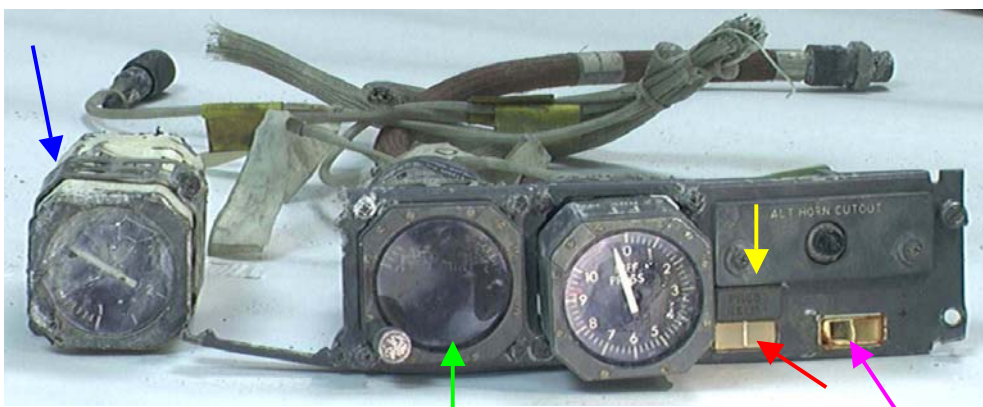
Figure 37: M188 panel. Note that the vertical speed indicator was detached from the module.

- Vertical Speed Indicator not attached to panel (blue arrow).
- Corrosion present on various surfaces with salt residue and sediment.
- **AUTO FAIL** legend plate is missing (purple arrow).
- **PRESS RELIEF** lower Indicator light cover is missing (red arrow).
- Panel frame is bent inward on left and broken at Vertical Speed Indicator frame.

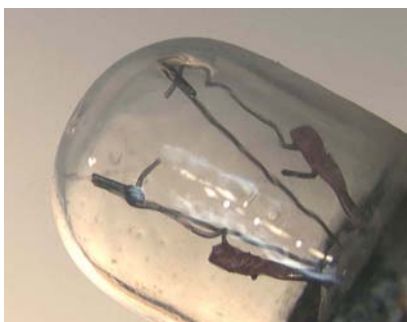
Figure 40: **PRESS RELIEF** light, lower left lamp.

- Filament is broken - (Ref. Figure 37, red arrow for lamp location).

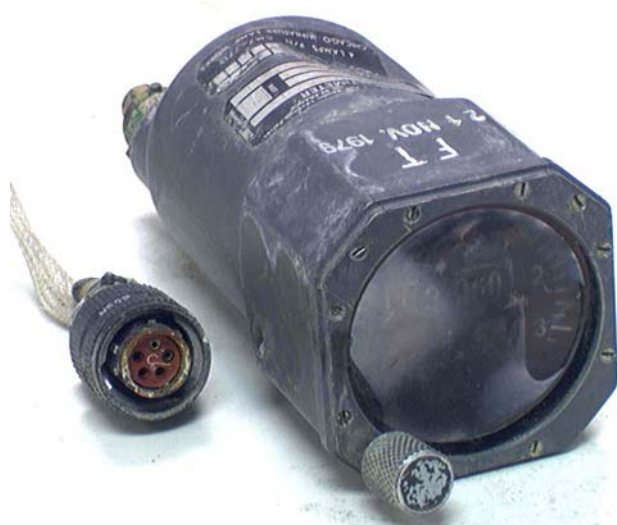
Figure 42: CABIN ALT Indicator (Ref. Figure 39, green arrow for location on module)

- 50% of face obscured by opaque discoloration inside of glass.
- BARO set knob bent upward.
- Dent in rear, top side of case.
- Dent on bottom side of case.
- Corrosion on sense line connection.
- Barrel Indicator reads approximately 13,000.
- Needle and barometric setting obscured by discoloration.
- Electrical connector appears undamaged.

- X-ray examination of internal parts revealed distorted bellows. No other observations made due to indistinguishable details.

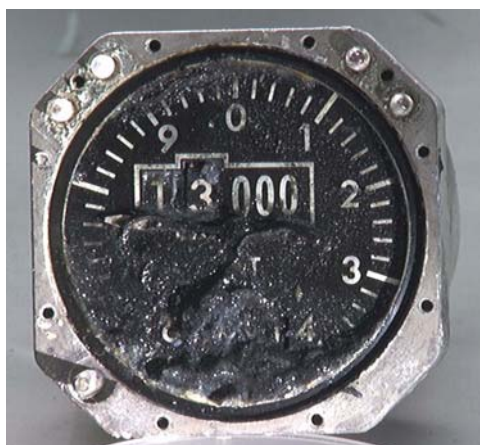
Figure 43: Cabin Altimeter Indicator, glass bezel removed

- Heavy coating of unknown sedimentary type debris on face of indicator (unknown black glutinous contaminant).
- After cleaning off debris, altimeter indicator reading confirmed to be 13,765 +/- 5.
- Microscopic examination of inner side of bezel shows no sign of impact damage.

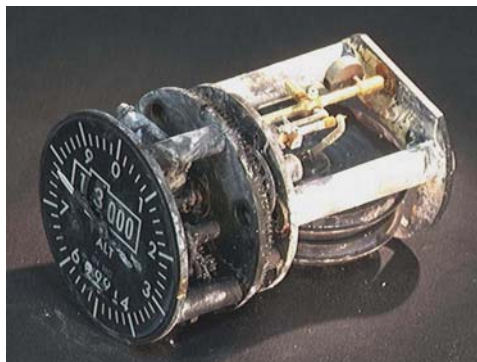
Figure 44: Cabin Altitude Indicator, housing removed.

- Removed back of Altimeter housing to observe internal mechanism. Large amount of sedimentary type debris noted internally.
- No observable damage to internal mechanical parts. It did not appear that the physical damage to the outer case caused the case to come into contact with inner components.
- Significant amount of sedimentary type debris noted on internal parts.

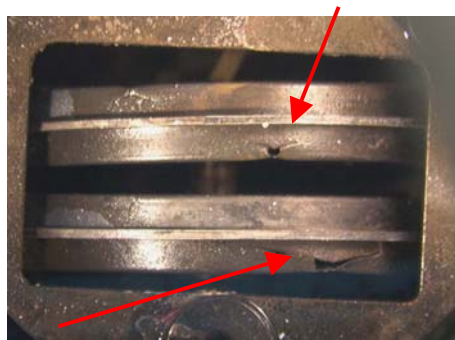
Figure 46: Cabin Altimeter Indicator, bellows, visible damage

- Both bellows have fractures along the outer circumference of the bellows. Those fractures appear on a portion of the bellows at the back of the instrument. The fractures are on the lower half of each of the bellows. The edge features, at the fractures, are oriented outward from the inside of the bellows.

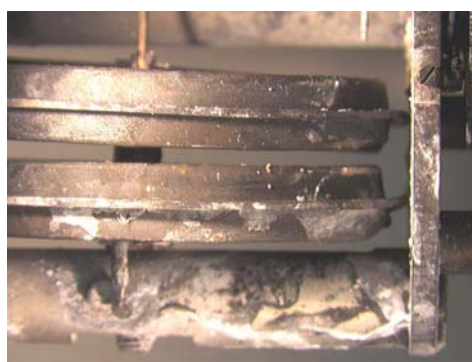
Figure 47: Cabin Altimeter Indicator, bellows displacement

- The upper bellows is tilted with respect to its axis. The lower bellows is also tilted, but to a lesser degree.
- The upper bellows is in contact with the gear mounting plate. The lower bellows flange is deformed at the point nearest the gear mounting plate, but doesn't contact the plate.

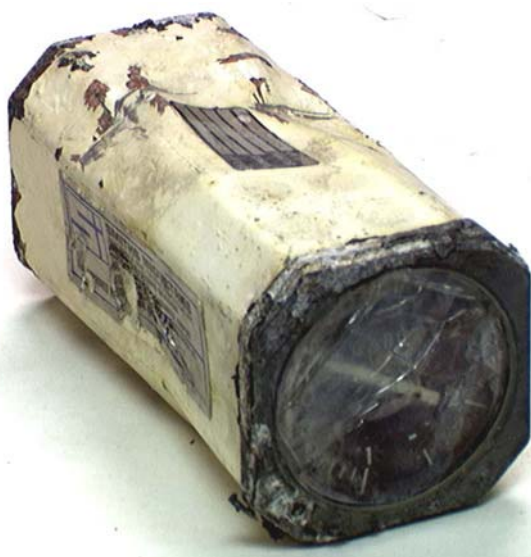
Figure 48: Cabin Vertical Speed Indicator

- Glass is broken.
- Numerous dents are on case.
- Needle is frozen at 500 FPM climb.

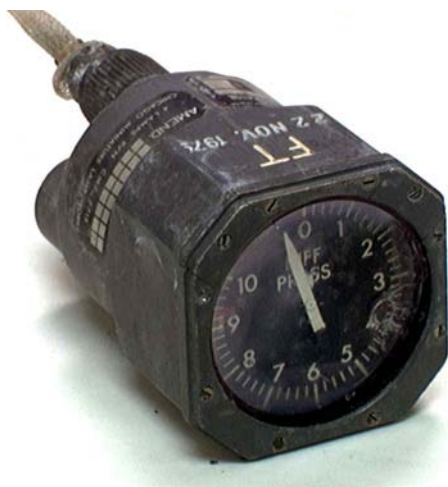
Figure 50: Cabin **DIFF PRESS** Indicator

- Water stains inside glass face.
- Needle is indicating below zero.

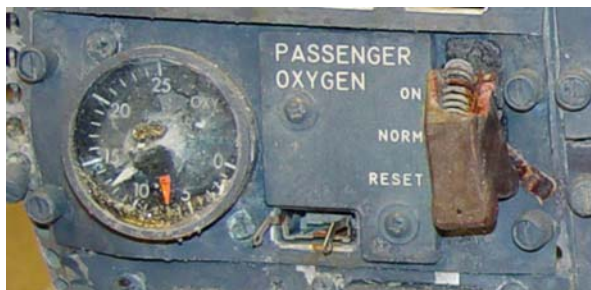
Figure 53: Passenger Oxygen Panel, module M183.

- Case removed indicator- found heavy corrosion and sedimentary deposits present internally.
- **PASSENGER OXYGEN** needle was disconnected from its driving rod, either on disassembly or prior to disassembly.
- No indication of needle strike on indicator face.
- Dial indicator needles at 700 PSI for passenger and 1250 PSI for crew.
- Residue visible through glass face of indicator.
- Power **ON** indicator legend plate, bulbs and retaining assembly are missing.
- Switch guard safety wire is broken.
- Switch guard broken and partially missing.
- Light plate is intact.

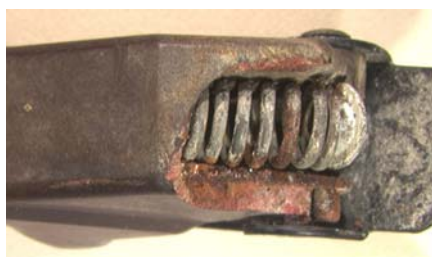
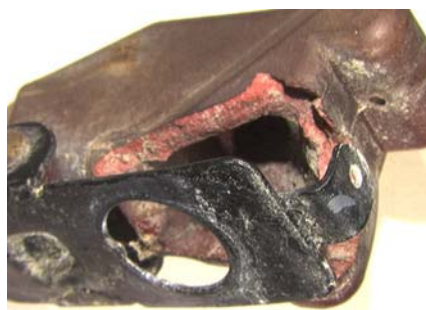
Figure 61: Top view of switch guard damage.

Figure 62: Bottom view of switch guard damage.

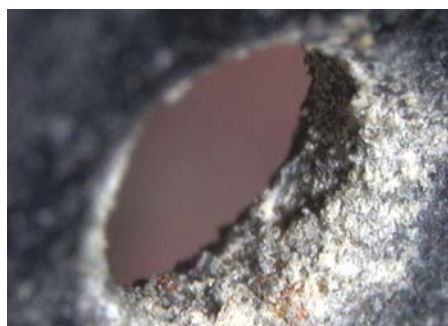
Figure 64: Switch safety wire (breakaway wire) tab hole.

- Observed sediment contamination on inside diameter of hole, recess.

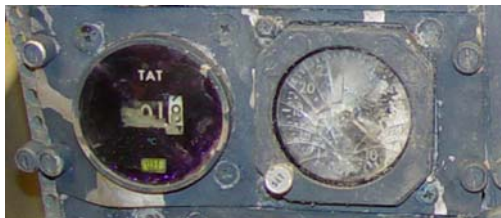
**Figure 65:** Clock Panel, module M184

- Clock glass is fractured.
- Hands set at approximately 0825, partially obscured by broken glass.
- **TAT** partially obscured by discoloration.
 - Reads 1.8 deg. C and **OFF**
- After removal from Flight Engineer's Panel, slight impact damage to top rear of case was noted.

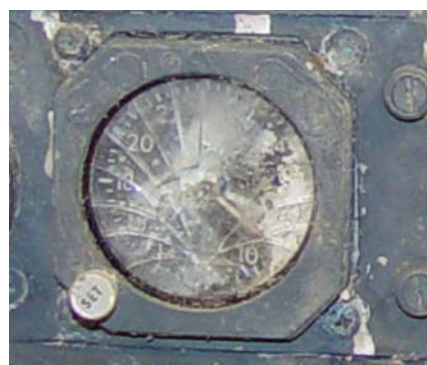
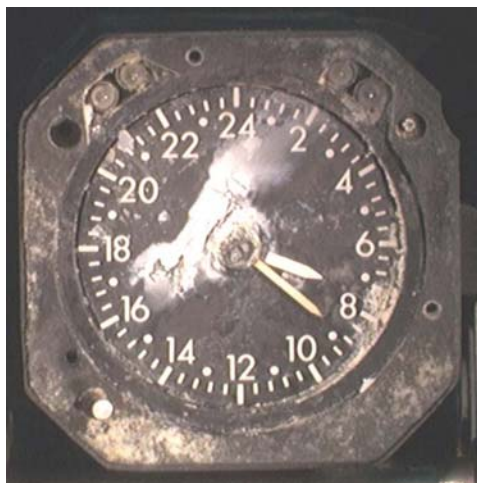
Detailed observations:**Figure 66:** M184 Clock, face glass fractured heavily.

**Figure 66a:** M184 Clock, face glass removed.

- After removal of bezel, actual time on clock reads 0722
