Aviation Occurrence Report Volume I

ASC-AOR-05-02-001

IN-FLIGHT BREAKUP OVER THE TAIWAN STRAIT

CHINA AIRLINES FLIGHT CI611

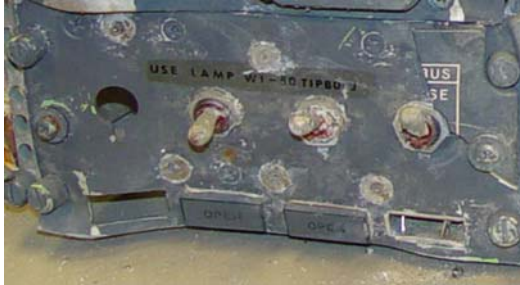
Figure 67: **DC BUS ISOLATION** panel, module M557

- Light plate is missing.
- All three switches' toggles are in up (**CLOSE**) position.
BUS 3 and **BUS ESS** toggles are bent upward.
- **ESS BUS, & OPEN** indicators legend plates, bulbs and retaining assemblies are missing.

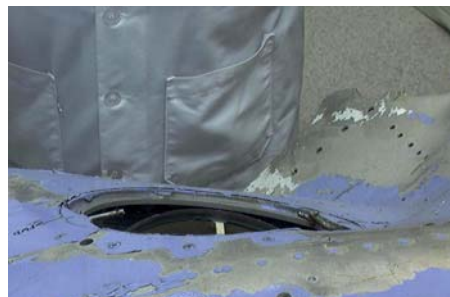
Figure 77: Upper pressure relief valve, (center of picture) distorted exterior skin.

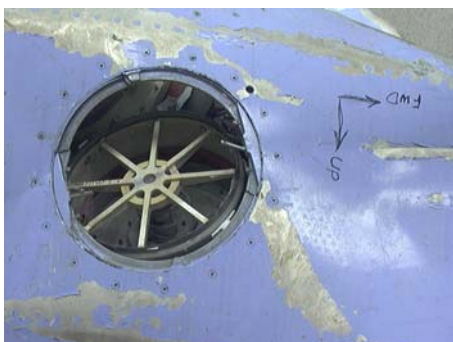
Figure 81: Upper Pressure Relief Valve, showing orientation, note that blowout doors are missing.

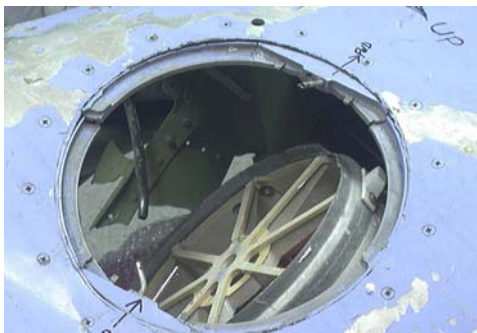
Figure 90: Exterior view of opening with valve not yet removed.

- Hinge pins are movable (free to rotate); aft/upper hinge pin is only one difficult not yet rotate and is bent outboard.

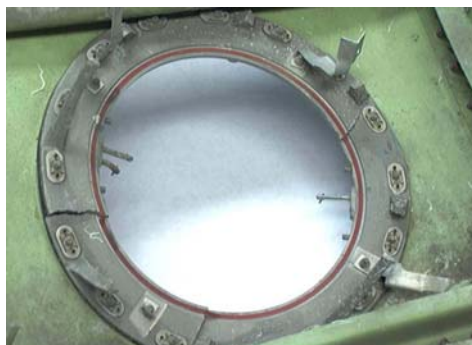
Figure 91: Interior view of opening with valve removed (looking inside to outside).

- Forward/lower hinge pin missing.

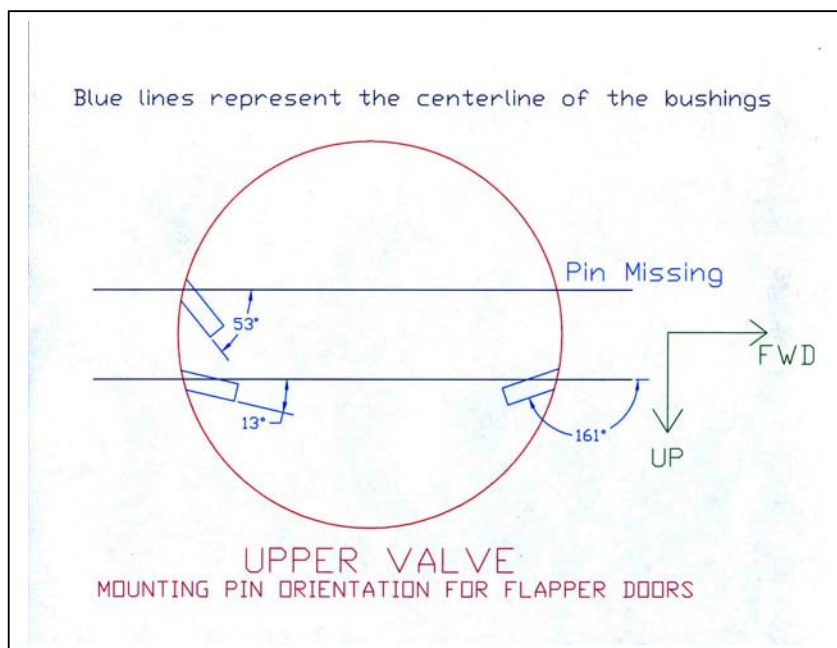
- Performed **measurement** of pin angles using a flat reference plane (outer skin of aircraft); using two imaginary reference lines running between the centerlines of the pin mounting holes (upper fwd to upper aft) & (lower fwd to lower aft). All angular measurements were based from these two imaginary lines. (See: diagram. Upper Valve, flapper doors' pins, orientation, Figure 96).
- Results of measurements (approximation):
Upper aft pin = 13°; Upper fwd pin = 161°; Lower aft pin = 53°

Figure 96: Upper Pressure Relief Valve, flapper valve doors, pin orientation.

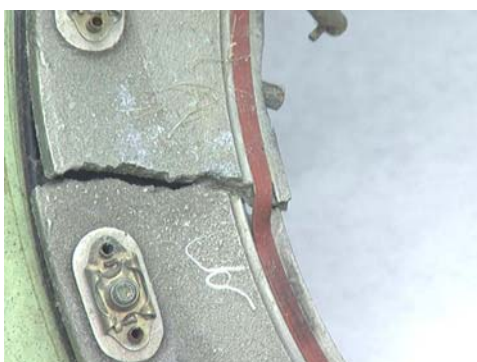
Figure 97: Non-metallic washer (gate seal) - continuous ring.

- Slight impression of knife-edge on seal.

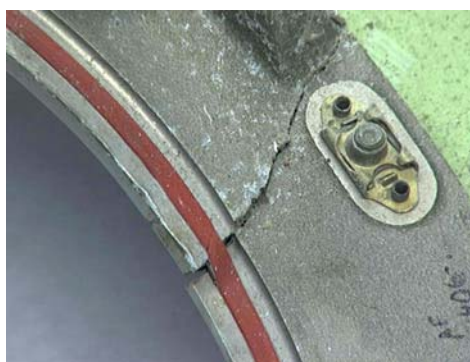
Figure 98: One slight cut adjacent to housing fracture.

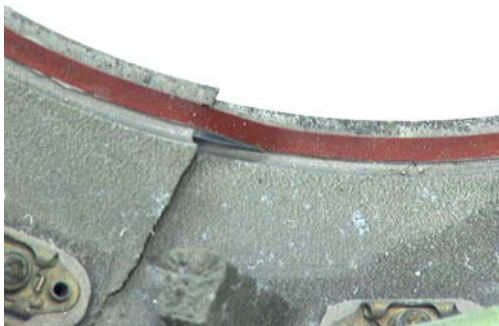
Figure 99: Another cut on the seal.

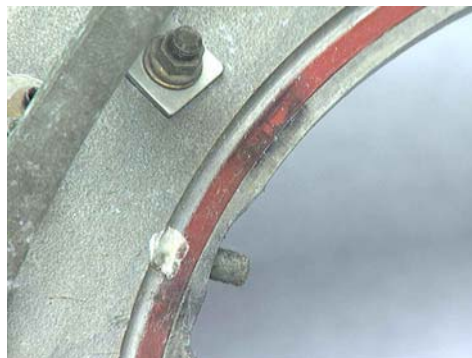
Figure 100: Discolored region of gate seal.

- Unknown white colored contaminant on seal.

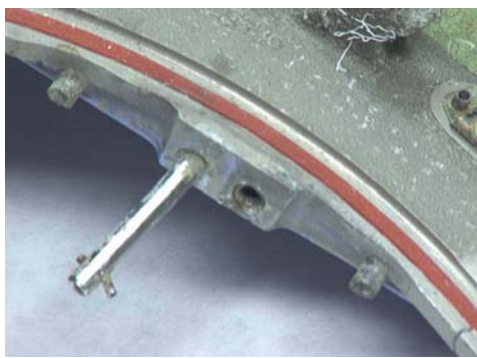
Figure 101: Forward stops & hinge pin, (looking from inside to outside).

- Forward/lower hinge pin is missing.

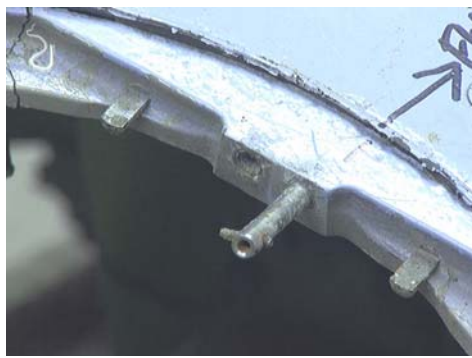
Figure 102: Forward stops and hinge pins, (looking from outside to inside).

- Forward/upper hinge pin can rotate freely.
- Stop pins look normal and unbent.

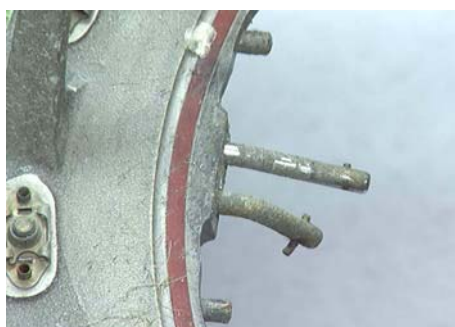
Figure 106: Aft hinge & stop pins (looking from inside to outside).

- Aft/lower stop pin appears to have a rust mark and can rotate.

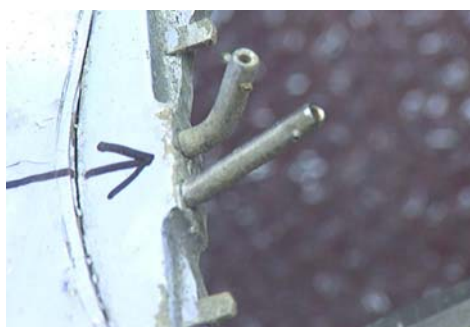
Figure 107: Aft hinge & stop pins, (looking from outside to inside)

- Aft/upper hinge pin (lower pin in photo) is difficult to rotate.
- Aft/lower hinge pin (upper pin in photo) rotates.

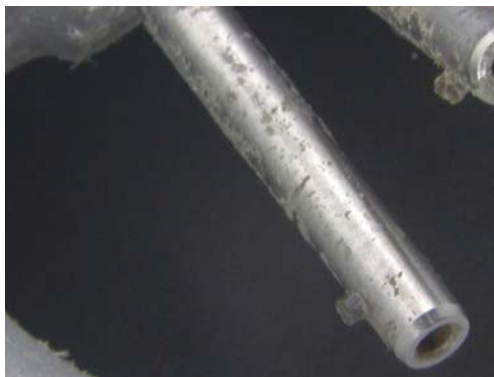
Figure 112: Aft/upper hinge pin, cotter pin is broken.

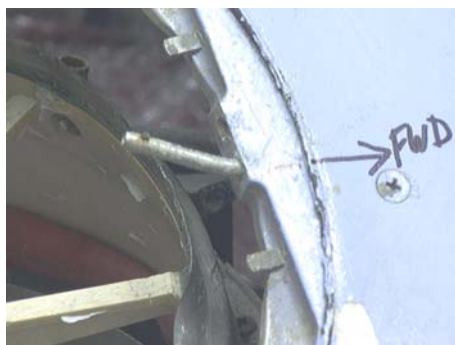
Figure 113: Forward/upper hinge pin, upper door (forward/ lower hinge pin is missing).

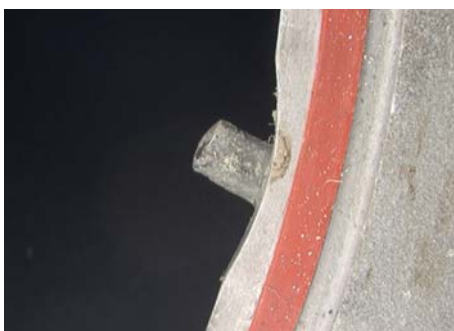
Figure 117: Overview of forward/upper stop pin as viewed from inside.

- Pin is relatively straight.

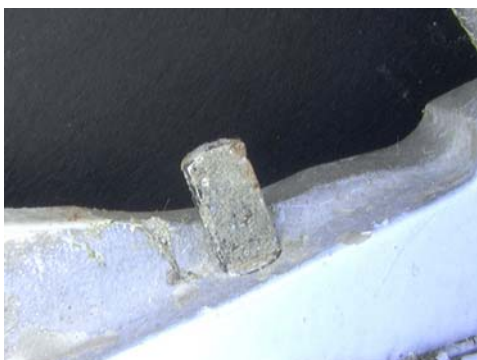
Figure 119: Overview of forward/upper stop pin, as viewed from outside.

- Pin is relatively straight, paint missing.

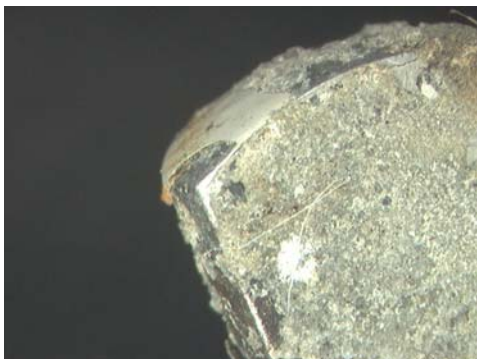
Figure 121: Forward/upper stop pin, close-up of figures #119 & #120.

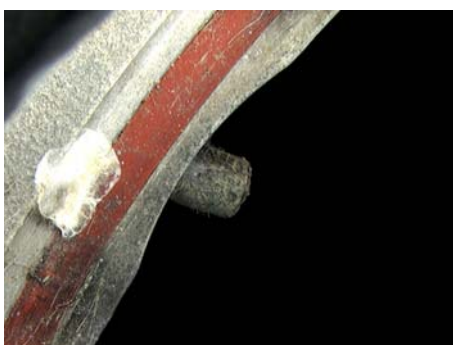
Figure 122: Overview of aft/upper stop pin, as viewed from inside.

- Pin is relatively straight.

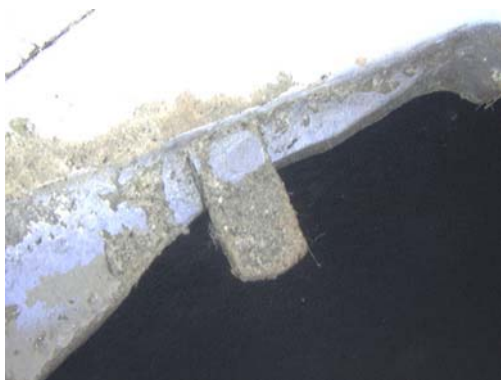
Figure 125: Overview of aft/upper stop pin as viewed from outside.

- Pin is relatively straight.

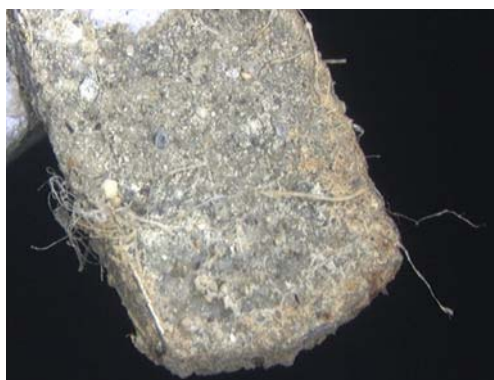
Figure 126: Aft/upper stop pin, close-up of figure #125.

- Paint is chipped.

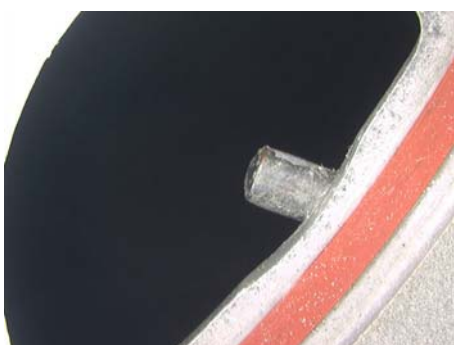
Figure 129: Overview of forward/lower stop pin, as viewed from inside.

- Pin is relatively straight.

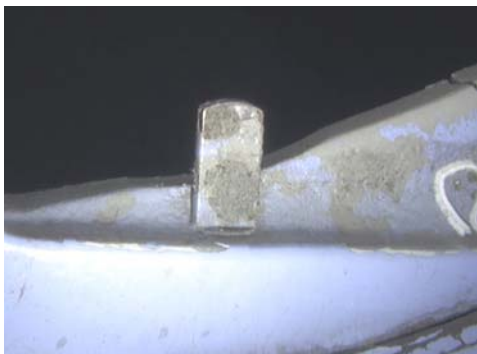
Figure 131: Overview of forward/lower stop pin, as viewed from outside.

- Pin is relatively straight.

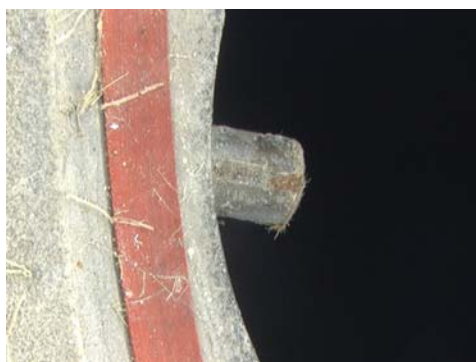
Figure 133: Overview of aft/lower stop pin, as viewed from inside.

- Pin is relatively straight.

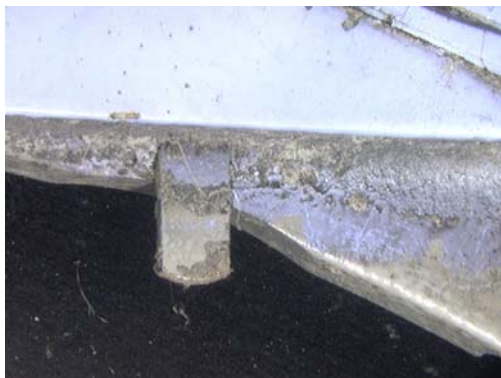
Figure 136: Aft/lower stop pin.

- Overall, pin is relatively straight.

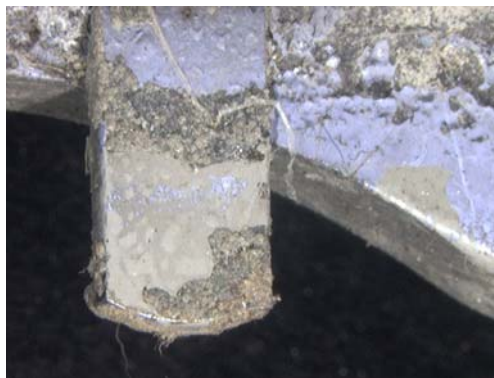
Figure 137: Aft/lower stop pin, close-up of figure #136.

- Paint is chipped.

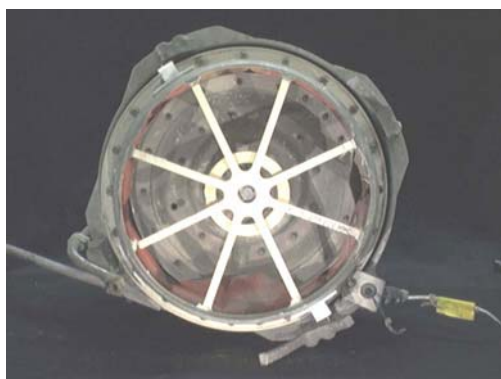
Figure 138: Overview of valve face.

- Knife-edge has some rolled over areas and some bent edges.
- In general, reasonably round.
- 2 gate spacers, HS P/N 727407-30 are missing, remaining 2 spacers on top and bottom as shown.

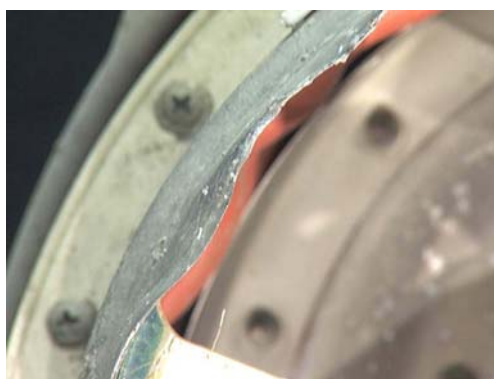
Figure 139: Close-up of knife-edge damage.

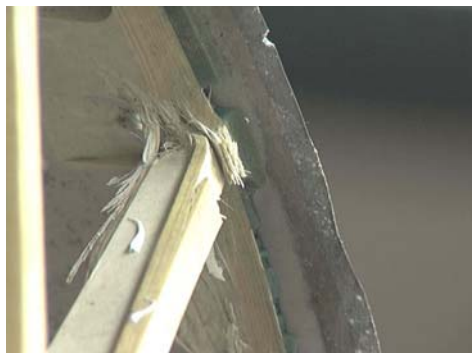
Figure 143: Close-up of web, representative of web fractures at gate ID.

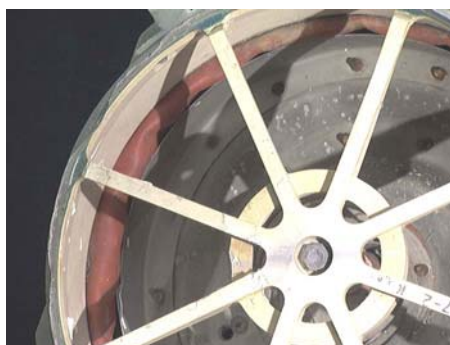
Figure 147: Diaphragm, apparently intact portion.

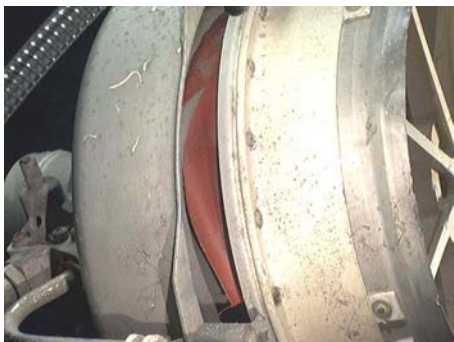
Figure 148: Diaphragm, circumferential tear.

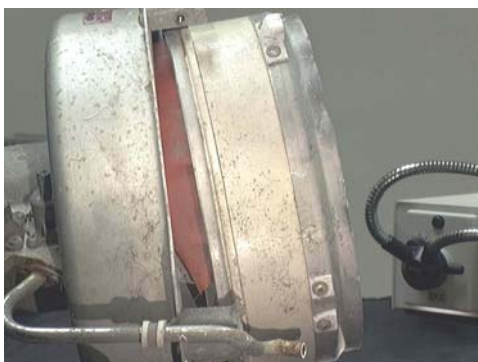
Figure 149: Offset angle between valve housing and gate.

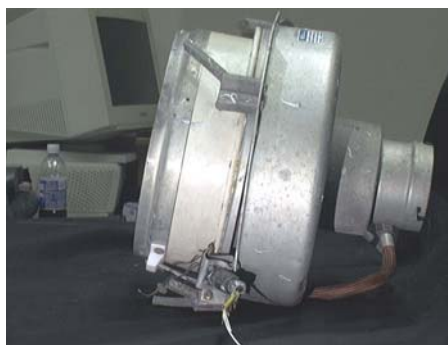
Figure 150: Offset angle (same as in figure #149) from the opposite side.

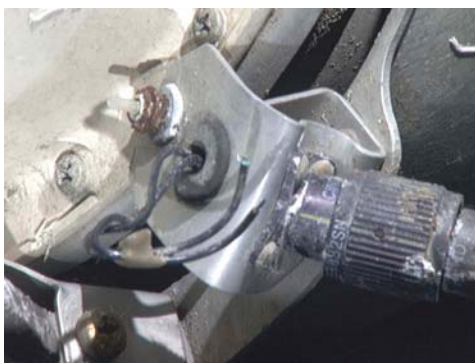
Figure 151: Switch mounting bracket, gate is against bracket.

- The switch actuator is intact but the basic switch is missing.
- The (electrical connector and plug) mating is intact.

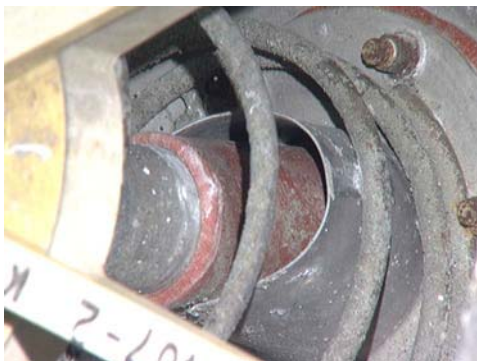
Figure 153: Center diaphragm & return spring.

- Diaphragm is intact and spring is unseated from valve cover.

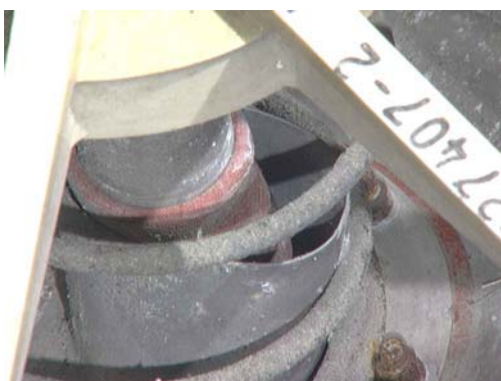
Figure 154: Center diaphragm guide, HS P/N 727411-1, showing distortion of guide itself.

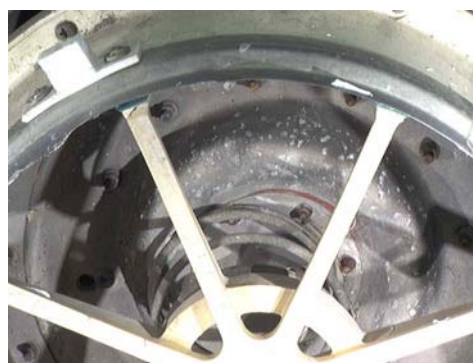
Figure 155: Gate return spring, showing unseated spring.

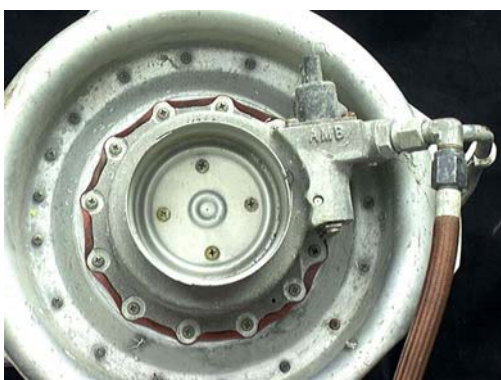
Figure 156: Overview of control and filter assemblies.

- The filter (HS P/N 715942-1), cover (HS P/N 727423-1) and spring (HS P/N 727430-1) – are all missing.
- Control orifice shown in bottom of filter housing looks clean.
- Exterior of sensors exhibit light deposits of contamination.

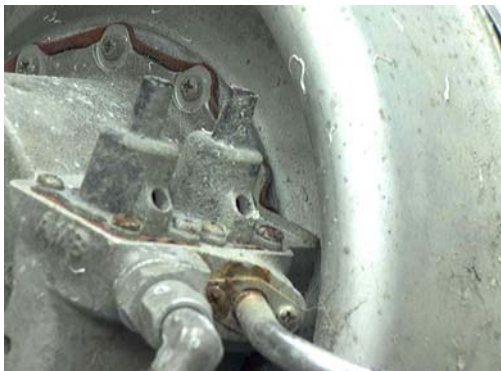
Figure 157: Exterior view of sensors, showing some apparent corrosion on the integral ambient sense tube.

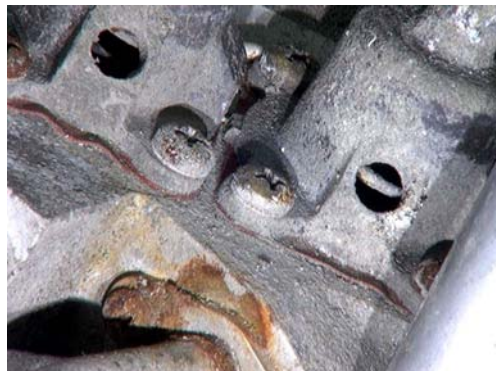
Figure 158: Cabin pressure sense ports on sensor adjustment springs.

- Holes look clear.
- Corrosion on tube retainer plate (HS P/N 727417-2).

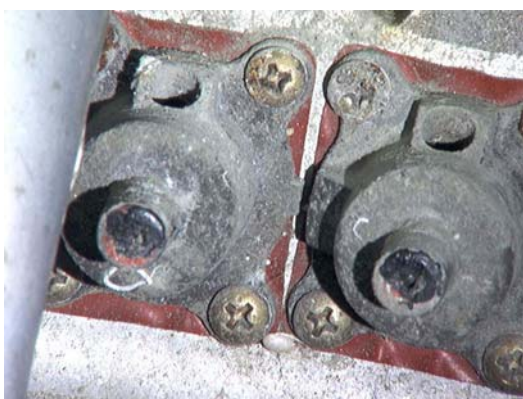
Figure 159: Control adjustment screws.

- Tamper proof seals are in place.

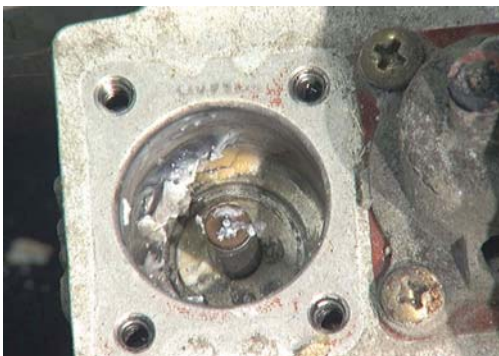
Figure 165: Remote ambient sensor housing bore.

- Salt & moisture present.
- Poppet is frozen.

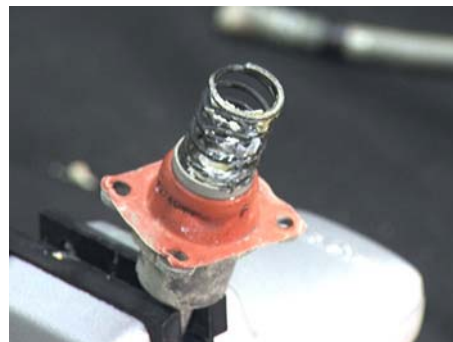
Figure 166: Diaphragm appears to be intact.

- Salt deposits on spring.
- Heavy corrosion on spring seat (one-third).

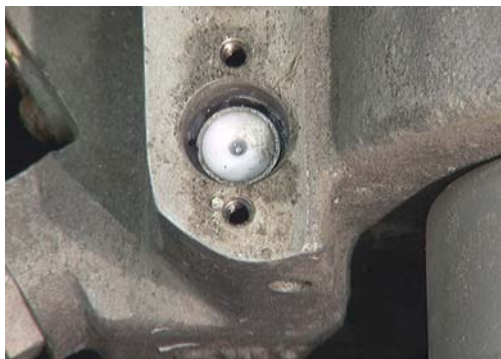
Figure 167: Remote ambient sensor poppet and guide, opposite side - relatively clean.

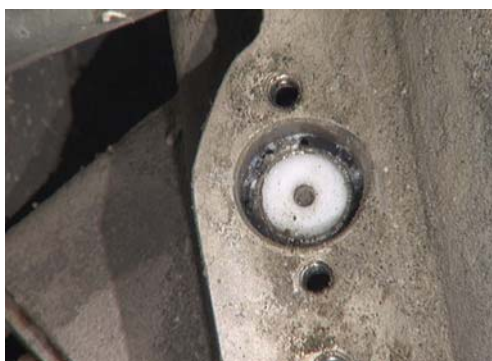
Figure 172: Opposite end of integral ambient sensor poppet and guide.

- A little moisture is present.

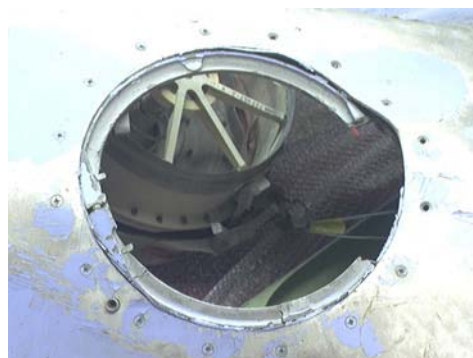
Figure 179: Exterior opening for Lower Pressure Relief Valve (valve still inside).

- External view shows the heads of 5 attachments screws to the skin, are missing and about 25% of mounting flange is missing.

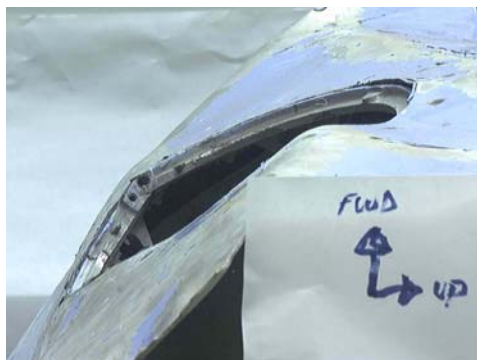
Figure 183: Skin distortion at valve mounting location.

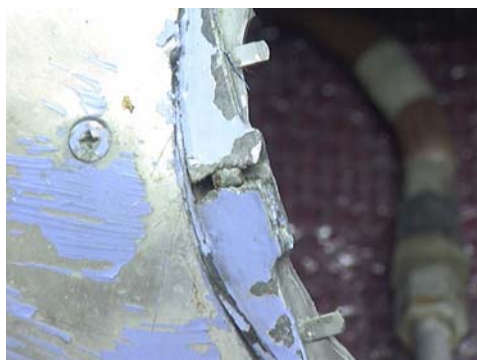
Figure 184: Exterior opening, close-up of fracture of valve housing at forward/upper hinge pin.

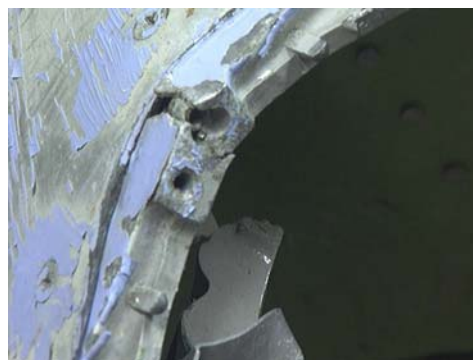
Figure 185: Exterior opening, close-up, another view of figure #184

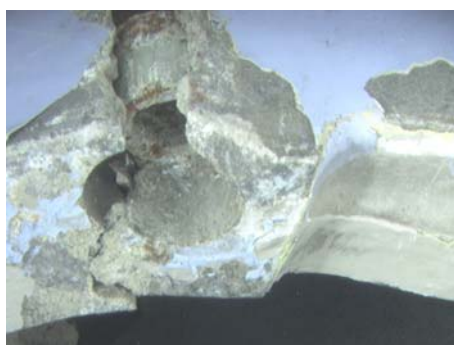
Figure 186: Forward/upper hinge pin bushing hole.

- Housing is cracked and contains partial bushing.

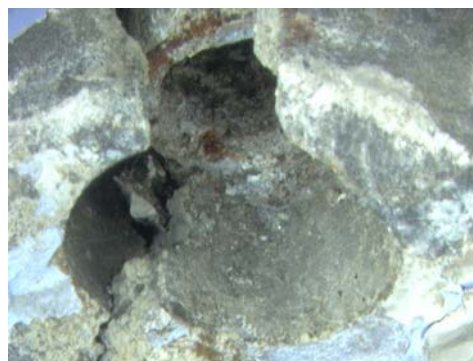
Figure 187: Forward/upper hinge pin, close-up of partial bushing.

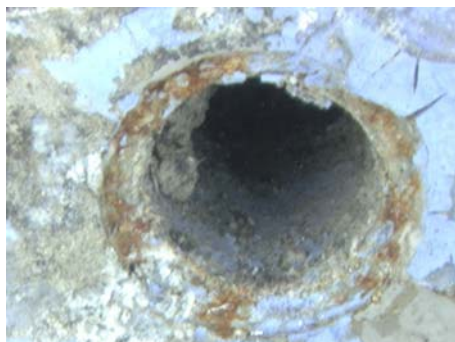
Figure 188: Forward/upper hinge pin, close-up view of partial bushing in hole.

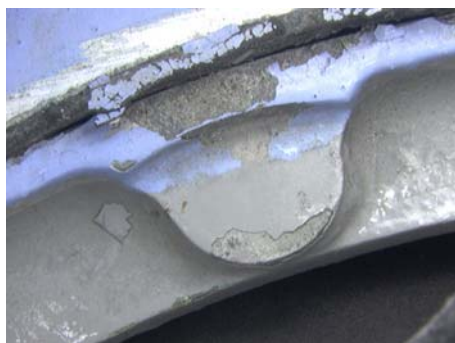
Figure 191: Upper stop pad; paint chipped.

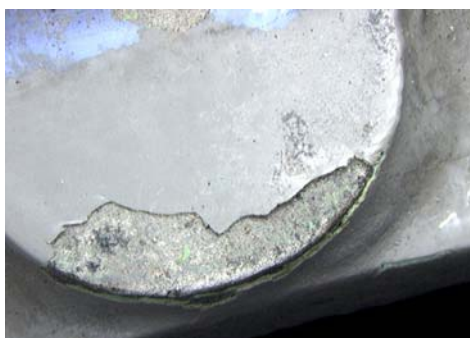
Figure 192: Upper stop pad, close-up of figure #191.

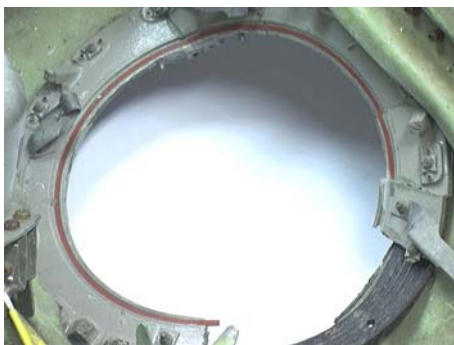
Figure 193: Non-metallic washer (gate seal), HS P/N 527355-13, as viewed from inside.

- Approximately 25% of seal is missing.
- Slight impression of gate knife-edge on seal surface.
- No abnormal cuts on seal surface.

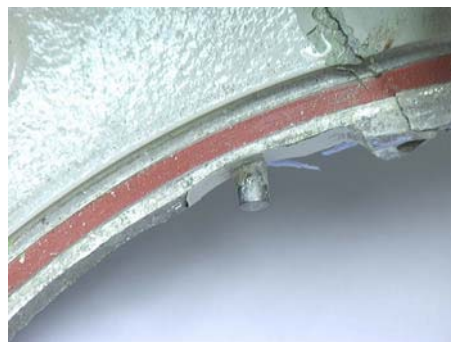
Figure 194: Exterior door open, stop pin, HS P/N 730539-1. Overview of forward/upper pin as viewed from inside.

- Appears to be normal and not bent relative to valve housing.

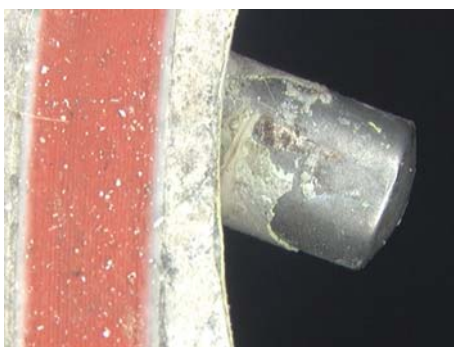
Figure 195: Forward/upper stop pin overview. View is looking from inside towards outside.

- Pin is relatively straight.

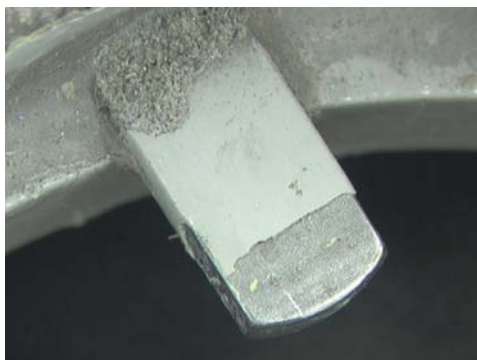
Figure 198: Forward/upper stop pin as viewed from outside looking inside..

- Pin is relatively straight.

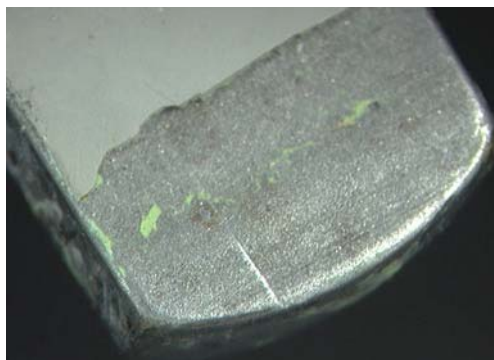
Figure 199: Forward/upper stop pin, close-up of figure #198.

- Paint is chipped.

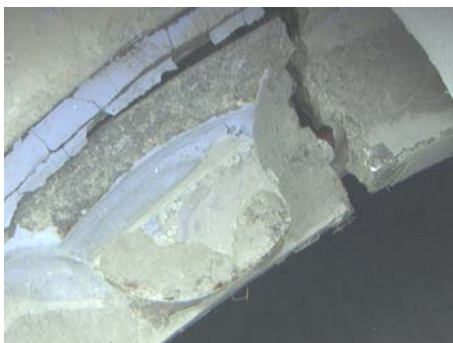
Figure 200: Lower stop pad, with adjacent crack on housing.

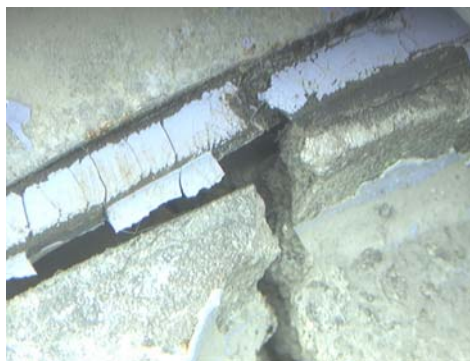
Figure 201: Detail of lower stop pad.

- It is broken away from housing (housing cracked).

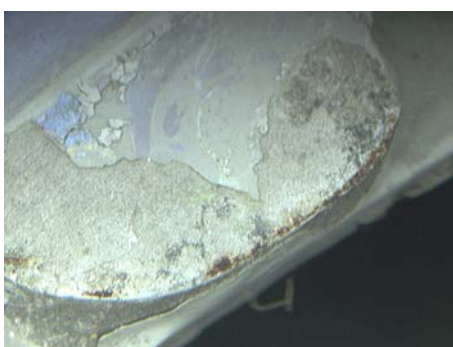
Figure 202: Close-up of figure #200, paint chipped.

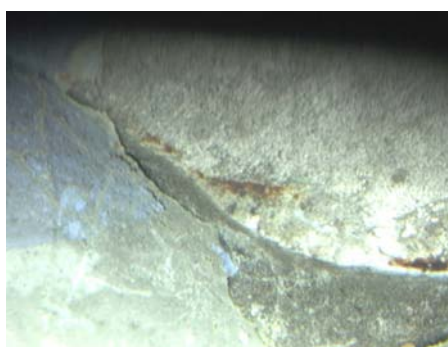
Figure 203: Close-up of figures #200 and #202, slight dent on pad, paint chipped.

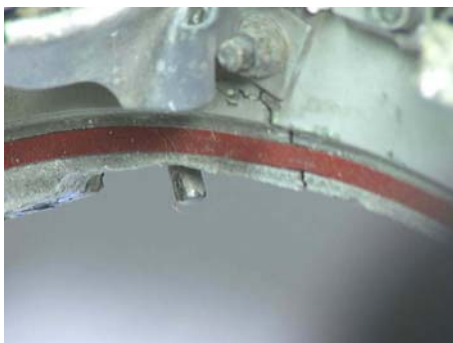
Figure 204: Exterior door open, forward/lower stop pin, HS P/N 730539-1, as viewed from inside.

- Appears to be normal and not bent relative to valve housing.
- Note: aft upper & lower pins are missing along with a portion of valve housing that they are normally installed in.

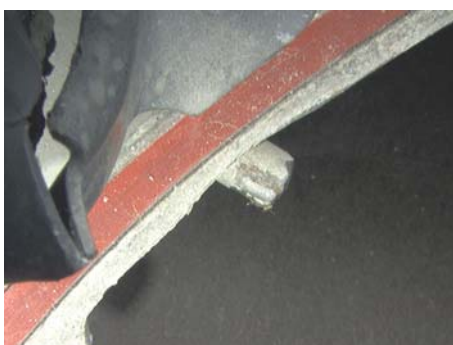
Figure 205: Forward/lower stop pin, overview as viewed from inside.

- Pin is relatively straight.

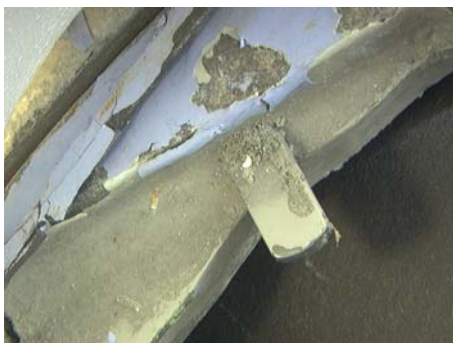
Figure 207: Forward/lower, stop pin as viewed from outside.

- Pin is relatively straight.
- Paint is chipped.

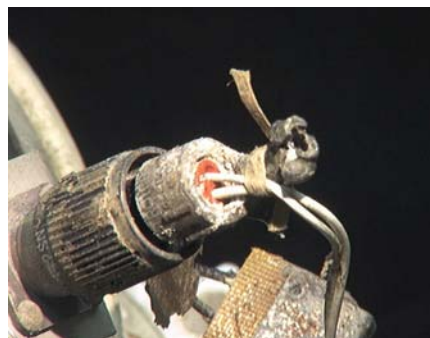
Figure 210: Electrical switch connector interface appears to be intact.

- Wires are intact exiting plug.
- Strain relief on backshell is broken.

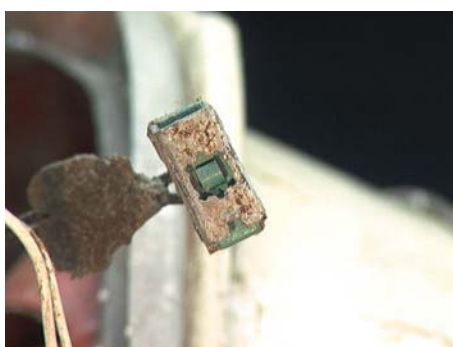
Figure 211: Switch plunger, part of HS P/N 727415-1.

- Switch appears to be intact but switch actuator is missing.

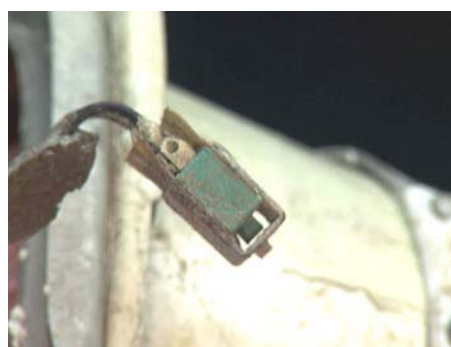
Figure 212: Switch (side view): actuator is missing from switch housing.

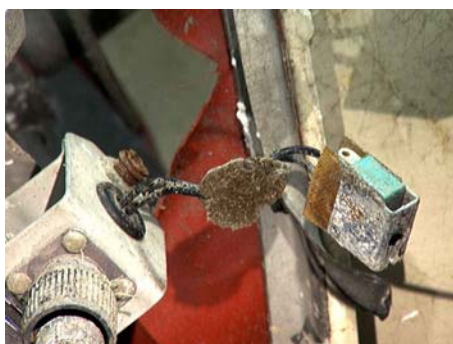
Figure 213: Switch lead wires showing bond detached from housing.

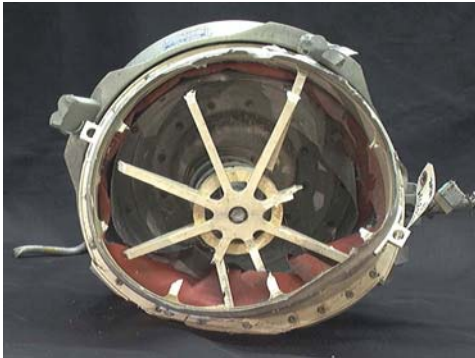
Figure 215: Overview of removed valve.

- Gate adapter is out of round.
- Web members have rotated approximately 45° in relation to case.
- Approximately 50% of edges were curled & torn.
- Light salt deposits.
- At attachment to gate HS P/N 727407-11, 50% of sealant is cracked.
- All 8 rivets (attaching gate to gate adapter) are intact.
- 2 of 4 spacers HS P/N 727407-30, are broken off at flanges.
- HS P/N 727407-11, gate – all 8 of center body webs are broken (7 of 8 at the inside diameter [ID] of the gate).

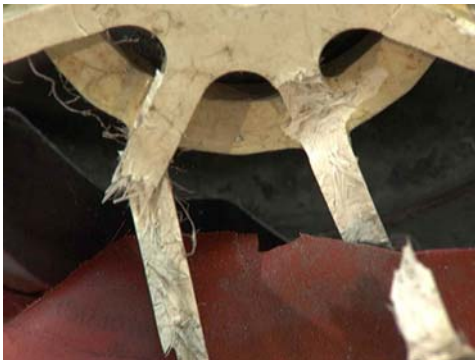
Figure 216: Gate webs, detailed view of broken web members.

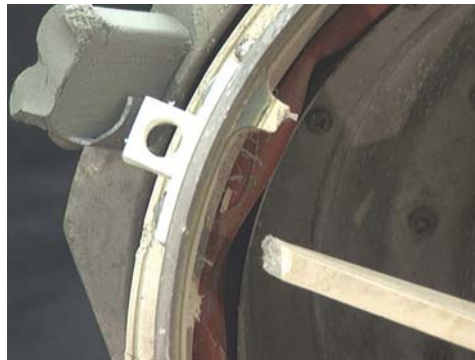
Figure 217: Broken web detail.

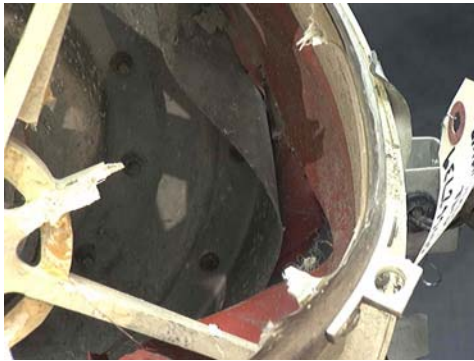
[Figure 218](#): Web damage.

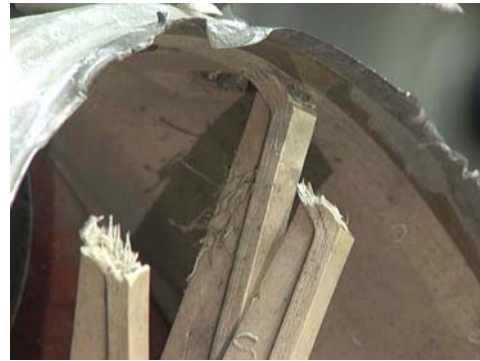
[Figure 219](#): Web damage.

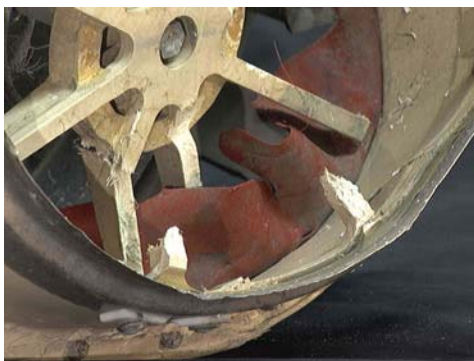
[Figure 220](#): Detail of more broken webs.

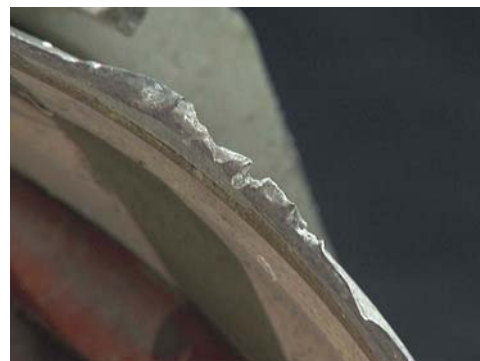
[Figure 221](#): Knife-edge close-up of damage.

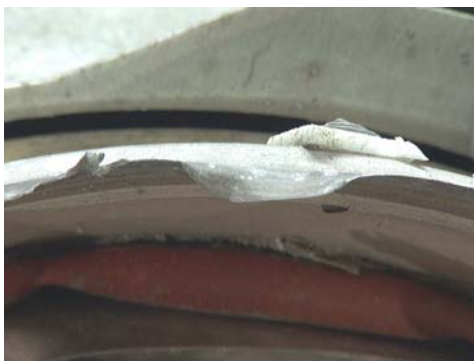
[222](#): Knife-edge damage.

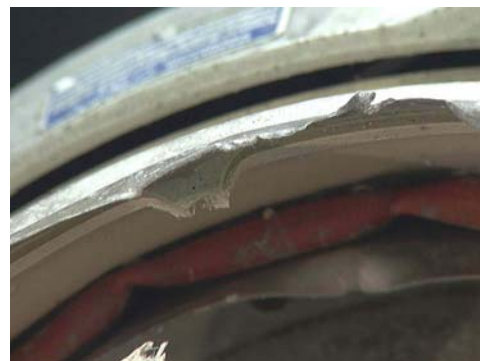
[Figure 223](#): Knife-edge damage.

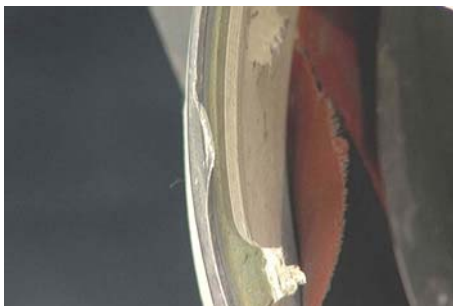
Figure 224: Knife-edge damage.

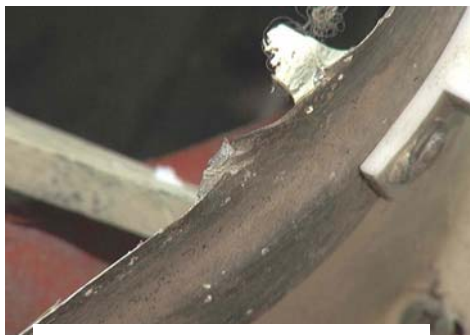
Figure 225: Knife-edge damage.

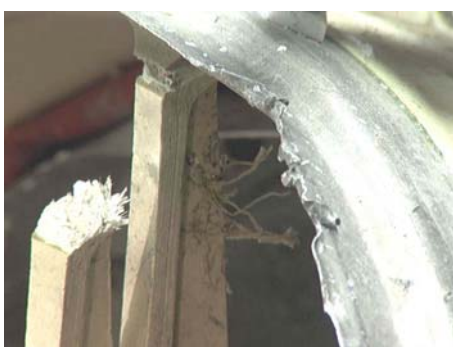
Figure 226: Knife-edge damage.

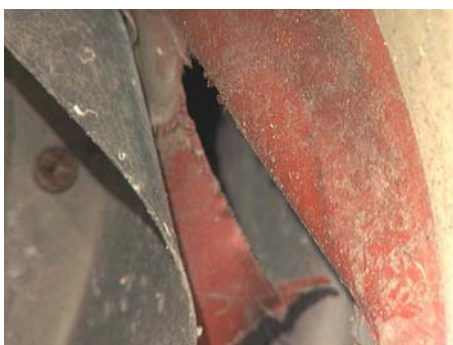
Figure 228: Outer diaphragm, approximately 60% of circumference is torn.

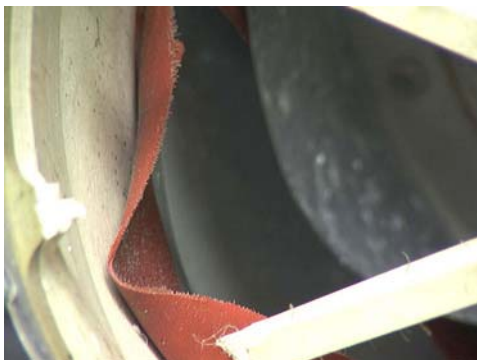
Figure 230: Outer diaphragm damage.

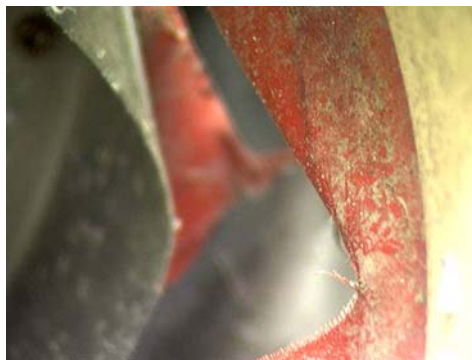
Figure 231: Outer diaphragm damage.

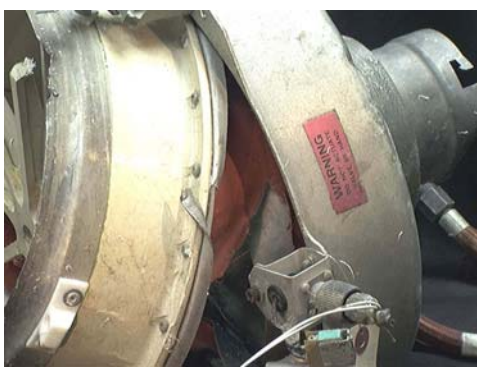
Figure 232: Side view of gate assembly & valve cover, showing the approximate 30° angle between gate assembly & valve cover.

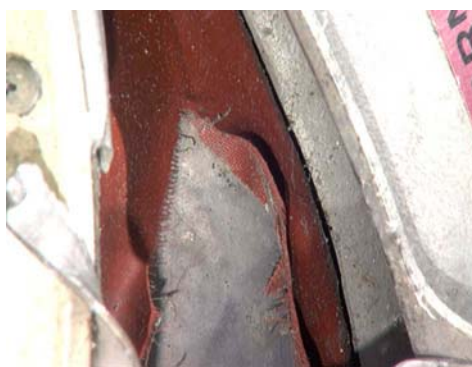
Figure 233: Outer diaphragm, close-up of tear origin.

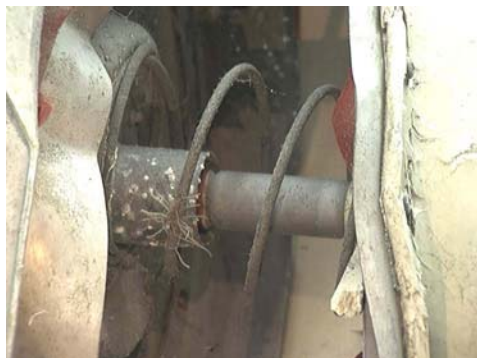
Figure 236: Gate return spring, HS P/N 727414-2 appears to be intact.

- Some unknown surface accumulation is present.

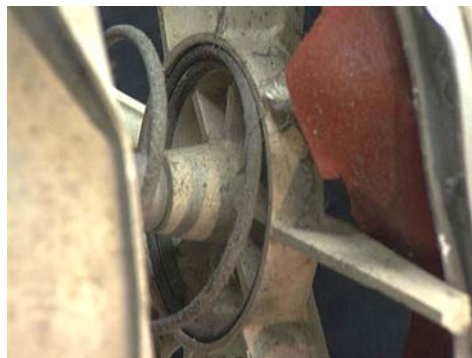
Figure 237: Gate return spring is seated in the gate. The end coil appears to be inside the last active coil.

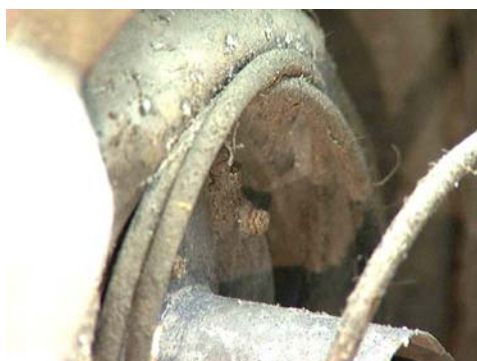
Figure 238: Gate return spring is over end showing intertwining of end coil and the active coil.

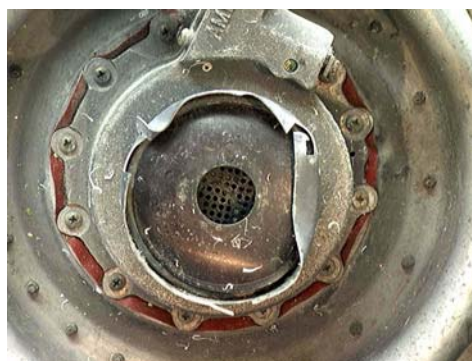
Figure 239: Overall of control, filter end.

- Filter cover HS P/N 727423-1 & spring HS P/N 727430-1 are missing.
- Filter housing HS P/N 727426-1 is bent over holding filter in place.

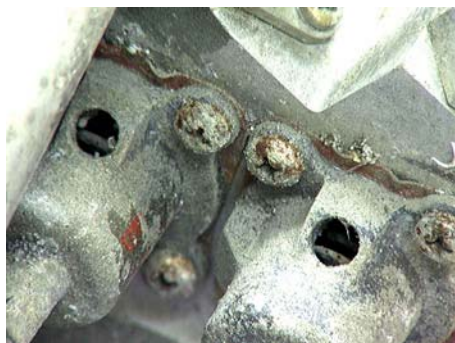
Figure 241: Cabin pressure sense ports.

- Ports appear to be un-plugged.
- Some accumulation deposits.
- Springs appear to be in place.

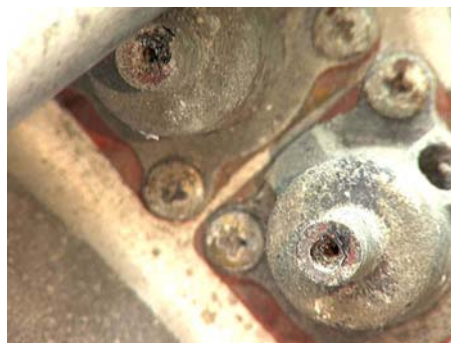
Figure 242: Control adjustment screws, both appear to be intact.

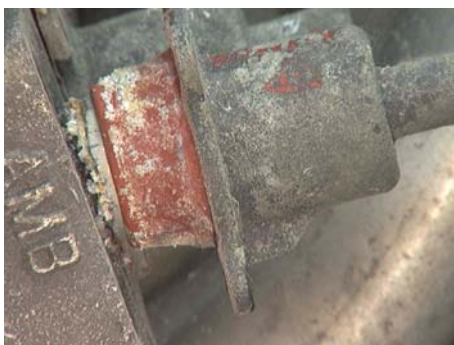
Figure 249: Remote ambient sensor, cover and diaphragm partially removed.

- Heavy salt deposits on spring, piston and diaphragm.

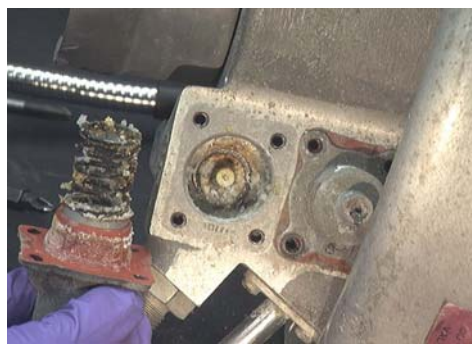
Figure 250: Showing remote ambient sensor removed.

- Heavy salt deposits on spring & housing bore.
- Diaphragm appears to be intact, poppet moves freely.

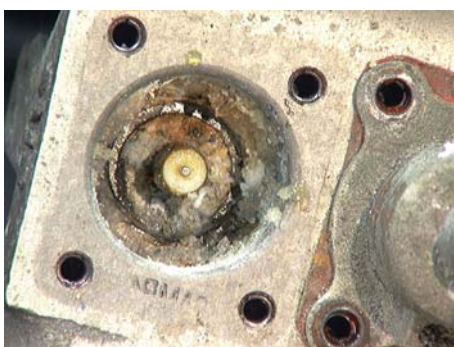
Figure 251: Close-up of salt deposits inside housing bore.

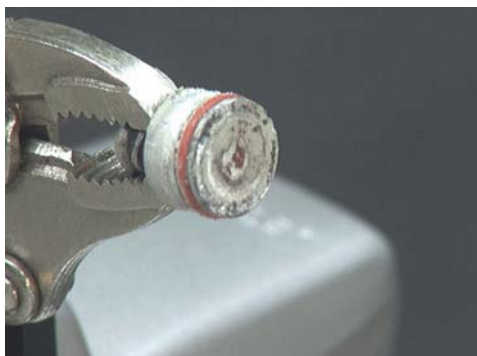
Figure 253: Plug HS P/N 719280-1 and seal, seal looks normal and uncut.

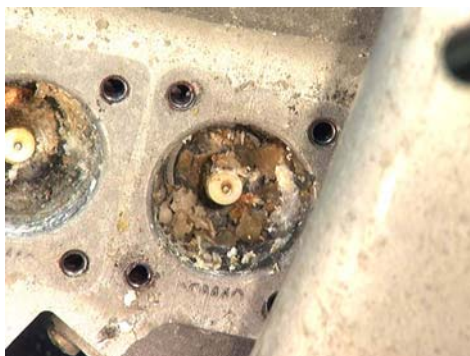
Figure 254: Integral sensor housing bore.

- Heavy deposits.
- Poppet appears to be frozen.
- Salt deposits on end of poppet.

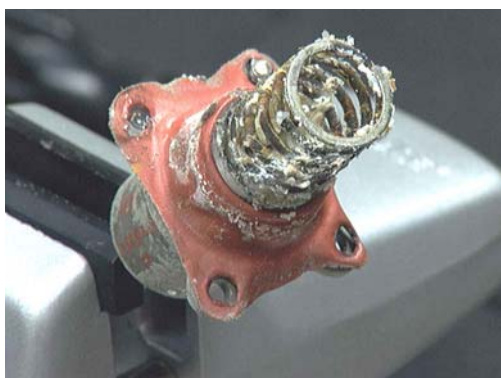
Figure 255: Integral sensor spring and diaphragm.

- Heavy salt deposits.
- Diaphragm intact.
- Spring has heavy salt deposits and possibly salt corrosion.

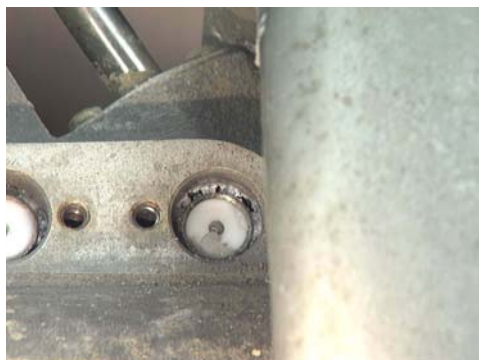
Figure 256: Opposite end of integral sensor poppet and guide; heavy salt deposits.

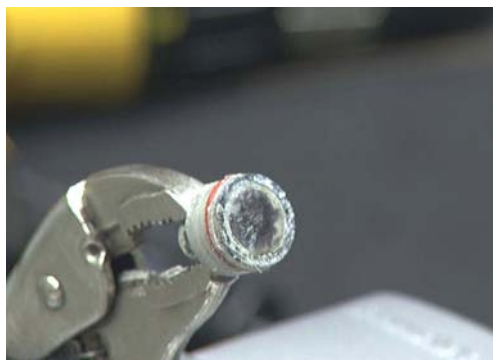
Figure 257: Plug for integral sensor, seal looks normal and uncut.

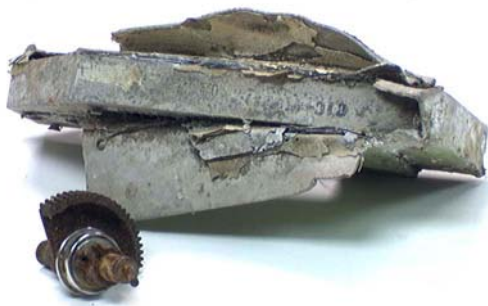
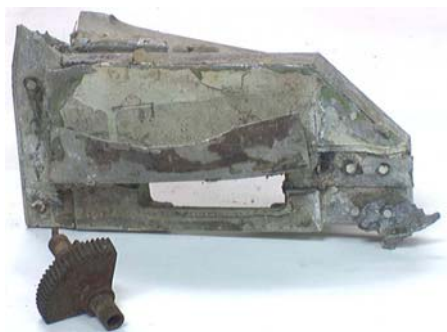
Figure 274. Appears to be a portion of a gear/cam assembly and structure.

Figure 275. Appears to be a portion of a gear/cam assembly and structure, different view from figure #274.

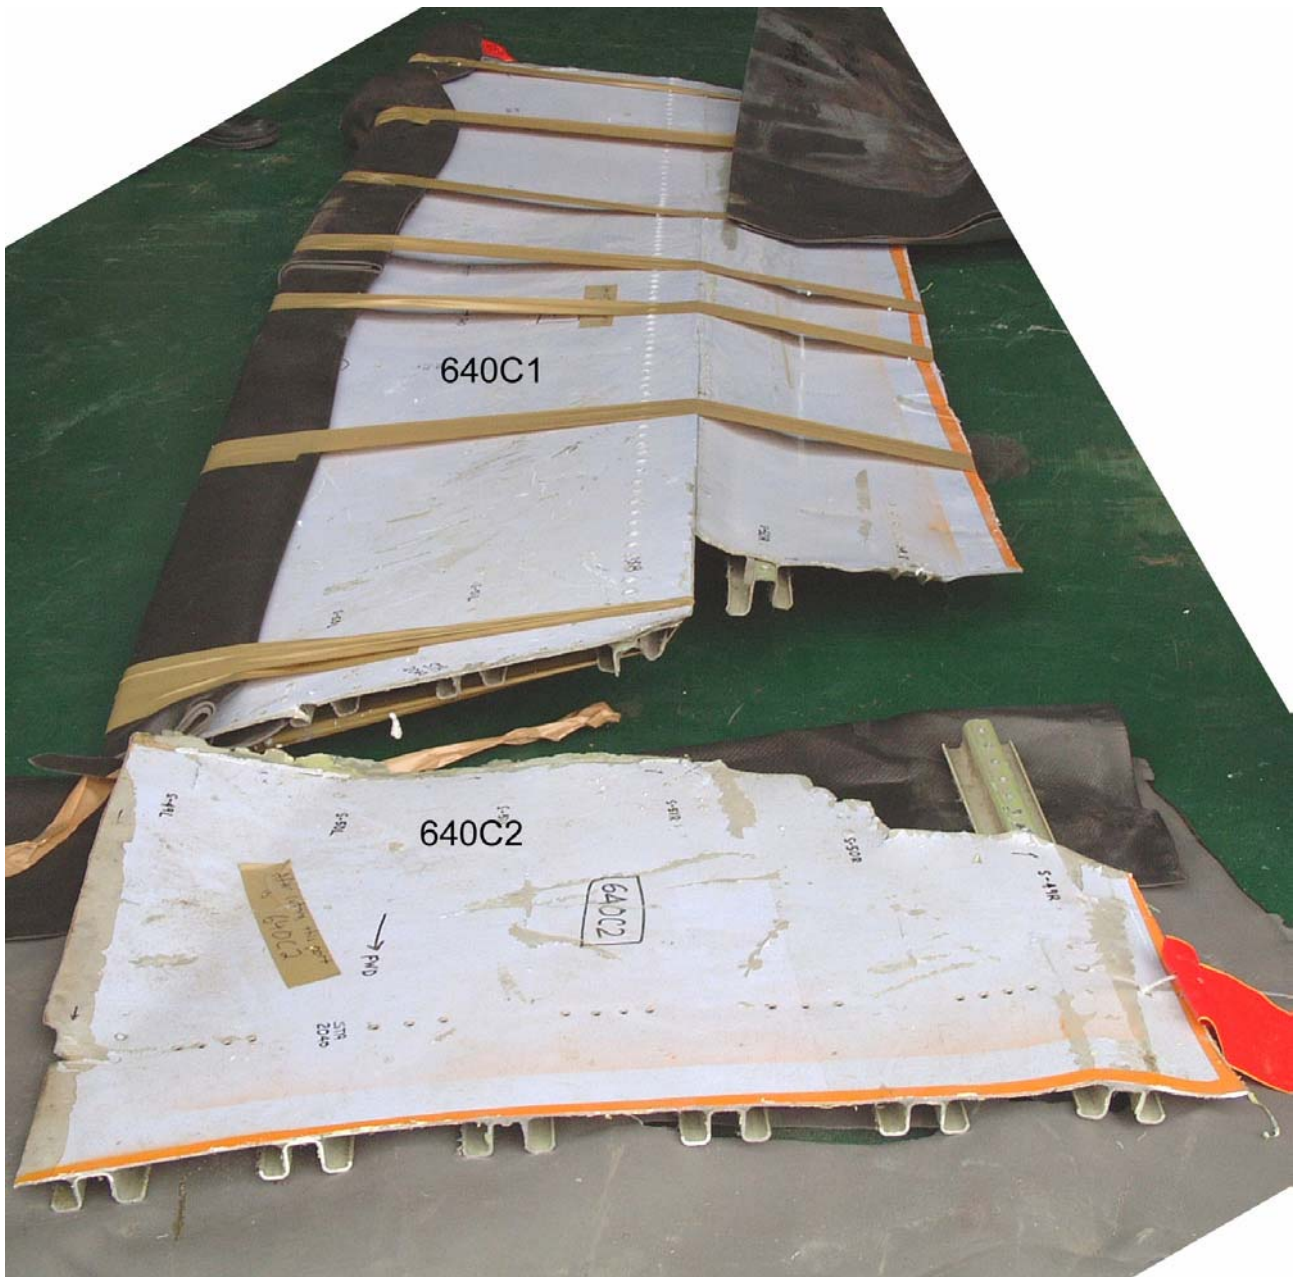
Figure 1

An overall appearance of ITEM 640C wreckage, submitted to AMD for failure analysis is shown in Figure 1, which consists of ITEM 640C1 and 640C2. At first, the ITEM 640C wreckage was visually examined and its features were recorded in detail. Further, failure analyses were done as well to identify extent of fatigue area, initiation sites and direction of crack propagation in order to provide valuable information for determining root cause of CI611 plane crash.
