Aviation Occurrence Report Volume I

ASC-AOR-05-02-001

IN-FLIGHT BREAKUP OVER THE TAIWAN STRAIT

CHINA AIRLINES FLIGHT CI611

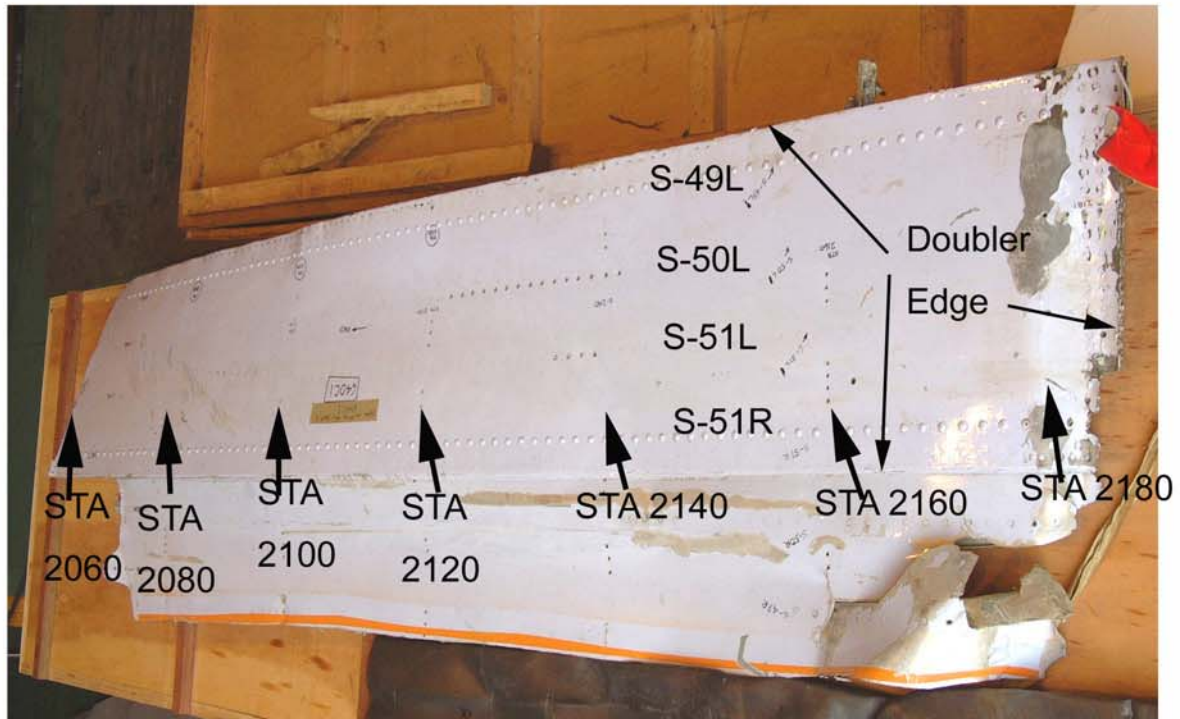
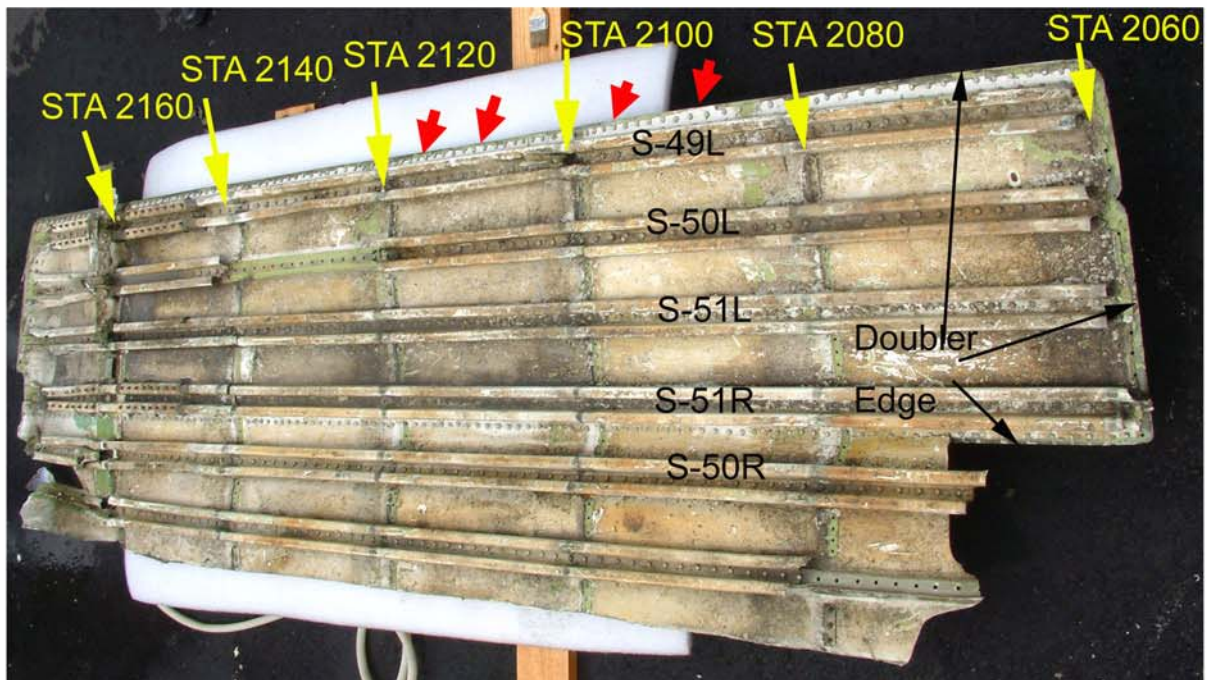
Figure 2

Figures 2a and 2b, shows both sides of 640C1 and indicates where a repair doubler was attached to the outboard fuselage skin. The range of doubler was approximately within the area between frames STA 2060 and 2180 and stringers S-49L and S-51R, respectively. Figure 2a indicates that all the frames came off of the skin and were missing. However, aside from the section between STA 2120 and STA 2140 of stringer S-50L, almost all stringers were still attached to the fuselage skin. By way of visual examination, the fuselage skin was found to have suspected evidence of fatigue cracking (fracture surface normal to the surface of skin) that was close to, and parallel with, stringer S-49L. This portion of the skin fracture is marked with red arrows in Figure 2a.

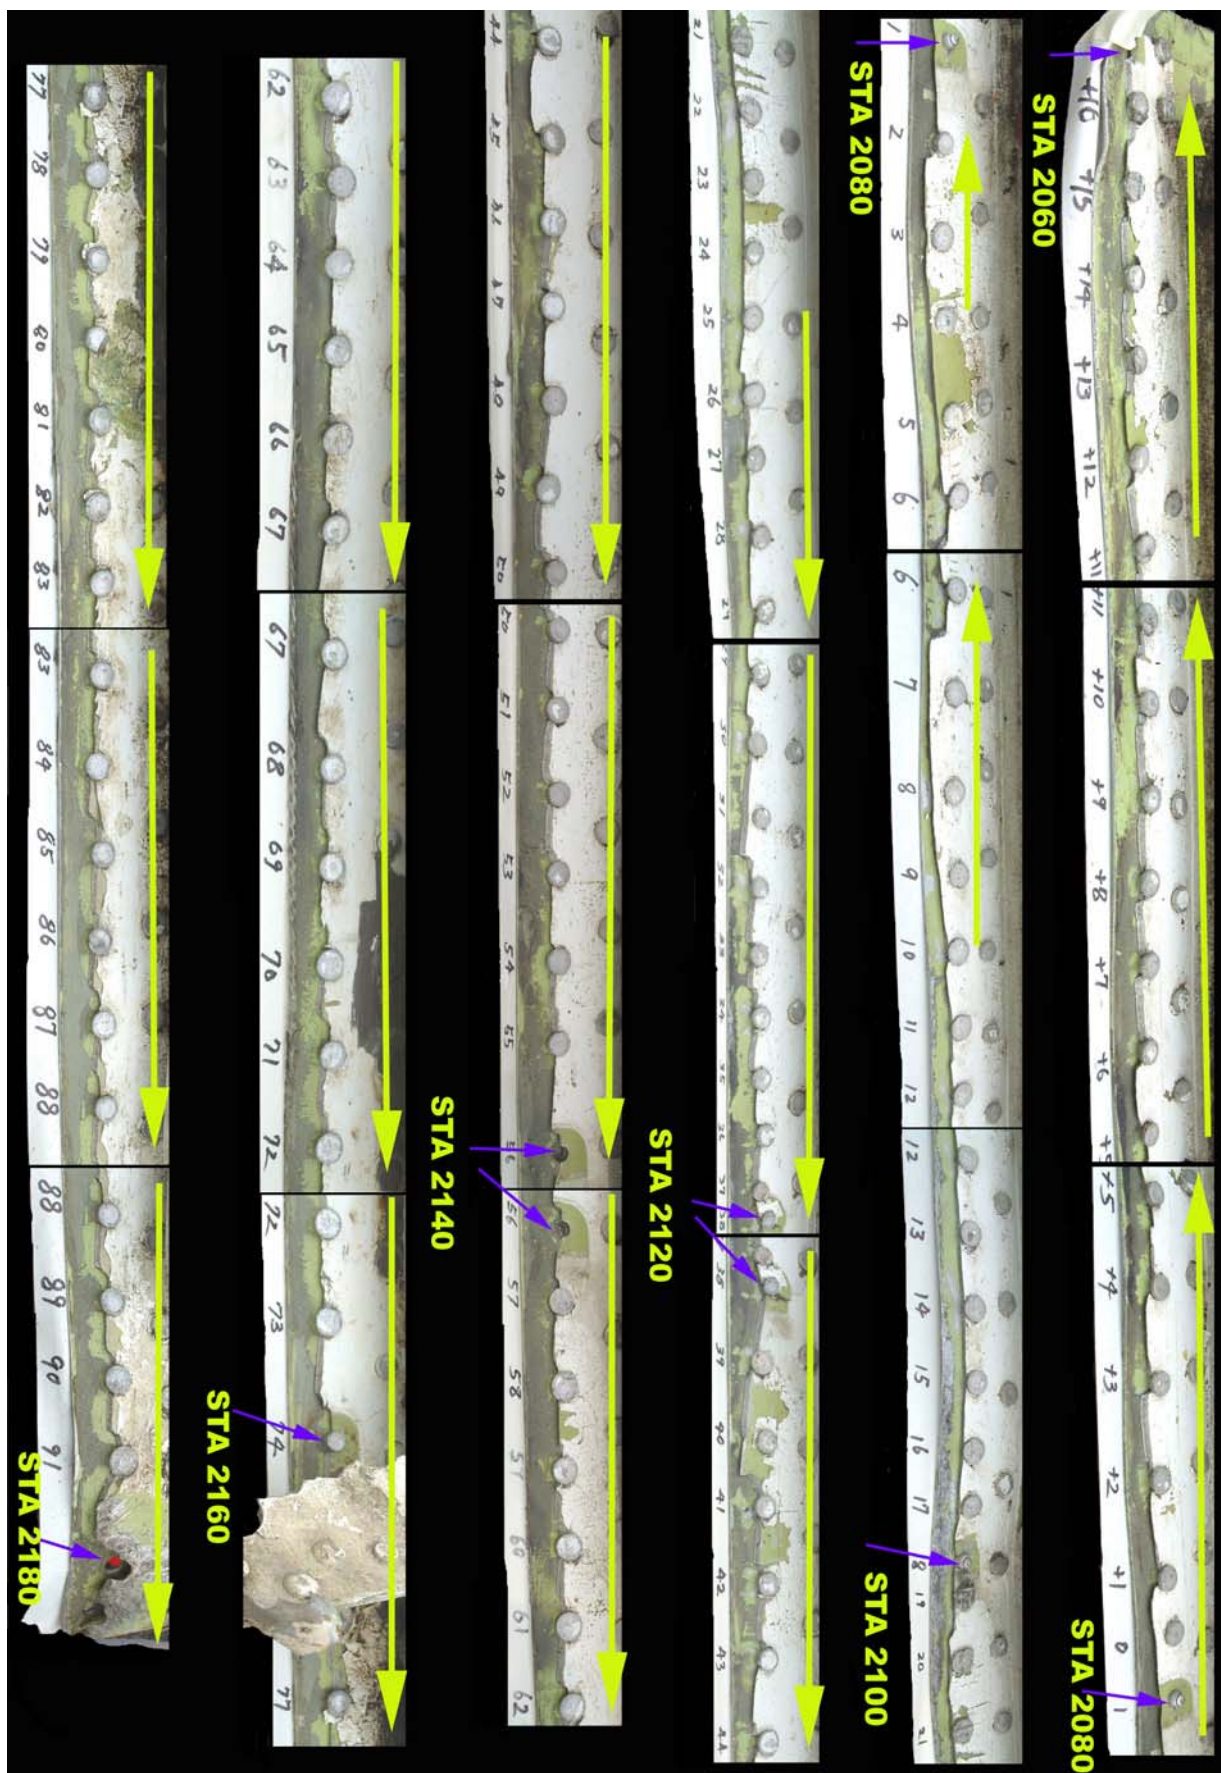
Figure 3 is composed of 18 photos and shows an overall view of the skin fracture surface along the direction of stringer S-49L. For referencing purposes rivets were identified by the numbers +17 to 91 along the fracture as shown in figure 3. The same identification for these rivets was used throughout the report.

The fracture surfaces near the rivets from +17 to 91 in Figure 3 were examined by low-magnification optical (light) microscopy for suspected evidence of fatigue cracking. Three sections of the skin fracture incorporating rivets and doubler sections were removed by saw cutting for macroscopic examination and are shown in figure 4. Macro examination using low power optical method was performed at the AMD laboratory while the fracture surfaces were cleaned with a soft bristle brush and acetone during examination. The following group representatives participated in macroscopic examination of fracture surface.

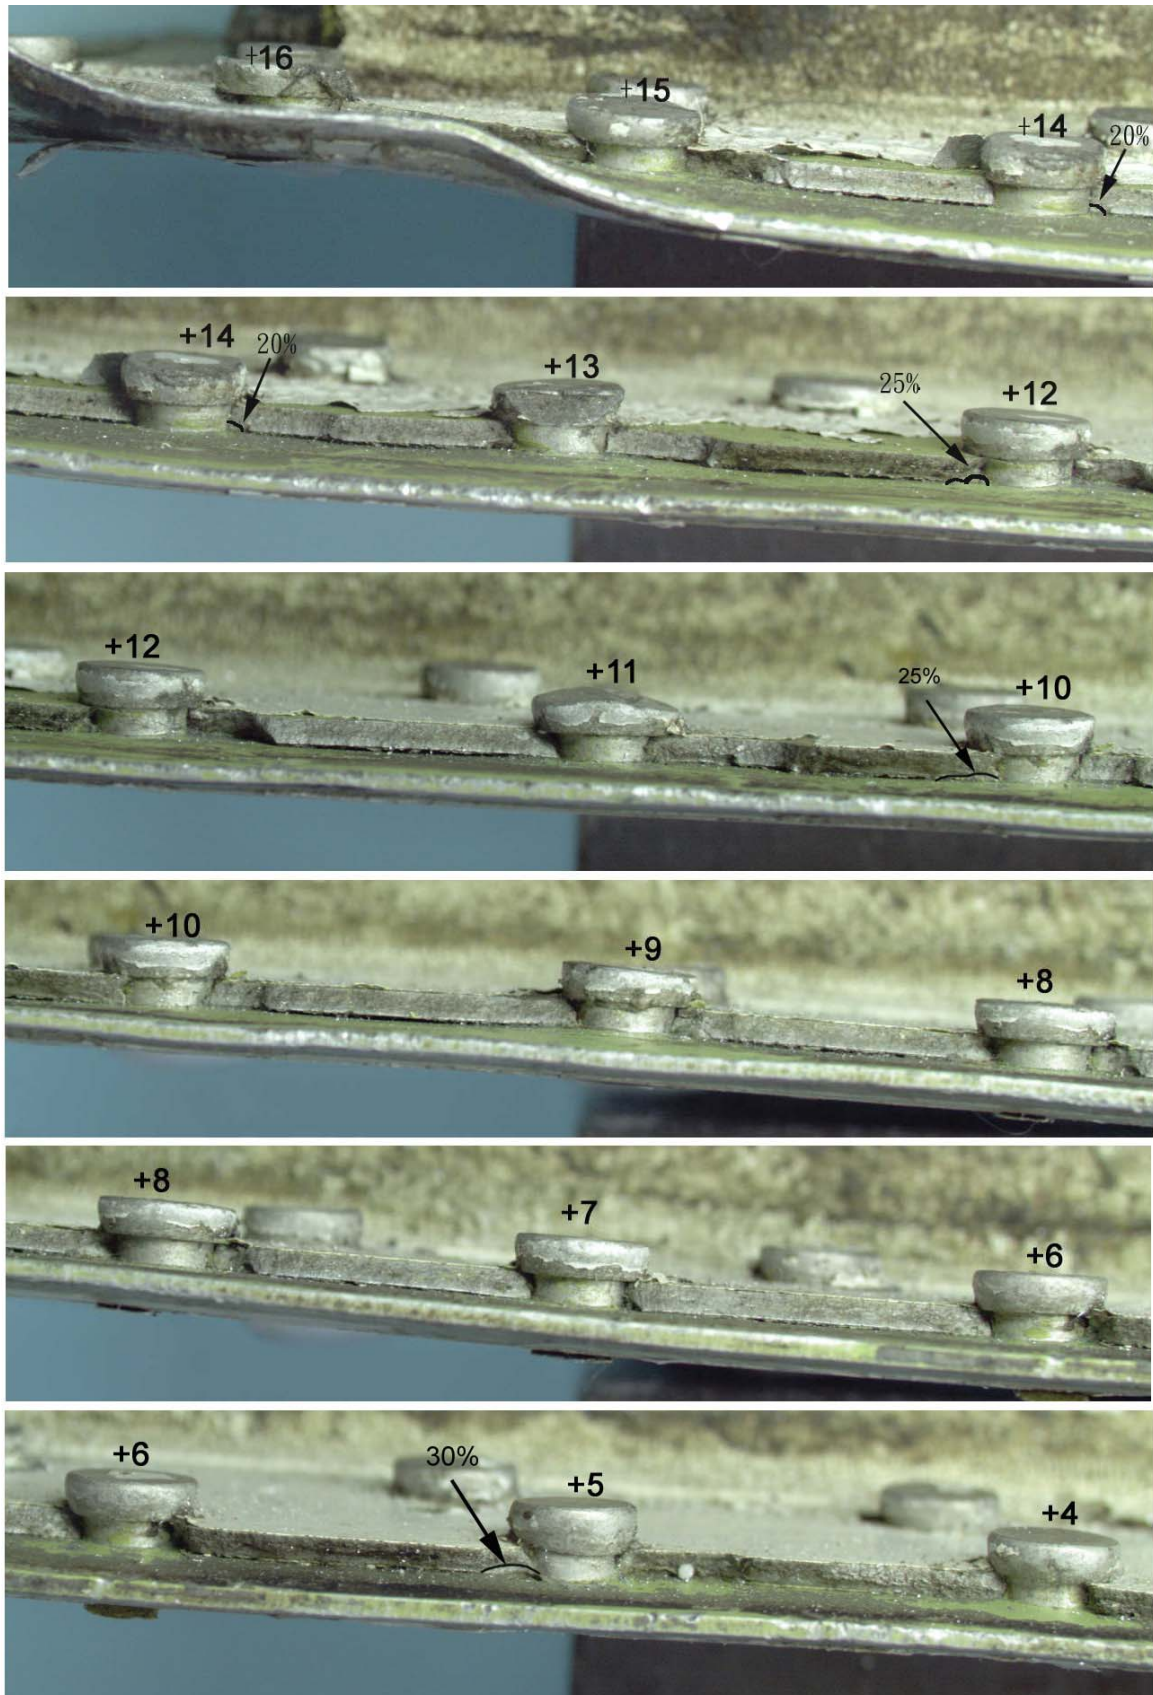
Figure 5

1. The extent of fatigue cracking was determined by SEM examination. The extent of fatigue cracking is shown in Figures 5 through 10, in which the fatigue propagated from the edge next to the doubler until it reached the black curves shown in these figures. Outside of the fatigue regions the fracture features were typical of an overstress separation. The quantities in Figures 5 through 10 denote the ratio of maximum depth of fatigue crack to the thickness of fuselage skin in the corresponding location. It should be noted that in most circumstances the fatigue initiated at the skin edge next to the doubler and progressed inboard through the direction of skin thickness. The majority of the fatigue cracking was associated with frame STA 2100, in the area corresponding to the region of rivets from 10 to 25. Figure 11 is a drawing (not to scale) indicating the fatigue cracking on the skin fracture surface from rivets +17 through 56.

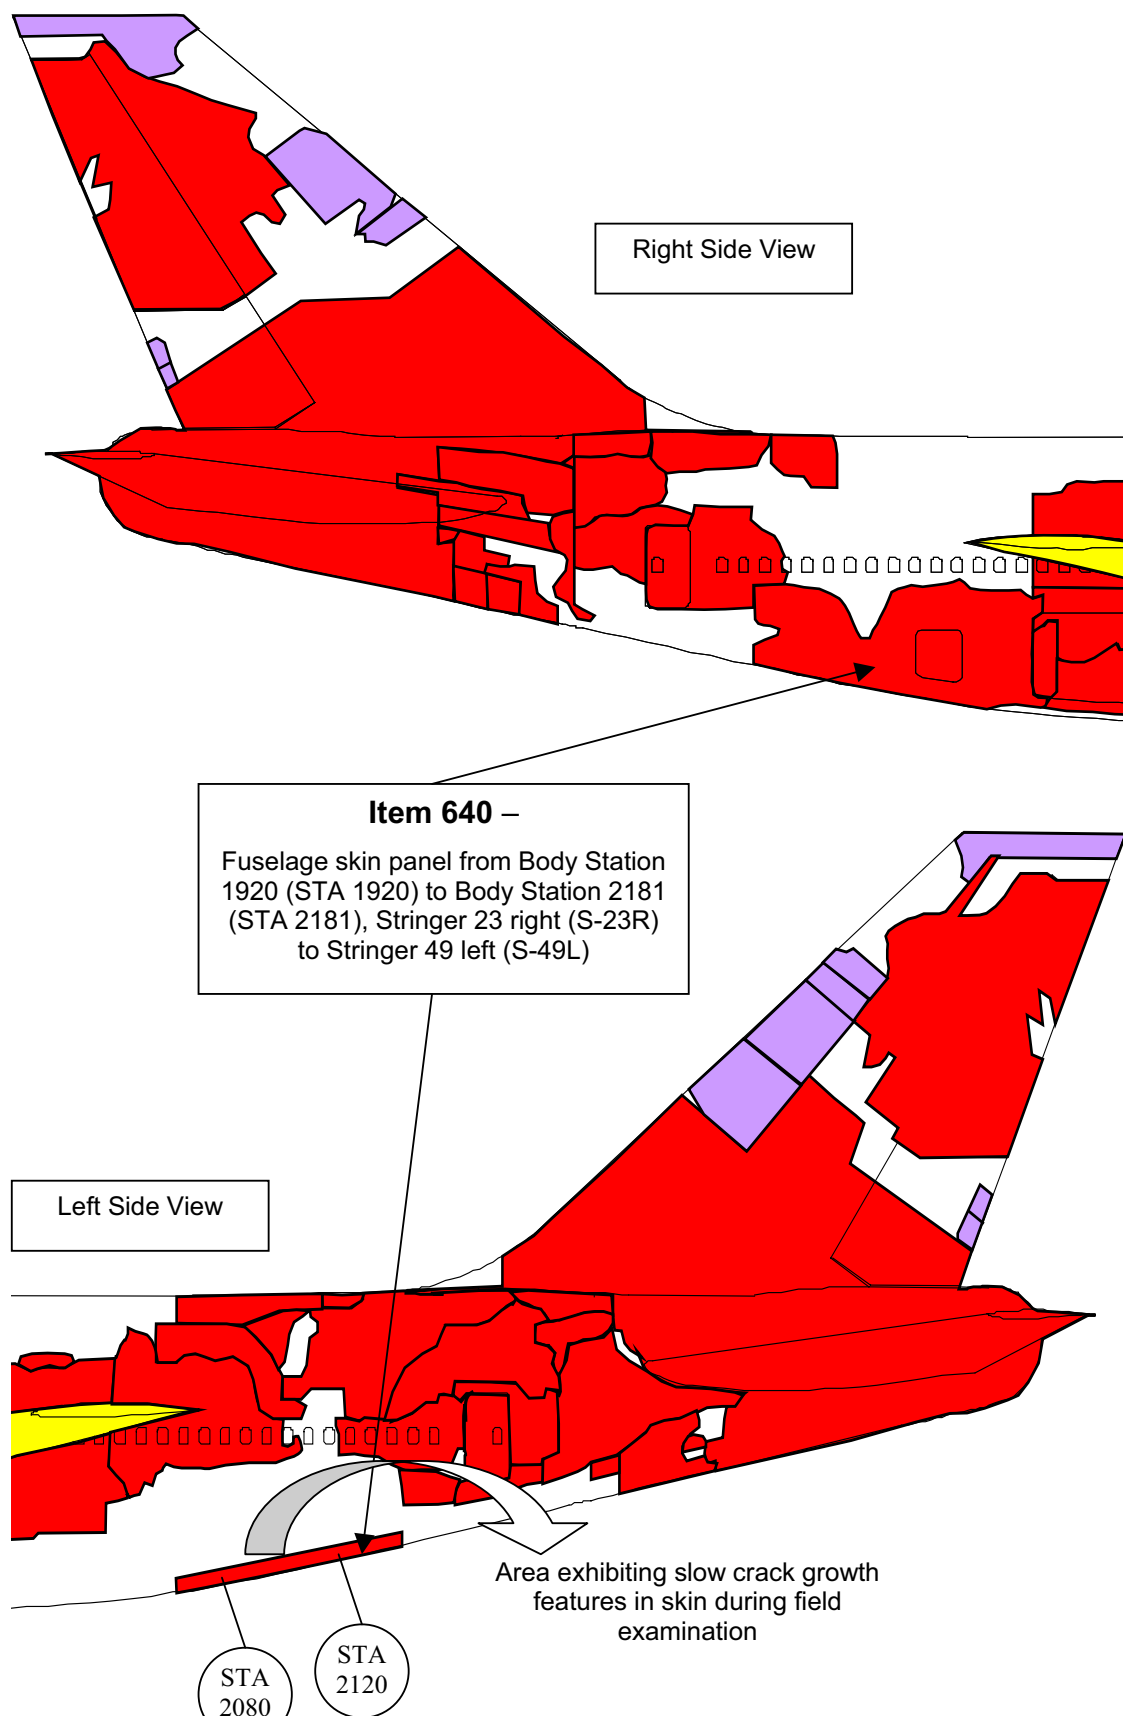
Figure 1.
Partial wreckage recovery map for CI611 showing the location of the item 640 skin panel and the area where slow crack growth features were found in the skin along S-49L during field examination.

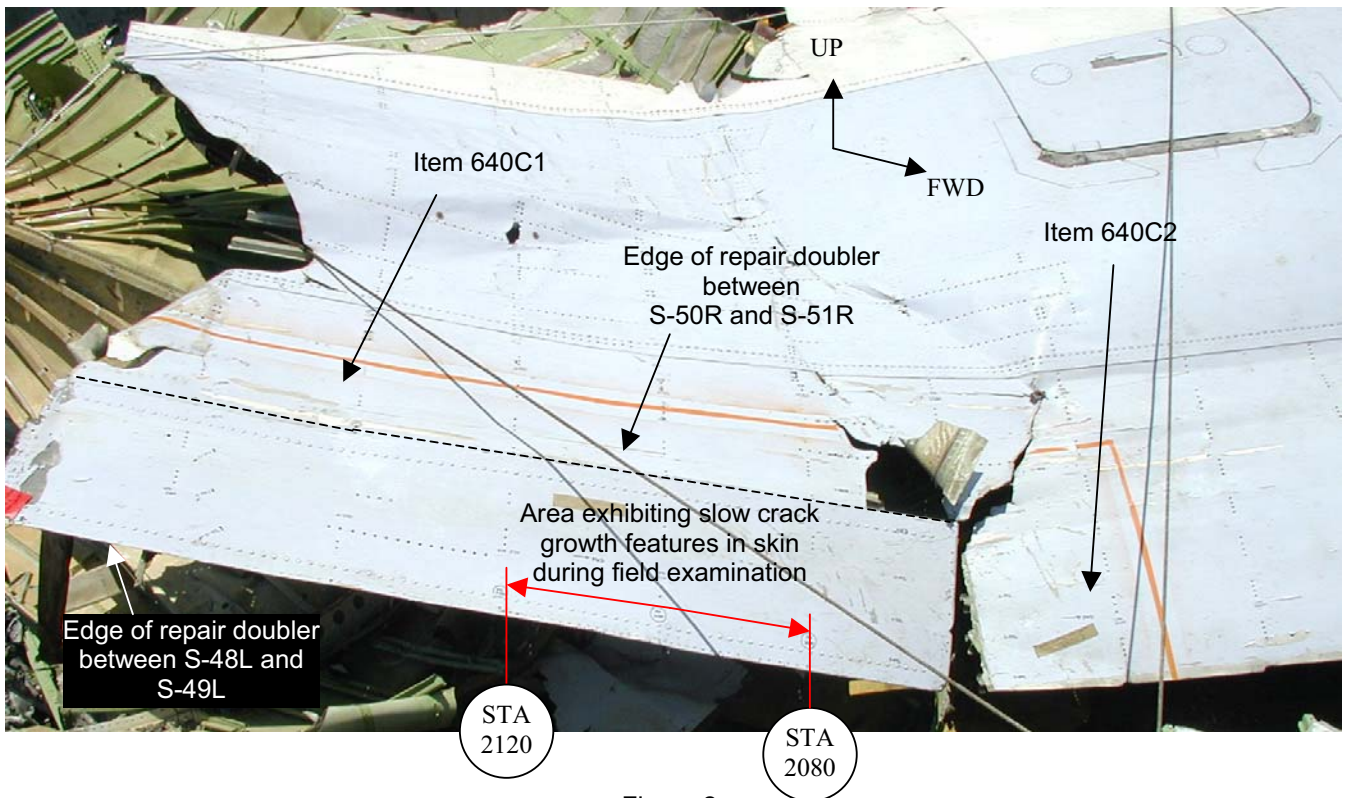
Figure 2.

Item 640C1 and C2 Skin panel segments prior to removal from the parent item 640 wreckage in Makung, Taiwan.

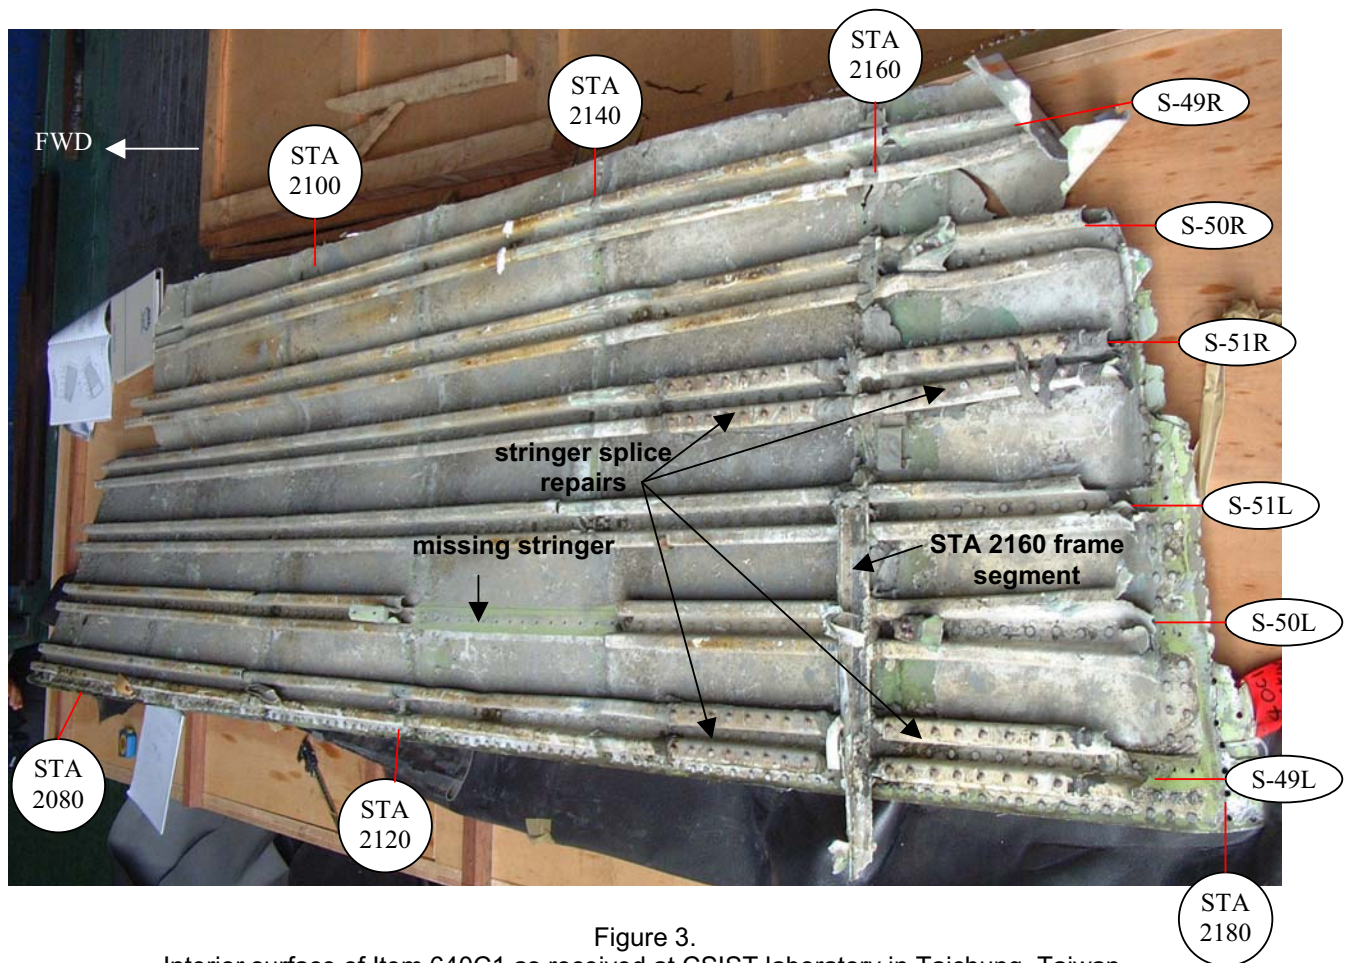
Figure 3.

Interior surface of Item 640C1 as received at CSIST laboratory in Taichung, Taiwan.

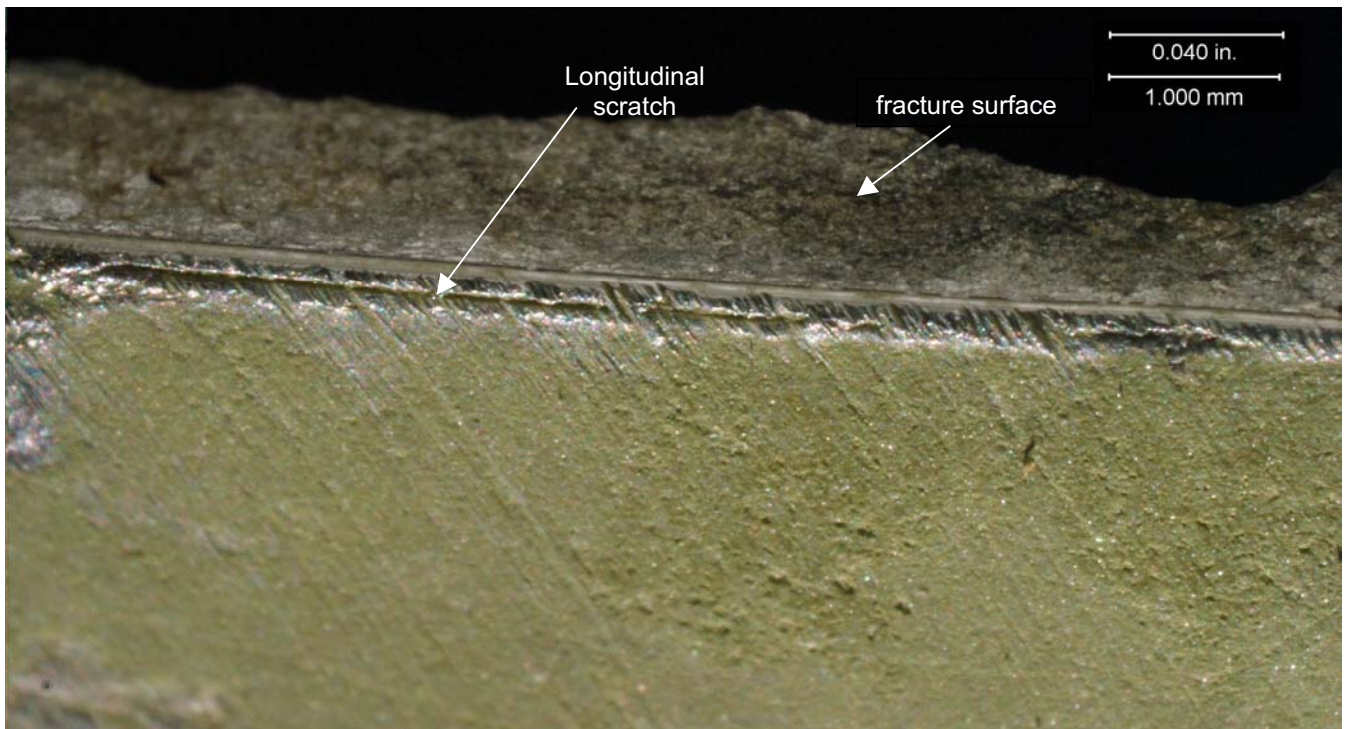
Figure 7.

Surface of skin faying with repair doubler near hole 20 showing the longitudinal scratch where fatigue crack initiation occurred from multiple origins. Also note the sanding marks induced during rework of the skin.

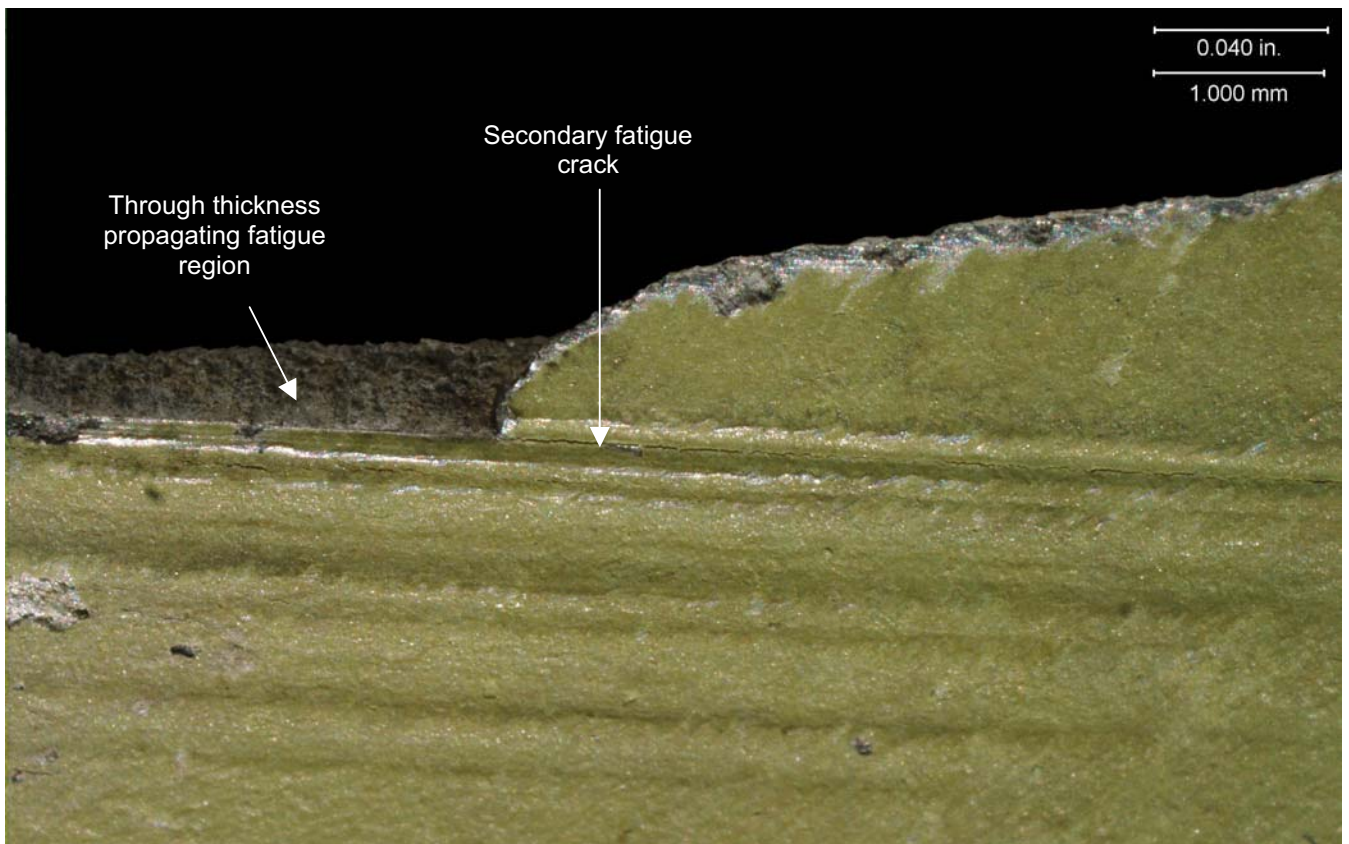
Figure 8.

Surface of skin faying with repair doubler between hole 29 and hole 30 showing the longitudinal scratches in relationship to this fatigue crack. Note the secondary crack extending out of this common scratch.

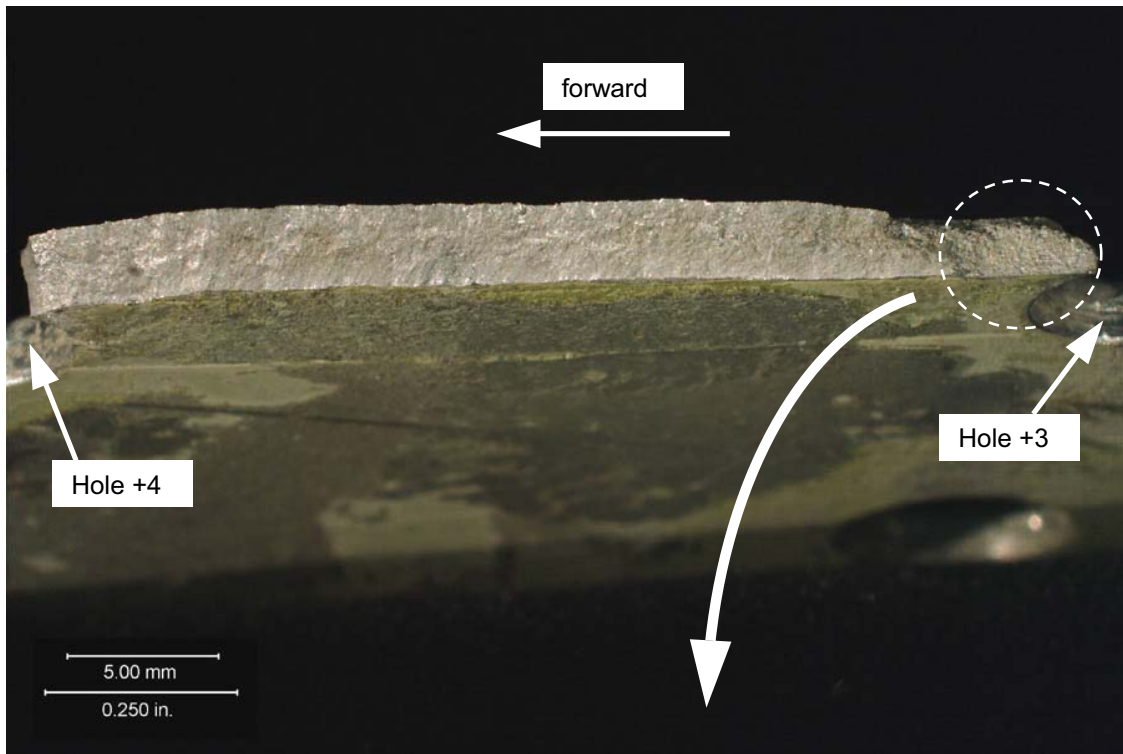
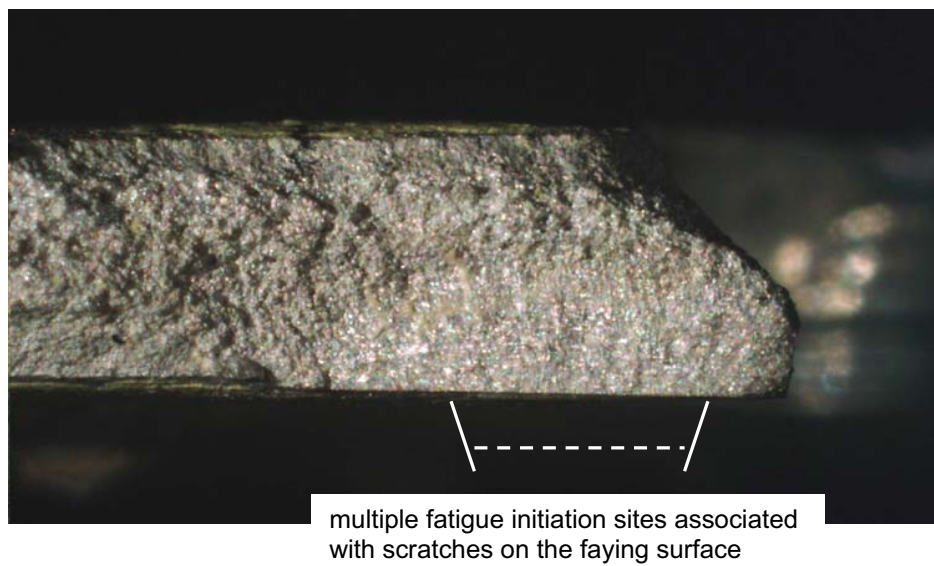
From Hole 4 to Hole 26 the fracture surface generally maintained a flat profile through the skin thickness, with the exception of an intermediate segment between Holes 6 and 10 where the fracture assumed a slanted profile. The forward and aft end of the flat profile fatigue fracture surfaces displayed transition zones where the cracking mechanism changed from plane strain to plane stress conditions. Large transition zones were associated with the forward and aft extension of the main fatigue cracking between holes 10 and 25, as well as the forward extension of the fatigue cracking between holes 4 and 6 (see Figures 9 through 11). Generally, the smaller flat profile fatigue regions forward of hole 3 and aft of hole 32 displayed relatively brief transition zones. Figures 12 through 14 demonstrate the very small transition zones at holes +3 and 39.

Figure 12, Photographs of the fracture segment extending from Hole +3 to +4 (top), and closer view of the flat profile fatigue region on the forward side of Hole +3 (bottom).

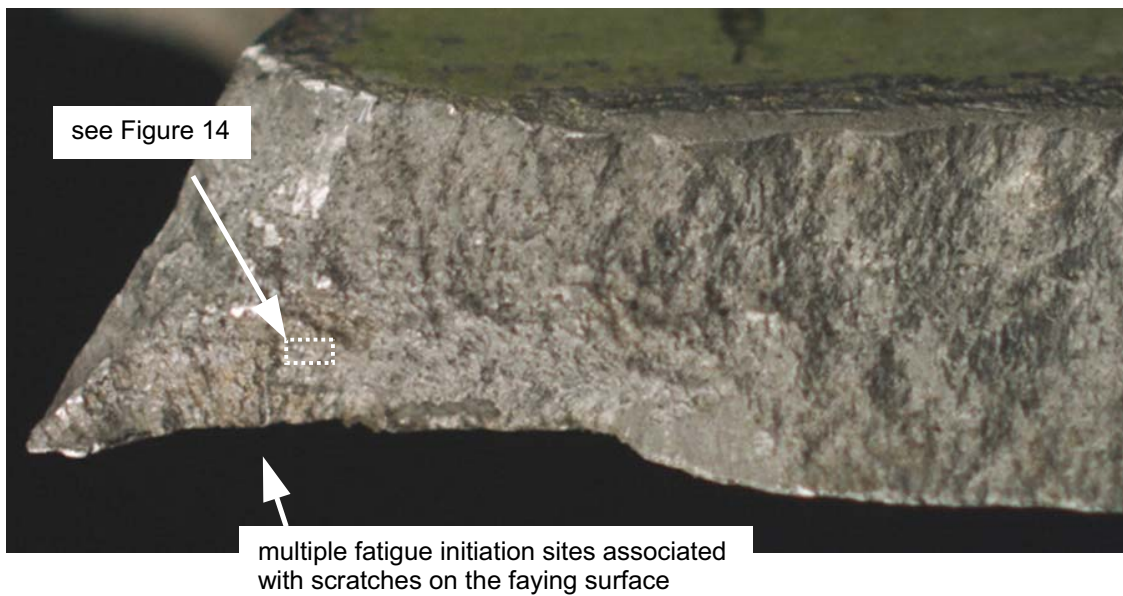
Figure 13, Photographs of the fracture segment extending from Hole 39 to 40 (top), and closer view of the flat profile fatigue region and short transition zone on the aft side of Hole 39 (bottom). SEM photographs showing a dramatic increase in striation spacing near the extent of the flat fracture thumbnail (indicated area) are shown below in Figure 14.

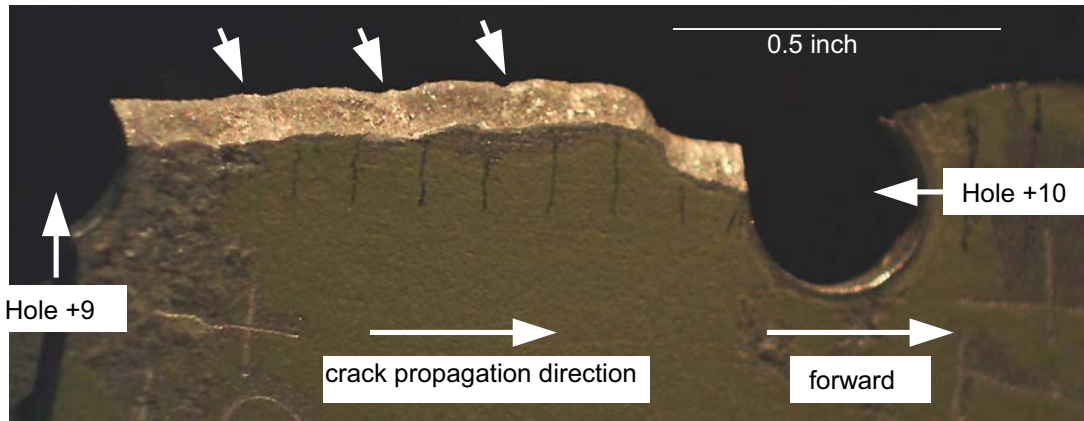
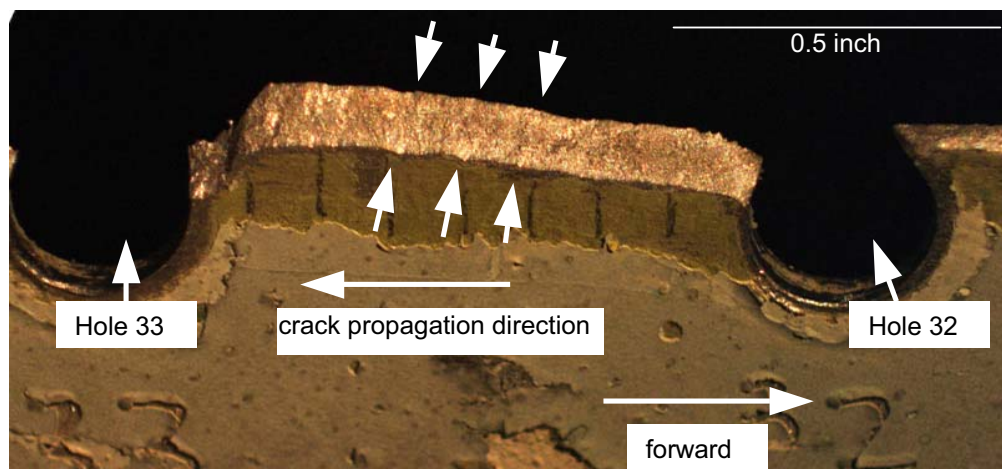
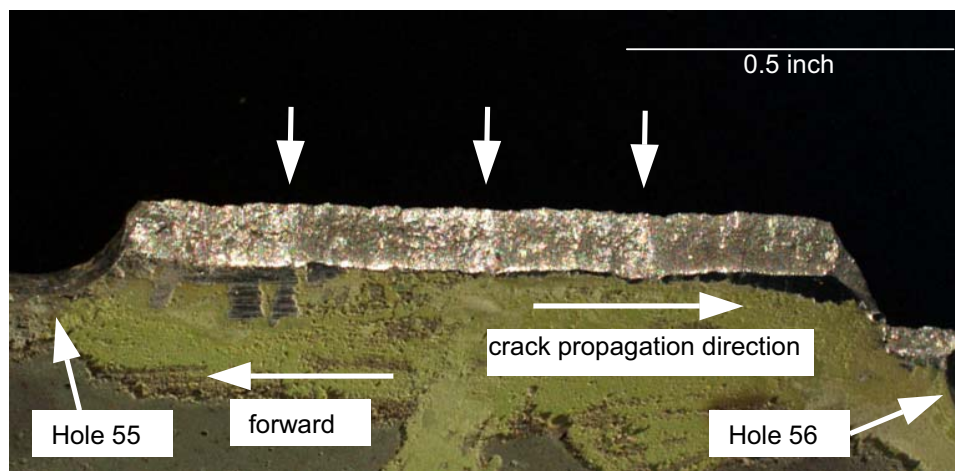
Beyond the flat profile and transition zones of the main fatigue areas, the fracture surface contained numerous segments that displayed indications of incremental crack growth (referred to as quasi-stable crack growth in this report) that could be observed visually or with the aid of low power optical instrumentation (Figures 15 and 16). In general, these indications were observed to increase in spacing as the distance from the flat profile fatigue regions increased in both the forward and aft directions. Such features were also observed on the fracture face between holes 6 and 10 with increasing spacing in the forward direction (Figure 17). Incremental crack growth indications were observed as far forward as approximately STA 2055 and as far aft as hole 56 (STA 2140).

Figure 16, Photographs showing the incremental crack growth indications on the fracture segments between Holes +9 and +10 (top), Holes 32 and 33 (center), and Holes 55 and 56 (bottom).

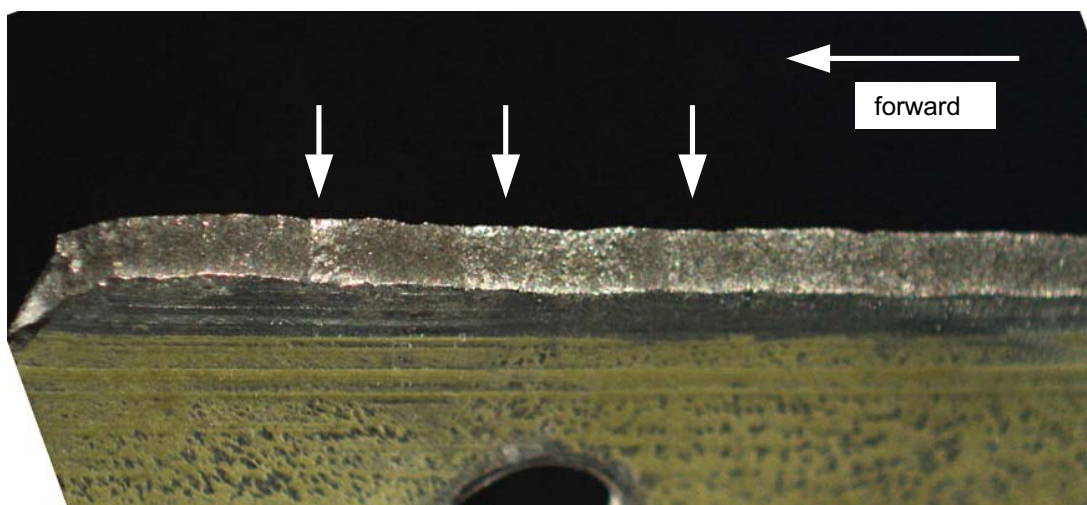
Figure 17, Photograph showing the incremental crack growth indications (arrows) on the fracture segment near Hole 7, which is between the two main fatigue cracking systems at Holes 4 and 5 and Holes 10 through 25.

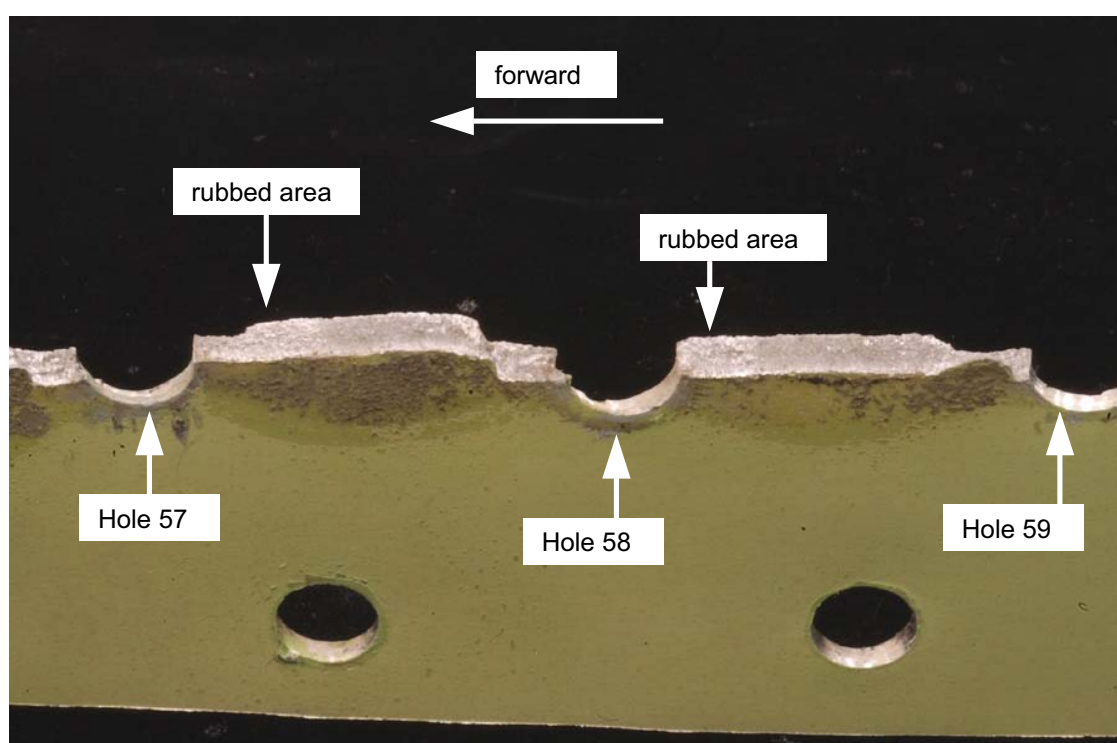
Cyclic rubbing of the fracture surface and associated compression deformation of the cladding was observed along the faying surface providing additional evidence of cracking that occurred prior to the accident flight. Figure 18 shows the visible appearance of the fracture surface near holes 57, 58, and 59. The damage that produced the scratches on the faying surface removed significant amounts of cladding. However, all areas where cladding remained forward and aft of the main fatigue cracking displayed compressive deformation due to crack closure as far forward as hole +17 and as far aft as hole 62. Figures 19 through 21 are SEM photographs showing the appearance of such aluminum cladding deformation. The remaining fracture aft of hole 62 displayed "necking", which is typical of continuous tensile loading to ultimate tensile separation (Figure 22). These observations suggest that cracking in the skin was continuous from approximately STA 2055 to 2146, or approximately 93 inches prior to the accident flight.

Figure 18, Photograph of the fracture surface at Holes 57, 58, and 59. The shiny areas are indicative of rubbing with the mating fracture surface and appeared consistently forward of this area, but were not present aftward beyond Hole 62.

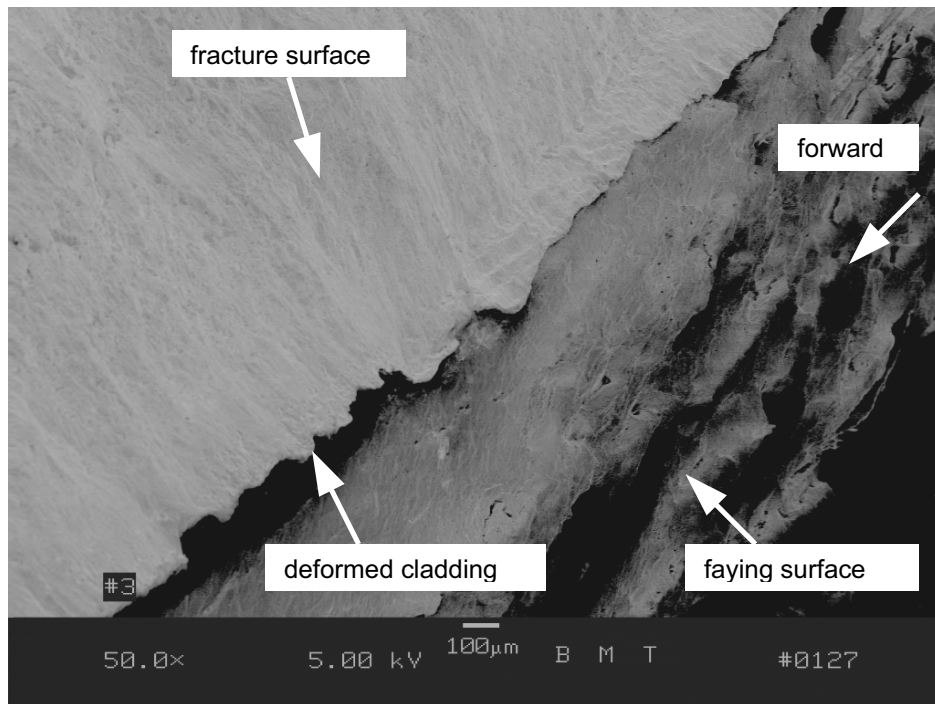
Figure 19, Scanning electron microscope photograph along the edge of the fracture common to the faying surface where the aluminum cladding remained near Hole 3. The fracture surface profile was slanted here. Another example further forward of this area is shown in Figure 20 below. Quasi-stable crack growth beyond these regions allowed cyclic crack closure, causing surface rubbing and compressive deformation of the cladding.

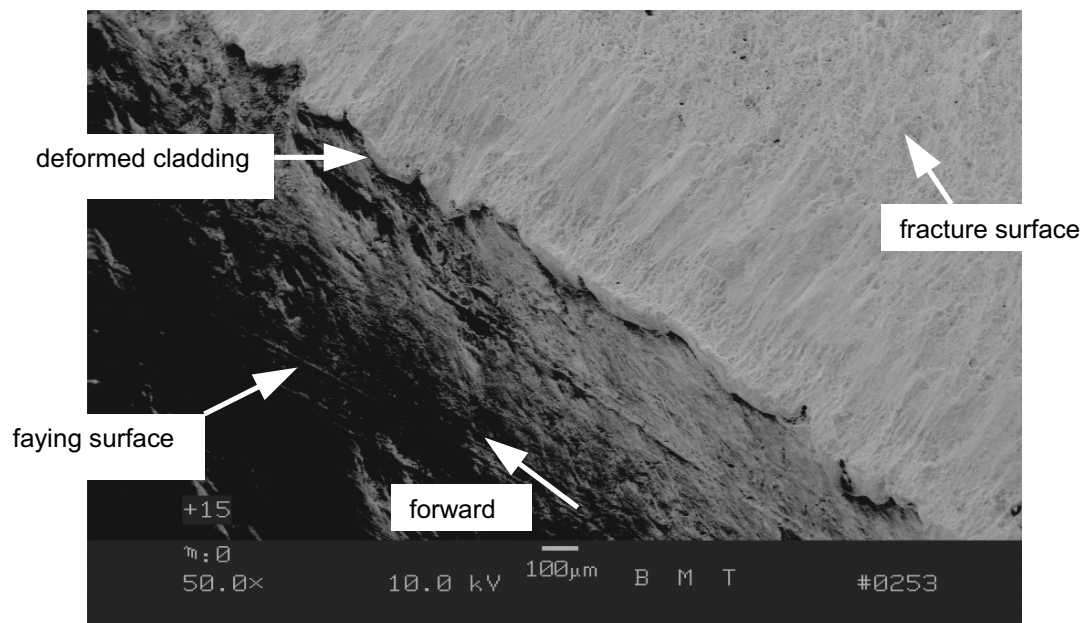
Figure 20, SEM photograph showing the compressive deformation of the cladding just forward of Hole +15.

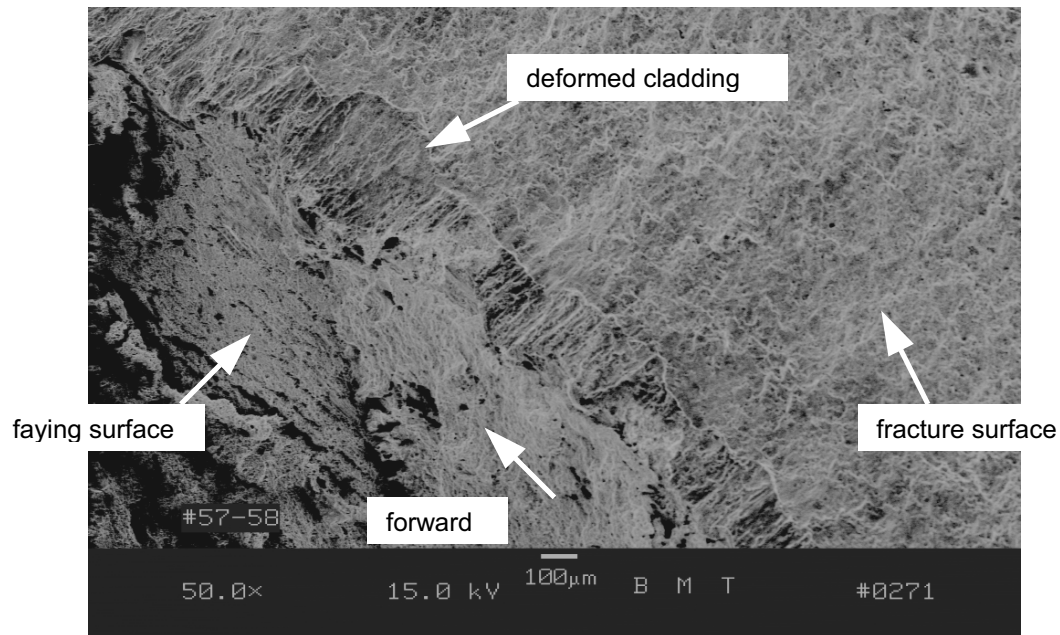
Figure 21, SEM photograph showing the compressive deformation of the cladding between Holes 57 and 58. Note that the degree of compressive damage is less severe than that observed closer to the main cracking system, Figure 19 for example. Fracture surfaces near the extreme extent of pre-existing cracking would have experienced few repetitive crack closures.

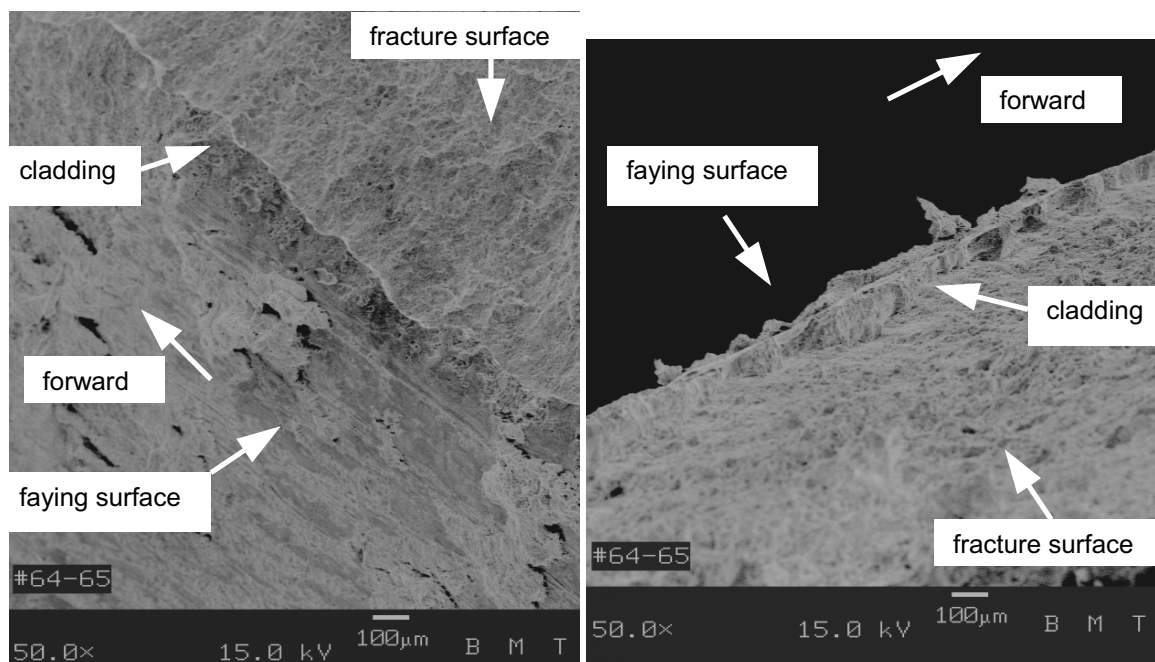
Figure 22, opposing angle SEM photographs of the fracture segment between Holes 64 and 65 showing the cladding on the faying surface retaining its upward profile from the necking process during ultimate tensile separation without subsequent crack closure.

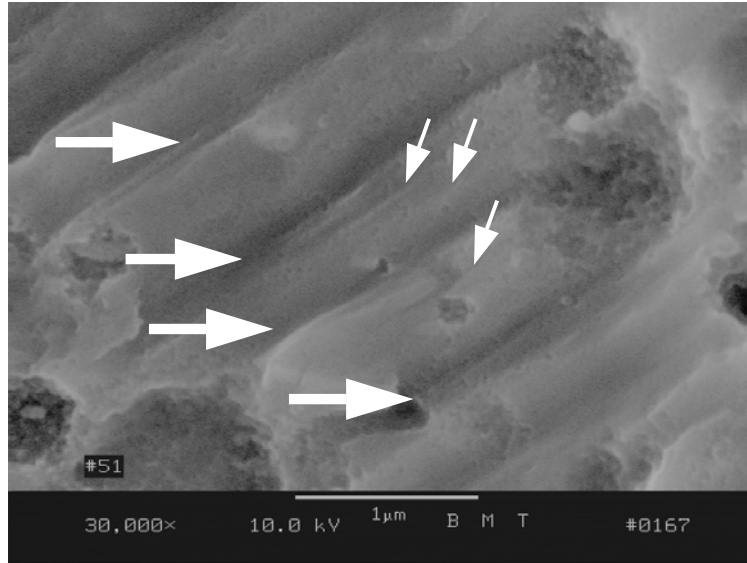
Although much of the fracture suffered from heavy corrosion, fatigue striations were resolved by SEM in many local areas of the fatigue cracking regions as described in Figures 5 and 6. Striation counting was performed at a number of locations along the flat profile fatigue regions of the fracture. Since the fracture surface was not continuous from a single fatigue initiation origin to the ultimate extent of stage II (striation producing) cracking, it was not possible to estimate a time of initiation. Instead, the nature of cracking on this detail provided numerous initiation sites along scratches on the faying surface, with subsequent propagation in the through-thickness direction. Because cyclic cabin pressure is the prevailing driving force for cracking at this detail, each striation is considered to represent the microscopic crack advancement during one flight cycle of the airplane. Thus, striation counting was performed in order to obtain an estimate of the number of flight cycles that contributed to the fatigue crack propagation through the material thickness. Reference 1 reported the observation of “major” and “minor” striations. The occurrence of striation-like features appearing between actual striations is not uncommon for fatigue cracks in similar structural details propagating at mature growth rates. These minor striation-like features are shown in Figure 23 and were ignored for striation counting purposes.

Figure 23, SEM photograph showing minor striation-like features (indicated with smaller arrows), which were also observed during examination at the Chung Shan Institute of Science and Technology. Such features are not uncommon and were ignored for striation counting purposes. The striations corresponding to flight cycles, and used for estimating growth rates are indicated with the large arrows.
