Aviation Occurrence Report Volume I

ASC-AOR-05-02-001

IN-FLIGHT BREAKUP OVER THE TAIWAN STRAIT

CHINA AIRLINES FLIGHT CI611

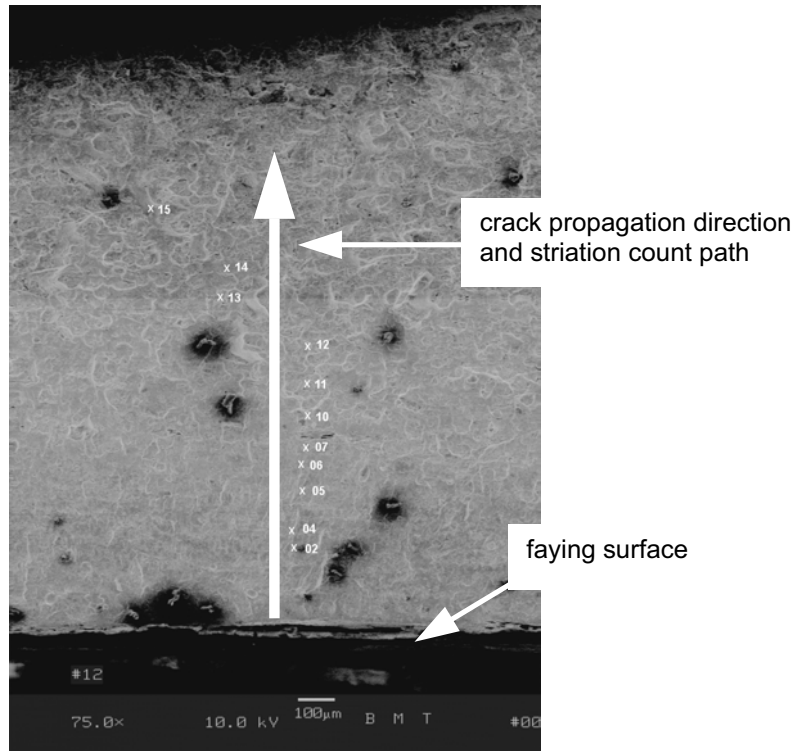
Fatigue cycle estimates were obtained at the locations on the fracture listed in Table VII along with the calculated results. For each location, a traverse across the fracture at several points between the skin surfaces was made by sampling striation spacing with SEM photographs (Figure 24). For determining the crack length at each sample point, x and y Cartesian coordinates generated by the SEM stage were recorded and compared with a reference slope using an analytical geometrical approach. Striation spacing was determined by direct measurement from a photograph at each sampling location. The data was reduced and calculated by employing a trapezoidal integration method, whereby the number of cycles between two successive data points is equal to the distance divided by the average striation spacing (half of the sum of the growth rates at the two points). Although this approach may not precisely represent actual cracking behavior, it removes some of the subjectivity of assigning best-fit curves to widely scattered data points and can provide useful information, given an understanding of its limitations.

Figure 24, SEM photograph showing the locations through the skin thickness that were sampled for crack growth rate at Hole 12. The approach was repeated for other through-thickness areas

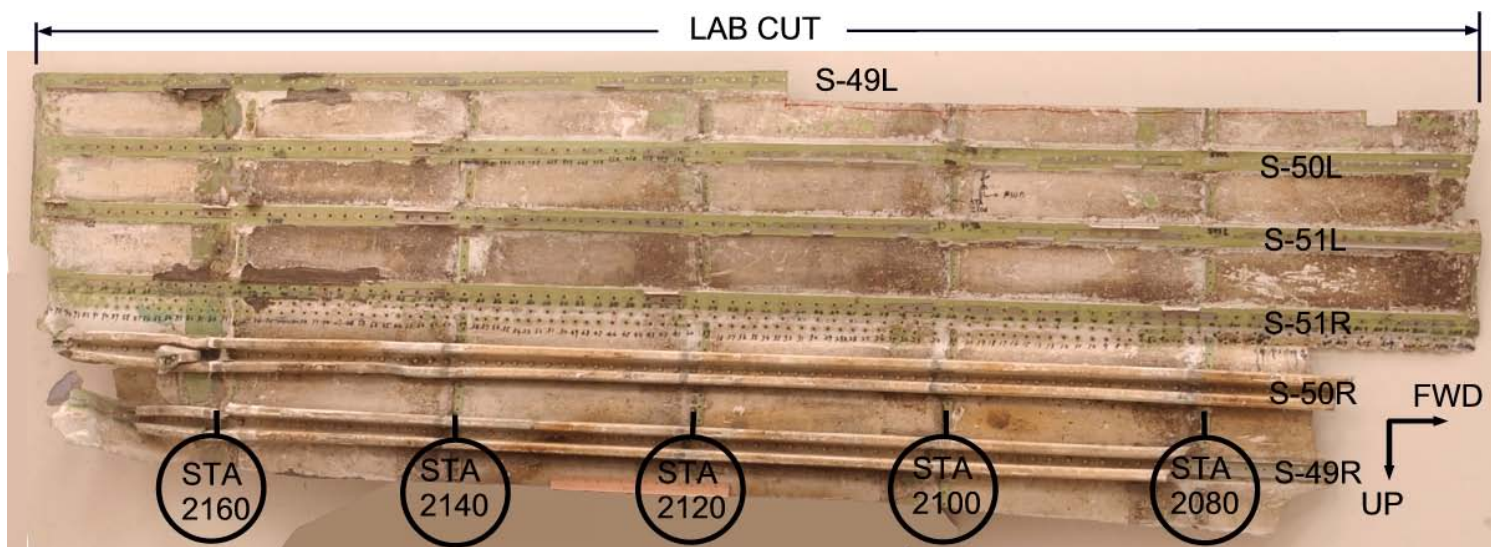
Photographs showing features of the as-received item 640 C1 skin inboard and outboard (repair faying surface) surfaces are shown in Figures 25 and 26 respectively. Protective finishes had previously been removed from much of the repair faying surface at the CSIST to enable examination of skin damage consistent with a tail strike event. Close-up photographs displaying the extent of damage consistent with a tail strike are shown in Figures 27 through 36. This damage consists primarily of fore to aft (longitudinal) scratching with the most severe scratching typically occurring at the location of skin stiffening members such as skin stringers and body frame shear ties. Figure 37 displays the location of the most severe skin damage. As noted in this photograph, the most severe damage consistent with a tail strike occurred on the left hand side of the airplane in the area covered by the repair doubler. Evidence of an attempt to blend out these skin scratches, in the form of rework sanding marks, was noted over much of the repair surface.

FIGURE 25. AS RECEIVED ITEM 640 CI SKIN INBOARD SURFACE- The S-49L fracture segment was removed at the CSIST during the initial examination.

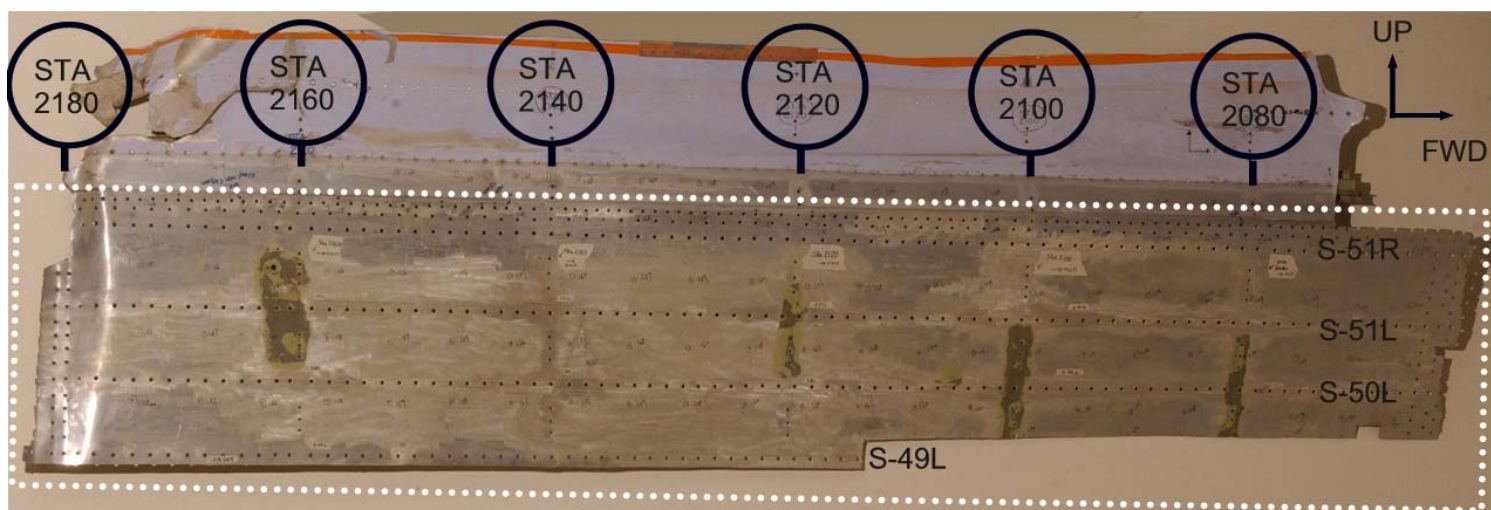
FIGURE 26. AS RECEIVED ITEM 640 C1 SKIN OUTBOARD SURFACE – The approximate location of the repair doubler is shown with dotted lines. Protective finishes were removed from the repair faying surface at the CSIST.

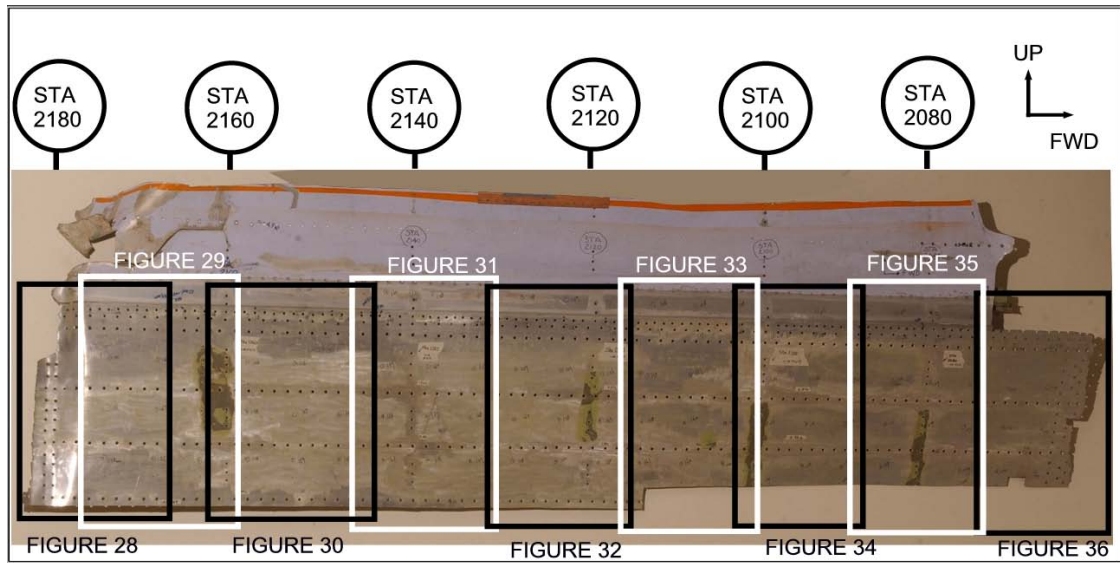
FIGURE 27. SCRATCH PHOTOGRAPH LEGEND – This illustration identifies the location of following photographs that document scratch features observed on the skin repair faying surface. Scratches are fore/aft in orientation and characteristic of a tail strike event.

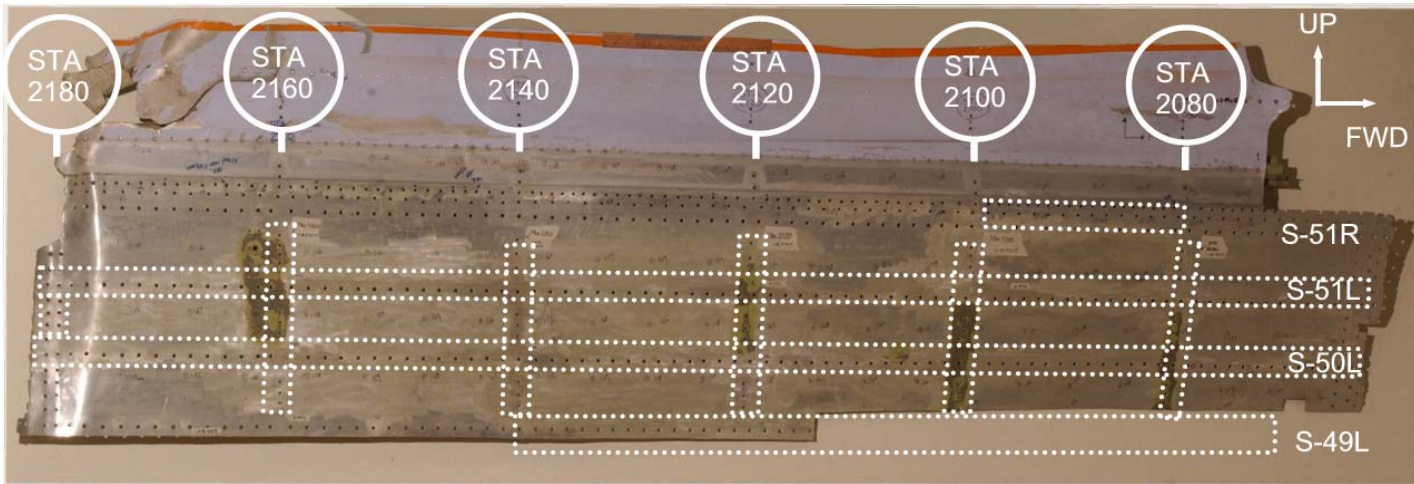
FIGURE 37. AREAS OF MOST SEVERE SKIN DAMAGE – Scratch severity was greatest in the left hand/forward area of the skin.

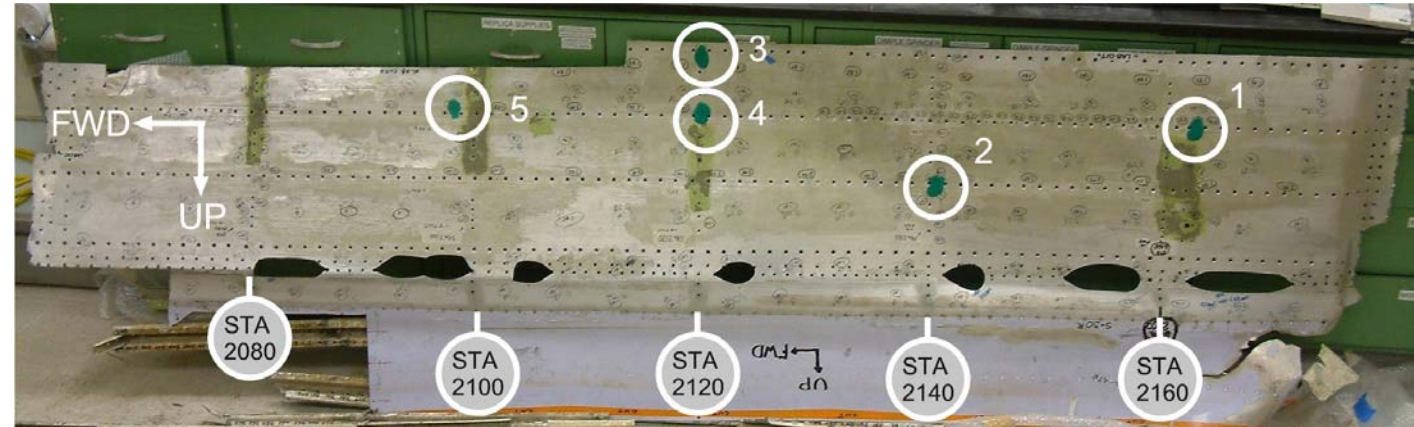
FIGURE 38. LOCATION OF SCRATCH REPLICATION AREAS

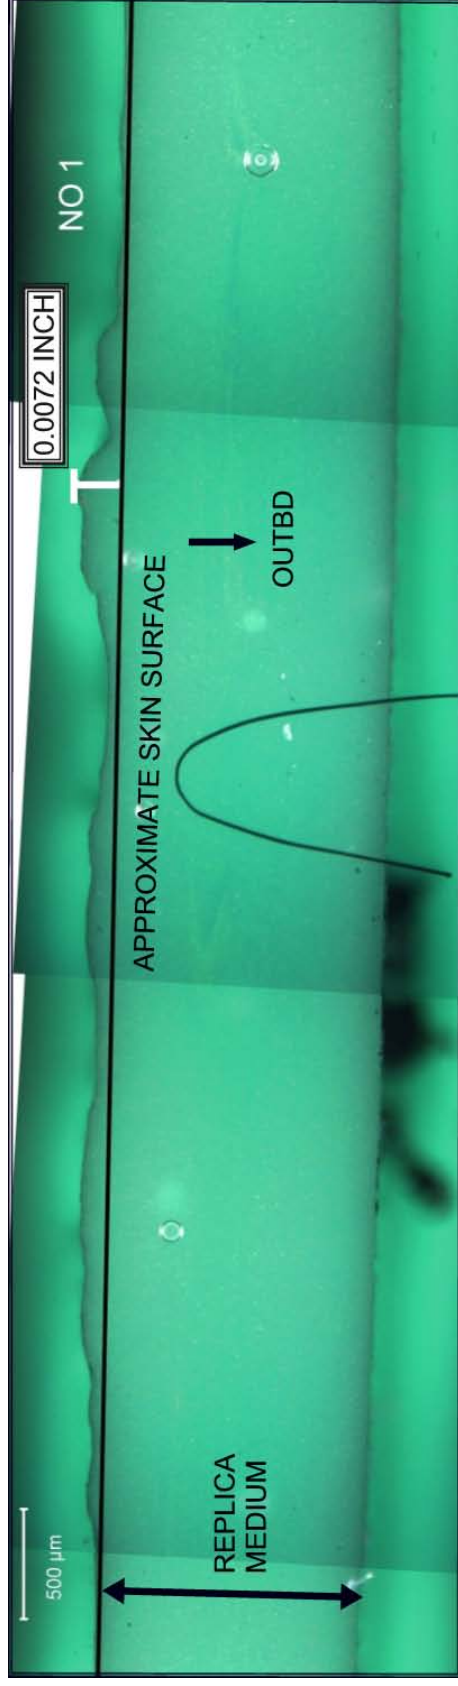
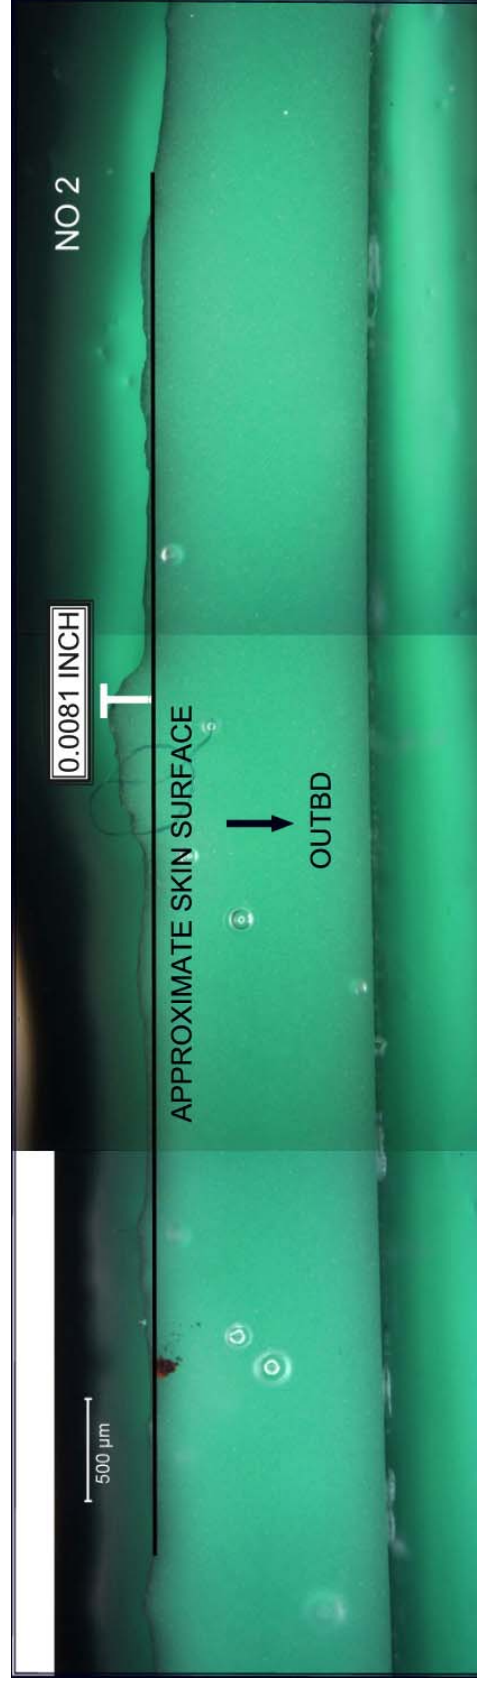
FIGURE 39: SCRATCH PROFILE COMPOSITE PHOTOGRAPHS – The replication medium creates a “positive” of the skin scratches. Scratch features of replica locations 1 and 2 are shown above.

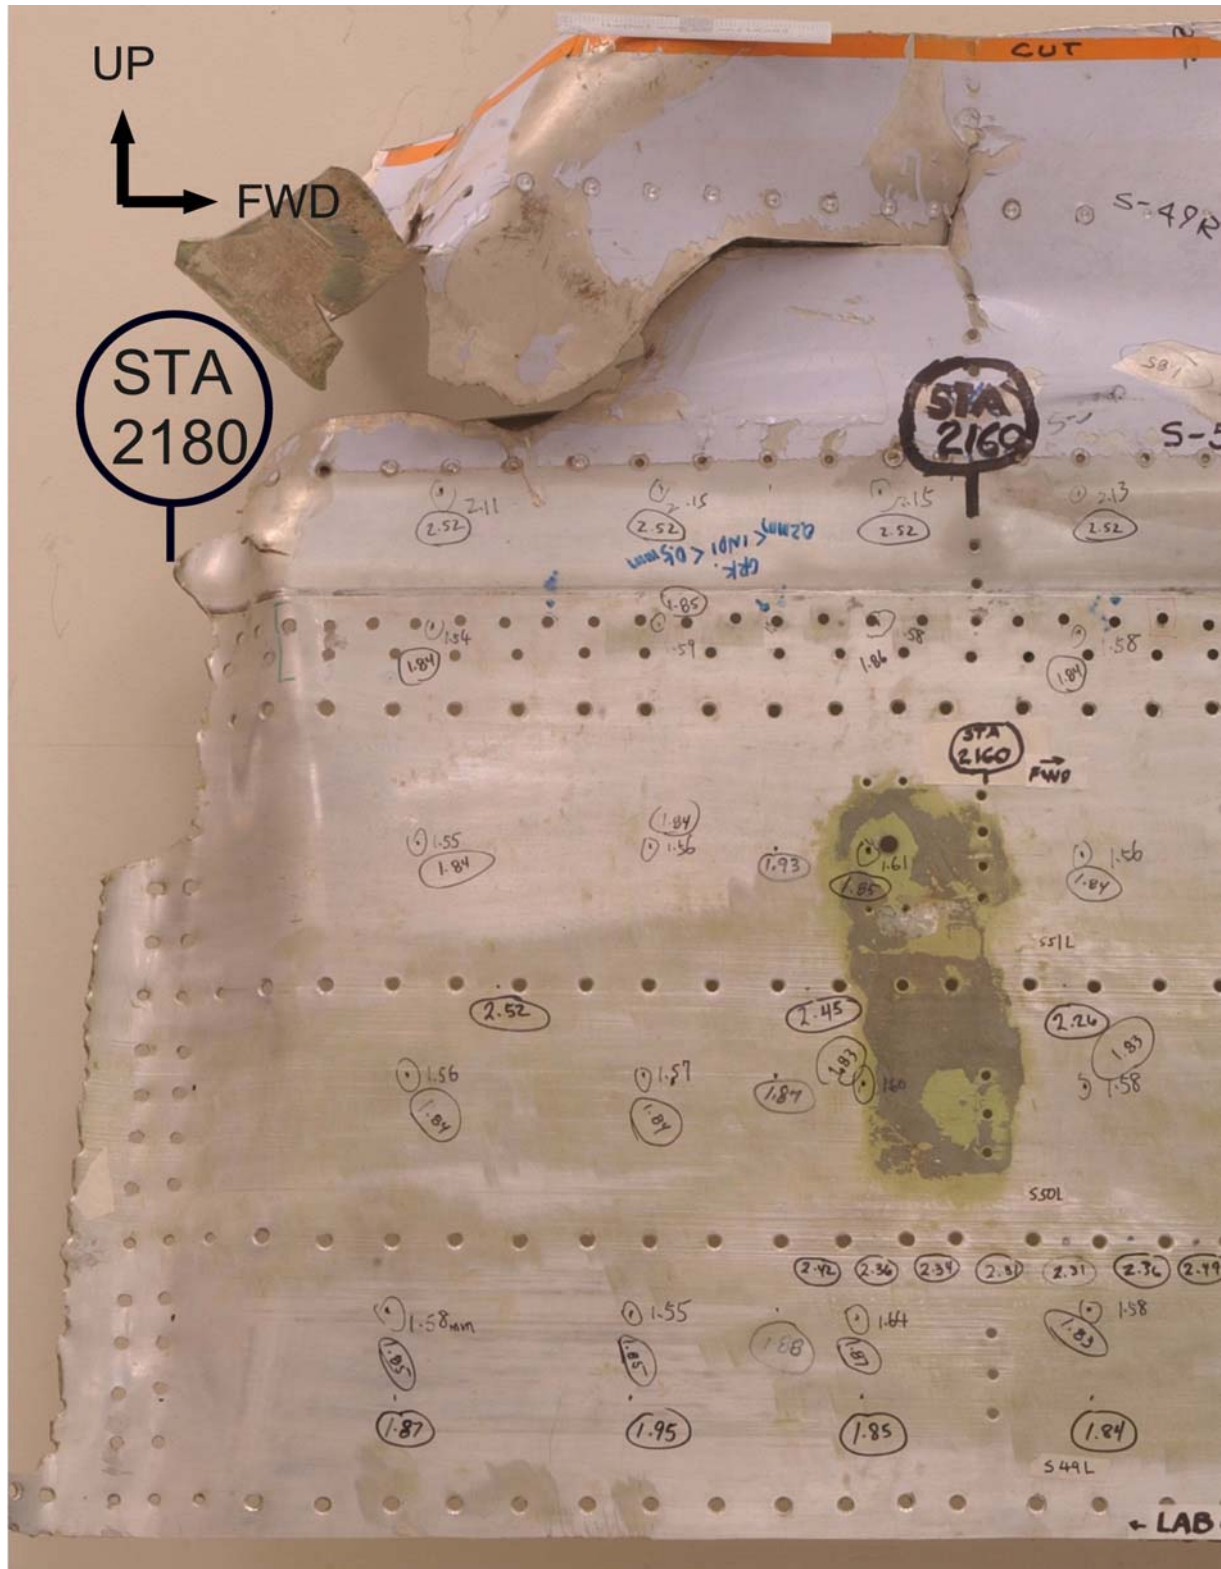
The thickness of the skin was measured ultrasonically at several locations. Thickness measurements were recorded in millimeters directly on the skin at point of measurement and are documented in Figures 41 through 46. The ultrasonic unit was calibrated using a reference sample and ultrasonic measurements were also verified using a calibrated micrometer. Ultrasonic skin thickness measurement was a duplication of work previously done at the CSIST, however the CSIST measurements were consistently lower than measurements performed at Boeing. The reason for this discrepancy is unknown, but may have been due to an instrument calibration error.

Figure 41. SKIN THICKNESS MEASUREMENTS - All measurements are in millimeters. Circled values were performed at Boeing.

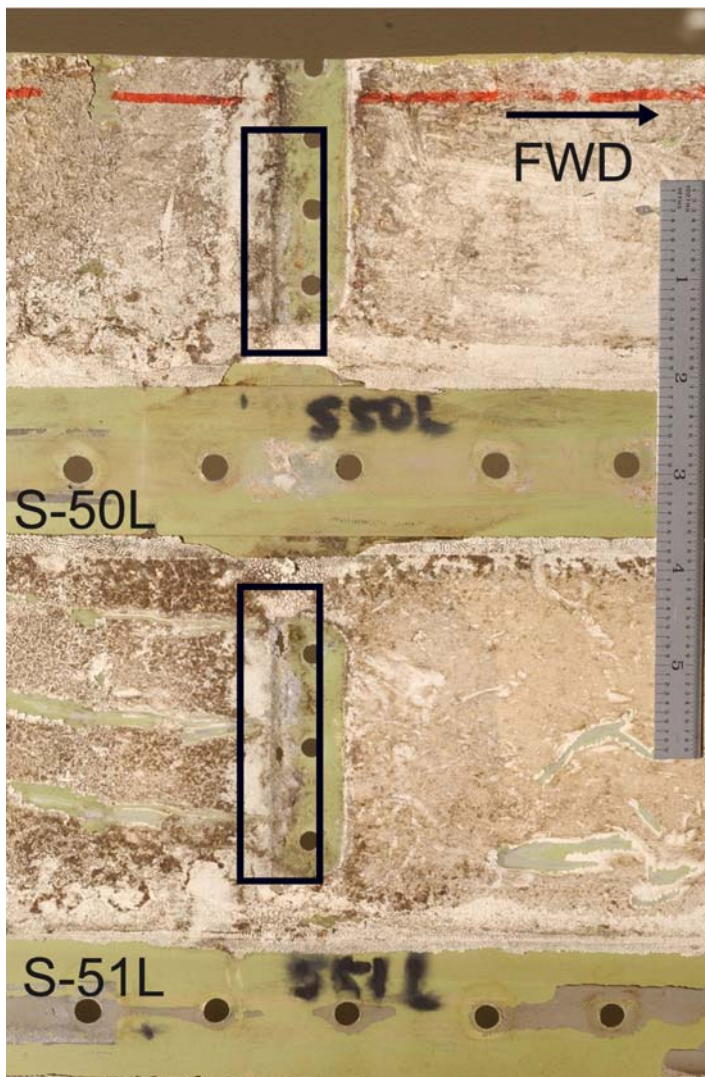
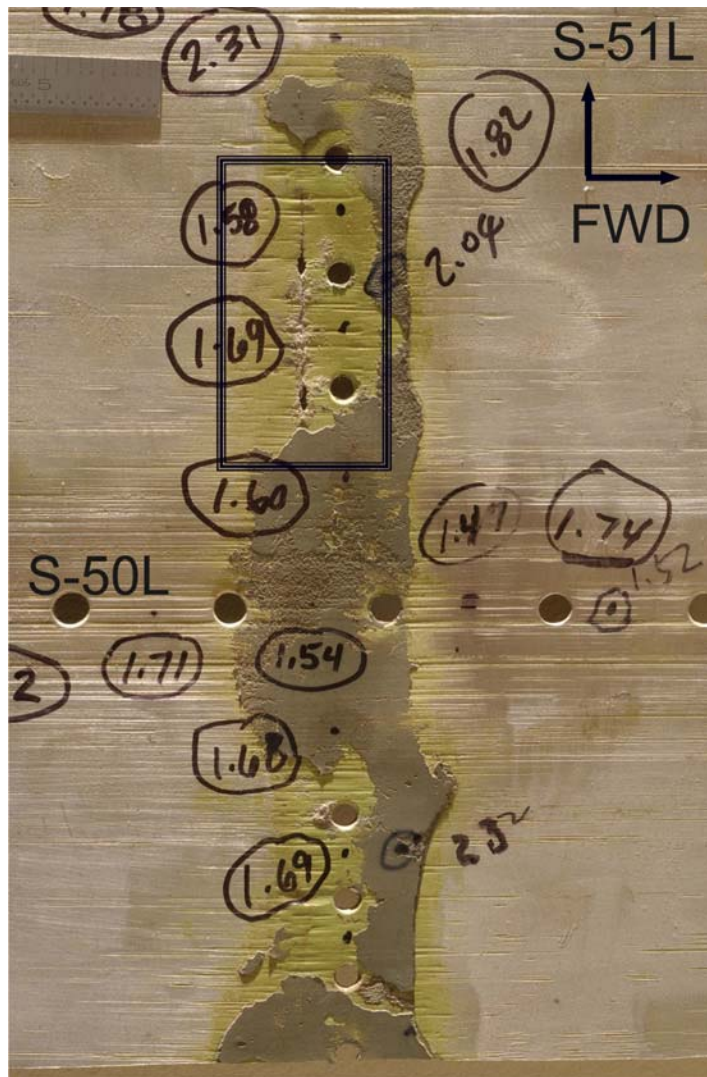
Corrosion was noted at several shear tie locations on the skin inboard surface sometimes penetrating completely through the skin thickness. General features of this damage and the general condition of the skin indicate that the corrosion most probably existed at the time of the accident, and was not a result of salt water immersion after the event. Photographs displaying these corrosion features are shown in Figures 47 through 49. Table VIII records visual observations of these features.

Figure 47. SKIN CORROSION FEATURES AT STA 2080 - Areas of corrosion are identified with rectangles above. Corrosion penetrated completely through the skin thickness at the shear tie located between S-50L and S-51L.

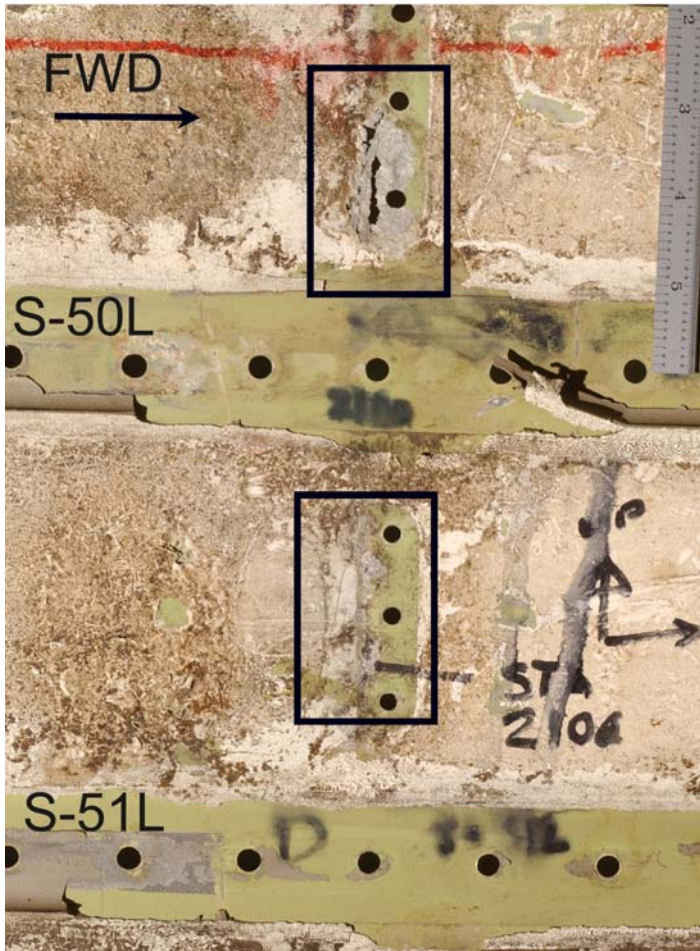
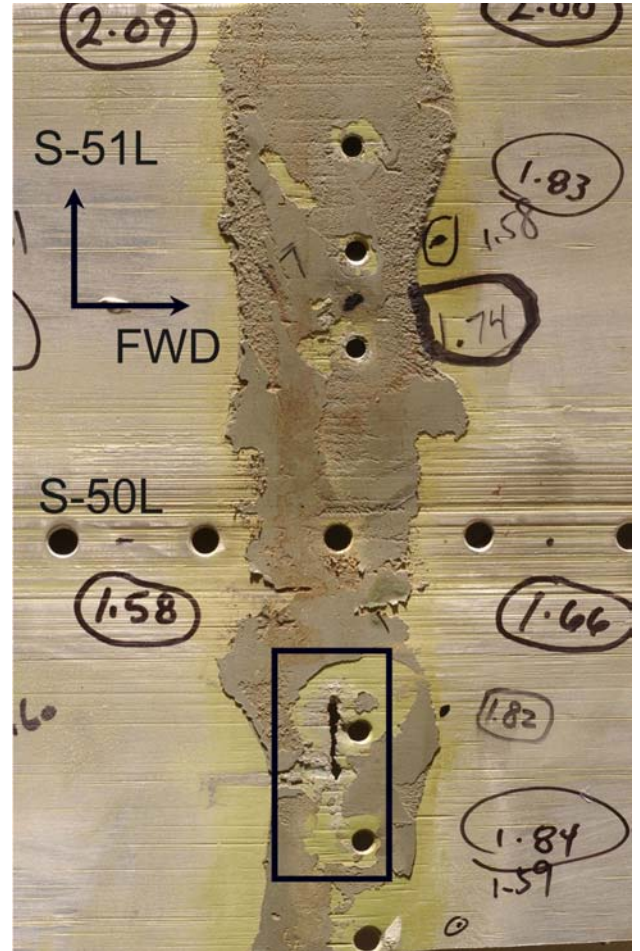
Figure 48. SKIN CORROSION FEATURES AT STA 2100 - Areas of corrosion are highlighted with rectangles. Corrosion penetrated completely through the skin thickness between S-49L and S-50L.

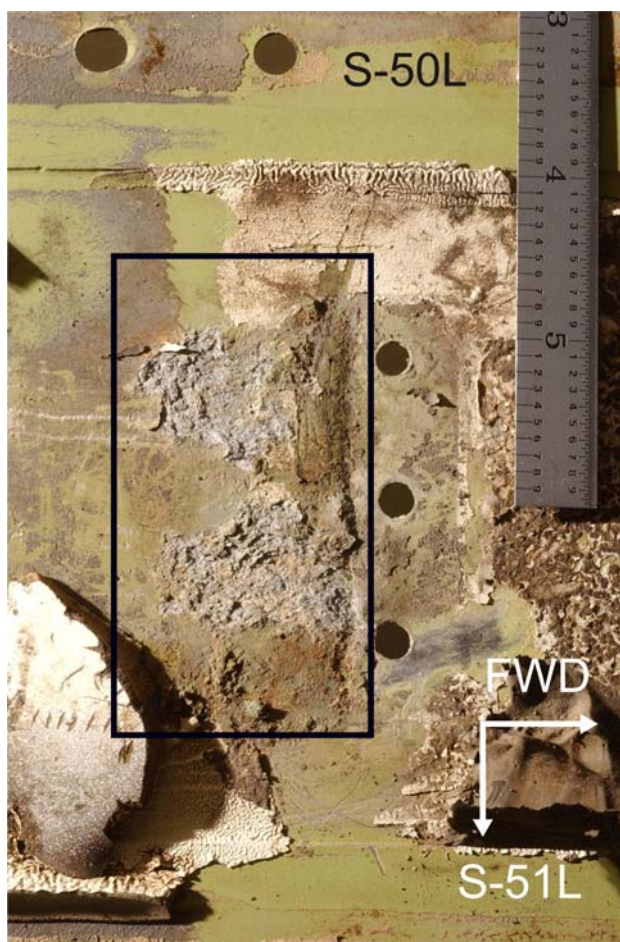
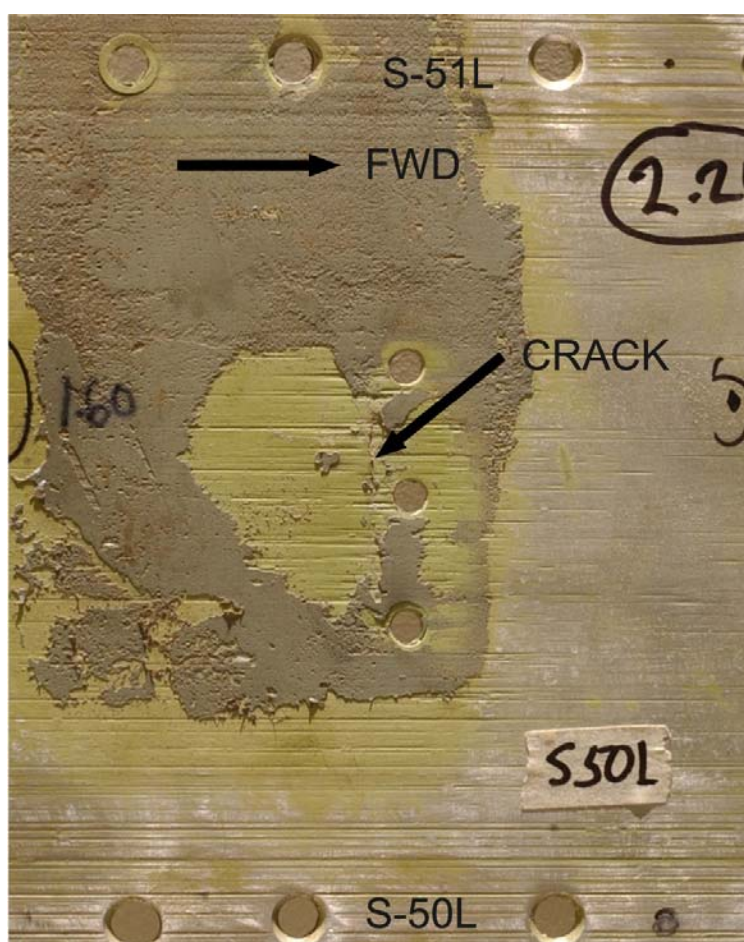
Figure 49. CORROSION FEATURES AT STA 2160, INBOARD SURFACE - The area of corrosion is identified with a rectangle above. A crack noted on the skin faying surface may have been the result of exfoliation corrosion penetrating from the skin inboard surface.

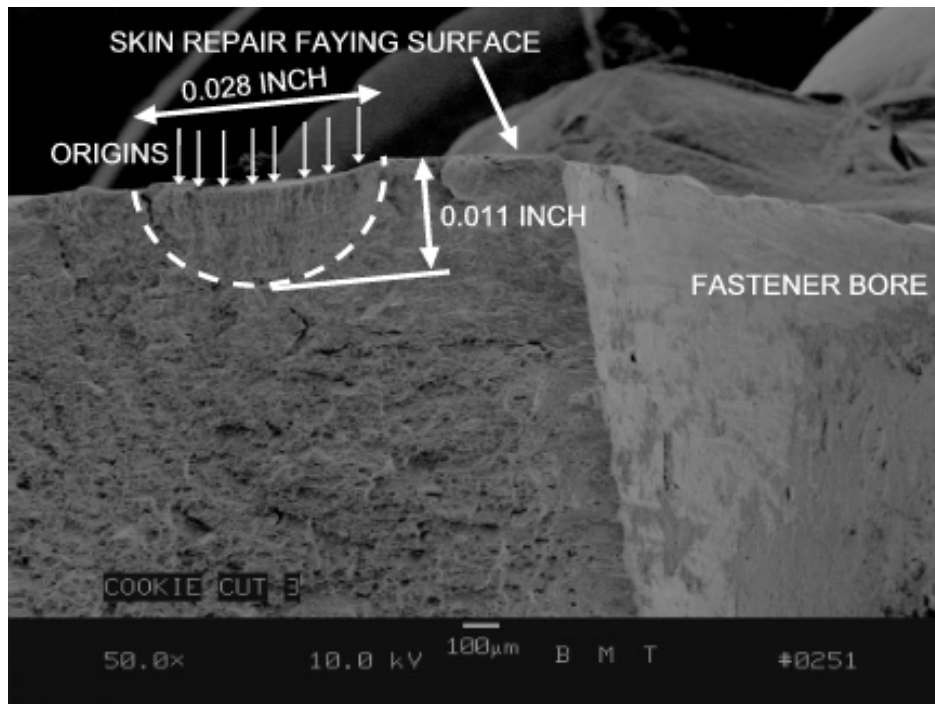
Figure 54. COOKIE CUT # 3 FATIGUE CRACK FEATURES – The extent of fatigue cracking is identified with a dashed line. Multiple fatigue origins are denoted with arrows.

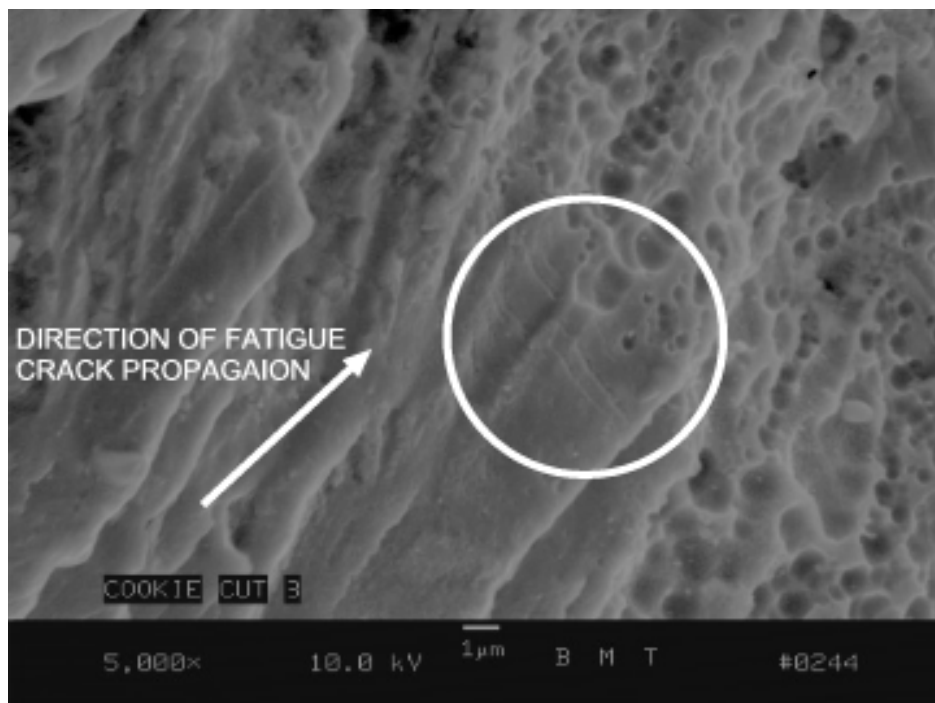
"Cookie cuts" were excised from the skin at HFEC crack indications to enable further examination. Figures 50 through 53 document the location of cookie cut samples. Cookie cuts 1 and 4 were inadvertently damaged during removal, destroying all fastener bore features. The remaining excised samples were penetrant inspected and optically examined to 50X. Cracking was visually identified on three of the remaining cookie cuts (#3, #7 and #9). Cracks in cookie cuts #3 and #9 were successfully opened, while #7 proved too small to open. Crack features were examined from low to high magnification in a Scanning Electron Microscope (SEM). Figures 54 through 57 display the crack features. Cracking in cookie cut #3 was due to fatigue originating from multiple origins at the skin faying surface, away from the fastener bore (Figure 54). The crack length was 0.028 inch and maximum crack penetration through the skin thickness was 0.011 inch. Cracking in cookie cut #9 was also due to fatigue but initiated from the fastener bore from an origin near the bore/skin repair faying surface interface (Figure 56). The crack length and its propagation through the skin thickness were both 0.044 inch. Fatigue features seen in both cracks were indicative of fuselage pressure cycles (Figures 55 and 57).

Figure 55. FATIGUE FEATURES FOUND IN CRACK AT COOKIE CUT #3 - Circled area identifies typical fatigue striations characteristic of fuselage pressure cycles observed at the maximum depth of cracking in Cookie Cut #3

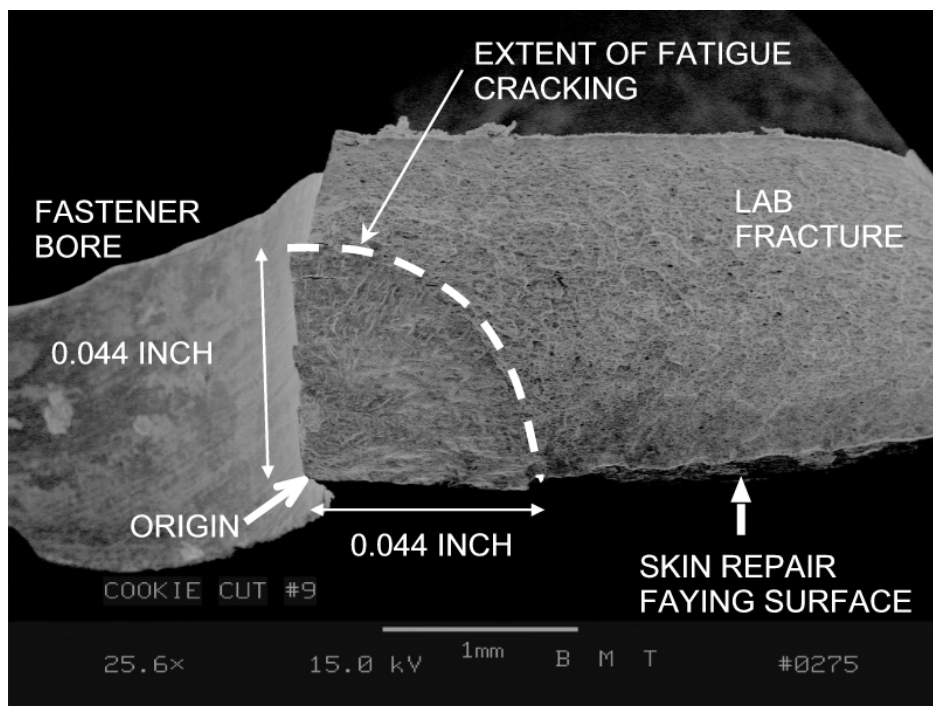
Figure 56. COOKIE CUT #9 FATIGUE CRACK FEATURES - Cracking initiated from the single origin noted above.

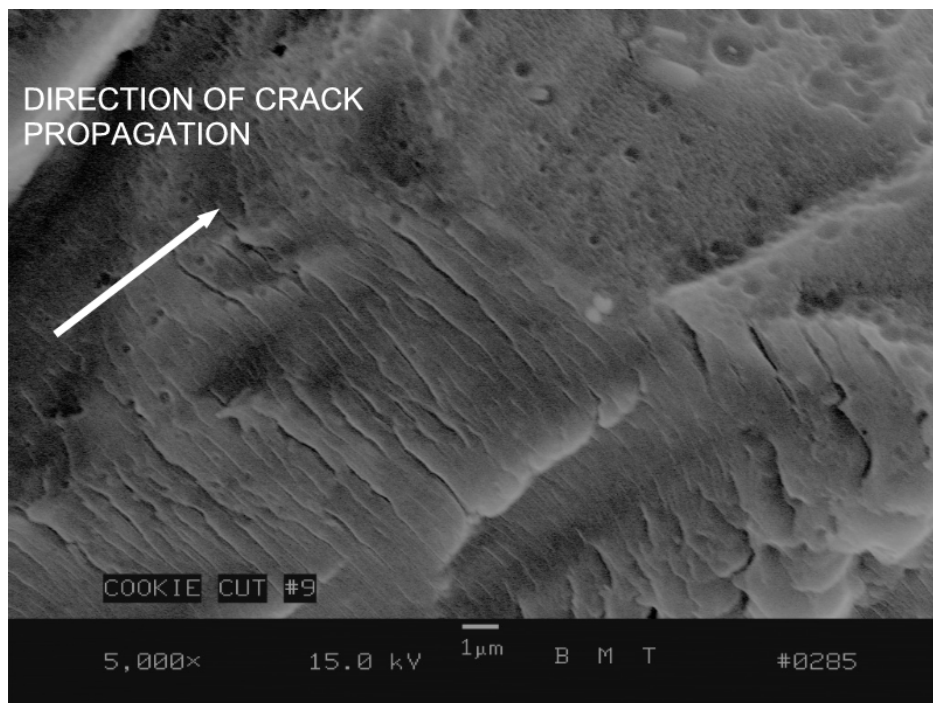
Figure 57. COOKIE CUT #9 FATIGUE STRIATIONS – The above features were located at the maximum extension of the fatigue crack.

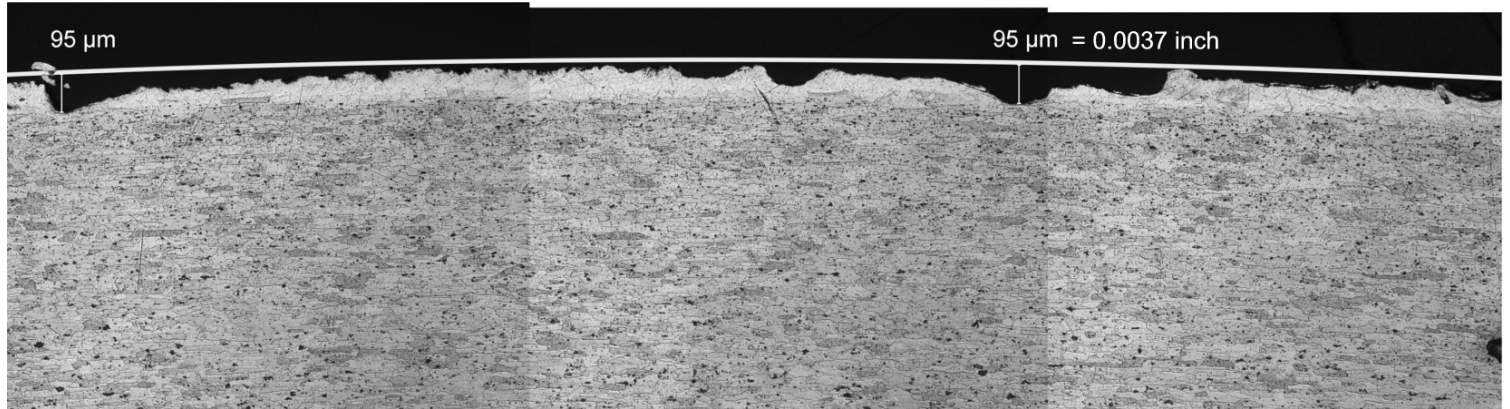
A metallographic specimen was removed from plane A-A (Figure 51) to examine scratch features associated with sealant fillet seal scratching. A composite photograph of this section is shown in Figure 58. Maximum scratch depth was measured at 0.0037 inch. Plane AA also traversed the only area of probable tail strike damage associated with the right hand side of the repair. The damage at this location was much less severe than the skin damage on the left hand side of the repair. Figure 59 displays surface features associated with the outer fastener row of the repair. A maximum scratch depth of 0.0008 was measured optically in this location.

Figure 58. FILLET SEAL SCRATCH FEATURES - These skin surface features were observed at Plane A-A Figure. The clad layer of the skin appears to be penetrated at both measurement locations.

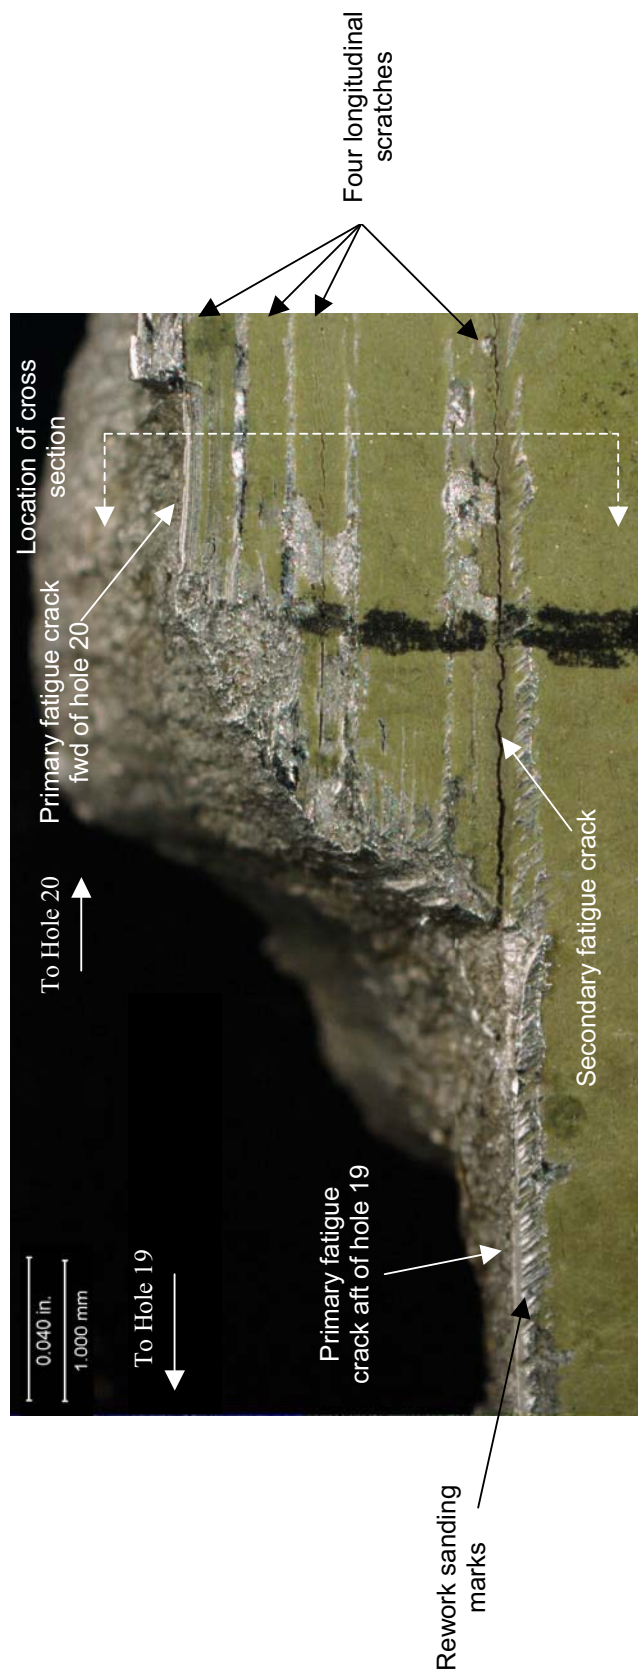
Figure 63.

Location of cross section taken to characterize the scratch depth and in the main fatigue region between holes 19 and 20.

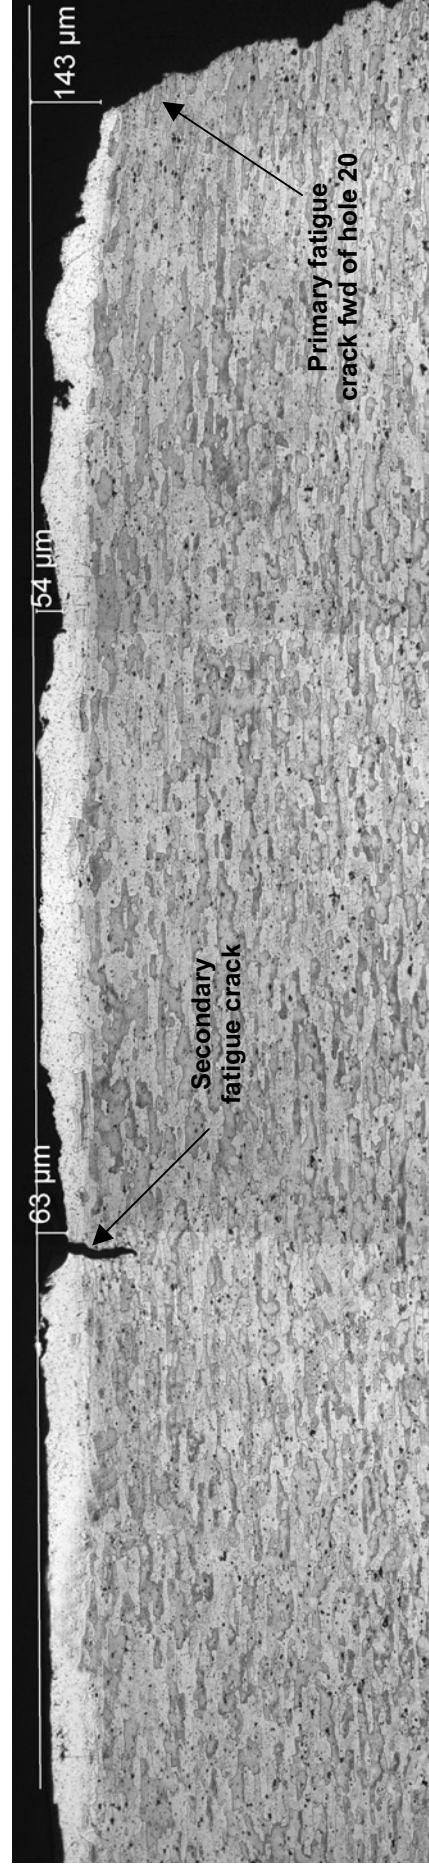
Figure 64.

Metallographic specimens were taken through the main fatigue region to characterize the depth and geometry of the longitudinal scratches initiating the through-thickness fatigue cracks. The cross sections were taken in the vicinity of STA 2100 between holes 18 and 19 and between holes 19 and 20. Figure 61 provides the location of the cross section taken between holes 18 and 19. At this location two longitudinal scratches were visible with one being the initiation site for the primary fatigue crack forward of hole 19 and another scratch being the site for initiation of the primary fatigue crack aft of hole 18. A secondary fatigue crack under that primary fatigue crack aft of hole 18 was also present. Evidence of rework blending (sanding) was present in the vicinity of the scratches. To accurately determine the depth of these scratches a line was projected back to an area of undisturbed clad material. At this location the depth of the scratches measured from 0.0043 inch (110 microns) to 0.0046 inch (118 microns) (see Figure 62). The cross section taken between hole 19 and 20 represented an area with a number of scratches where the primary fatigue crack aft of hole 20 and secondary fatigue crack initiated. Figure 63 provides the location where the cross section was taken. Rework sanding was also present at this location and therefore a similar projection technique was employed to accurately determine the depth of the scratches in this area. The depth of scratches ranged from 0.0056 inch (143 microns) at the primary fatigue crack to 0.0025 inch (63 microns) at the secondary fatigue crack origin (see Figure 64)

Metallographic montage through the area indicated in Figure 63 above. The line shown was projected back to an area of undisturbed clad material to determine the depth of the scratches at the primary and secondary fatigue cracks present in this area.

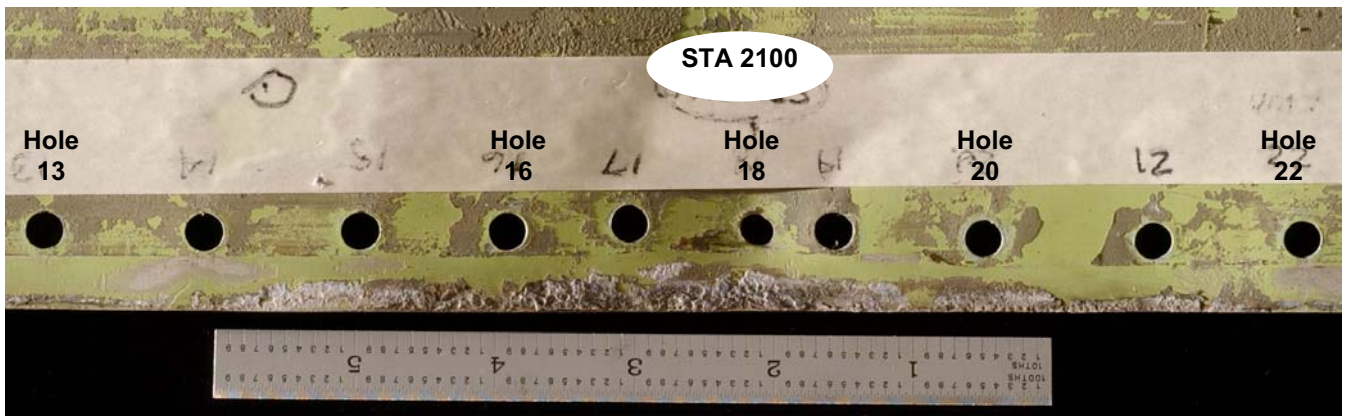
Visual examination revealed a light colored deposit on the overhanging portion of the faying surface of the doubler (mating surface with skin) above the fracture surface at S-49L. Low power optical examination of this area revealed that this light colored deposit had a similar appearance to the light blue exterior paint applied to the doubler. This light colored deposit was on top of what appeared to be the sealant used during installation of the doubler to the skin. The deposit was present between holes 10 and 25 with the largest area observed between holes 14 and 22 (see Figures 65 and 66). Two samples of this deposit were removed in the vicinity of hole 18 (STA 2100) and subjected to organic analysis utilizing Fourier Transform Infrared Spectroscopy (FT-IR). A sample of the exterior paint on the doubler was also removed as well as the sealant on the faying surface for baseline comparisons. FT-IR analysis of the deposit revealed that the spectra of the light colored deposit was an excellent match to the reference light blue exterior paint on the doubler (see Figure 67). Optical examination of the deposits showed that the paint had cured in place and therefore must have flowed between the doubler and skin while wet. As noted in the CSIST report the doubler in the vicinity STA 2100 was deformed locally in an outward direction with the fractured skin. This observation, along with the confirmation of paint on the doubler faying surface at STA 2100, would suggest that the doubler was displaced from the unrecovered portion of the skin during the last repaint of the airplane. As was previously noted, the main fatigue crack was centered about STA 2100 from hole 10 to 25.

Figure 65.
Faying surface of doubler with skin showing the light colored deposit present from hole 14 to 22.

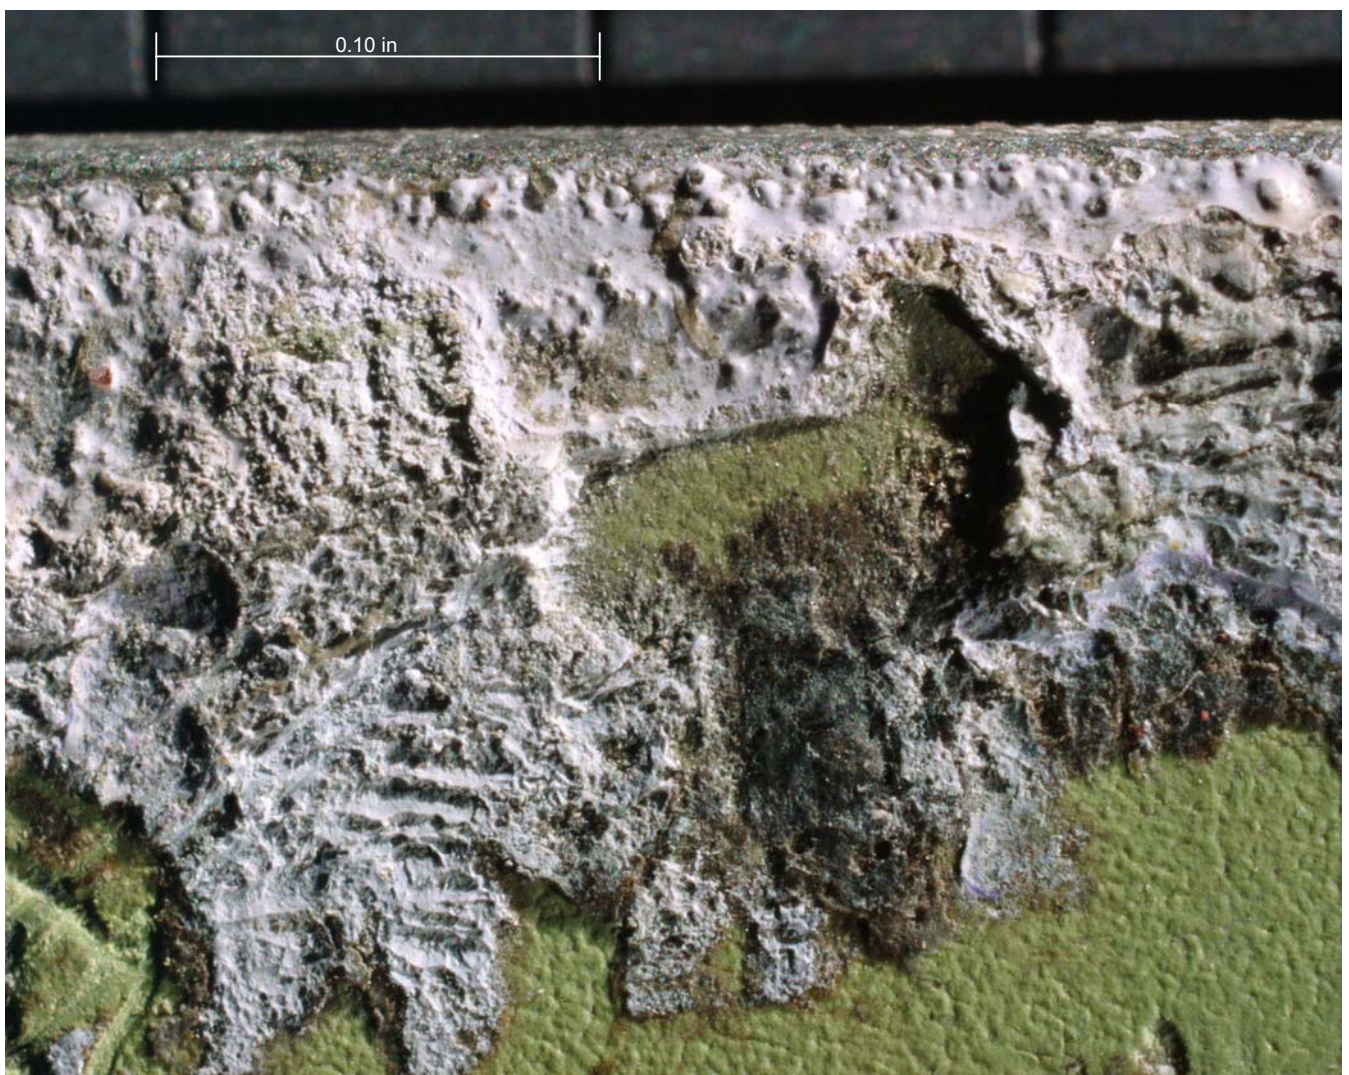
Figure 66.
Higher magnification image of light colored deposit on faying surface of doubler in the vicinity of hole 15. Note the smooth bubbled appearance of the deposit adjacent to the edge of the doubler indicative of paint flow into the joint.
