Aviation Occurrence Report Volume I

ASC-AOR-05-02-001

IN-FLIGHT BREAKUP OVER THE TAIWAN STRAIT

CHINA AIRLINES FLIGHT CI611

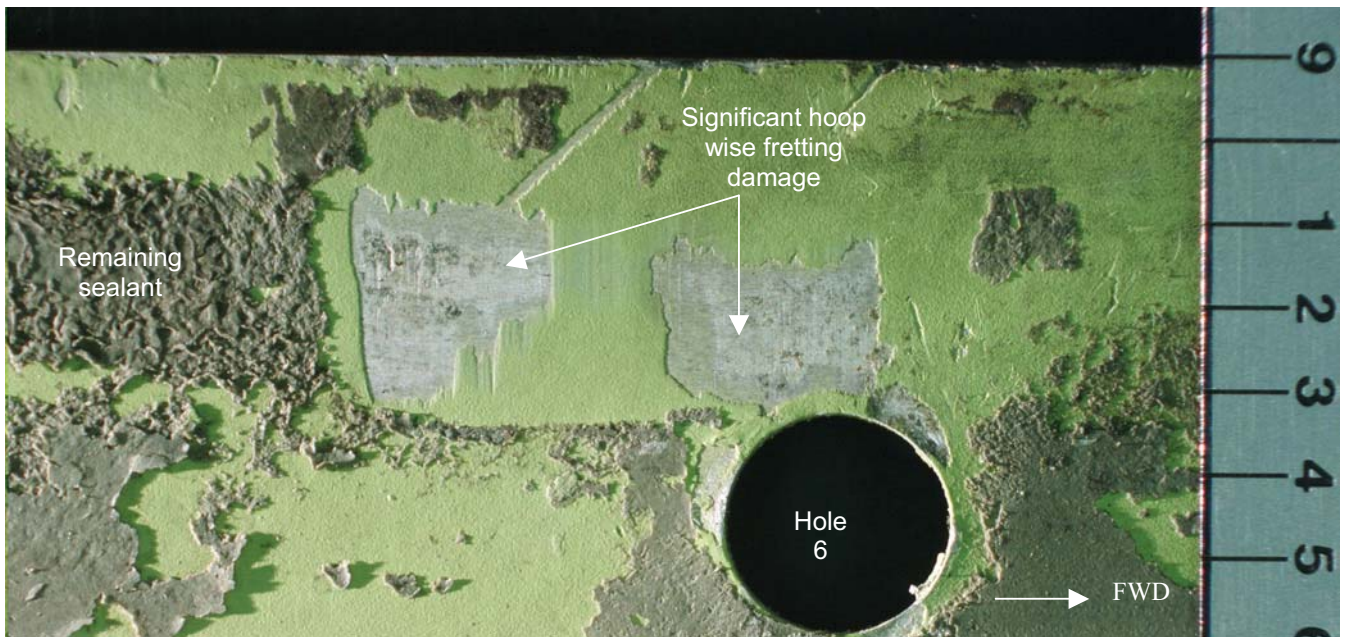
Figure 68.

(~STA 2061) to hole 49 (~STA 2132) with the most significant degree present between holes 8 and 43. Low power optical examination determined the fretting damage resulted from hoop-wise movement. The degree and position of this hoop wise fretting is documented in Table X with photographic examples provided in Figure 68 and 69. The source of this fretting damage was not conclusively determined but based on its location with respect to fatigue cracking and further progression of the crack in a quasi-stable manner, it most likely is the result of repeated crack opening during crack propagation prior to the accident flight.

Faying surface of doubler in the vicinity of hole 6 showing an example of significant fretting damage at the 10:00 to 11:00 and 1:00 to 2:00 clock positions.

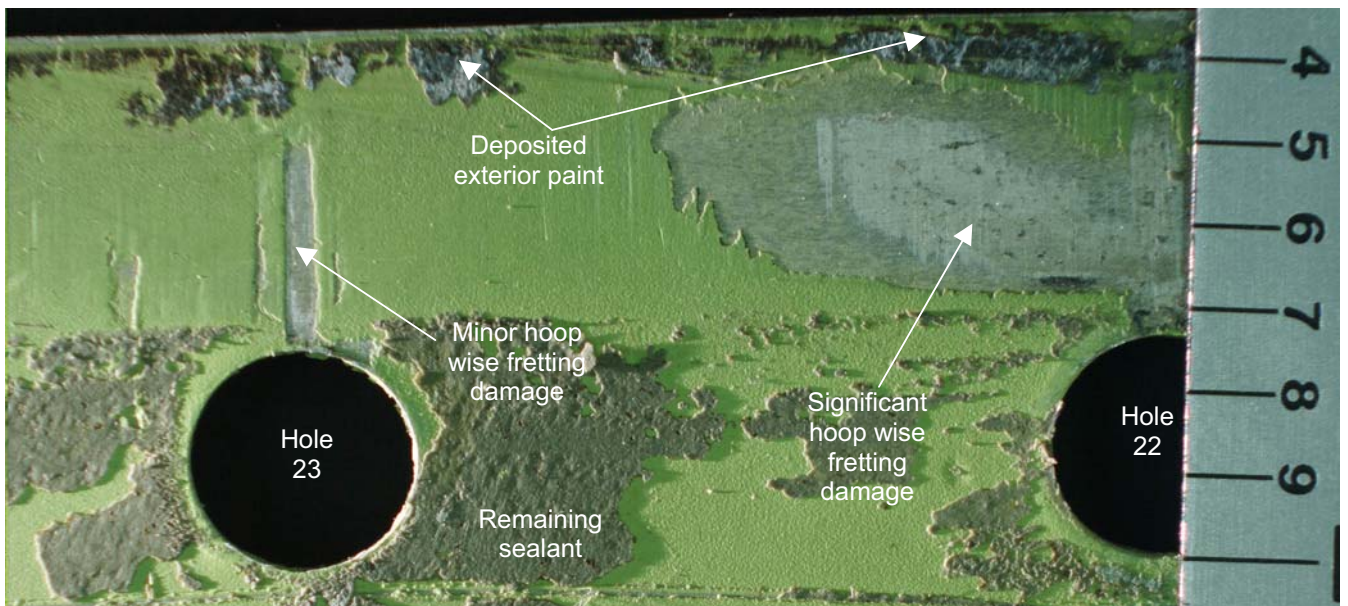
Figure 69.

Faying surface of the doubler showing an example of minor fretting at the 12:00 clock position of hole 23 and significant fretting at the 10:00 to 12:00 clock position of hole 22. Note the presence of deposited paint near the edge of the doubler.

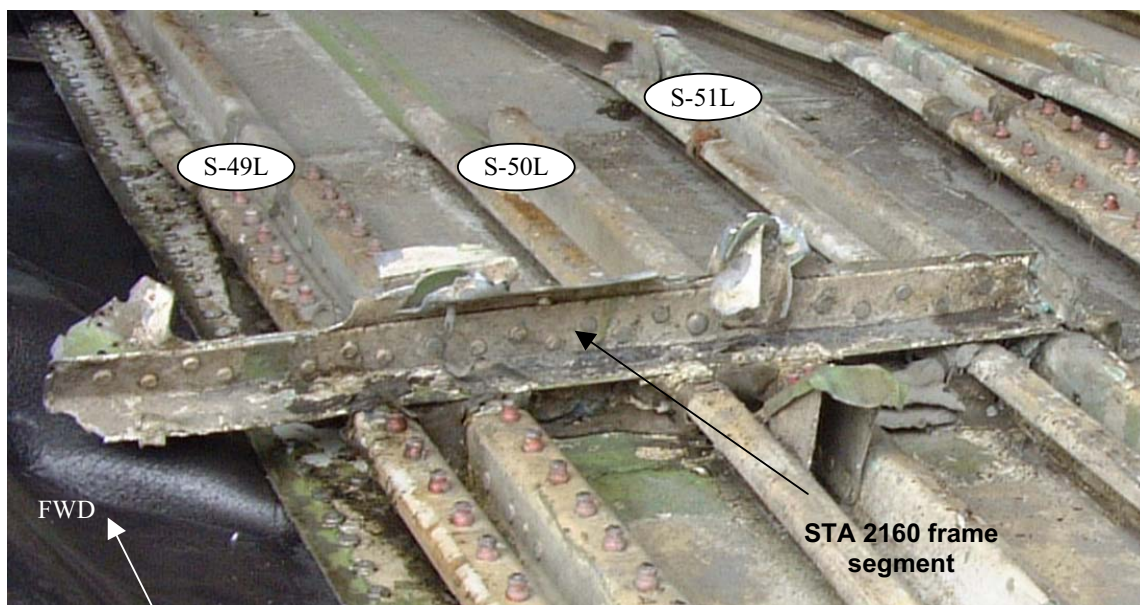
Figure 70.
Condition of the STA 2160 frame segment prior to disassembly from the Item 640C1 skin panel at the CSIST.

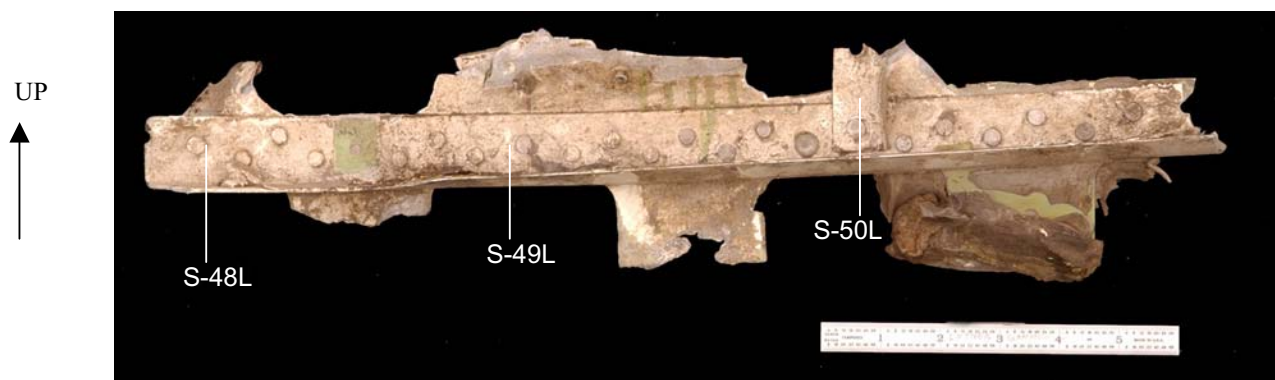
This frame segment was part of the recovered item 640C1 skin panel and was removed during disassembly at the CSIST laboratory (see Figure 70). The overall condition of the submitted frame segment as received by BMT is shown in Figures 71 and 72. The frame segment contained three shear ties, the failsafe chord, a portion of a stringer clip and a portion of the web. A repair existed at the shear tie between S-51L and S-50L. The repaired shear tie exhibited no corrosion, however, the mating interior surface of the fuselage skin as previously described in Figure 49 displayed two pockets of exfoliation corrosion with corresponding cracks visible on the exterior surface of the original skin (faying surface with repair doubler). A significant lump of sealant was found attached to the aft side of the shear tie free flange and skin flange. An impression of the skin corrosion was evident in the surface of the sealant faying with the interior surface of the skin. The shear tie between S-50L and S-49L was heavily corroded with no remaining skin flange attachment provided for examination. The associated mating interior surface of the fuselage skin displayed no evidence of corrosion. The shear tie between S-49L and S-48L was heavily corroded with no remaining skin flange attachment. The skin at this location was free of corrosion on the interior surface mating with the shear tie skin flange, however this represents only a small portion of the mating interior surface. The rest of associated mating interior surface has not been recovered to date.

Figure 71.
As received condition of the STA 2160 frame segment submitted for examination. The aft surface is shown in this view.

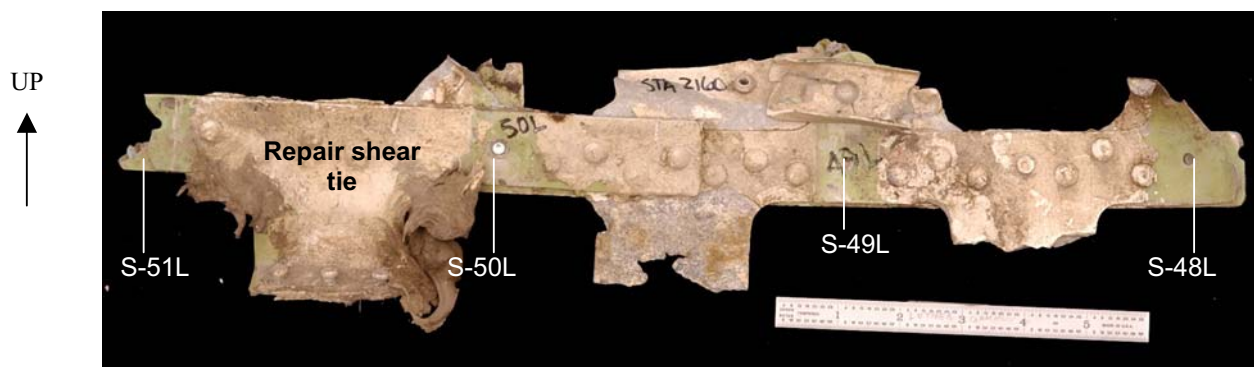
Figure 72. As received condition of the STA 2160 frame segment submitted for examination. The forward surface is shown in this view.

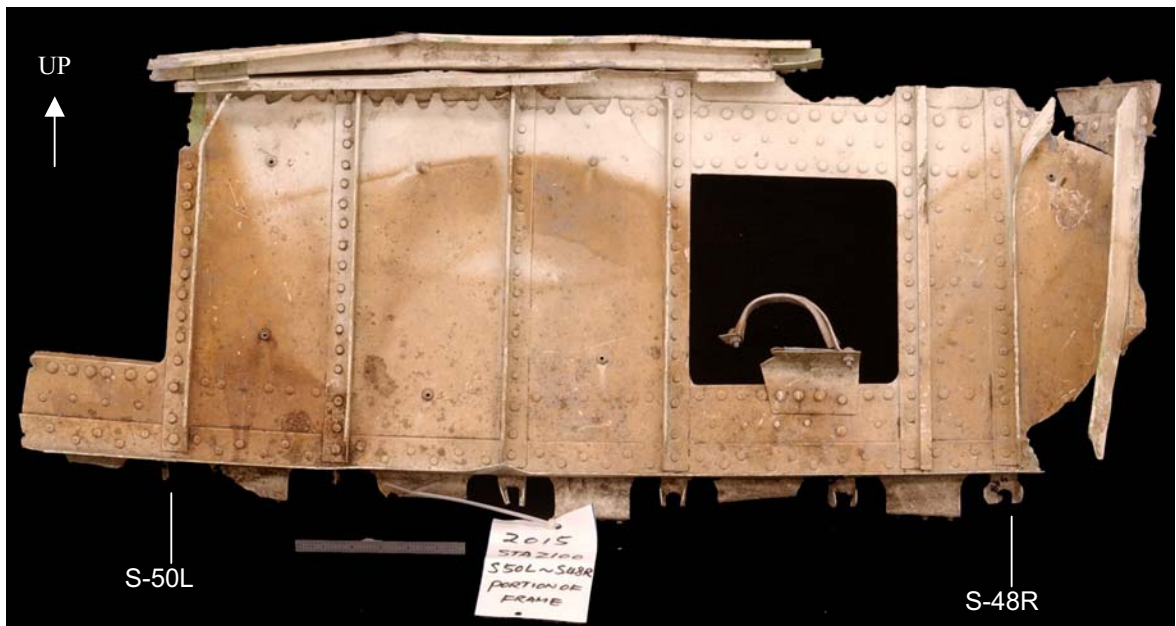
Figure 75. As received condition of the STA 2100 frame segment submitted for examination.
The aft surface is shown in this view.

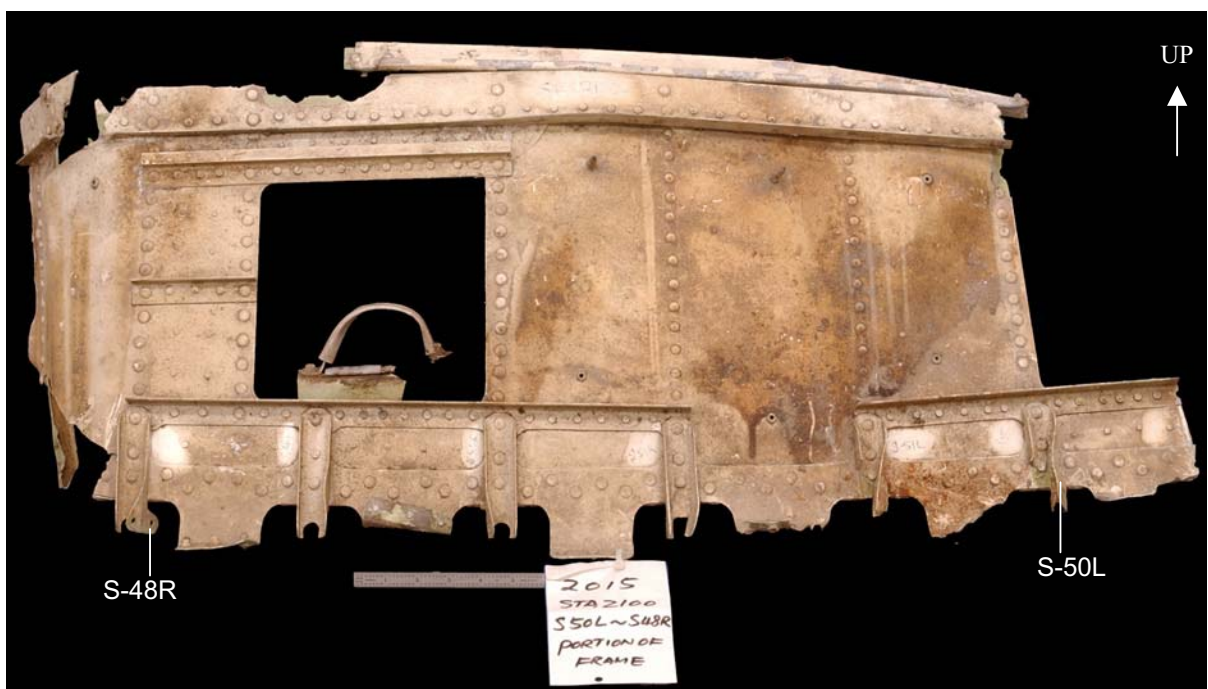
Figure 76. As received condition of the STA 2100 frame segment submitted for examination.
The forward surface is shown in this view.

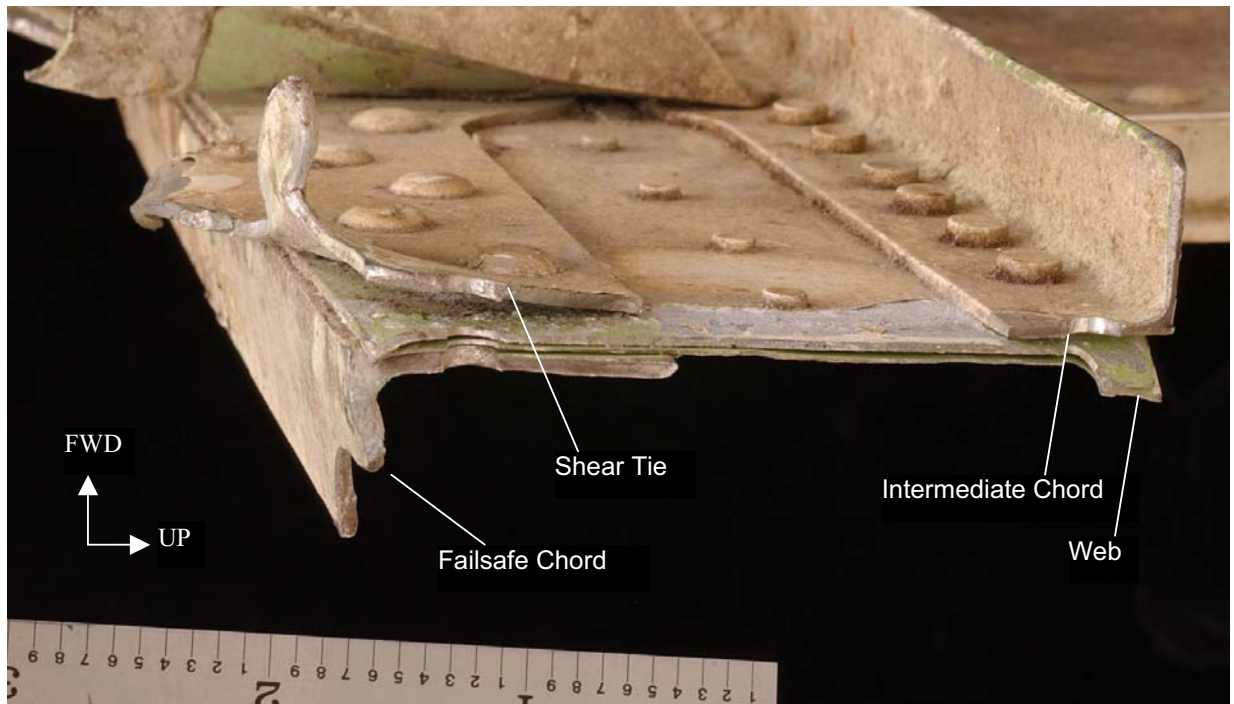
Figure 77.
Fracture at S-49L of the STA 2100 frame segment showing deformation in shear tie and web.

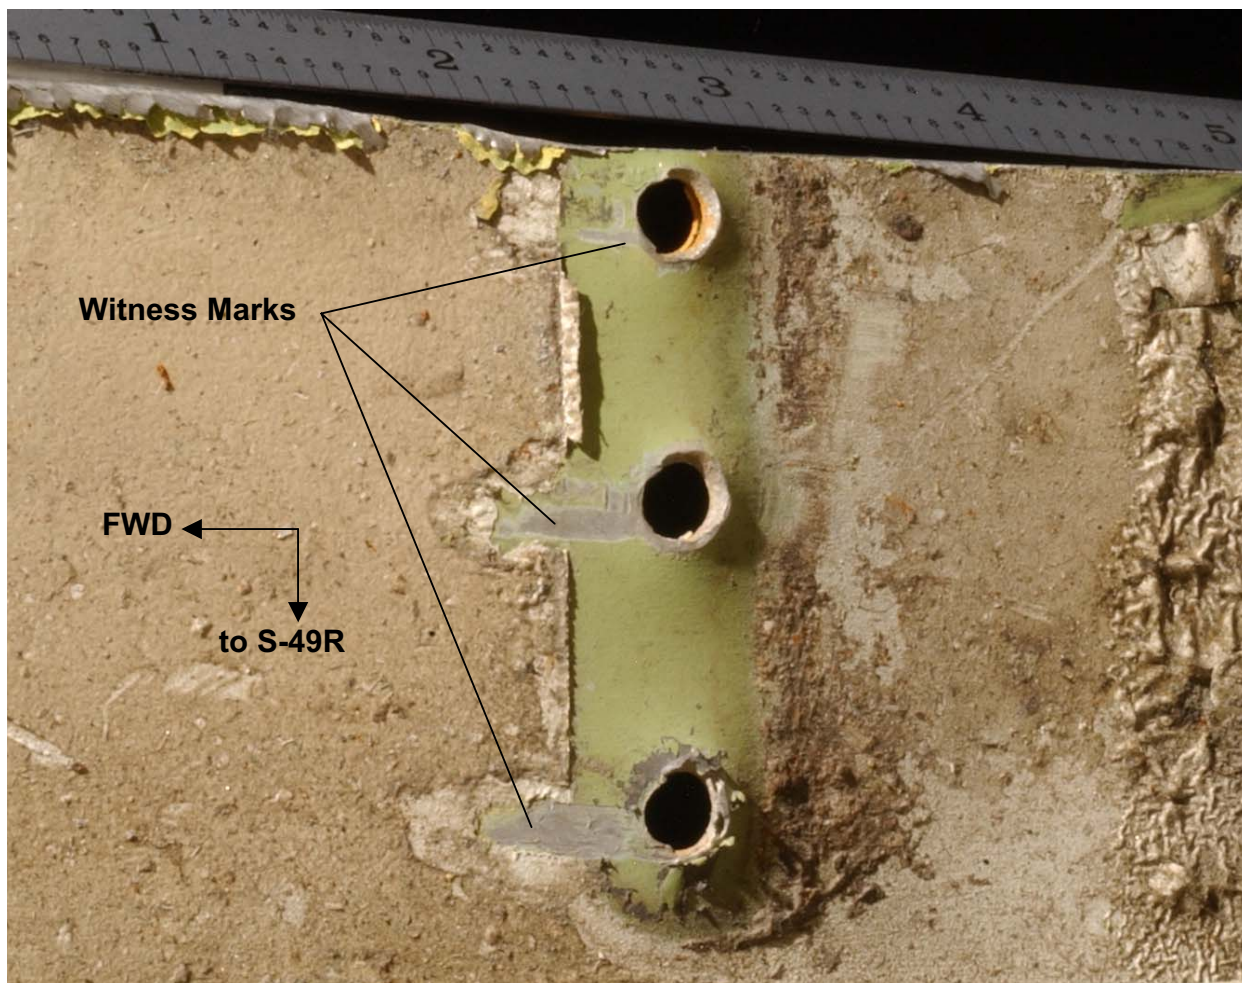
Figure 79.
Witness marks and deformation in skin at shear tie fastener holes common to S-49R /S-48R at STA 2100.

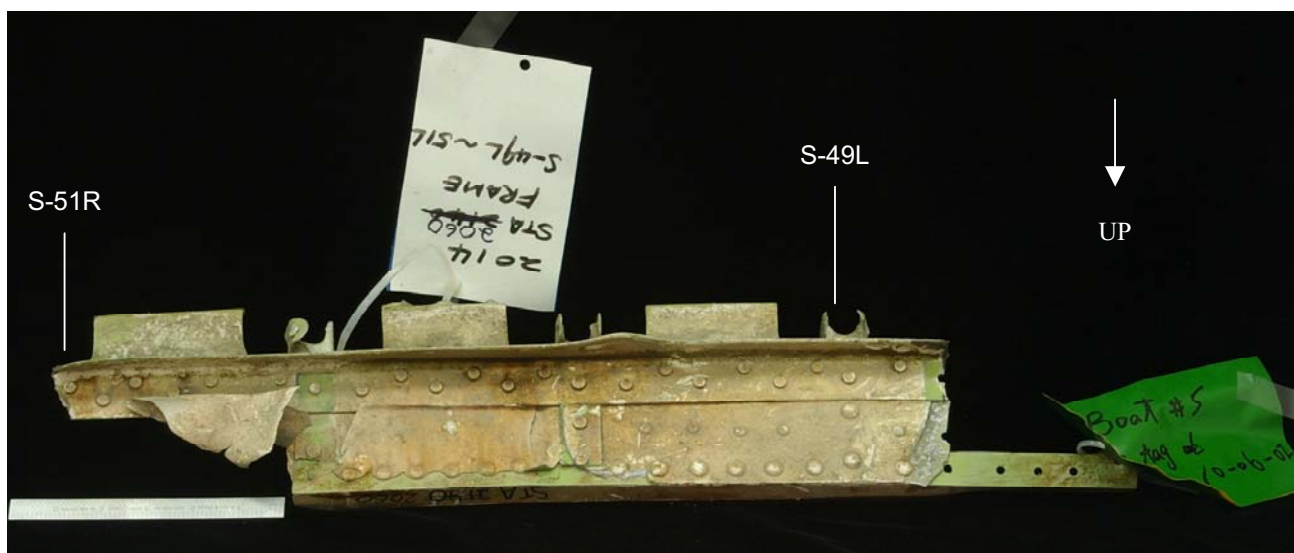
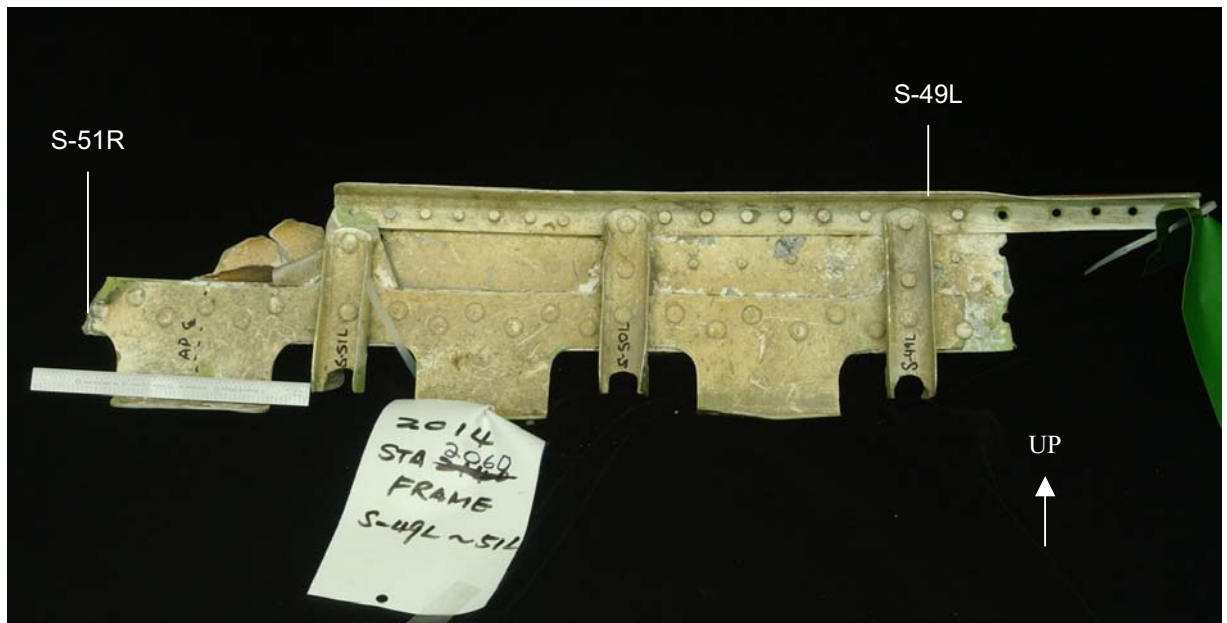
The as-received condition of this frame segment is shown in Figures 80 and 81. This frame segment contained three stringer clips, two shear ties, the failsafe chord, the intermediate chord and a portion of the web.

Figure 80. As received condition of the STA 2060 frame segment. The aft surface is shown in this view.

Figure 81.
As received condition of the STA 2060 frame segment. The forward surface is shown in this view.

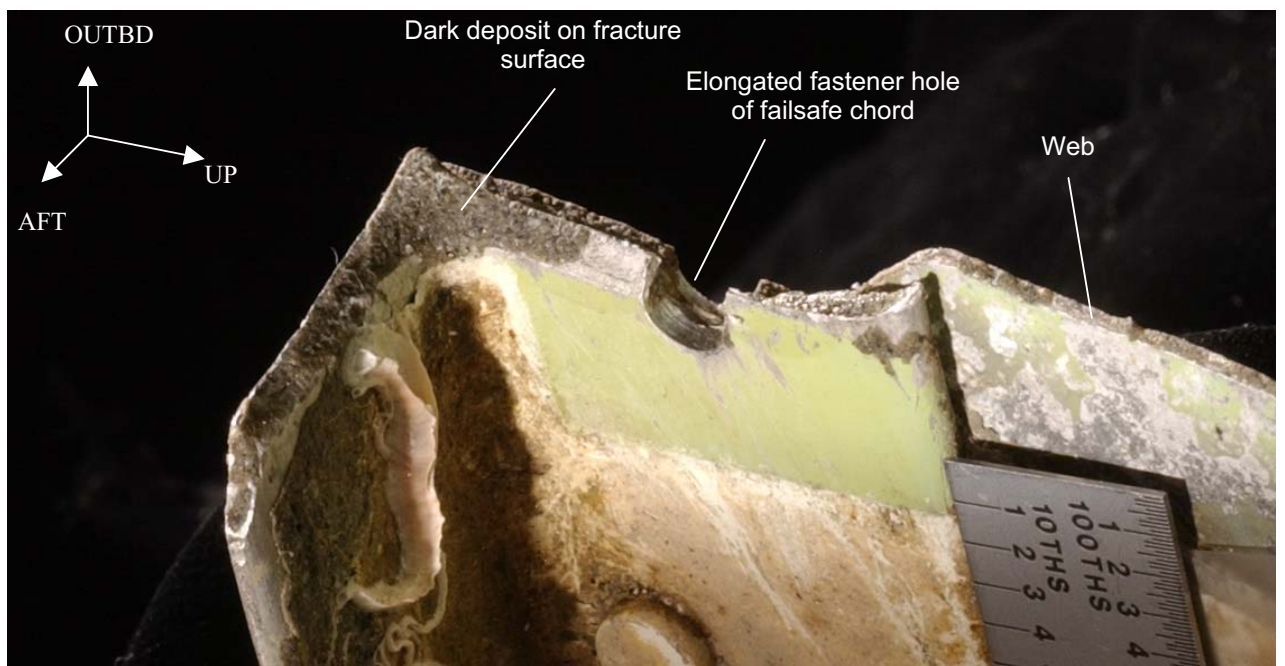
The fracture at S-49L was common with the failsafe chord and web. The shear tie at this location fractured through one fastener hole inboard of this location. Visual examination of the fracture surface of the failsafe chord revealed a slanted fracture profile, however, a heavy, dark deposit in a localized area of the fracture precluded complete examination (see Figure 82). Attempts to remove this deposit using

Figure 82.
Fracture surface of failsafe chord and web common to S-49L of the STA 2060 frame segment.

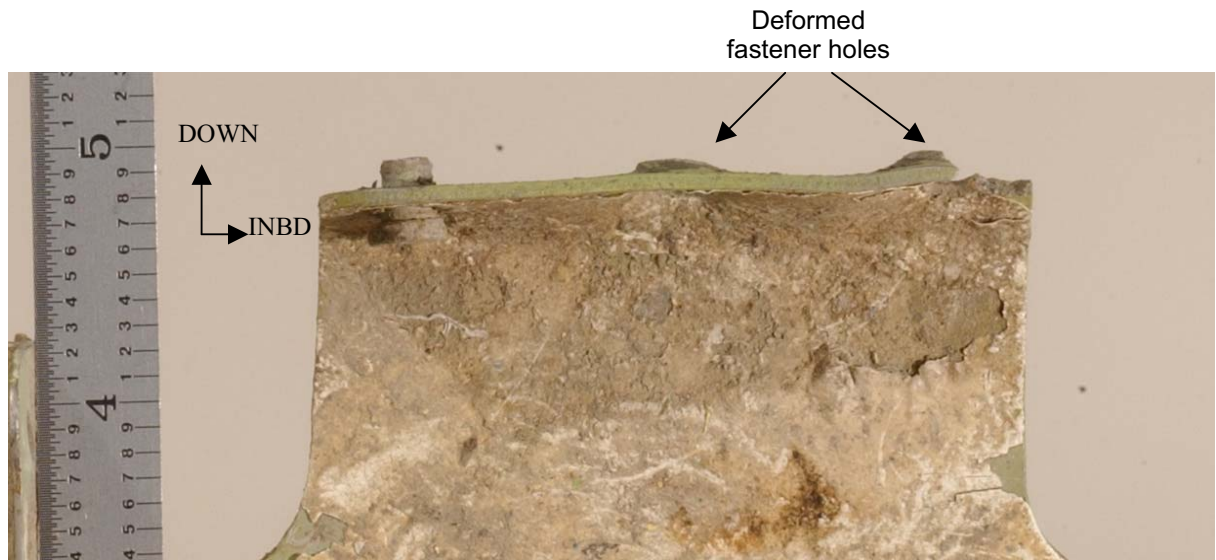
Figure 83.

Visual examination of the shear ties from this frame segment was performed to determine the direction of separation from the skin. The shear tie between S-51R and S-51L was missing the skin attachment rivets and contained no fractures, however, the skin flange was bent in the downward direction. The shear tie between S-51L and S-50L was fractured at the inboard most fastener hole common to the skin flange. The middle fastener hole was deformed in the downward direction. The outboard most rivet remained in the skin flange with the manufactured countersink head pulled off (see Figure 83). This shear tie also exhibited downward deformation of the skin flange. The shear tie between S-50L and S-49L was also missing the skin attachment rivets and exhibited downward deformation of the middle skin flange fastener hole. In addition, the stringer clip at S-51L exhibited a bearing fracture through one of the attachment lugs. All these observations were consistent with the application of a straight tensile load on the shear ties of this frame segment.

Shear tie between S-51L and S-50L of the STA 2060 frame segment showing deformation of skin flange fastener holes in the downward direction.

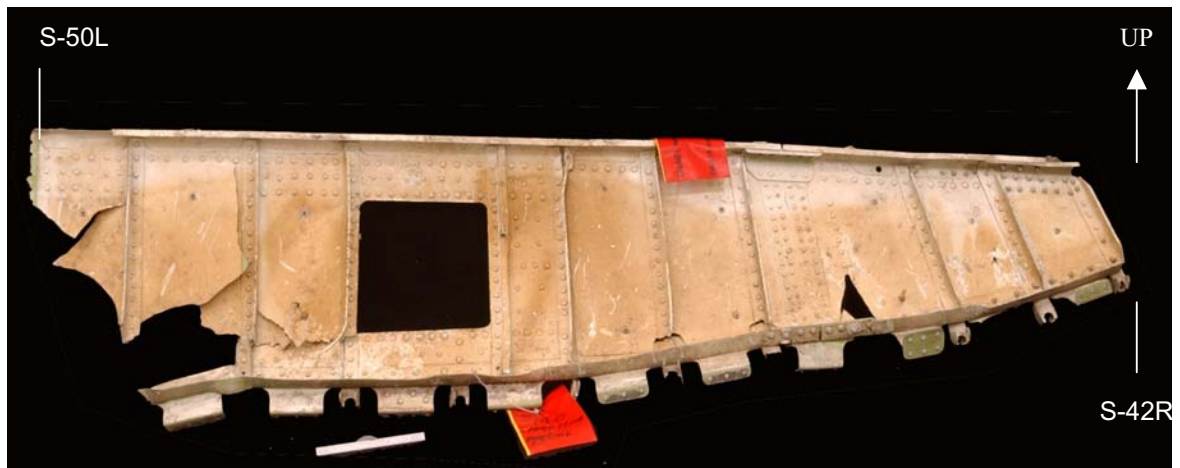
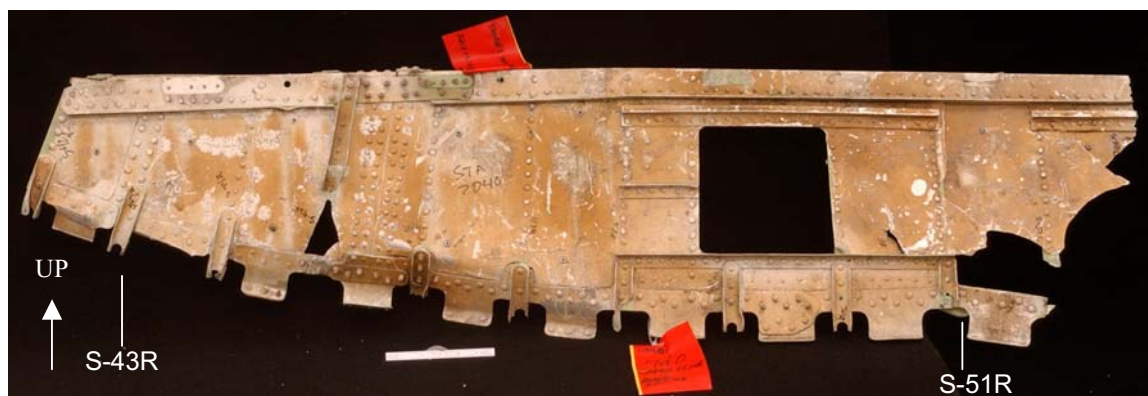
Figure 84 and 85 provide overall views of the aft and forward faces of this frame segment submitted for examination.

The failsafe chord, web, and shear tie all were fractured at S-51L. At S-42R the fracture was common with the failsafe chord and web. Examination of these fracture surfaces with the use of visual and low power optical techniques revealed slanted fracture profiles with no evidence of any pre-existing corrosion or slow crack growth regions. The overall fracture morphologies were consistent with ductile separation. At S-51R, the failsafe chord was fractured at the free flange radius with deformation consistent with compression buckling (see Figure 86). All of the inner chord fractures exhibited slanted fracture profiles with fracture morphologies consistent with ductile separation as well.

Figure 84. As received condition of the STA 2040 frame segment submitted for examination. The aft surface is shown.

Figure 85. As received condition of the STA 2040 frame segment submitted for examination. The forward surface is shown in this view.

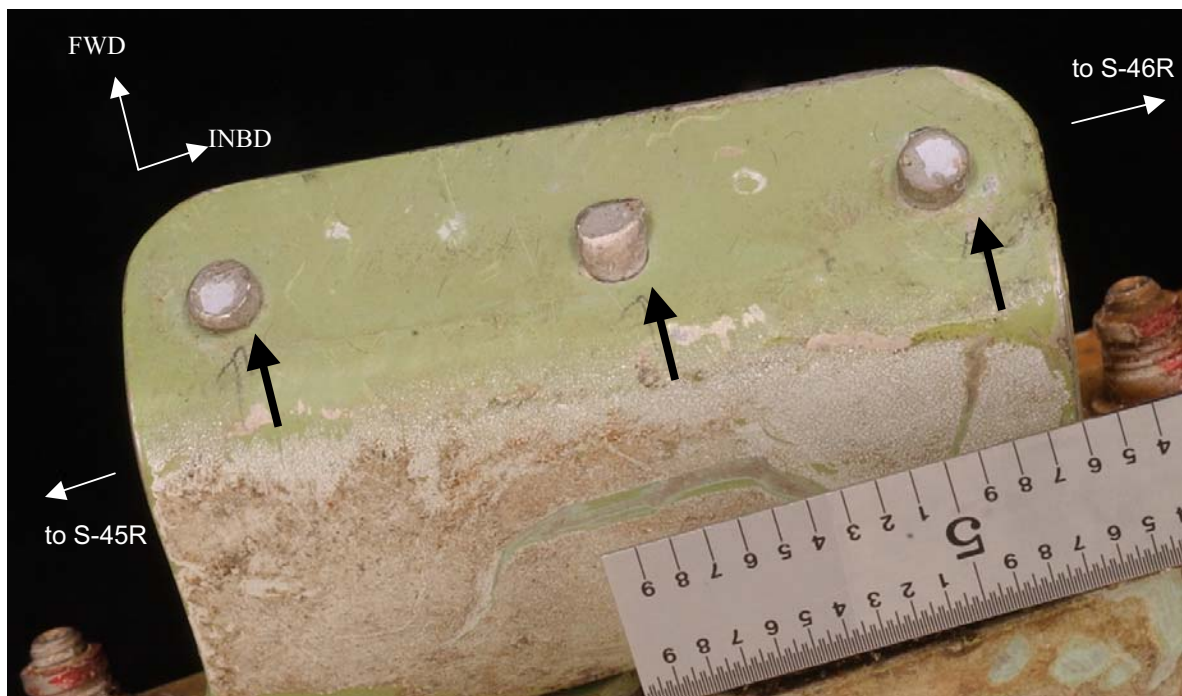
All of the shear ties on this frame segment with the exception of the two at the far right side (between S-42R and S-44R) exhibited no fractures. The extruded "T" shear tie between S-42R and S-43R was fractured through the forward skin flange while the sheet metal shear tie between S-43R and S-44R was fractured through the free flange. Visual and low power optical examination of these fracture surfaces revealed slanted fracture profiles with fracture morphologies typical of ductile separation. The remainder of the shear ties on this frame experienced skin flange rivet fractures. These rivet fractures were examined to help determine the direction of loading during separation from the skin. The skin flange rivets present on the three shear ties between S-45R and S-48R exhibited evidence of loading in the forward to forward/inboard direction (see Figure 87) while the four shear ties between S-48R and S-51L exhibited evidence of loading in the aft/outboard direction (note the direction of loading for the shear tie between S-51R and S-51L was identical to the other three shear ties) (see Figure 88). All these shear ties exhibited no deformation except for the location between S-45R and S-46R which exhibited forward deformation.

Figure 87. Skin flange rivet fractures at shear tie between S-45R and S-46R of the STA 2040 frame. Black arrows indicate the direction of loading.

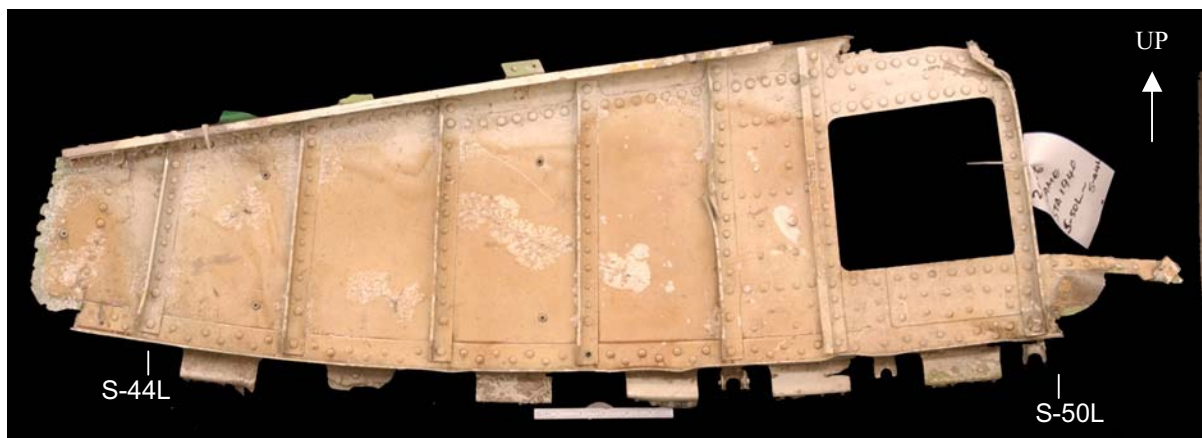
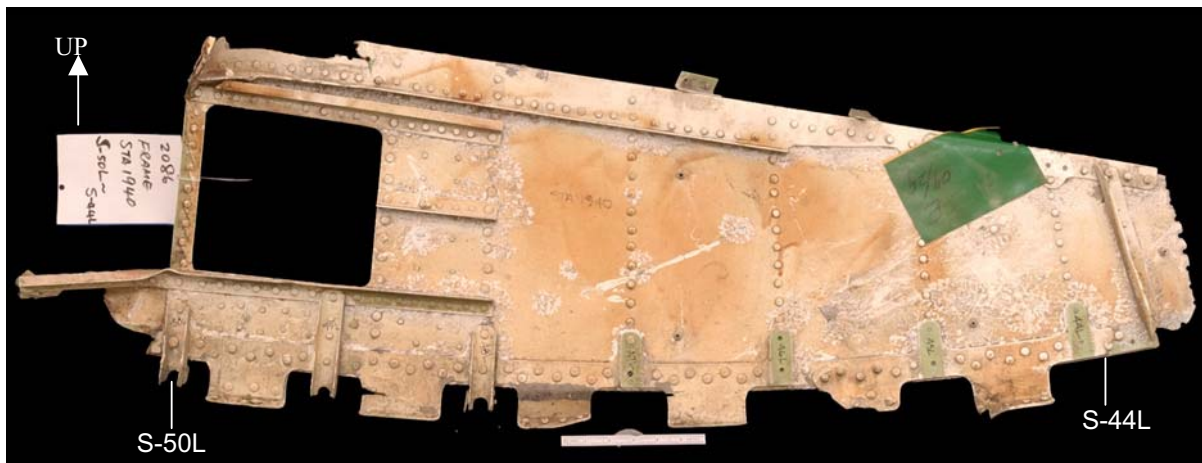
The as-received condition of this frame segment is shown in Figures 89 and 90. This frame segment contained two repairs of shear tie locations and one repair to the web. The shear ties were repaired between S-50L and S-49L with the use of a doubler (see Figure 91) and between S-46L and S-44L with the use of a replacement shear tie/doubler combination (see Figure 92). The web was repaired with the use of a doubler placed on the aft side under the cut-out between S-50L and S-49L (see Figure 93).

Figure 89. As received condition of the STA 1940 frame segment submitted for examination. The aft surface is shown in this view.

Figure 90.
As received condition of STA 1940 frame segment submitted for examination.
The forward surface is shown in this view.

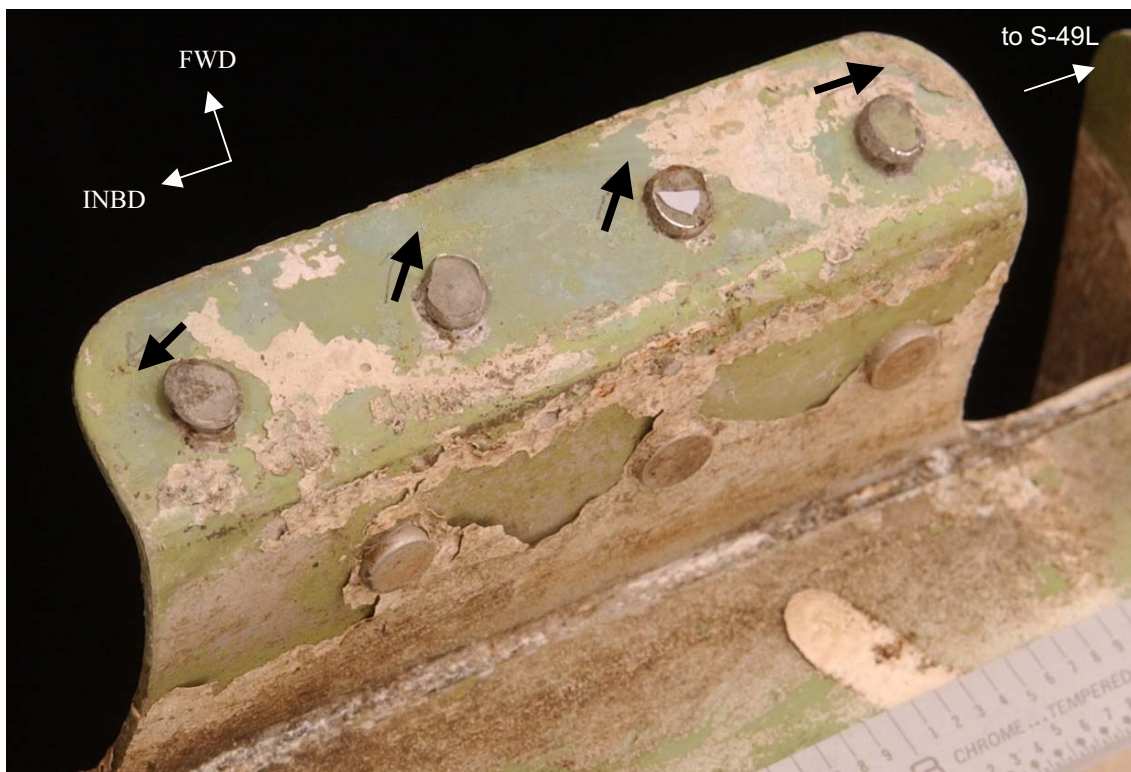
Figure 95. Shear tie between S-50L and S-49L of STA 1940 frame segment.
Black arrows indicate the direction of loading.

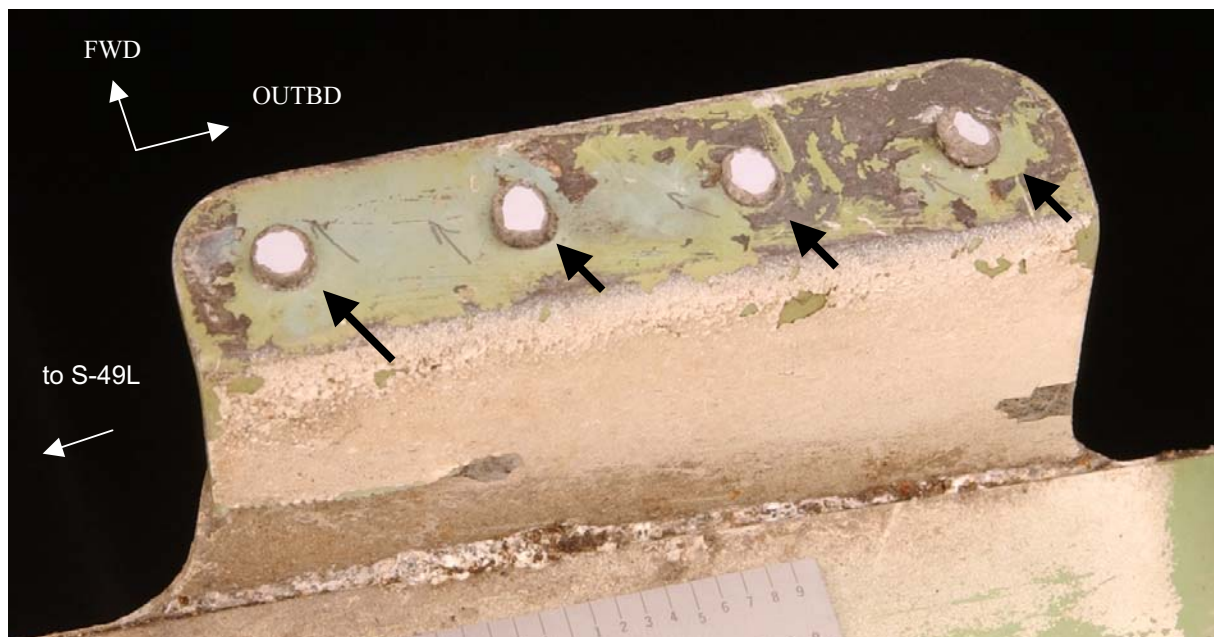
Figure 96.
Shear tie between S-49L and S-48L of STA 1940 frame segment.
Black arrows indicate the direction of loading.

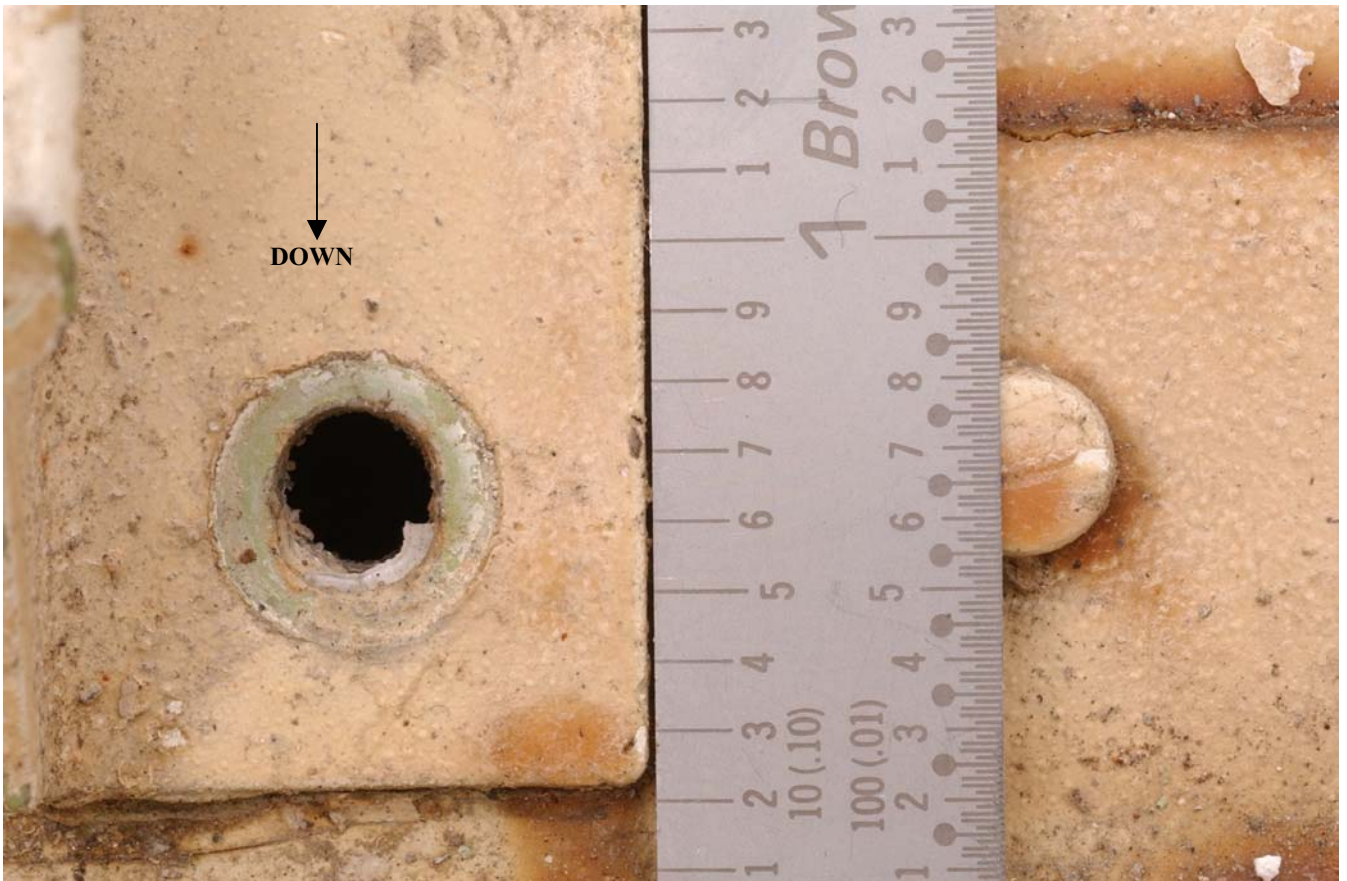
Between S-47L and S-44L the stringer clips were missing from this frame segment. The rivet fractures and or hole deformation at these locations were examined to determine if any evidence of separation direction was present. At all of these stringer clip locations the rivets were fractured and remained in the shear tie except at the lower attachment hole at S-47L which was missing the rivet. All of the fractured rivets that could be viewed (some of the fractures existed at the web/shear tie interface) exhibited signs of loading in the downward direction. The lower attachment hole at S-47 exhibited elongation in the downward direction as well (see Figure 98).

Figure 98.
FWD view of STA 1940 frame segment showing downward deformation of
the lower attachment hole of shear tie at S-47L clip.

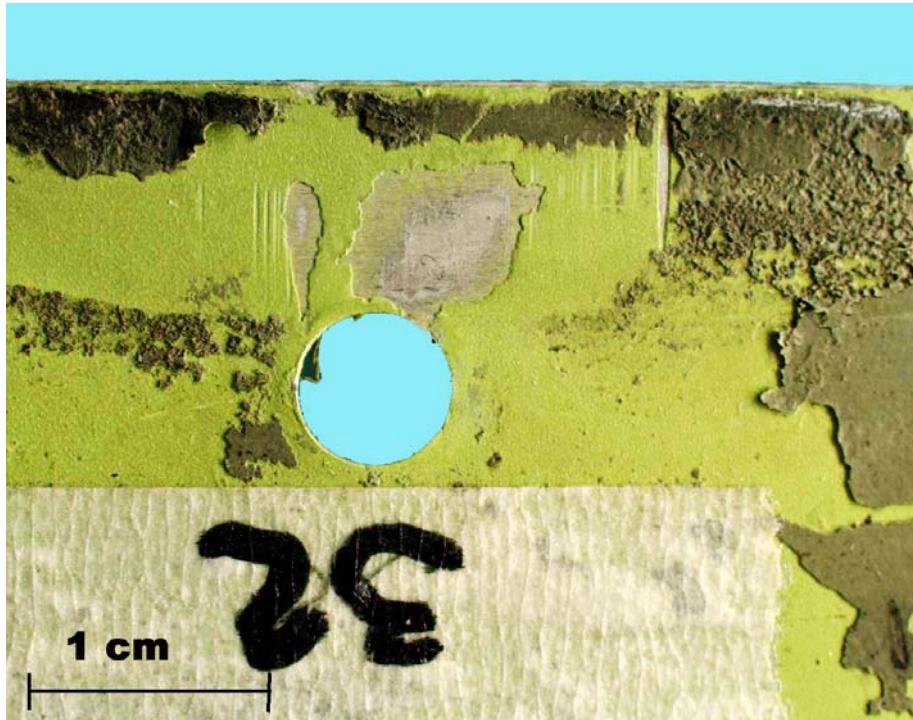
- (1) The surface markings near hole 32 are presented in Figure 1, and an optically magnified photograph of the subject area is shown in Figure 2. Figure 1 shows that the surface markings at the suspected area of contact exhibit many colors. Figure 2 shows that some hoop-wise scratches (marked by arrows) were visible on the surface of the suspected area of contact.
- (2) Figure 3 is an SEM photograph at point A in figure 2, indicating that the grooves of the scratches were covered by some material(s).
- (3) Two cross section locations were chosen to characterize the surface markings. Figures 5 and 6 are the metallographic photographs through the area marked by the data sampling cut #1 and data sampling cut #2 respectively, shown in Figure 4, showing that there was some material superimposed over the grooves of the scratches.

Figure 1, Surface markings adjacent to hole 32, showing the different colors on the metal surface.

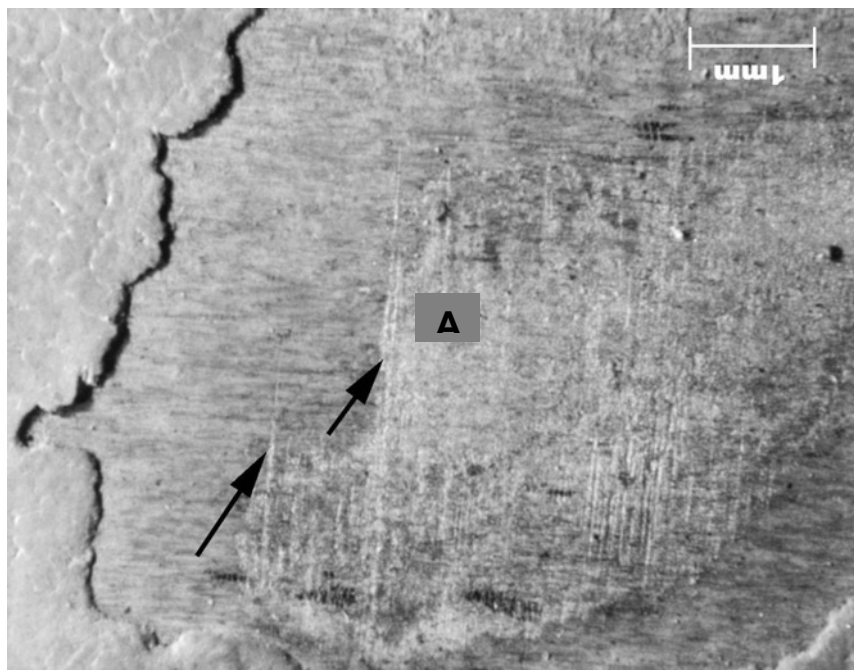
Figure 2, Optical magnification photograph of the marking area in Figure 1.

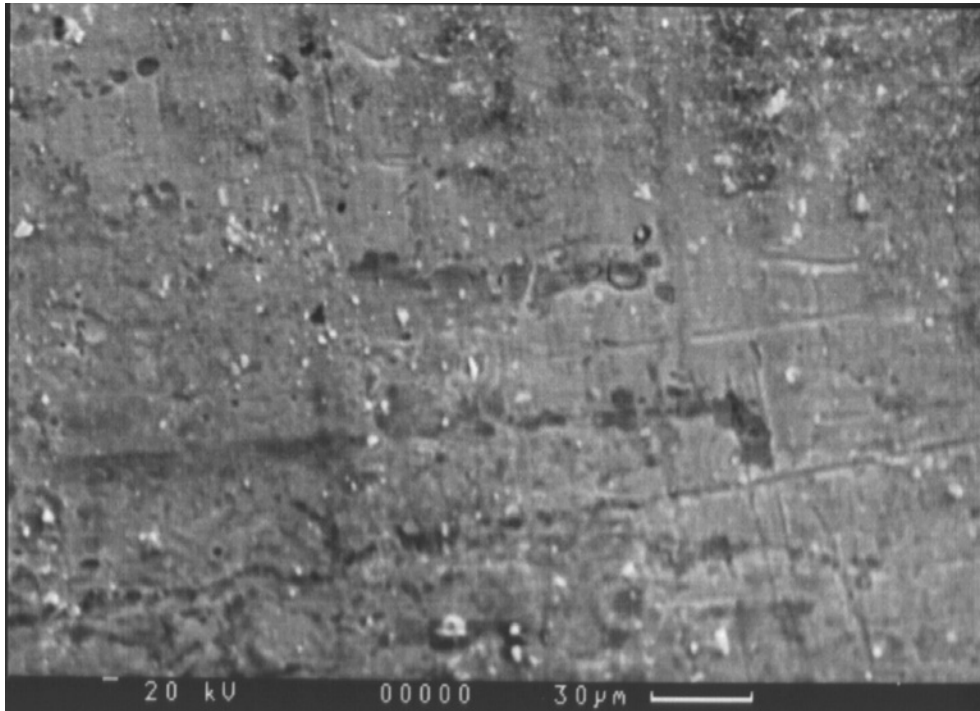
Figure 3, SEM photograph at point A in figure 2, indicating that the grooves of some of the scratches were covered by some material.

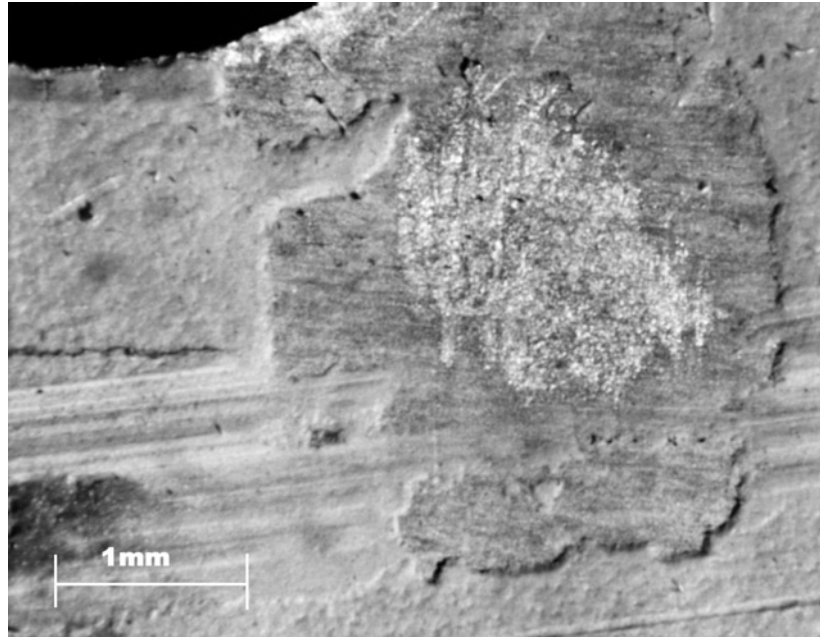
Marking areas of interest adjacent to holes 11, 49 and +16 are shown in Figure 7, 8, 9, respectively; all showing scrape/scratch marks on the surface.

Figure 7 Surface area adjacent to hole 11.

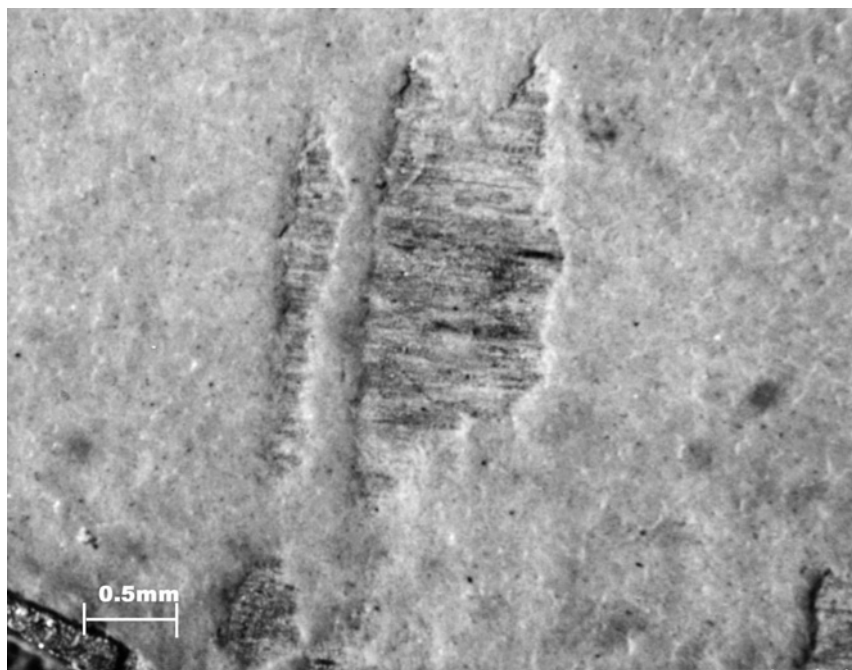
Figure 8 Surface area adjacent to hole 49

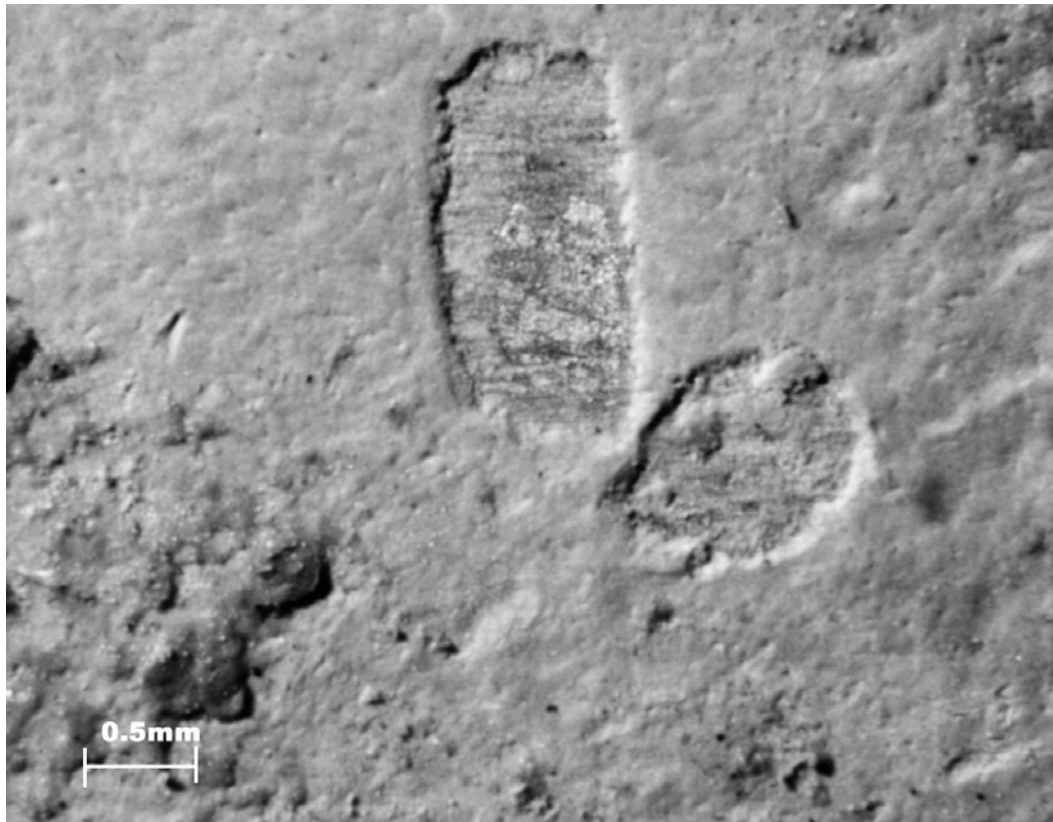
Figure 9 Surface area adjacent to hole +16
