Aviation Occurrence Report Volume I

ASC-AOR-05-02-001

IN-FLIGHT BREAKUP OVER THE TAIWAN STRAIT

CHINA AIRLINES FLIGHT CI611

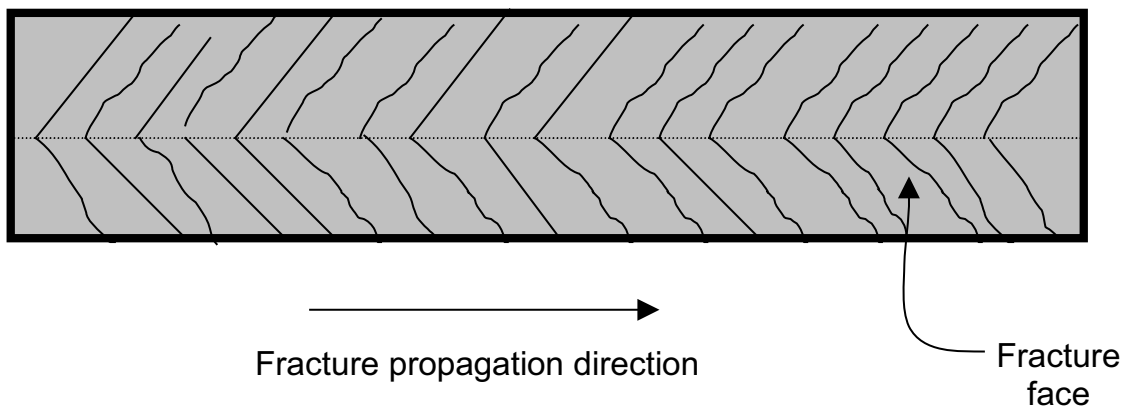
Item 640 S-49L, STA 2100

Multiple crack initiation sites along length

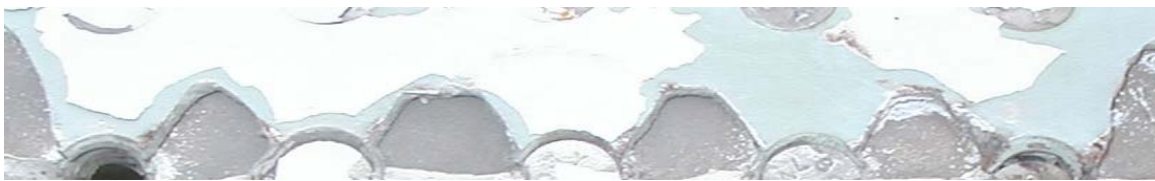
Item 652 STA 460

No apparent directionality in this local area
