- Final Report -

AAIS Case N°: AIFN/0016/2014

Hydraulic Fluid Mist and Protective Breathing Equipment Fire in the Passenger Cabin

Operator:	Emirates
Make and model:	Airbus A330-243
Nationality and registration:	The United Arab Emirates, A6-EAQ
Place of occurrence:	Karachi International Airport
State of Occurrence:	Pakistan
Date of occurrence:	4 October 2014

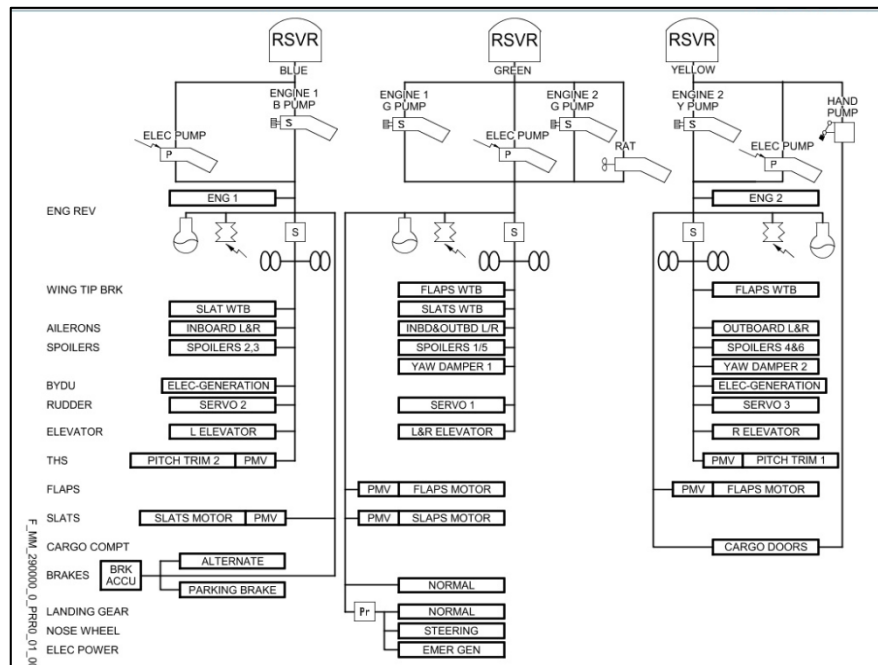
Figure 2. Hydraulic system architecture

A schematic of the hydraulic power supply to the various flight controls is illustrated in figure 2.

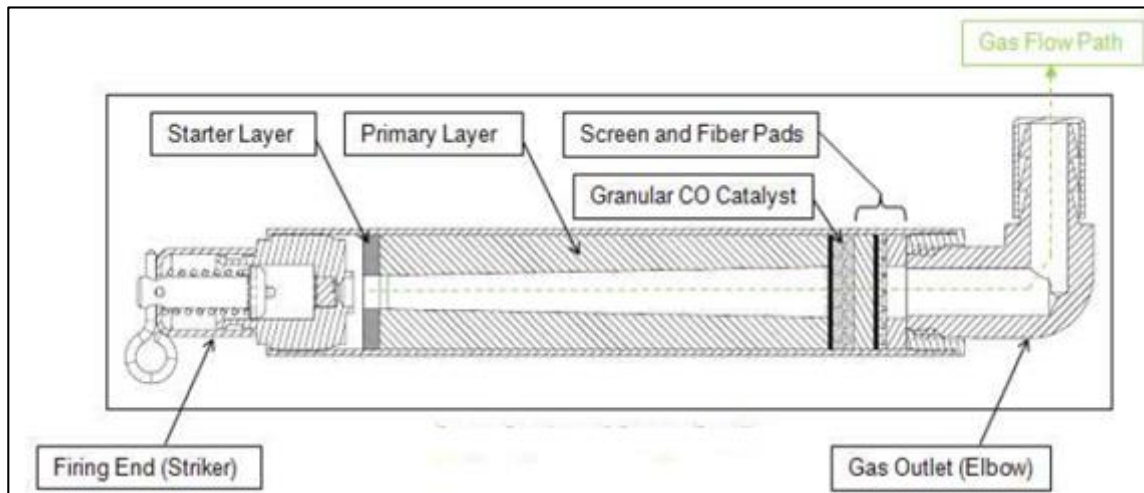
Figure 8. Cross section of the starter candle [Source: B/E Aerospace CT scan report]

The chlorate starter candle is designed to deliver a fixed volume of approximately eight liters of oxygen over duration of less than 20 seconds by the chemical decomposition of sodium chlorate. The starter candle is contained in a small stainless steel cylinder affixed to the base of the KO_2 canister (figure 8).
