FINAL REPORT

**Garuda Airlines
Boeing 737-300 Registration PK-GGG**

**Singapore Airlines Engineering Company
Maintenance Jeep**

AIB/AAI/CAS.001

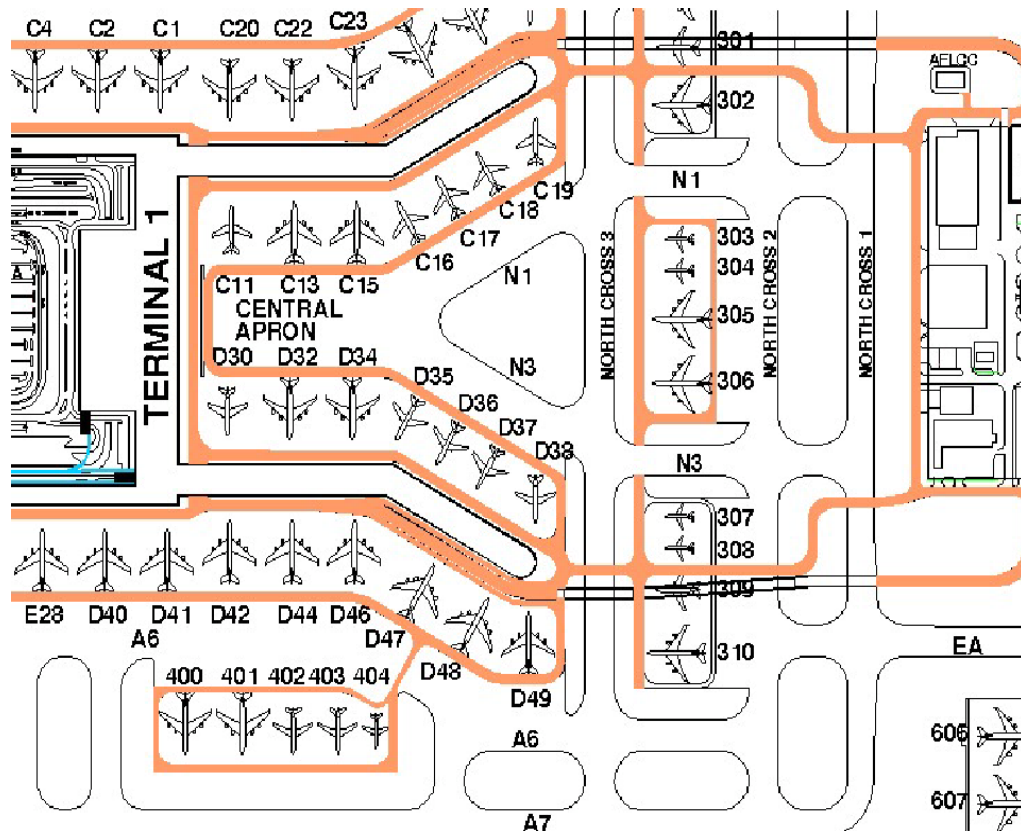
Chart showing layout of taxiways around the Central Apron

- 3.1.8 The red traffic lights at the incident junction were checked on the same night after the collision incident by the CAAS' maintenance contractor and Apron Control and Management Services duty staff and were found to be working properly.

- 4.3 CAAS should consider reviewing the reliability of the traffic light systems at the North Cross Taxiways area. [AAIB Recommendation R-2004-013]
- 4.4 It is recommended that Garuda Indonesia require its flight crews to disconnect their aircraft’s flight data and cockpit voice recorders immediately after an aircraft has come to rest following a ground incident or accident. Although this is not a safety deficiency, implementation of the recommendation will ensure that the contents in the recording, which are crucial to subsequent investigations, are preserved. [AAIB Recommendation R-2004-014]

CAAS has reviewed the reliability of the traffic light systems at the North Cross Taxiways area of Changi Airport and instituted a number of improvements.
