INVESTIGATION REPORT OF ACCIDENT INVOLVING GEORGIAN AIRWAY'S AIRCRAFT CRJ-100ER (4L-GAE) AT KINSHASA'S N'DJILI AIRPORT DEMOCRATIC REPUBLIC OF CONGO (DRC) ON 04 APRIL 2011

Investigation report of accident involving Georgian Airways CRJ-100ER (4L-GAE), which occurred at Kinshasa's N'DJILI Airport, Democratic Republic of Congo (DRC) on 04 April 2011.

FINAL REPORT OF TECHNICAL INVESTIGATION ON THE ACCIDENT OF THE CRJ-100 PLANE, REGISTER 4L-GAE

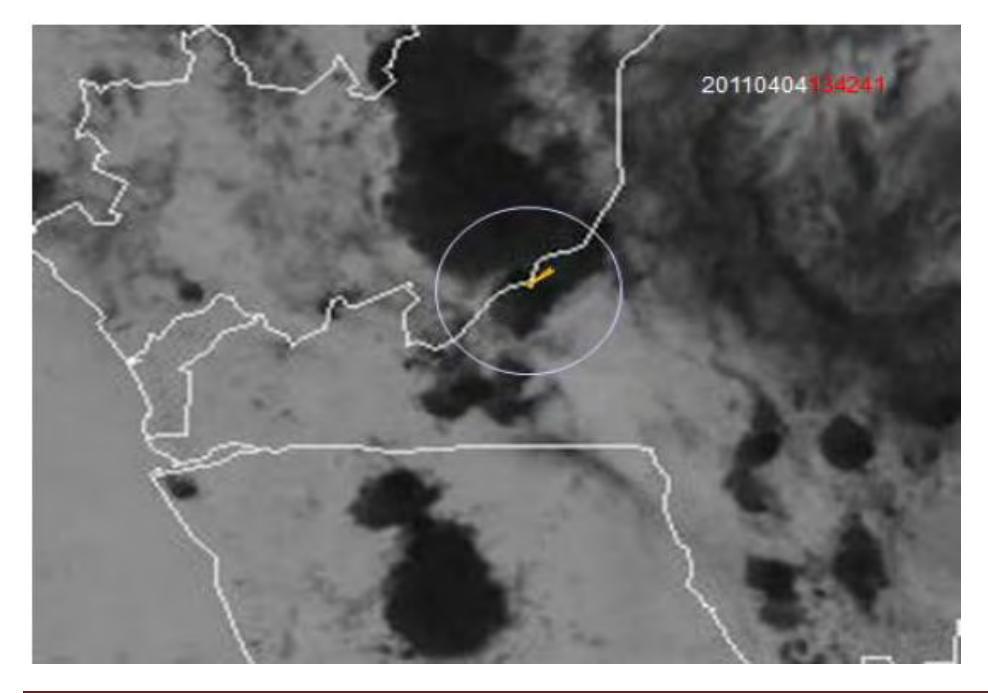
Above: EUMETSAT Infra Red photo of 1257 42 (about 50 seconds after the accident) showing Kinshasa airfield and Runway 24 Localizer Approach path (not to scale).

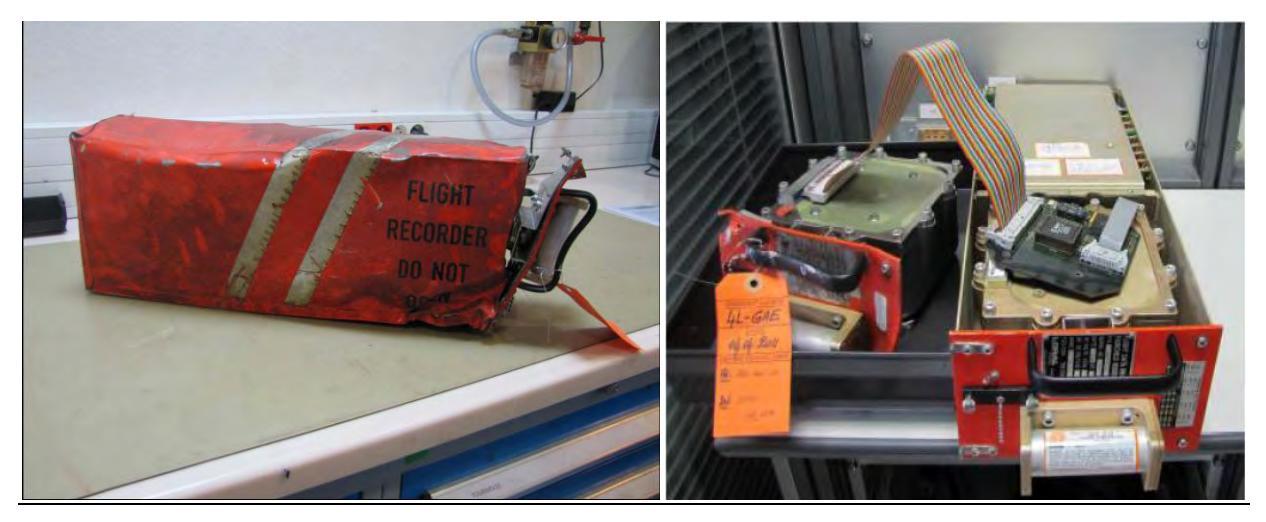
The aircraft was equipped with a Fairchild F1000 Flight Data Recorder and a L3 Com A200S Cockpit Voice Recorder. The recorders were deciphered at Bureau d' Enquetes et d'Analyses (BEA) at Paris in May 2011. Flight Data Recorder had suffered damage during the accident and direct download of data was not possible. BEA used alternate procedures to download data from the FDR. The data was later transferred electronically to Transportation Safety Board, Canada which took the lead in analysis of data,
