This document is based on the data collected on the circumstances of the accident, which then has been analysed for the investigation. The focus of the investigation of the tragic accident to GF-072 has been to establish what happened, to analyse how and why the occurrence took place, and from this analysis to determine what the occurrence reveals about the safety health of the aviation system. Such information is used to arrive at conclusions and make safety recommendations aimed at reducing or eliminating the probability of a repetition of the same type of occurrence, and where appropriate, to increase the overall safety of the aviation system.

## Executive Summary

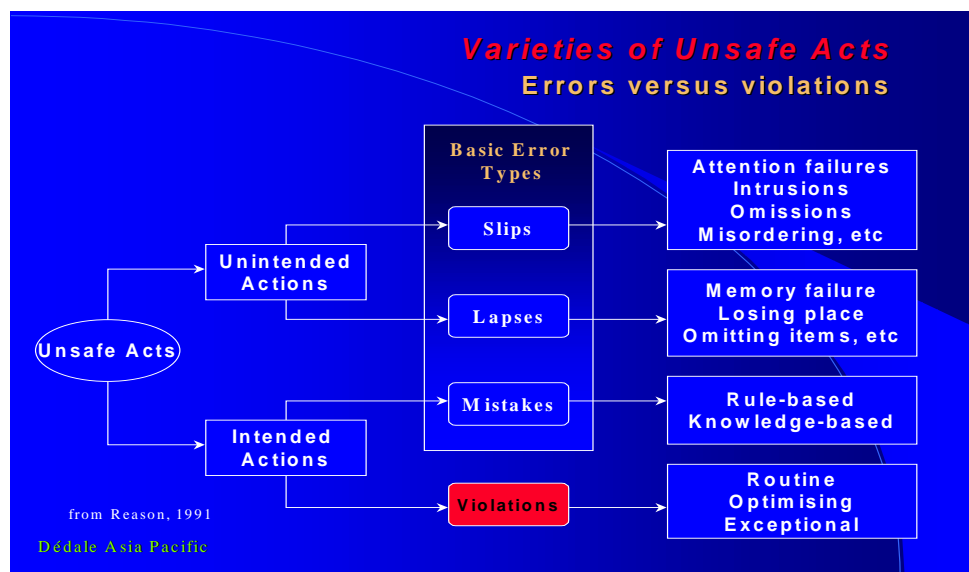
**Figure 10: Varieties of Unsafe Acts**

The Reason Model uses the term ‘unsafe acts’ to refer to decisions or actions which have an immediate effect on the safety of the operation. Unsafe acts can be further categorised in terms of ‘intended’ and ‘unintended’ actions. Intended actions can be either mistakes, or violations (see Figure 10).

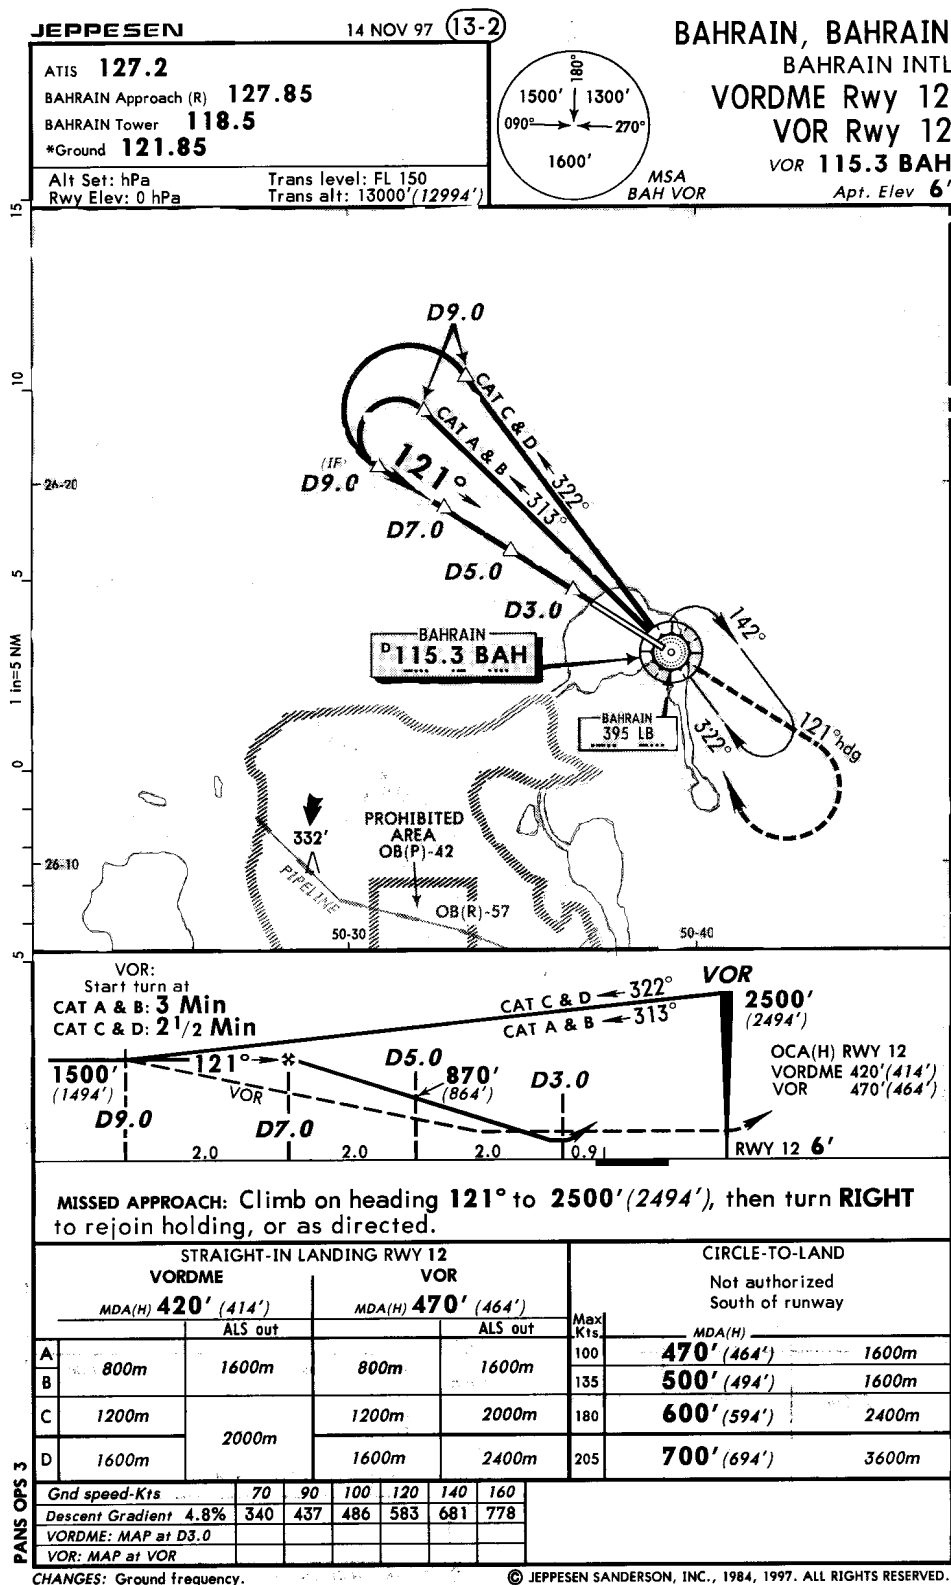
Figure 1: Instrument Approach Chart of Bahrain Runway 12 VOR/DME Procedure

This request was for a non-standard manoeuvre. The ATC "approved" the request, as there was no conflicting air traffic (aircraft) in the area. However, the ATC was not aware that GF-072 was "visual with the airfield", and in addition, GF-072 had not cancelled the instrument flight rule (IFR) condition. Consequently, the correct course for the ATC would have been to ask GF-072 to carry out a standard missed approach procedure; that is: "Climb on heading 121 degrees to 2500 ft (2494 ft AGL), then turn right to rejoin holding, or as directed". (see Figure 1: Instrument Approach Chart Bahrain Runway 12 VOR/DME). For the other analysis, refer to sections 2.4.2 and 2.6.
