ATSB TRANSPORT SAFETY REPORT
Aviation Occurrence Investigation AO-2008-053
Final

Oxygen cylinder failure and depressurisation
475 km north-west of Manila, Philippines
25 July 2008
Boeing Company 747-438, VH-OJK

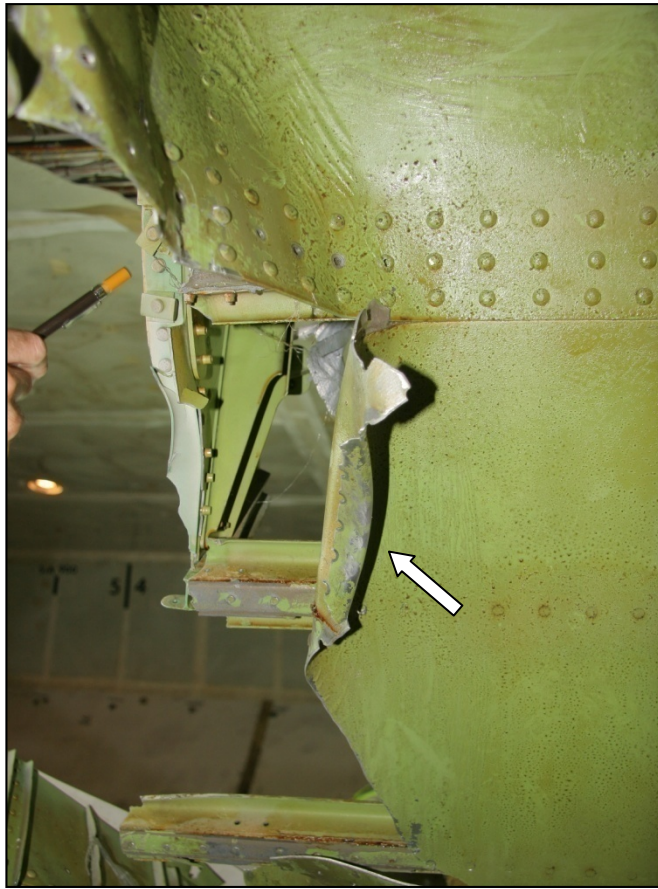
Figure 6: Oxygen cylinder held against skin fold to illustrate conformance

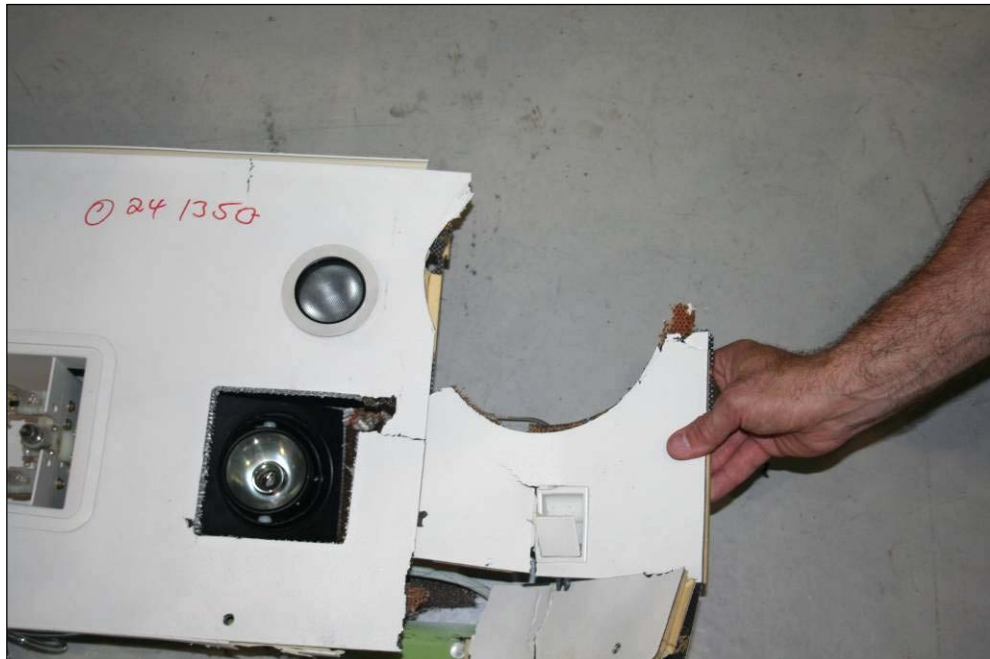
Figure 24: Overhead panel cut-out section recovered from the structure above the R2 door

Cylinder impacts overhead panelling end-on, producing circular cut-out type damage – see Figure 23 to Figure 25

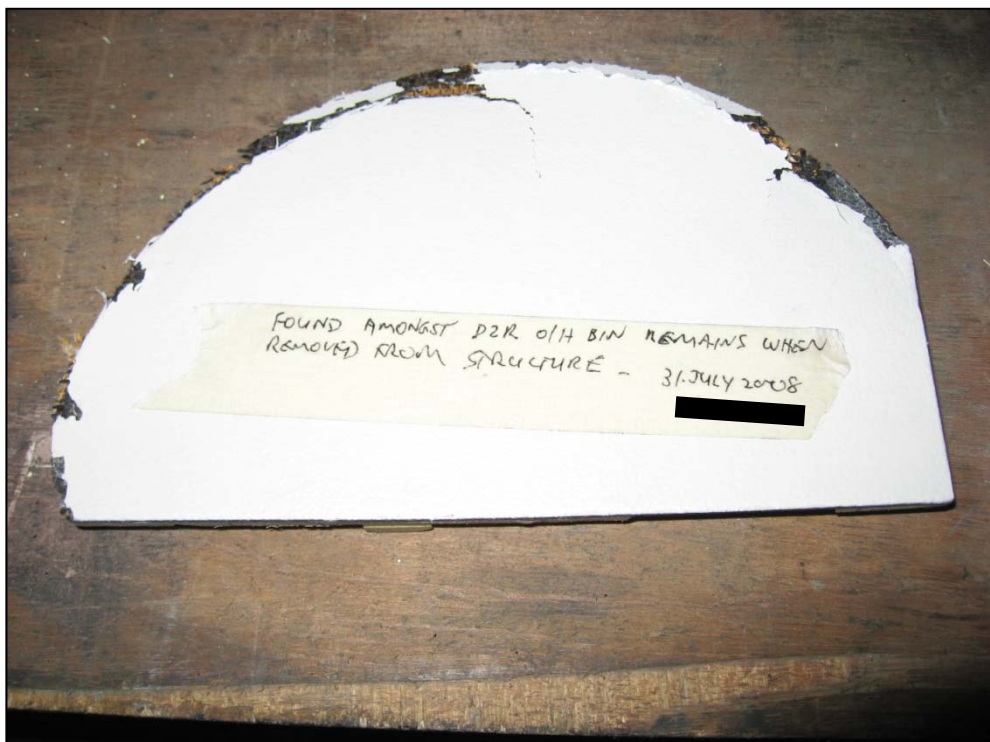
Figure 25: Panel with cut-out placed against another oxygen cylinder to illustrate the conformance in diameter

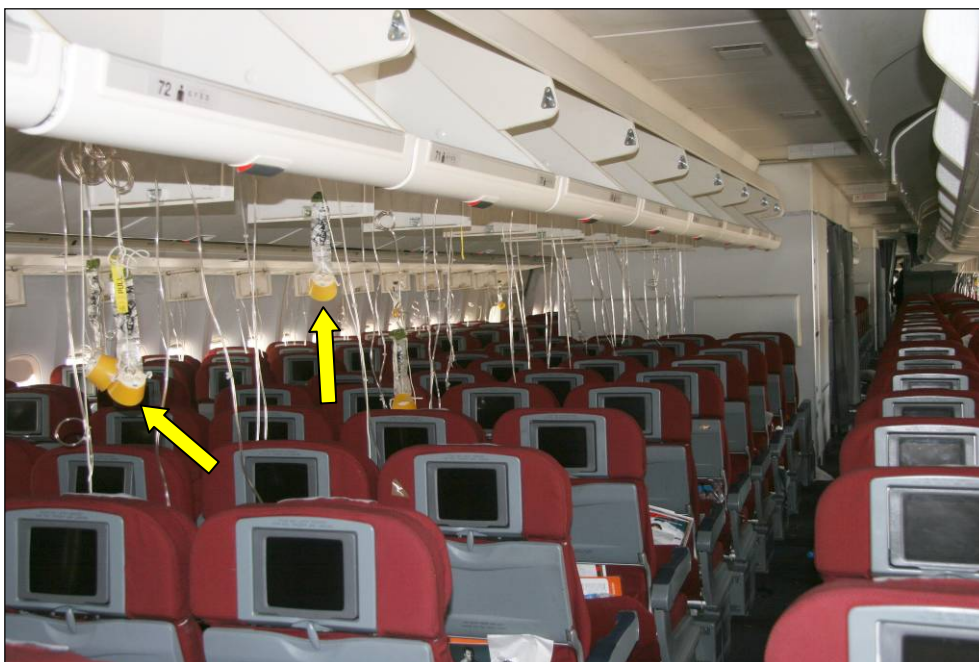
In the cabin crew positions, a total of 26 masks were found deployed, with 16 activated. Of the 19 portable oxygen cylinder/mask units, six were found with indications of use; the cylinders being either empty or with pressures less than their ‘full’ value of 1,850 psi.

Figure 26: Typical appearance of the cabin after arrival in Manila. Note the passenger masks dropped and activated, and those dropped and not activated (arrowed)

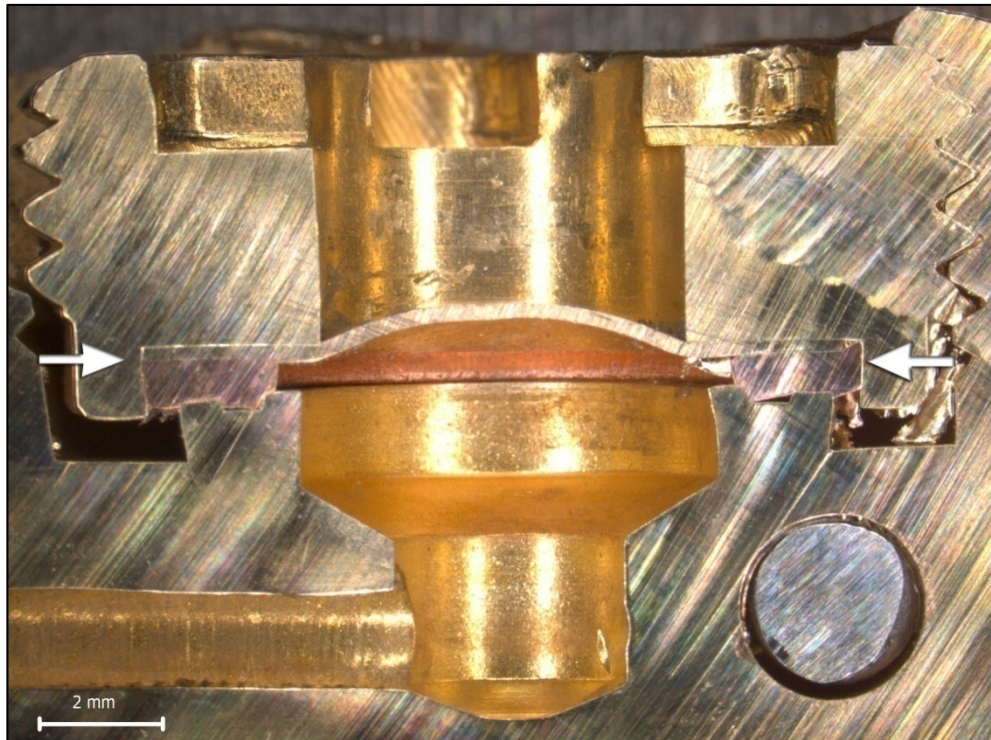
- the cylinder valve was fully opened at the time of failure
- witness marks and fracture features exhibited by the valve body were consistent with blunt impact and tensile/bending forces
- there was no evidence that the valve assembly had been exposed to a significant overpressure condition. The frangible (burst) disk within the valve was intact (Figure 41) and comparable in appearance to other serviceable items

Figure 41: Transverse section through the frangible disk (arrowed) and retaining assembly from the number-4 cylinder. The outward curvature is typical of normal service.

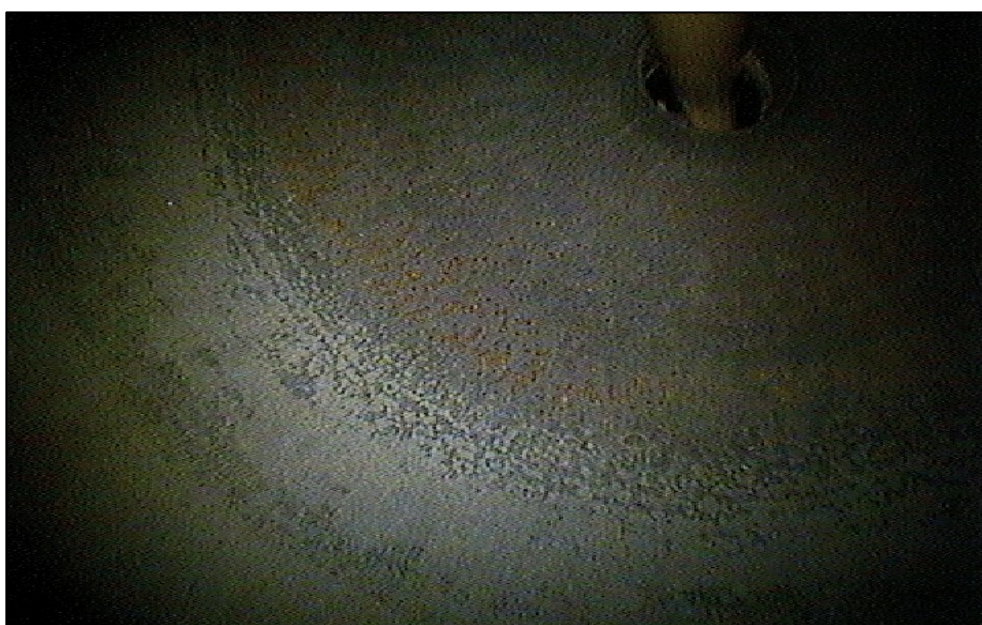
Internally, all cylinders were essentially free from any visible evidence of active pitting or general corrosion attack. Superficial corrosion staining and/or light surface deposits were evident in some cylinders (Figure 47), with the most visible areas around the upper dome and neck transition regions. One cylinder (S/N 535626) showed an irregular linear feature extending from the upper dome to part way along the cylindrical body (Figure 48). That cylinder was subsequently selected for sectioning and destructive examination to facilitate the characterisation of that feature and the general metallurgical condition.

Figure 47: Internal endoscopic view of the upper dome and neck region of cylinder S/N 535571

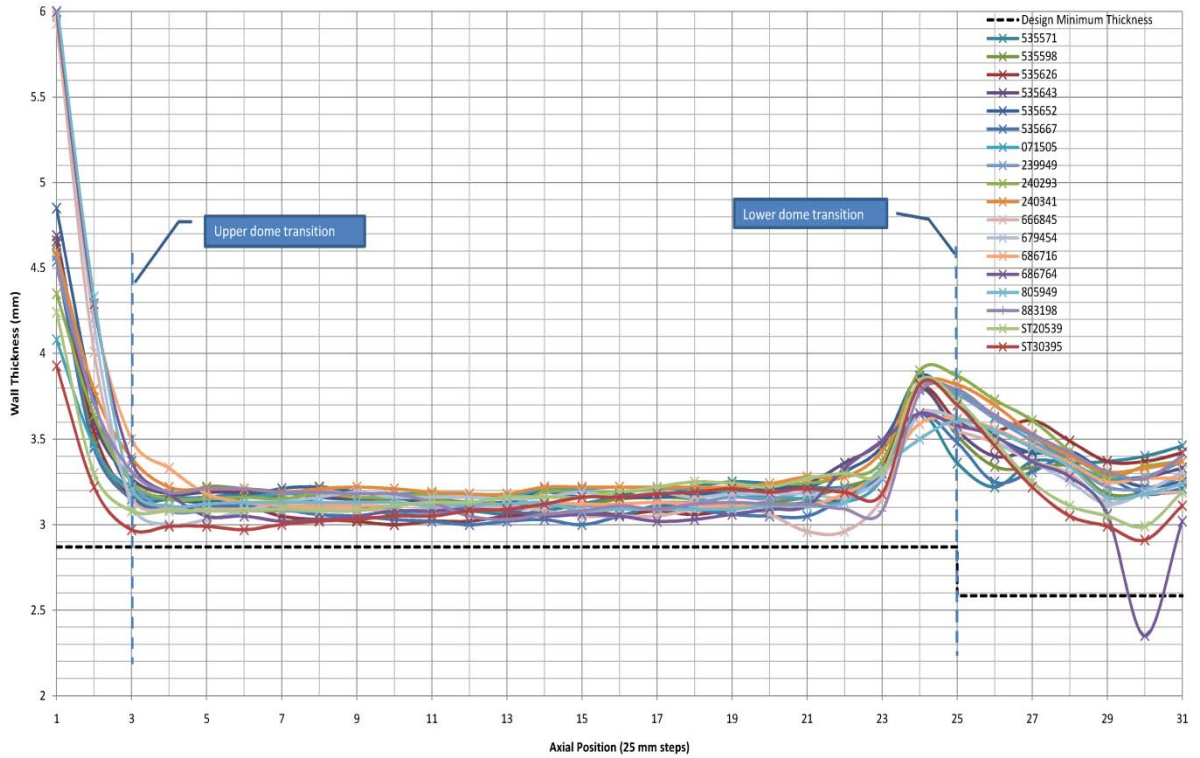
Figure 49 presents the results of the thickness survey, with the broken line below representing the design allowable minimum cylinder thicknesses for the cylindrical section (2.87 mm, 0.113 in) and the lower dome (2.58 mm, 0.102 in).

Figure 49: Graphical presentation of cylinder wall thickness measurements

Of the cylinders examined, only cylinder S/N 686764 showed a thickness value below the specified minima – a single location towards the centre of the lower dome. To further evaluate, a comprehensive survey was subsequently conducted over 100% of the lower dome surfaces of this cylinder. From that work, it was evident that the non-compliant area was restricted to a partial ring-shaped region approximately 20 to 40 mm (0.79 to 1.57 in) from the centre of the dome. Figure 50 and Figure 51 present the results of this work in conditionally-formatted tables.

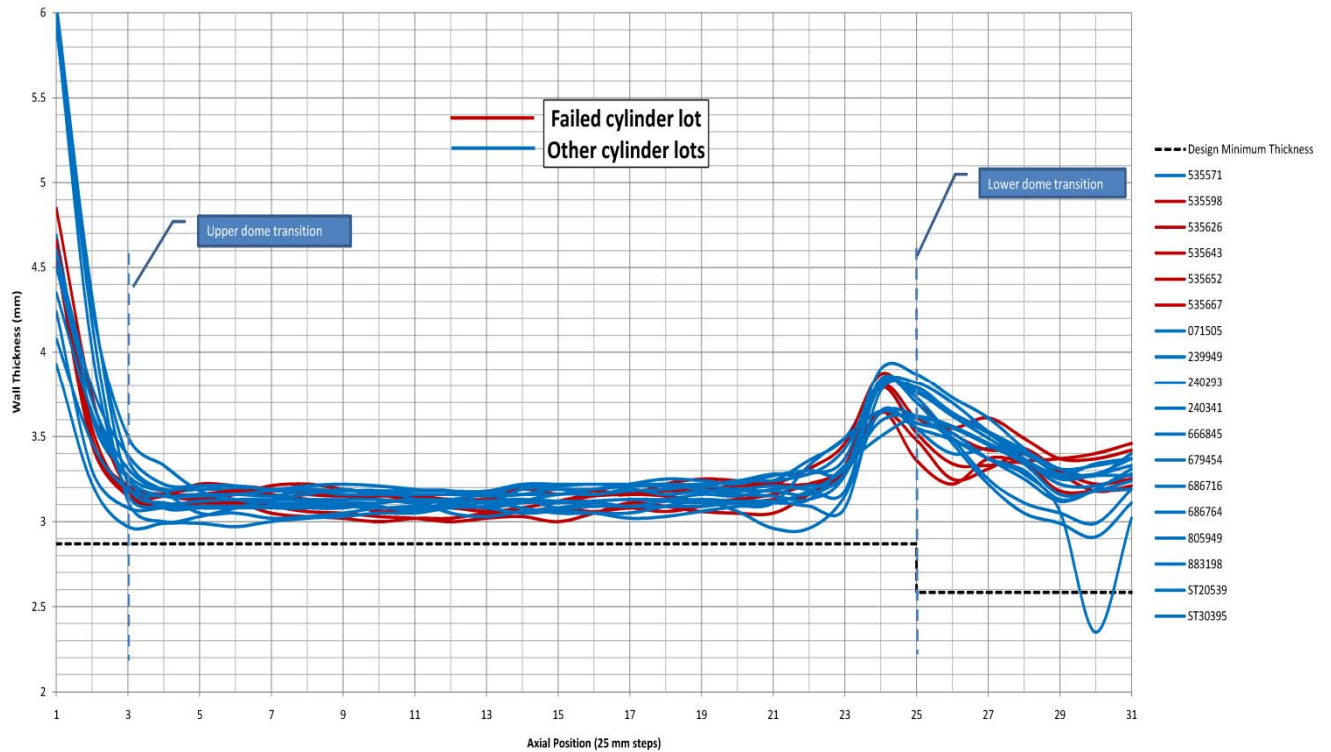
A comparison of the measured thicknesses of the cylinders from the same production batch as the failed item, against the other examined cylinders (various batches) showed no notable variation from the range of typical values presented (Figure 52).

Figure 52: Comparison of thicknesses from the failed cylinder batch, against the total lot examined

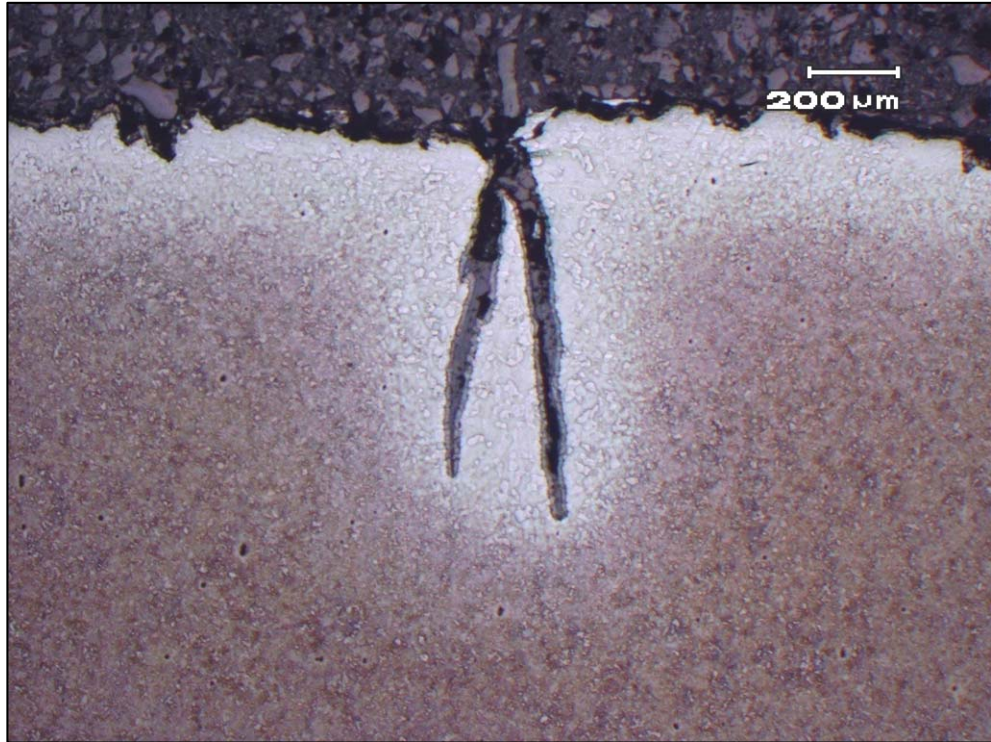
Figure 56: Largest of the internal surface intrusions identified around the cylinder neck transition

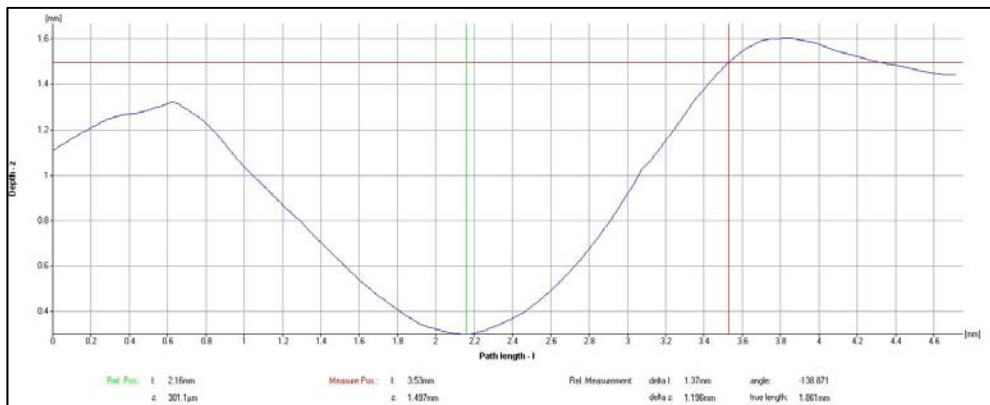
Of the stamped areas examined after removal of the surface paint coatings, the deepest impression (Figure 58) measured 1.196 mm (0.047 in), and presented a smooth, uniformly curved base profile (Figure 57). The typical depth of impression ranged from 0.4 to 0.8 mm (0.016 to 0.031 in), and all were smooth and uniformly formed in profile.

Figure 57: Profile form and measurements of a cylinder stamp marking

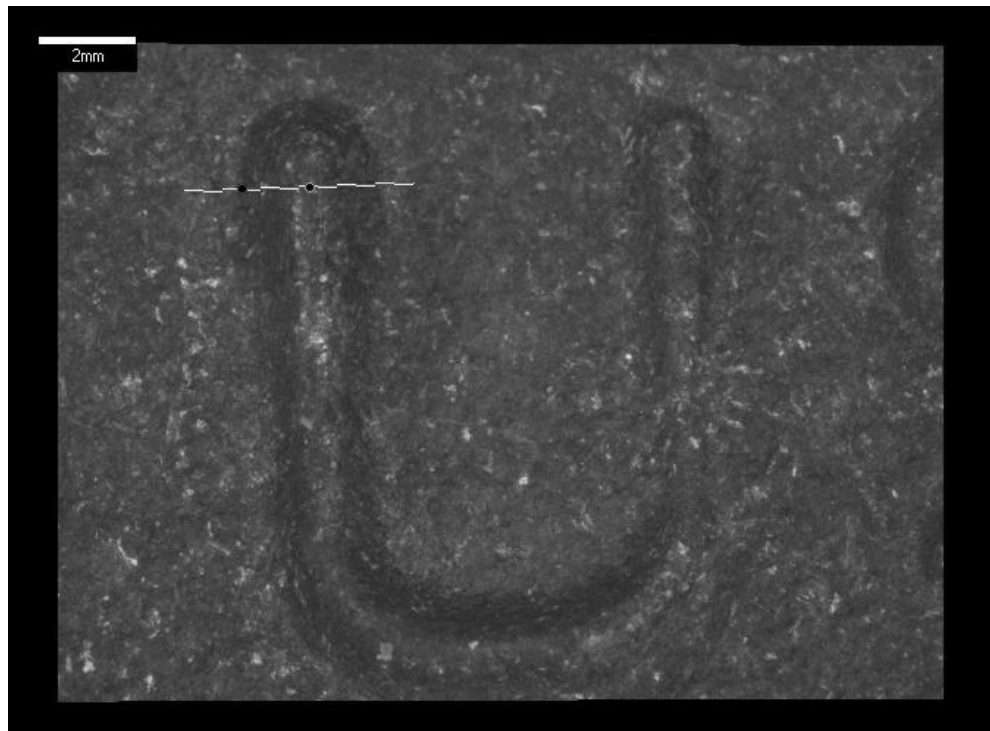
Figure 58: Cylinder stamp marking (letter 'U') with plane of profile measurement shown

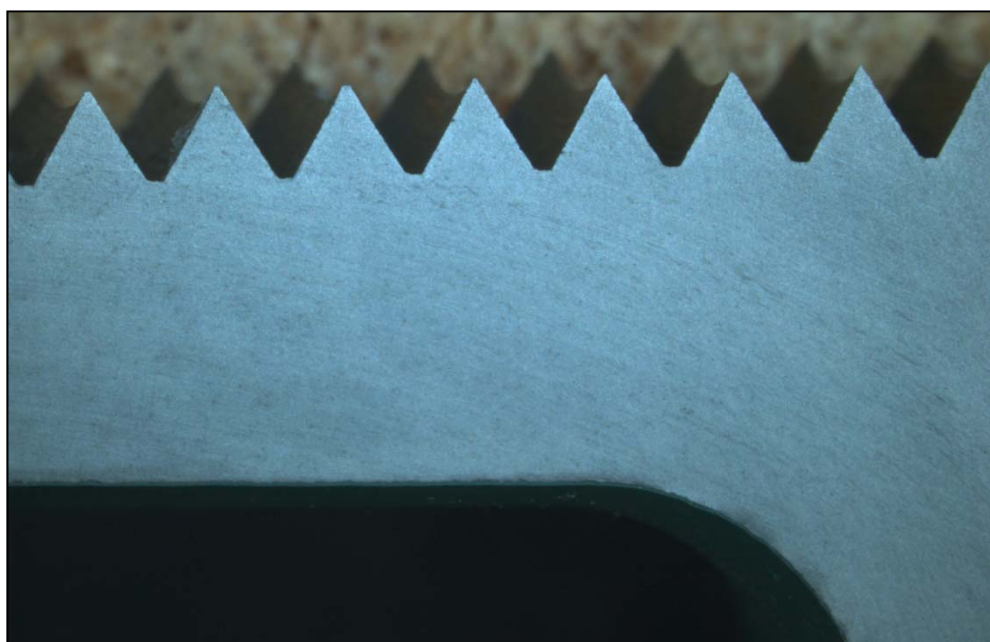
The cylinder manufacturing specification required the neck threads to be even, clean-cut and without cracks. To assess, a series of sections were taken longitudinally through the threaded neck of cylinder S/N 535626 and prepared for microscopic study. When examined in profile (Figure 59), the cylinder threads appeared fully-formed, with no evidence of cracks, tears or mal-formed areas.

Figure 59: Cylinder neck thread profile

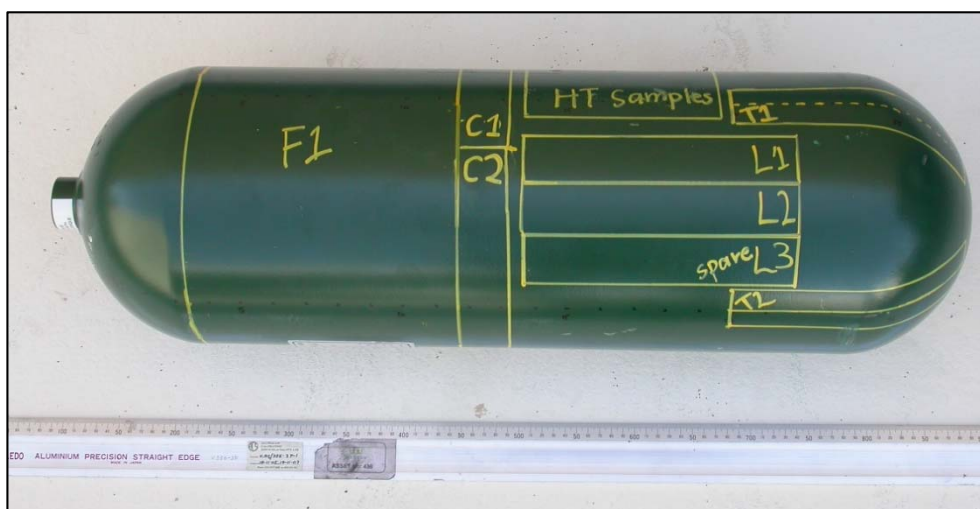
A single flattening test as described in section I of CFR Title 49 §178.44, was prepared and tested from the upper cylindrical section of the cylinder (the location marked F1 in Figure 60). When flattened between opposing knife edges having a 60° included angle and 12.5 mm (0.5 in) edge radii, the specimen cracked longitudinally (Figure 61) at a knife edge separation of approximately 60 mm (2.4 in). As such, the test did not comply with the requirements specified by CFR Part 49 §178.44 section (p)(1), which stipulated *'flattening required without cracking to ten times the wall thickness of the cylinder'* (28 mm / 1.13 in).

A repeat of the flattening test (using a non-standard 25 mm / 1 in wide specimen) also failed to comply with the specification requirements – exhibiting cracking and surface tearing across one of the stressed surfaces.

Figure 60: Cylinder S/N 535652 with locations of mechanical test specimens marked. L, T & C are the longitudinal, transition and circumferential tensile test specimens, F1 the flattening test specimen

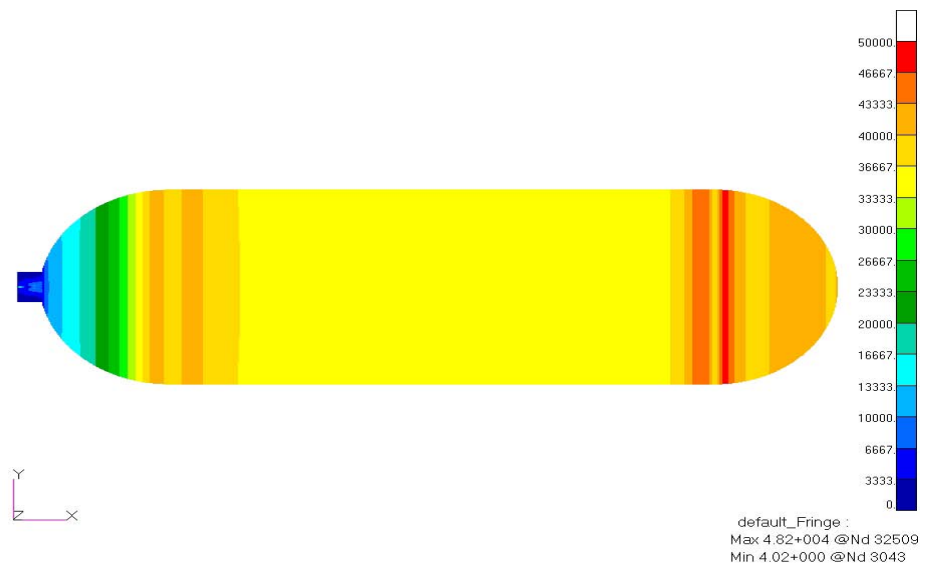
Taking into consideration the allowable reduction in wall thickness within the lower hemisphere (90% of the minimum cylindrical thickness), the FEM analysis revealed the presence of elevated peaks in the longitudinal stress field associated with the transition region between the cylindrical and lower hemispherical sections (Figure 66 and Figure 67). The peak longitudinal stress in this region was 45.9 ksi (316.5 MPa); a factor of 1.3 times the average longitudinal stress in the main body of the cylinder.

Figure 66: Stress distribution within the cylinder. Peak stress is shown in red

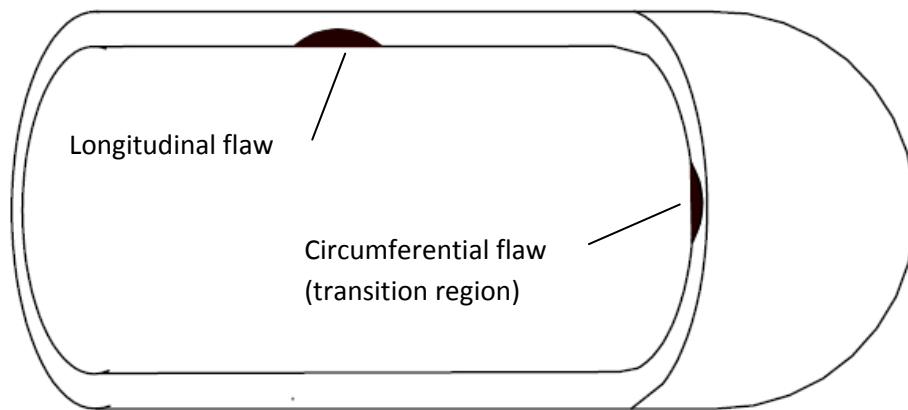
Figure 68: Cylinder flaw locations considered

Two potential locations were considered for the possible presence of critical semi-elliptical flaws within the failed cylinder (Figure 68):

- the inner surface longitudinal flaw within the cylindrical (main body) of the cylinder
- the inner surface circumferential flaw within the transition region between the main body and the lower hemispherical end of the cylinder.

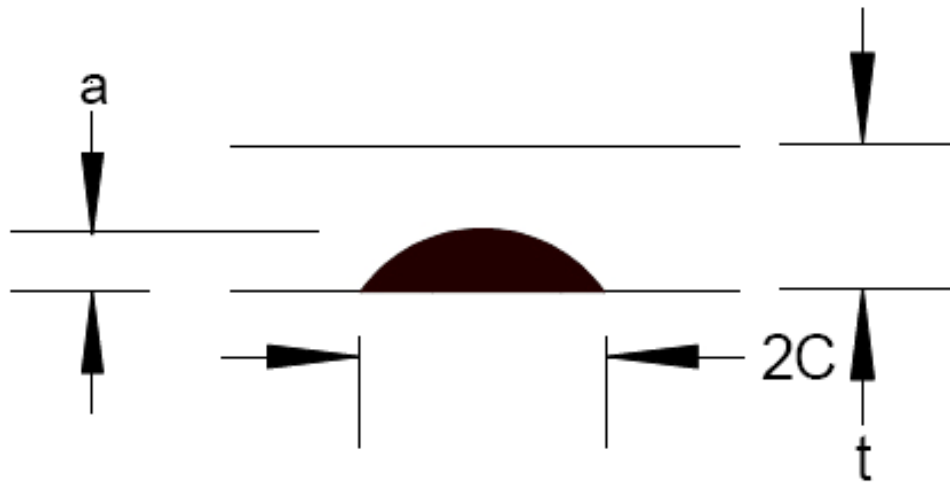
Figure 69: Dimensional illustration of the surface flaws considered

Through the preparation of residual strength diagrams that demonstrate the relationship between flaw size and pressure vessel stress, a conservative representation of critical sizes for semi-elliptical flaws (Figure 69) of various aspect ratios³⁵ was prepared for two nominal values of fracture toughness (K_{IC}) of the shell material (50 / 75 ksi $\sqrt{\text{in}}$).

The analysis results illustrated the key role played by aspect ratio in establishing the critical flaw size, with lower aspect ratio (longer, shallower) flaws proving more critical. From the results presented in Table 18 and Table 19, it was shown that the most significant (i.e. smallest) flaw that could present as critical to the integrity of the cylinder type at its working pressure (1,850 psi), was a longitudinal defect with a depth of 0.048 in (1.22 mm) and length of 0.478 in (12.1 mm), when evaluated using a limiting material fracture toughness of 50 ksi√in. The smallest circumferential defect (at the lower dome transition) that could lead to failure, was one with a depth of 0.078 in (2.00 mm) and length of 0.780 in (19.8 mm).

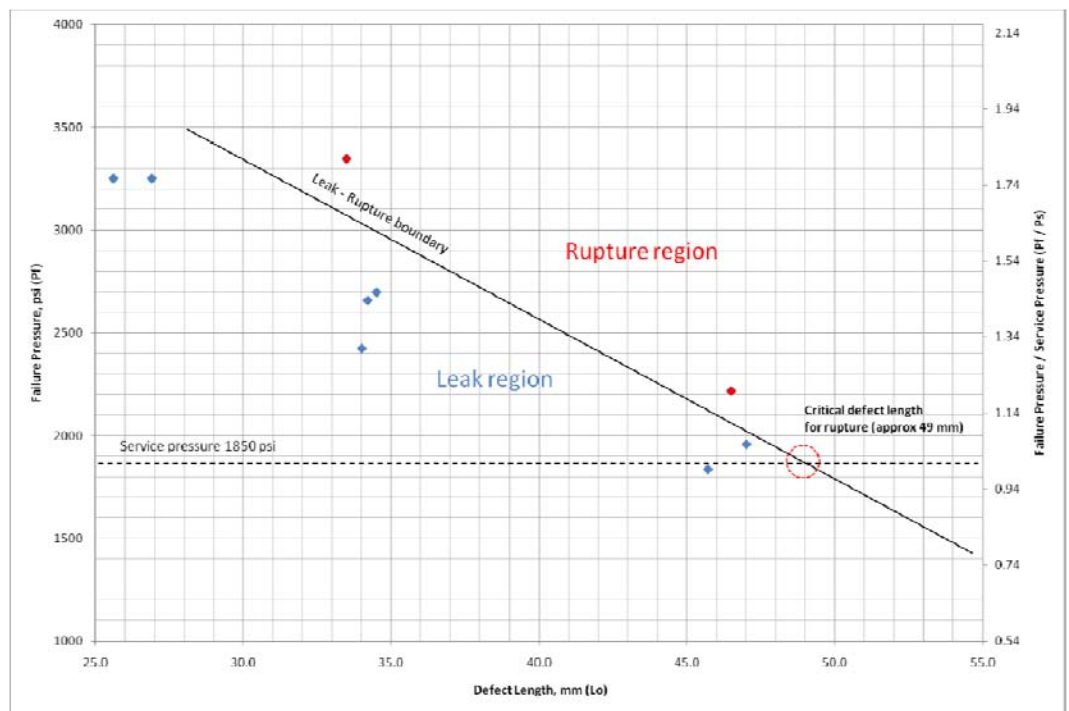
Figure 71: Graphical representation of failure pressure against defect length and failure mode

Table 20 presents a summary of the test results (failure pressure and failure mode) against the dimensions of the flaw at which failure occurred. Figure 71 and Figure 72 present the test results graphically, with the Leak – Rupture boundary fitted to the data set.

From an extrapolation of the Leak – Rupture boundary, the critical defect length for failure by rupture at 1,850 psi was estimated at approximately 49 mm (1.93 in). A similar technique applied to assess critical flaw aspect ratio returned a nominal value of 0.096, which represents a flaw depth of around 2.3 mm (0.09 in).

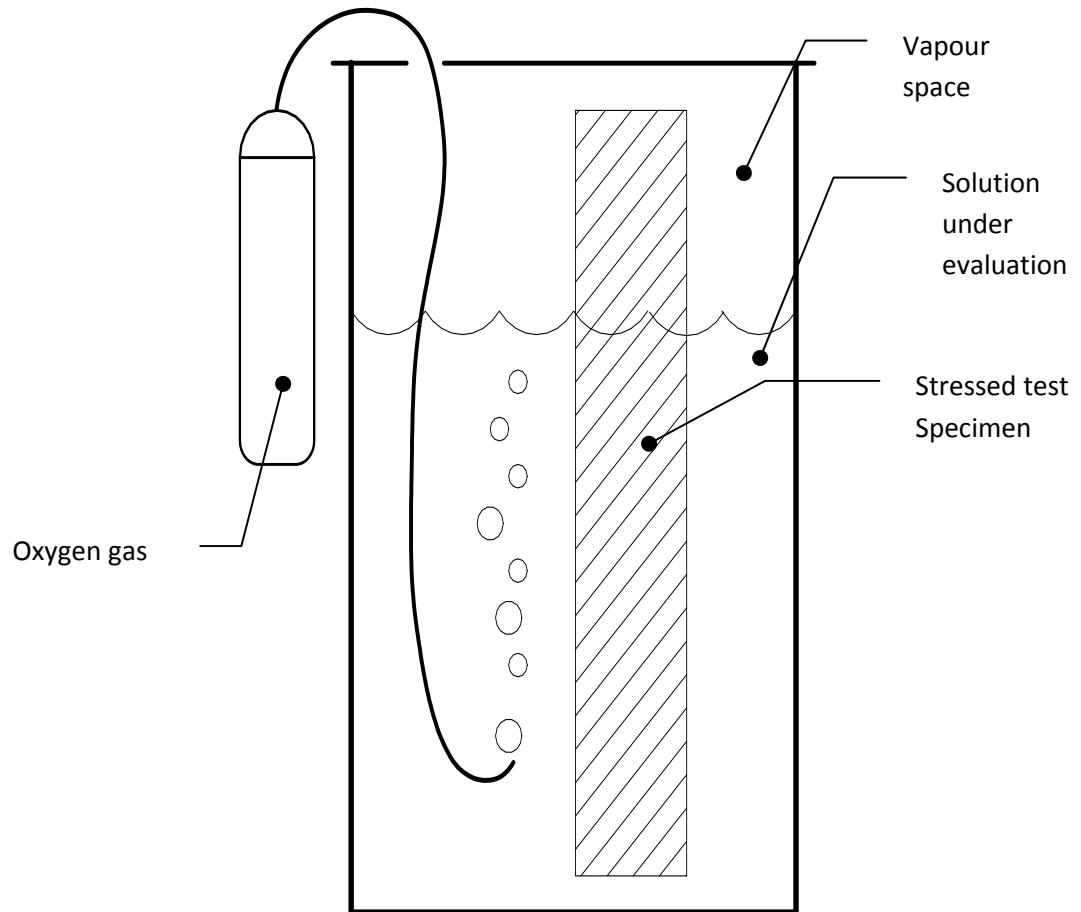
Figure 73: Environmental exposure testing arrangement

The environmental testing program consisted of placing suitably-prepared and pre-stressed⁴⁰ specimens into solutions of Isopropyl alcohol, Lenium GS[®] and A-Gasol[®]. The solutions were saturated by continuously bubbling a stream of oxygen through the liquid and into the vapour space above. Figure 73 illustrates the test arrangements.

During the exposure there was no visible change in the appearance of the specimens or the condition of the test solutions. Upon removal and microscopic scrutiny of the exposed surfaces, evidence of possible corrosion activity was noted. However, subsequent metallographic (microscopic) and physical testing showed no changes in the bulk material condition or ductility, and no significant differences between the exposed specimens and a control sample of the cylinder material.

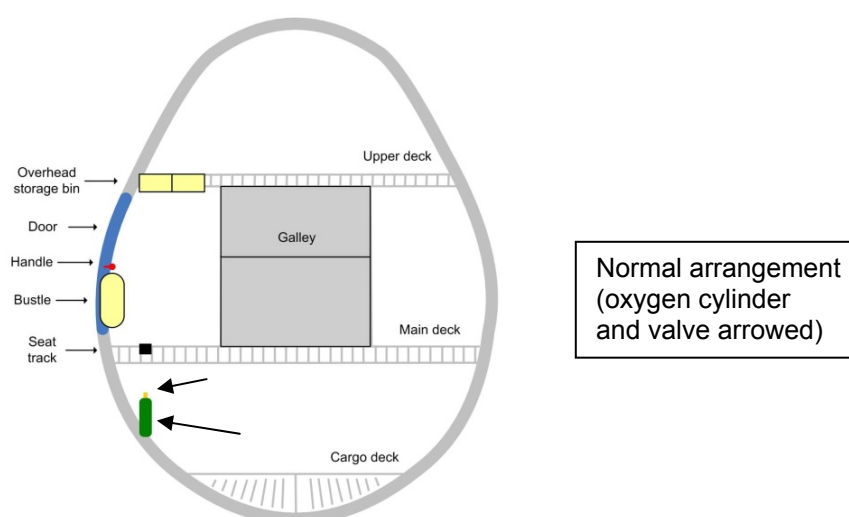
Figure 74: Cross-sectional representation of the aircraft at the R2 door

From the collection of physical evidence, a picture of the likely trajectory followed by the cylinder was developed, and is illustrated in Figure 74 through to Figure 80 following.

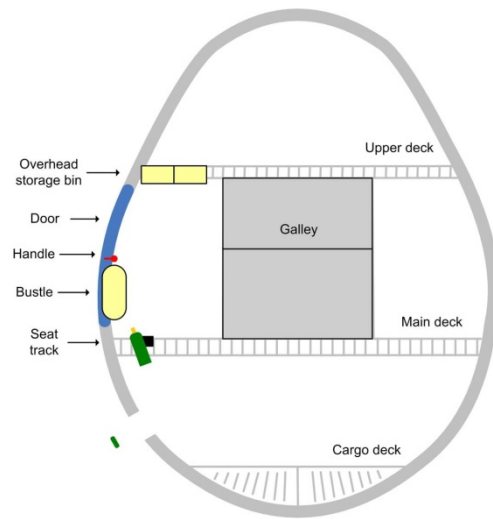
Figure 75: Trajectory sequence 2

Cylinder failure produces fuselage rupture, with the bulk of the cylinder length propelled upward through the cabin floor - see Figure 19

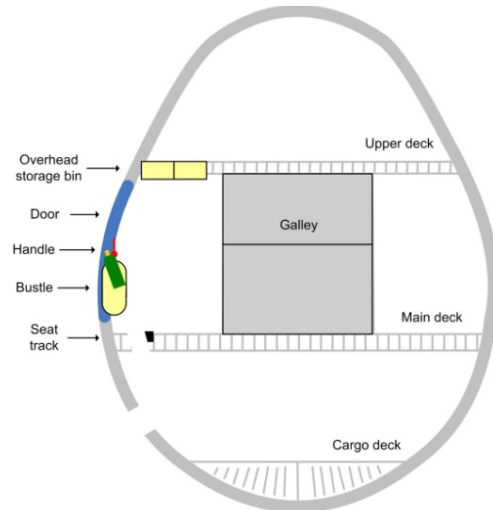
Figure 76: Trajectory sequence 3

Cylinder impacts R2 door frame and internal door handle - see Figure 20

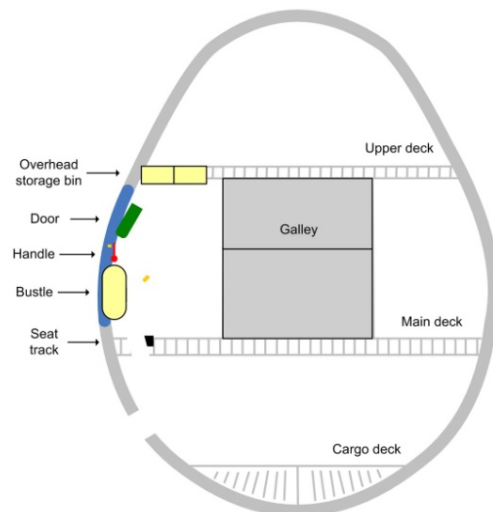
Figure 77: Trajectory sequence 4

Door frame impact breaks off cylinder valve and causes cylinder to invert while continuing to travel upward

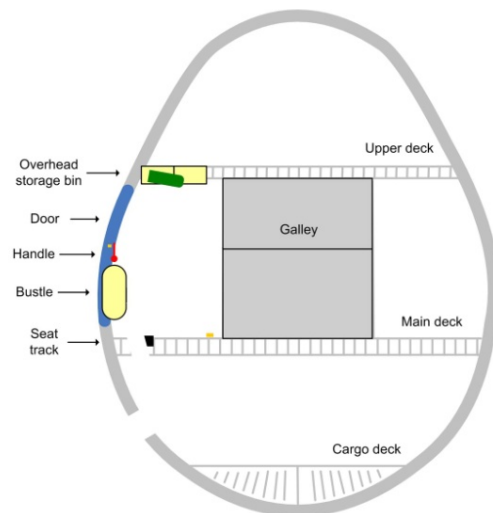
Figure 79: Trajectory sequence 6

Still rotating cylinder impacts overhead storage bin, producing semi-circular crushing damage – see Figure 26

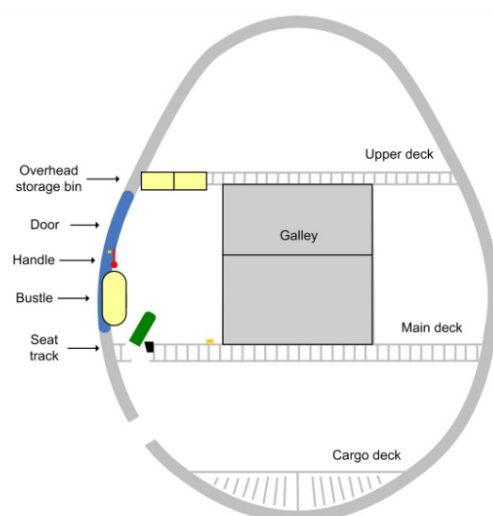
Figure 80: Trajectory sequence 7

Cylinder falls to cabin floor and exits the aircraft through the ruptured fuselage

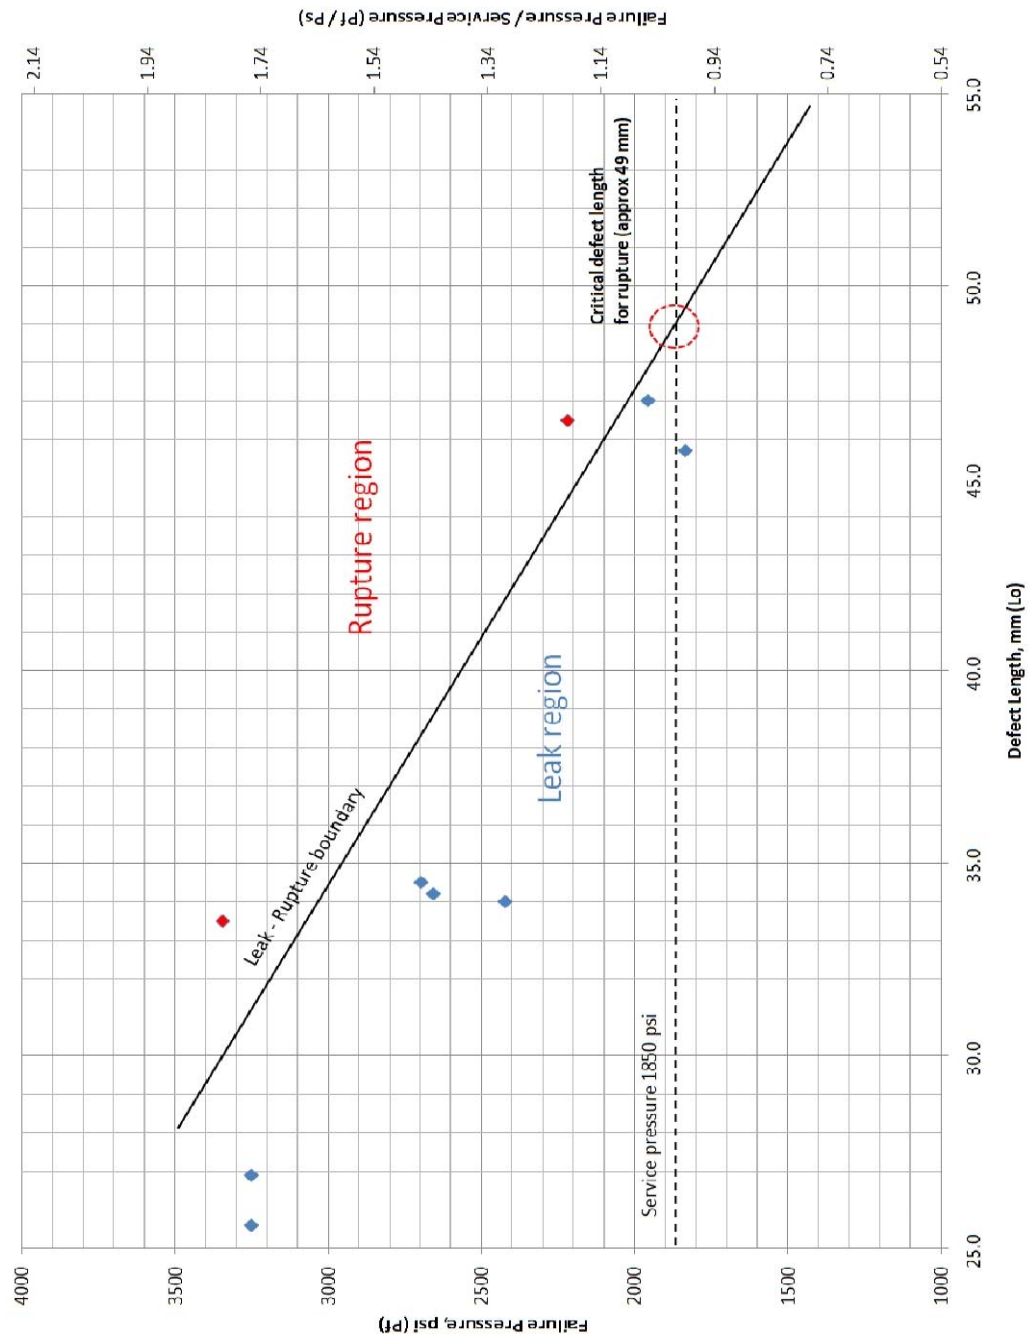
Figure A8: Graphical representation of test results

The results presented in Table A6 were plotted as failure pressure against defect length, and illustrate the general behaviour of the cylinder type, when pressurised in the presence of localised, axially-oriented physical defects (Figure A8).

From the graphical representation of the test results, it was possible to establish an approximate Leak – Rupture boundary, and from that, a nominal estimation of the defect length required to induce failure by rupture at the cylinder service pressure (1,850 psi). From the graph, that length was around 49 mm (2 in).

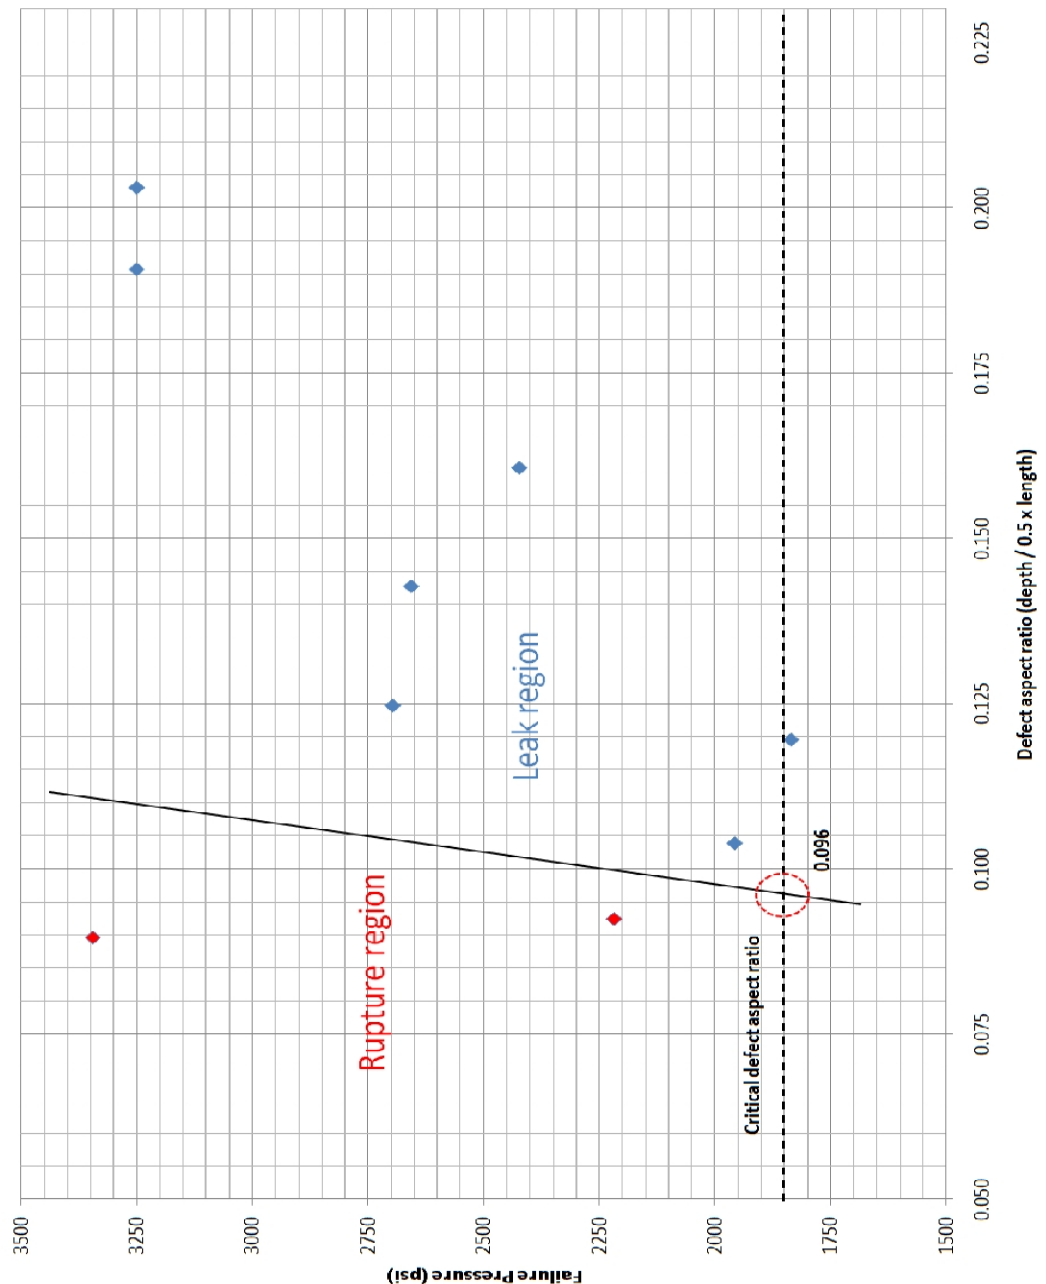
Figure A9: Graphical representation of flaw aspect ratio against failure pressure and mode

Given that defects are two-dimensional (i.e. have length and depth), the test data was examined to establish a relationship between failure pressure, failure mode and defect aspect ratio. Figure A9 illustrates this relationship.

While the number of data points available has limited the accuracy of the Leak-Rupture boundary line fitted to the Flaw Length and Aspect Ratio graphs, the estimates obtained for those parameters at the nominal service (operating) pressure of the cylinder type (1,850 psi) were considered valid, and indicative of the magnitude of a physical flaw that could produce failure by rupture at that pressure.

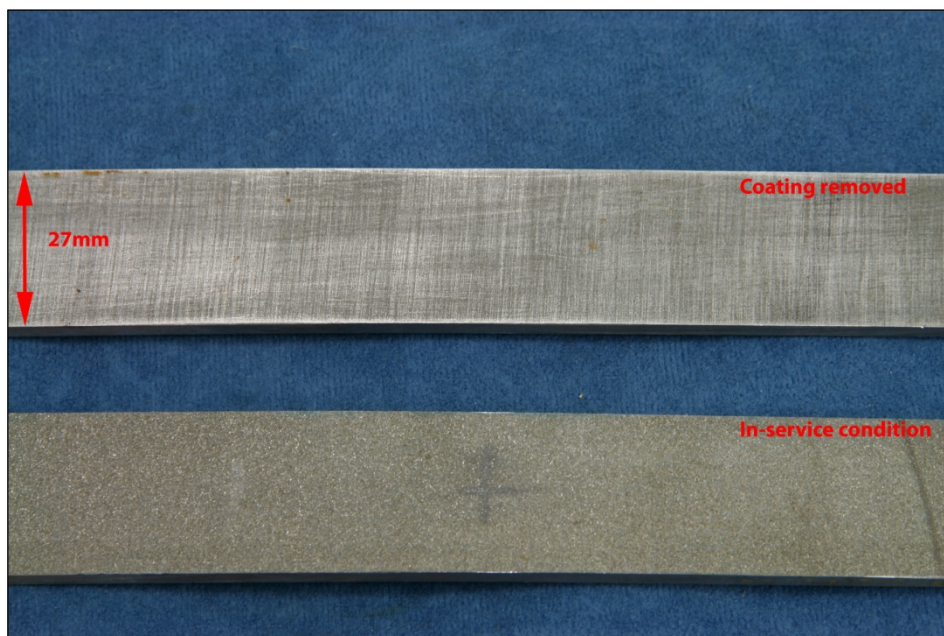
Figure B4: Samples removed from the Lenium GS® solution showing centre of sample under the highest tensile stresses

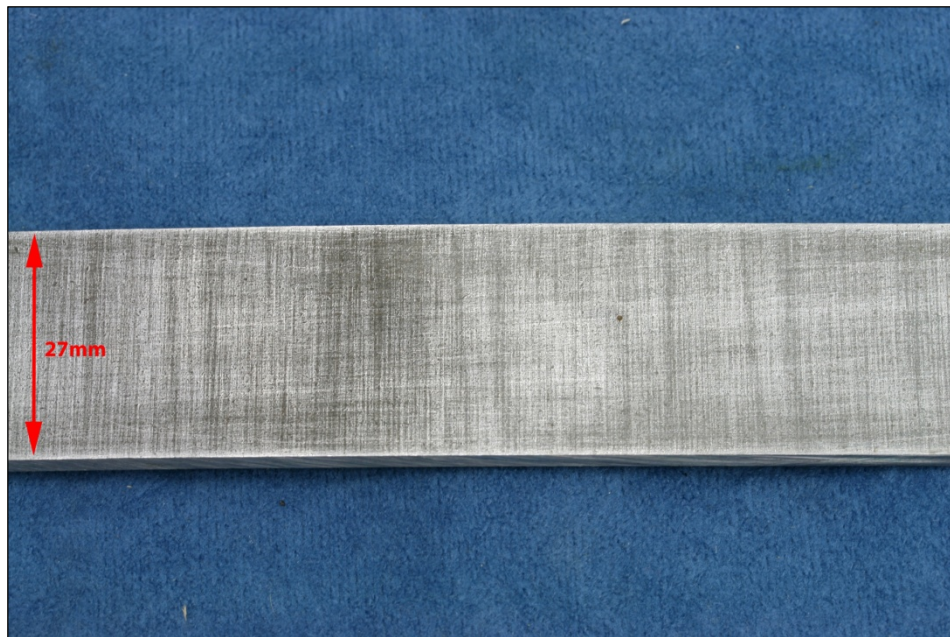
Figure B5: Centre of de-coated sample removed from the A-Gasol[®] solution. Samples from all test solutions displayed similar characteristics

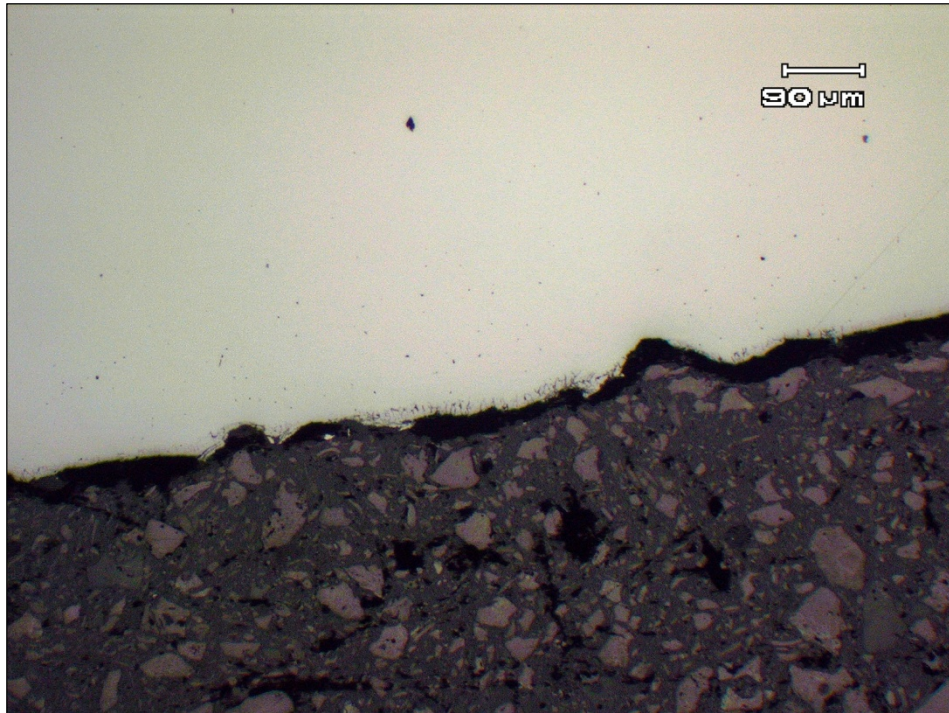
Figure B7: Micrograph of de-coated sample removed from Lenium GS upon conclusion of testing. Sample is in the un-etched condition

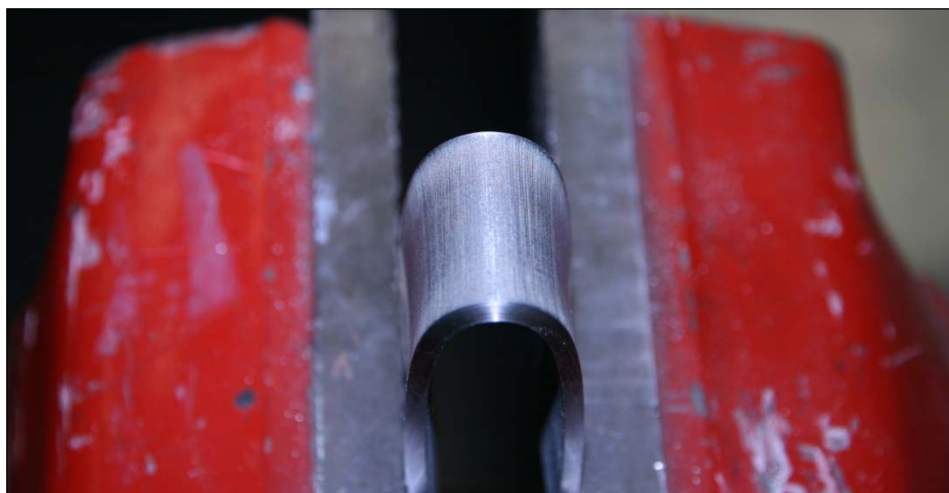
Figure B10: A-Gasol[®] sample during bend testing

All samples tested achieved the full bend, (Figure B10) with no cracking, tearing or other indications of reduced ductility, when observed both unaided and under the stereo-binocular microscope.
