SERIOUS INCIDENT

Aircraft Type and Registration:	Boeing 777-236, G-YMMP	
No & Type of Engines:	2 Rolls-Royce RB211 Trent 895-17 turbofan engines	
Year of Manufacture:	2001	
Date & Time (UTC):	14 June 2010 at 1617 hrs	
Location:	Singapore International Airport	
Type of Flight:	Commercial Air Transport (Passenger)	
Persons on Board:	Crew - 12	Passengers - 202
Injuries:	Crew - None	Passengers - None
Nature of Damage:	Extensive damage at rear of right engine nacelle and further airframe damage	
Commander's Licence:	Airline Transport Pilot's Licence	
Commander's Age:	44 years	
Commander's Flying Experience:	14,770 hours (of which 4,934 were on type) Last 90 days - 192 hours Last 28 days - 79 hours	
Information Source:	AAIB Field Investigation

Synopsis

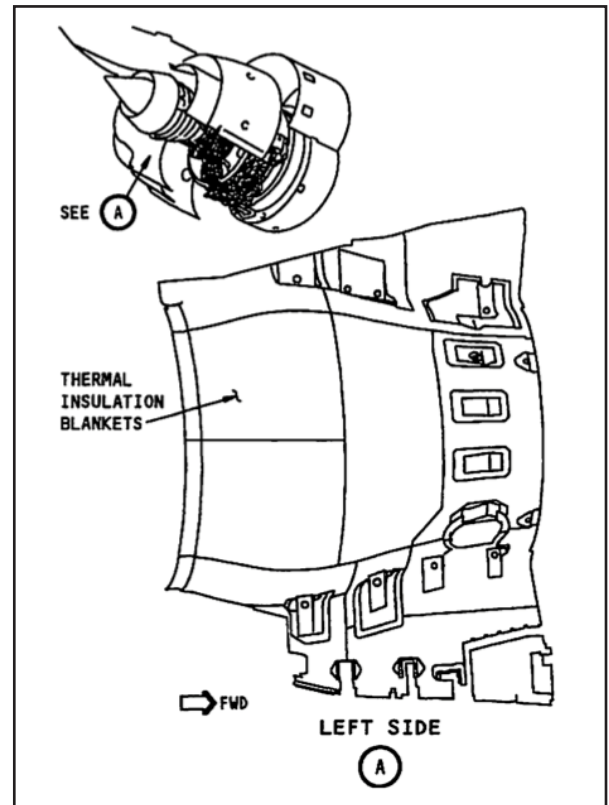
Figure 2

The inner wall of the fan duct cowl (Figures 2 and 3) is a composite material susceptible to;

'radiant heat damage from fires and [normal] engine operation'

Thrust reverser thermal barrier in fan duct cowl
(courtesy Boeing)

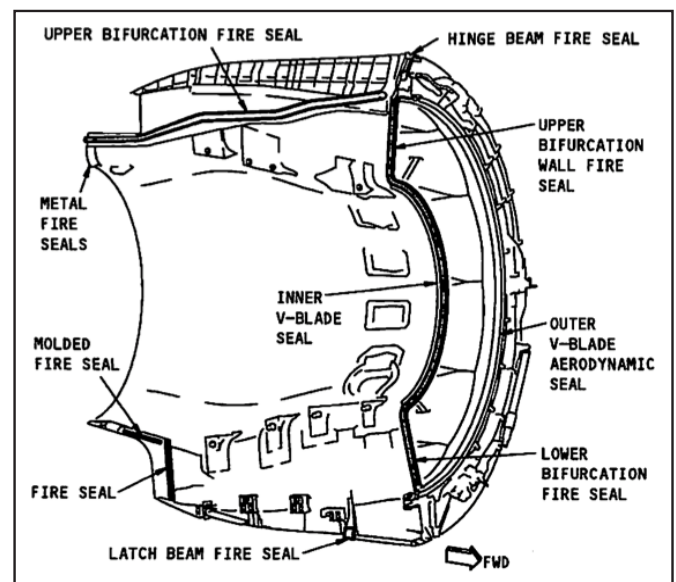
Figure 3

Location of thermal blanket seals in fan duct cowl
(courtesy Boeing)

without the thermal barrier. The barrier consists of thermal insulation blankets installed in the area bounded by the fire seals in Figure 3.

The integrity of the blanket-to-blanket seal, the blanket penetration seals and the blanket edge seals is critical to the success of the thermal barrier protection and to the preservation of the structural integrity of the thrust reverser inner wall. The maintenance manual states that large amounts of hot (leaked) compressor air:

'can penetrate through the gaps between the overlapped blankets to cause convective heat damage to the T/R inner wall'

'important to find any holes in the bleed offtake pneumatic ducts, or gaps at pneumatic duct connections, or damaged kiss seals and kiss seal mating surfaces during engine visual inspections.'

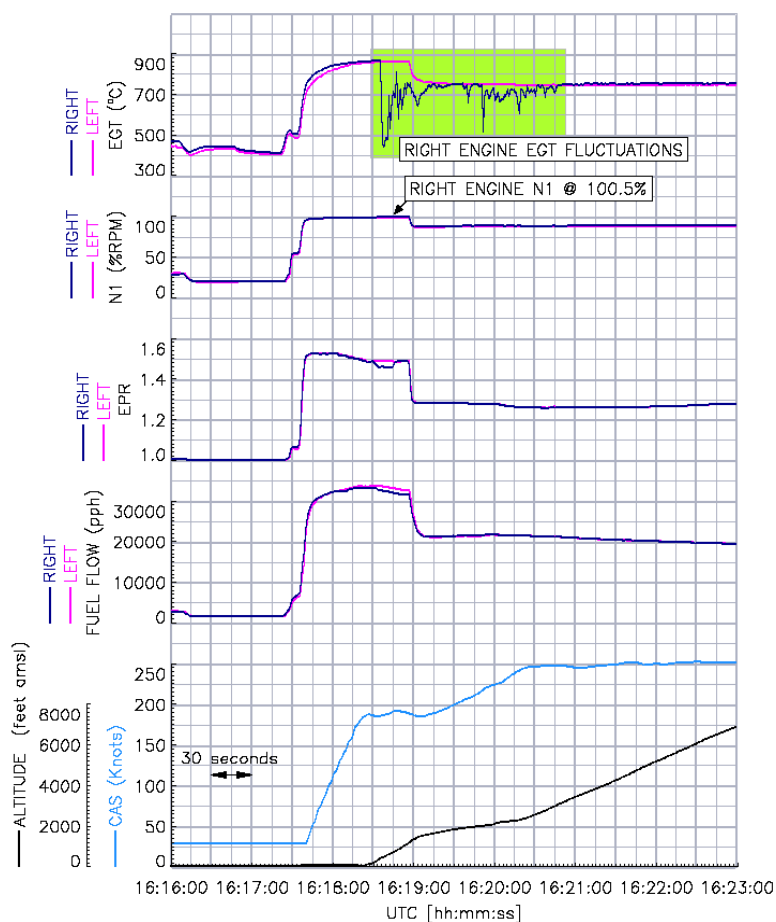
Data downloaded from the flight data recorder (FDR) for the incident flight is presented in Figures 4 & 5. Figure 4 shows the takeoff and climb to 7,000 ft amsl from Singapore International Airport. At 1618:35 hrs, as the aircraft climbed through 500 ft, the right engine

FDR data for the takeoff, showing right engine fluctuations

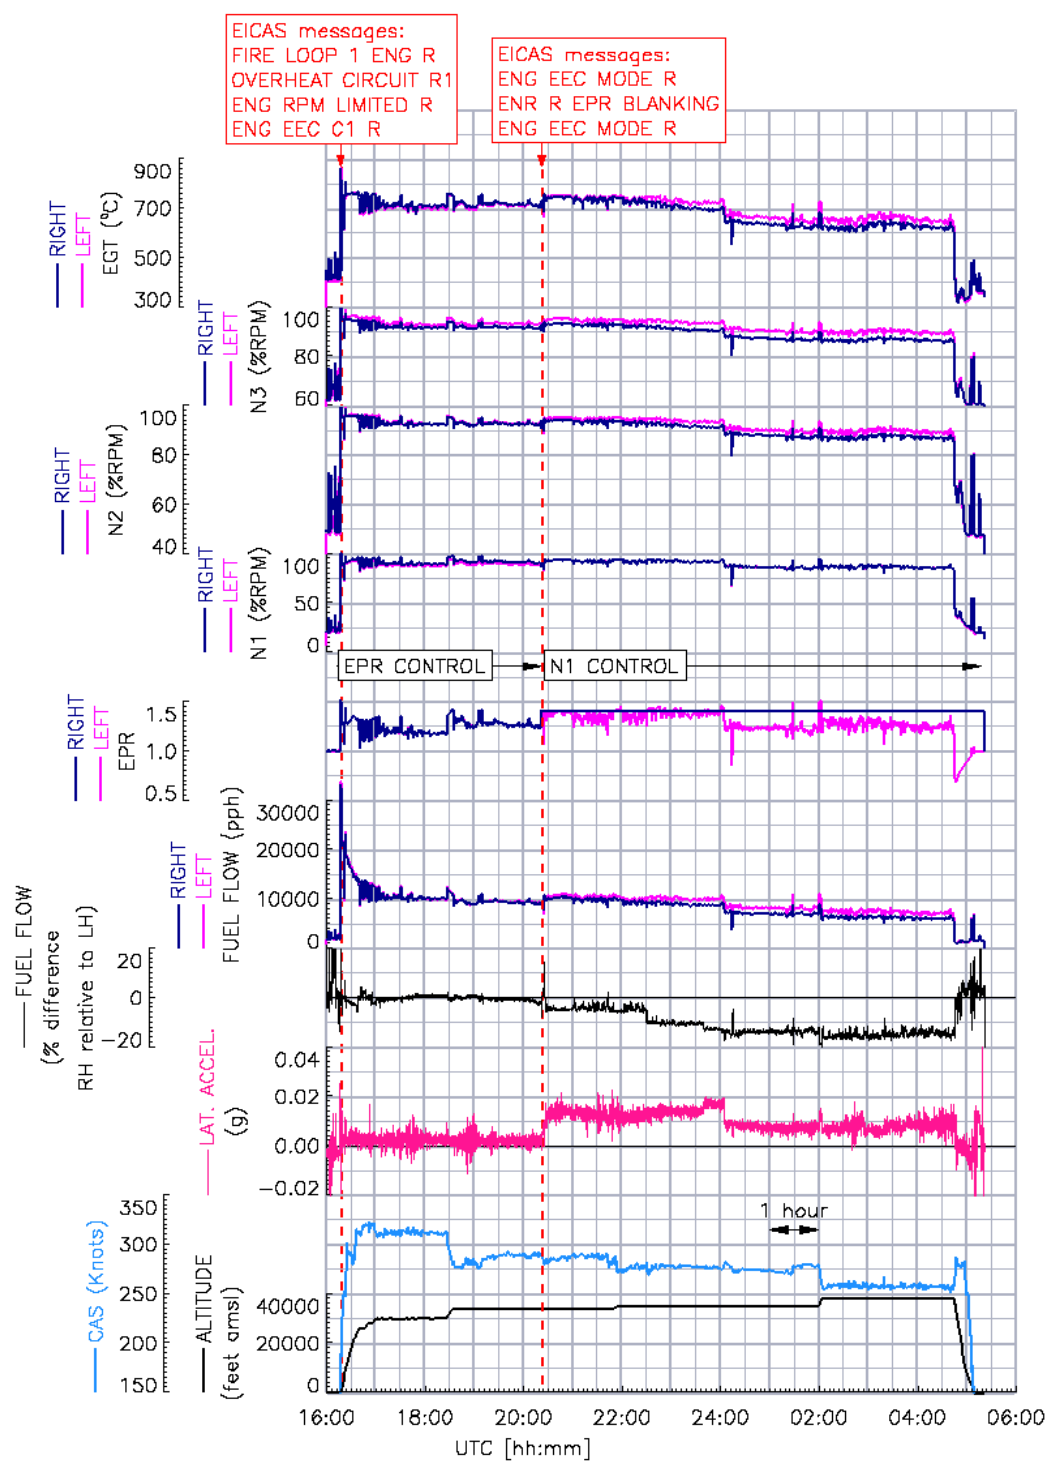
Salient FDR parameters of incident flight

Figure 5 shows data for the complete flight to London Heathrow Airport. Also indicated on Figure 5 are the EICAS messages displayed to the crew. These messages were recorded on the Maintenance Message Data Report, downloaded from the EICAS after the flight. The first set of messages were at 1618 hrs during the time of the right engine EGT fluctuations. However, the report only records the time for each message as hours and minutes so the exact timing is unknown. For the next four hours the EPRs and fuel flow for both engines were matched but small discrepancies between the engines were recorded for N1 (1 to 3.5%RPM), N2 (0 to 1%RPM), N3 (1 to 2%RPM), and EGT (0 °C to 8°C).

Following the event at about four hours, and the switching to 'Alternate' EEC mode (controlled by N1, rather than EPR), the higher power settings continued, with the left engine reflecting scheduled performance but the right engine performance degraded by the changes in effective nozzle areas. The total fuel consumption by the engines, resulting in the PAN diversion into Amsterdam, matched the aircraft tank quantities.
