Transportation Safety Board
of Canada

AVIATION INVESTIGATION REPORT A10A0032

RUNWAY EXCURSION

**CARGOJET AIRWAYS LTD.
BOEING 727-225, C-GCJZ
MONCTON, NEW BRUNSWICK
24 MARCH 2010**

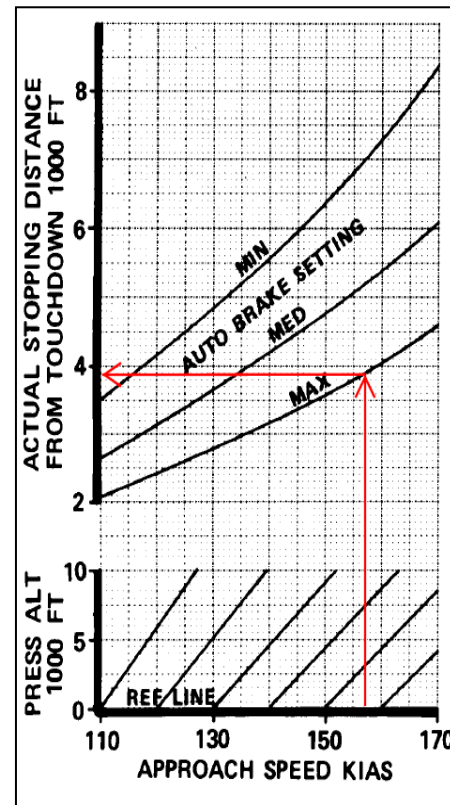
Figure 2. Boeing Actual Stopping Distance Chart

While the FCOM does not provide an actual value for stopping on a wet runway, that information is located in the AFM. According to the AFM, actual stopping distance on a wet runway, for the conditions listed above, would be approximately 500 feet greater than the value determined for a dry runway. Maximum manual braking would produce slightly shorter stopping distances if applied immediately upon touchdown. However, the benefits of
