# Air Accident Investigation Unit Ireland

**ACCIDENT**  
**Fairchild Aircraft Corporation**  
**SA 227-BC Metro III, EC-ITP**  
**Cork Airport, Ireland**  
**10 February 2011**

**AAIU Report No: 2014-001**  
**State File No: IRL00911013**  
**Report Format: Formal Report**  
**Published: 28 January 2014**

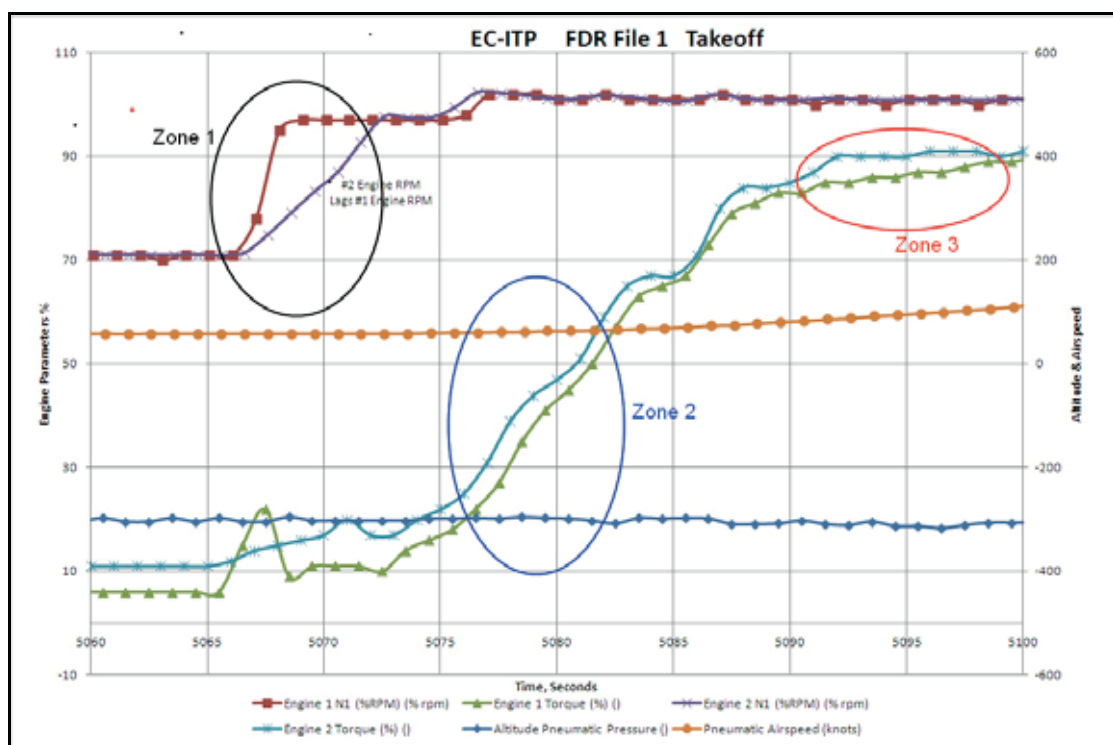
**Figure No. 1** shows FDR recorded parameters from EC-ITP on a take-off several weeks before the accident flight indicating that the  $P_{T2}/T_{T2}$  anomaly existed at that time.

**Figure No. 1:** Previous Take-off FDR Parameters

In Zone 1, the two curves show the engine speeds measured in RPM for the No. 1 engine (red) and the No. 2 engine (purple). The curves show that when the speed levers were advanced from Low RPM to High RPM in preparation for take-off and the engine speeds increased from 70% to approximately 97%, the speed response of the No. 2 engine lagged behind that of the No. 1 engine by approximately 5 seconds.

The effects of this on EC-ITP can be seen in Zone 2 of **Figure No. 1**, where the engine torques increase as the power levers are advanced. Since, during this phase of engine operation, the fuel flow to engine No. 2 is higher due to the low temperature signal being transmitted by the shortened bellows, the torque of engine No. 2 advances ahead of that of engine No. 1.

This effect can be seen in Zone 3 of **Figure No. 1** where the engine torques are settling close to take-off values, the torque achieved by engine No. 2 is several percentage points greater than that for engine No. 1.

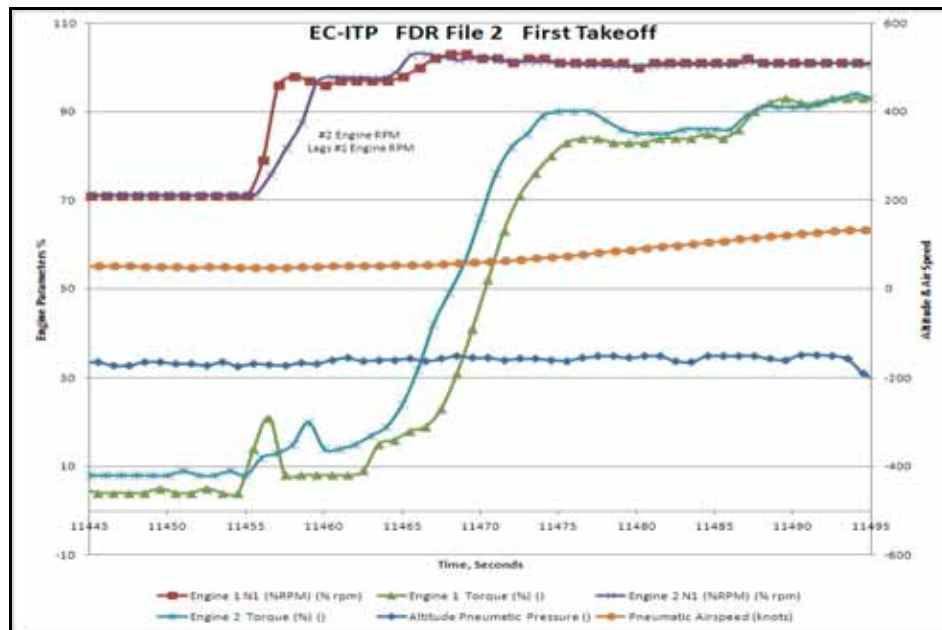
**Figure No. 4** and **Figure No. 5** present FDR data for two further take-offs made by EC-ITP some weeks before the accident flight. Similar characteristics are seen, in that the engine No. 2 RPM lags that of engine No. 1 as the speed levers are advanced in each case. Also, the torque achieved by engine No. 2 advances ahead of that achieved by engine No. 1 and, particularly as seen in **Figure No. 5**, the No. 2 engine torque remains higher than that of No. 1 engine as the aircraft speed increases during its take-off run.

**Figure No. 4:** Sample of take-off FDR parameters weeks prior to accident

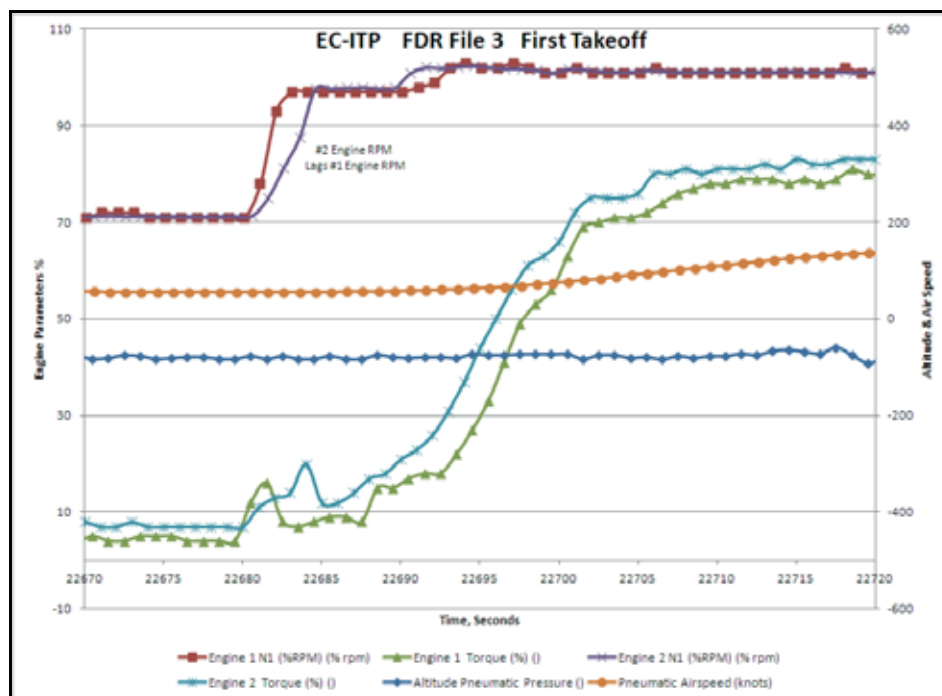
**Figure No. 5:** Additional sample of take-off FDR parameters weeks prior to accident

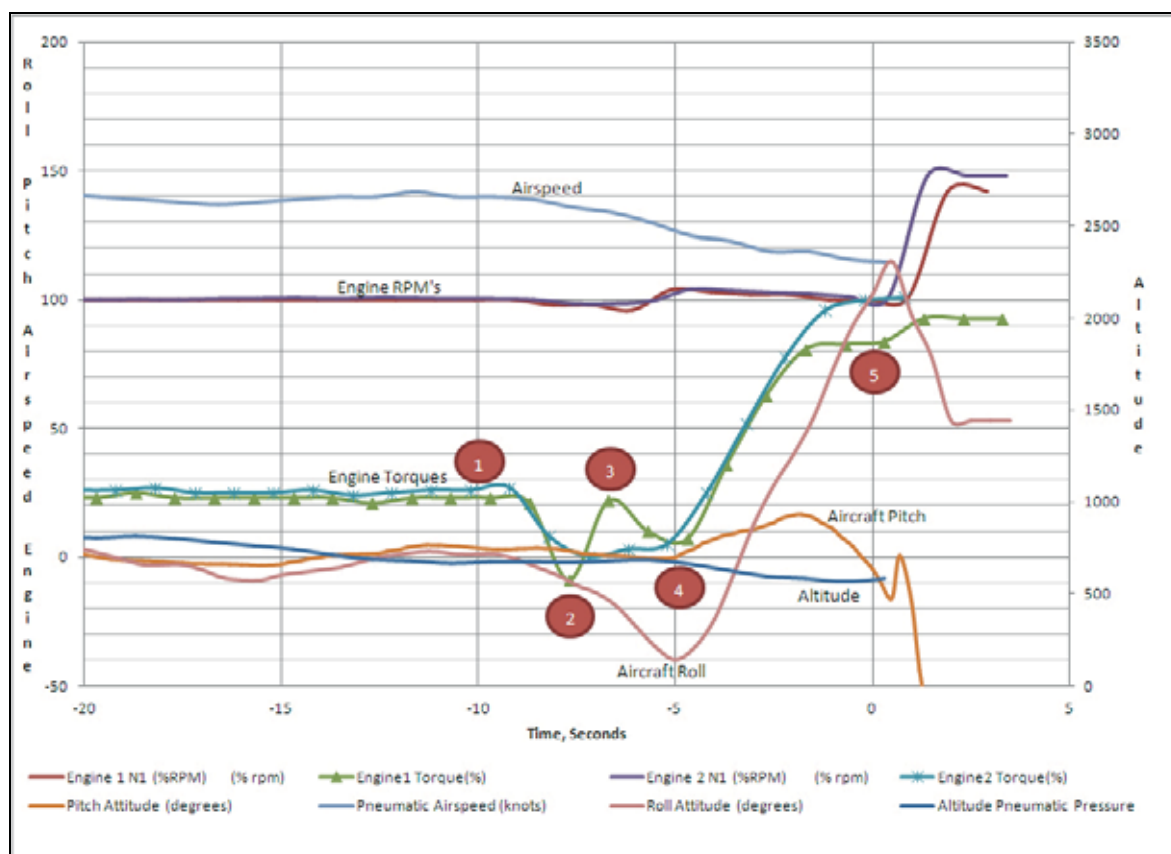
**Figure No. 6** illustrates various FDR parameters recorded during the accident sequence. The x-axis represents time measured in seconds with the “0” point representing a time approximately one second before commencement of the impact sequence, when the values of recorded parameters became unreliable.

**Figure No. 6:** FDR Parameters during final approach (accident flight)

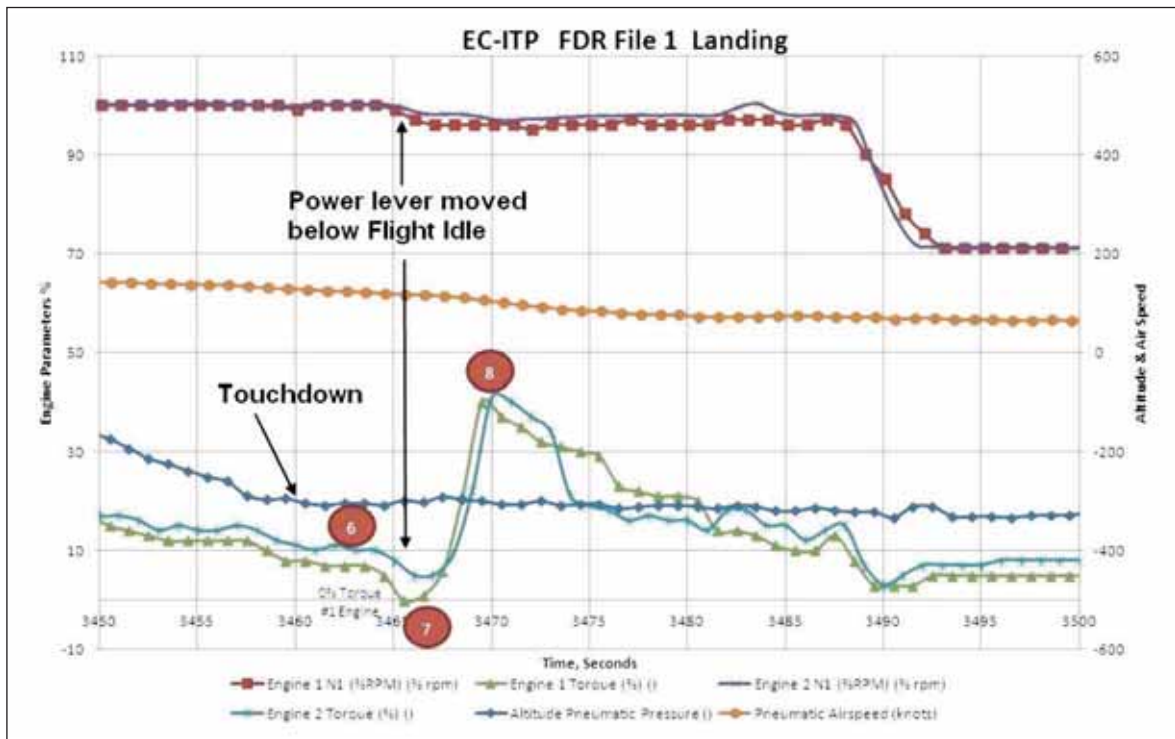
**Figure No. 8:** FDR Data from Previous Landing

The Investigation looked at a landing which had been made by EC-ITP at a Spanish airport several weeks before the accident, and for which FDR data was available. **Figure No. 8** illustrates the FDR data for this landing in similar format to that shown for the accident. Time in seconds is shown on the x-axis while the various engine parameters along with altitude and airspeed are shown on the y-axis. The touchdown occurred at FDR time reference 3460.

A similar analysis was carried out for this landing, and the manufacturer's computer model was used to calculate the fuel flows at datapoints 6, 7 and 8 as shown in **Figure No. 8**. The data is shown for the No. 1 engine in **Table No. 6** and for No. 2 engine in **Table No. 7**.

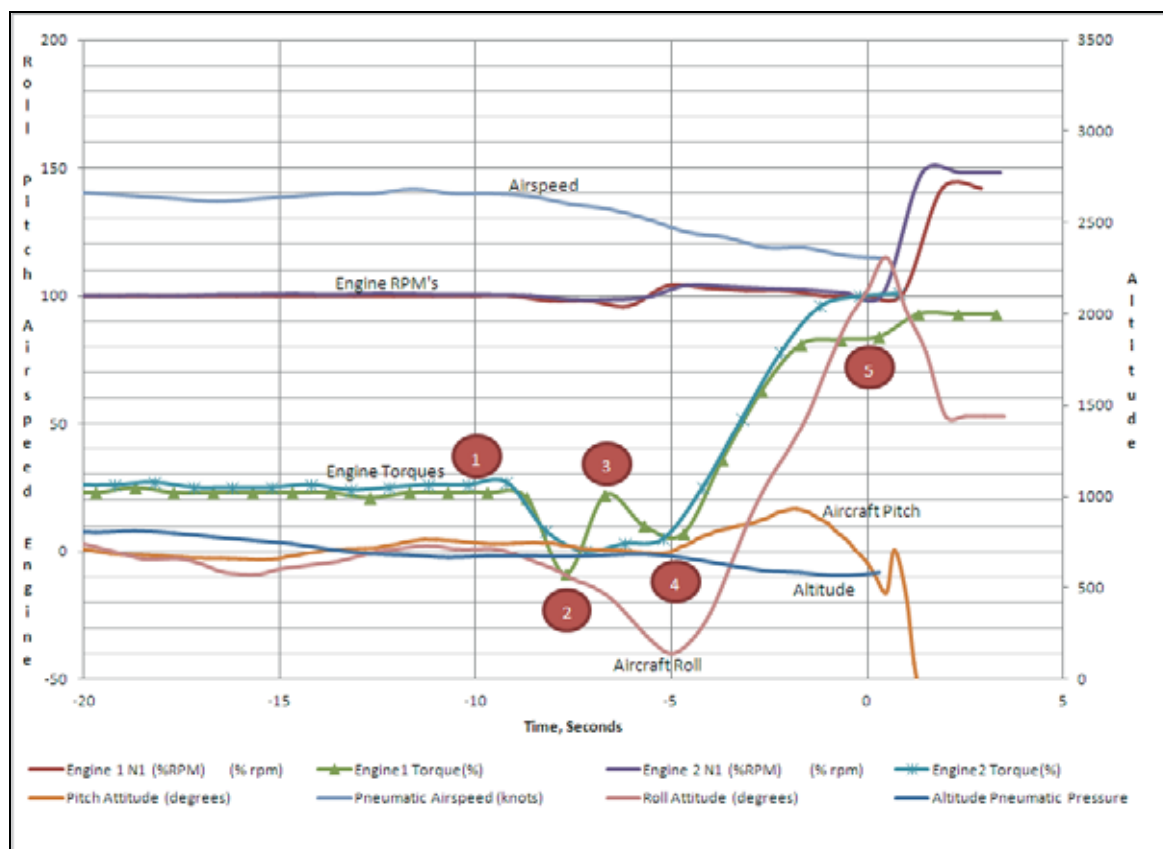
**Figure No. 9:** FDR Parameters during final approach (accident flight)

Regarding the final approach and the time period from -20 seconds to approximately -9 seconds, the engine torque for the No. 1 engine was recorded at values generally in the range 21 to 23% while that for the No. 2 engine was in the range 25 to 27%. During this period, the engine speeds were recorded as 100% for No. 1 engine and at values in a range between 100.0% and 100.7% for No. 2 engine, **Figure No. 9**.
