Lateral runway excursion during landing roll, nose landing gear collapse

Aircraft	Airbus A300-B4 registered EI-EAC
Date and time	16 November 2012 at 4 h 25 UTC ⁽¹⁾
Operator	Air Contractors
Place	Bratislava Airport (Slovakia)
Type of flight	International public cargo transport
Persons on board	Captain (PF) ; Copilot (PNF) ; Flight Engineer
Consequences and damage	Aeroplane severely damaged

This is a courtesy translation by the BEA of the Final Report on the Safety Investigation. As accurate as the translation may be, the original text in French is the work or reference.

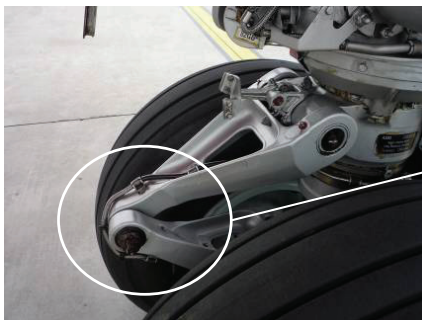
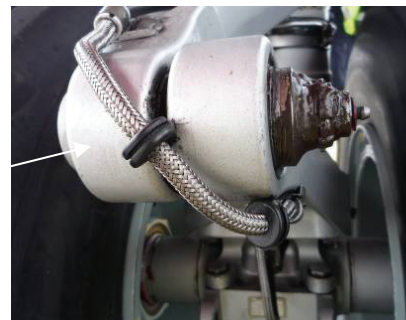
Diagram and photos (side and face views) of the NLG torque link assembly on the A300-B4

Liaison between the two arms of the torque link is ensured by an apex pin whose end has, successively, grooves, a thread and then more grooves. On this pin the following parts are installed:

1. a bevelled washer (P/N C59853-1),
2. the upper arm bearing,
3. a washer, (P/N C64066-1),
4. the lower arm bearing,
5. a grooved washer (P/N SL40374)
6. a crenelated nut,
7. a washer lock (P/N SL61WTM22P)

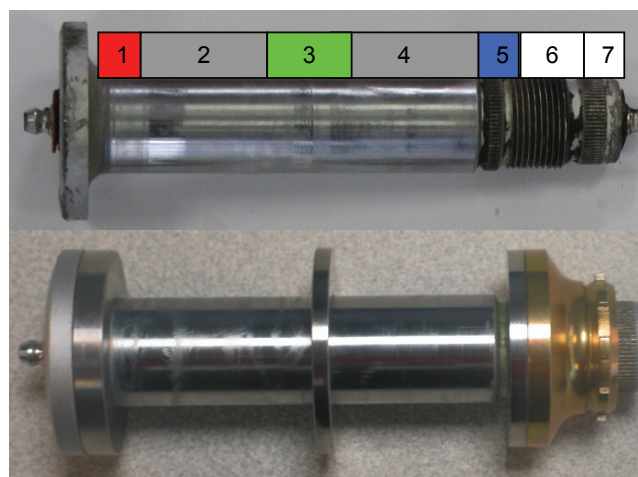
Apex pin without the torsion link arms

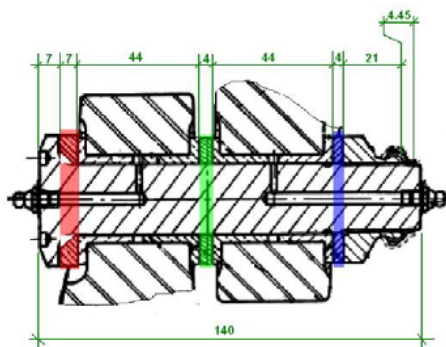
Dimensions

Dimensional analysis of the nominal installation showed that the total length of the assembled element was 140 mm. Once the last washer lock is positioned, the shaft projects by 4.5 mm. 0.5 mm of grooves are visible on the shaft.

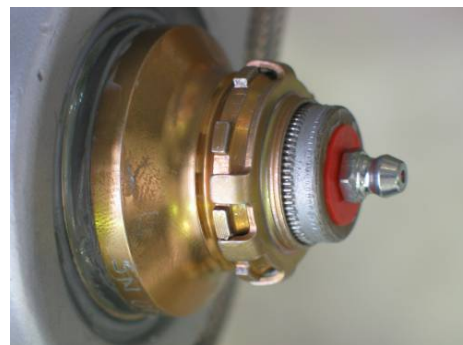
Photo of the end of the shaft with 0.5 mm of grooves visible after the washer lock.

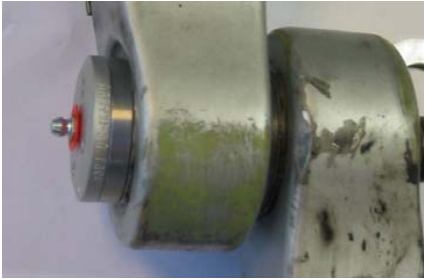
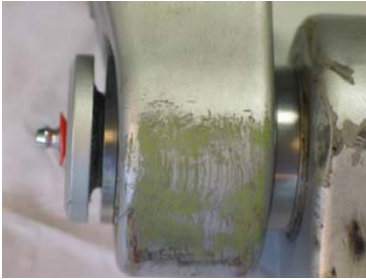
Step 1	
Correct assembly	Incorrect assembly

Installation of the bevelled washer with its bevelled side in contact with the shaft head leaves no play.	A 4.5 mm space is visible between the shaft head and the badly positioned washer.
Step 2

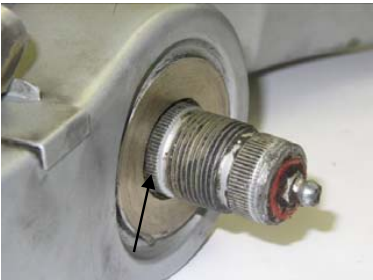
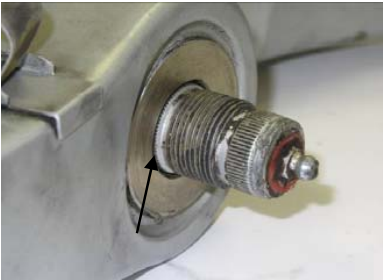
The shaft grooves appear. The grooved washer engages in the first grooves. Once in place this washer is prevented from rotating.	The shaft grooves no longer appear. The grooved washer can no longer engage in the shaft grooves. This washer can then rotate freely.
Step 3

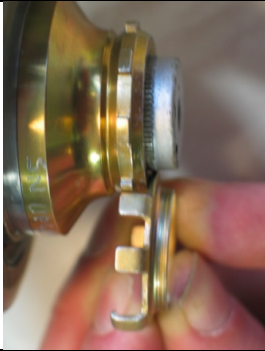
About 0.5 mm of shaft grooves is visible after installation of the washer lock.	The key washer cannot completely engage on the shaft grooves. The grooves go past the washer lock.

Incorrect installation of one or more washers on the nose gear torque link centre hinge made it impossible to lock the hinge shaft nut effectively. The unscrewing and the detachment of the latter in service caused the loss of nose gear steering. Free on its axle, the nose gear bogie began to shimmy, which made the aeroplane veer to the left. The aeroplane exited the runway and the nose gear collapsed during the collision with a concrete inspection pit for access to the runway lighting electric cables.
