**AIRCRAFT ACCIDENT REPORT**

**Saudi Arabian Airlines**

**Lockheed L-1011, HZ-AHK**

**August 19th 1980**

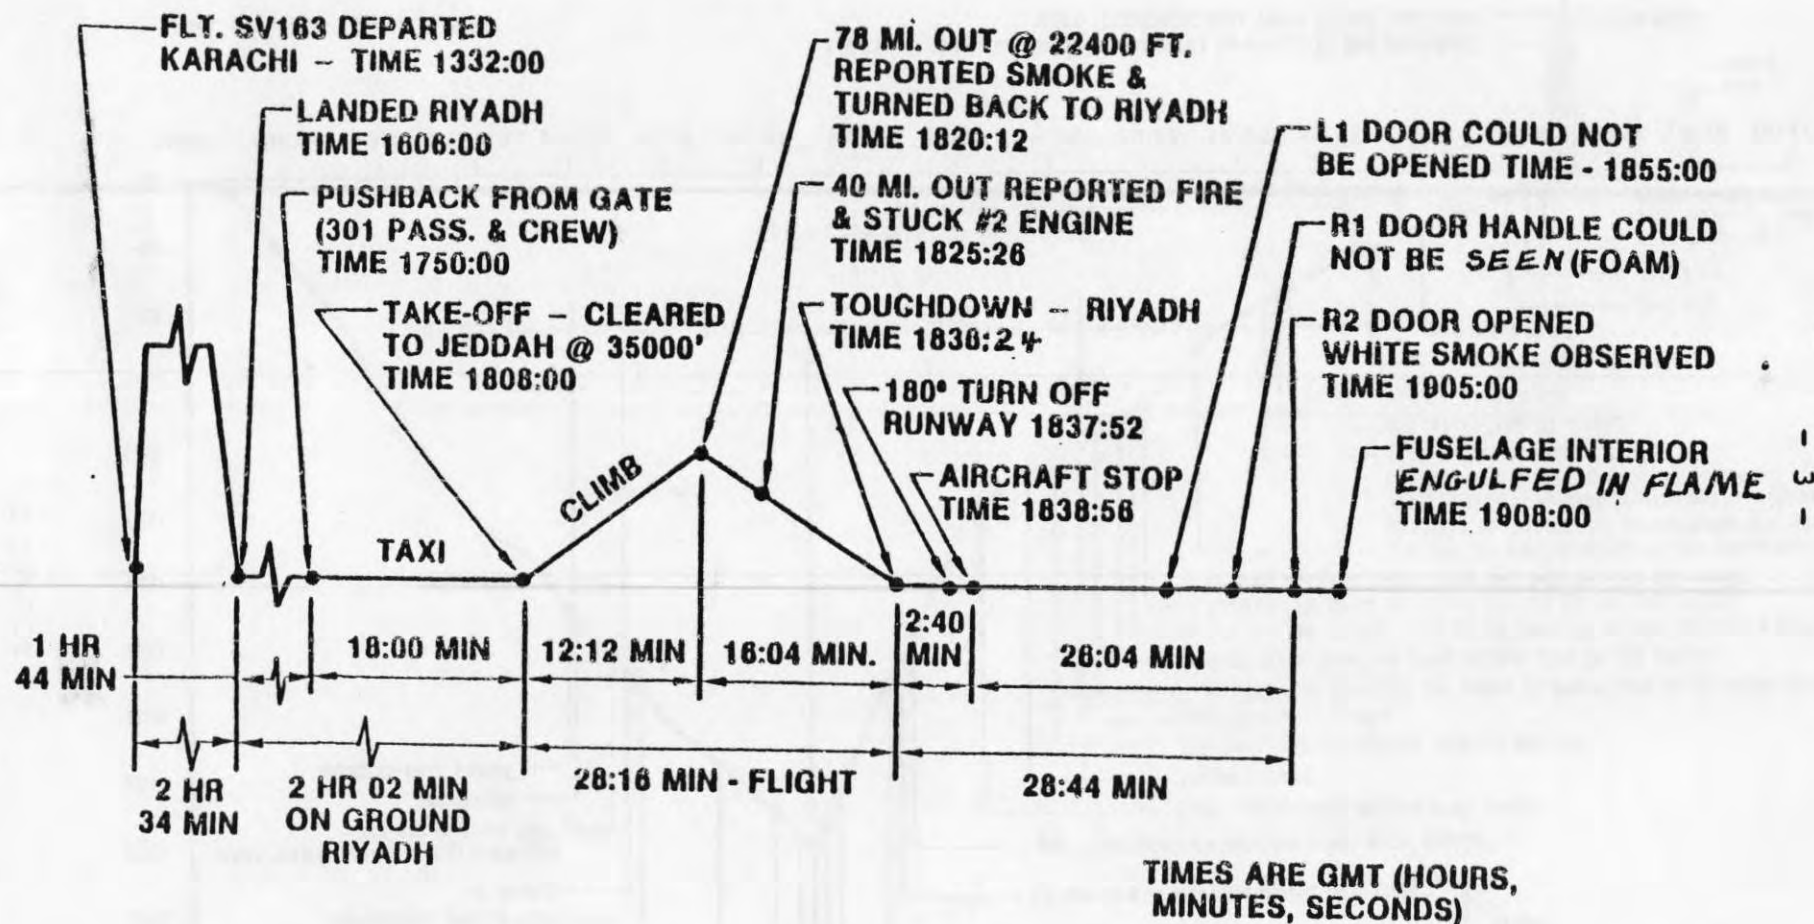
FIGURE 1

A total of 4 minutes and 21 seconds was spent by the flight crew in confirming the warning and when it became clear that a valid warning existed, the Captain elected to return to Riyadh. The Flight Engineer (F/E) had gone into the passenger cabin to investigate the situation and on returning to the cockpit, about thirty six seconds later, at about 1820:16, he informed the Captain that there was a fire in the cabin (see Appendix D - Cockpit Voice Recorder and Figures 1 and 2).

SV163 (S/N 1169) flight profile.

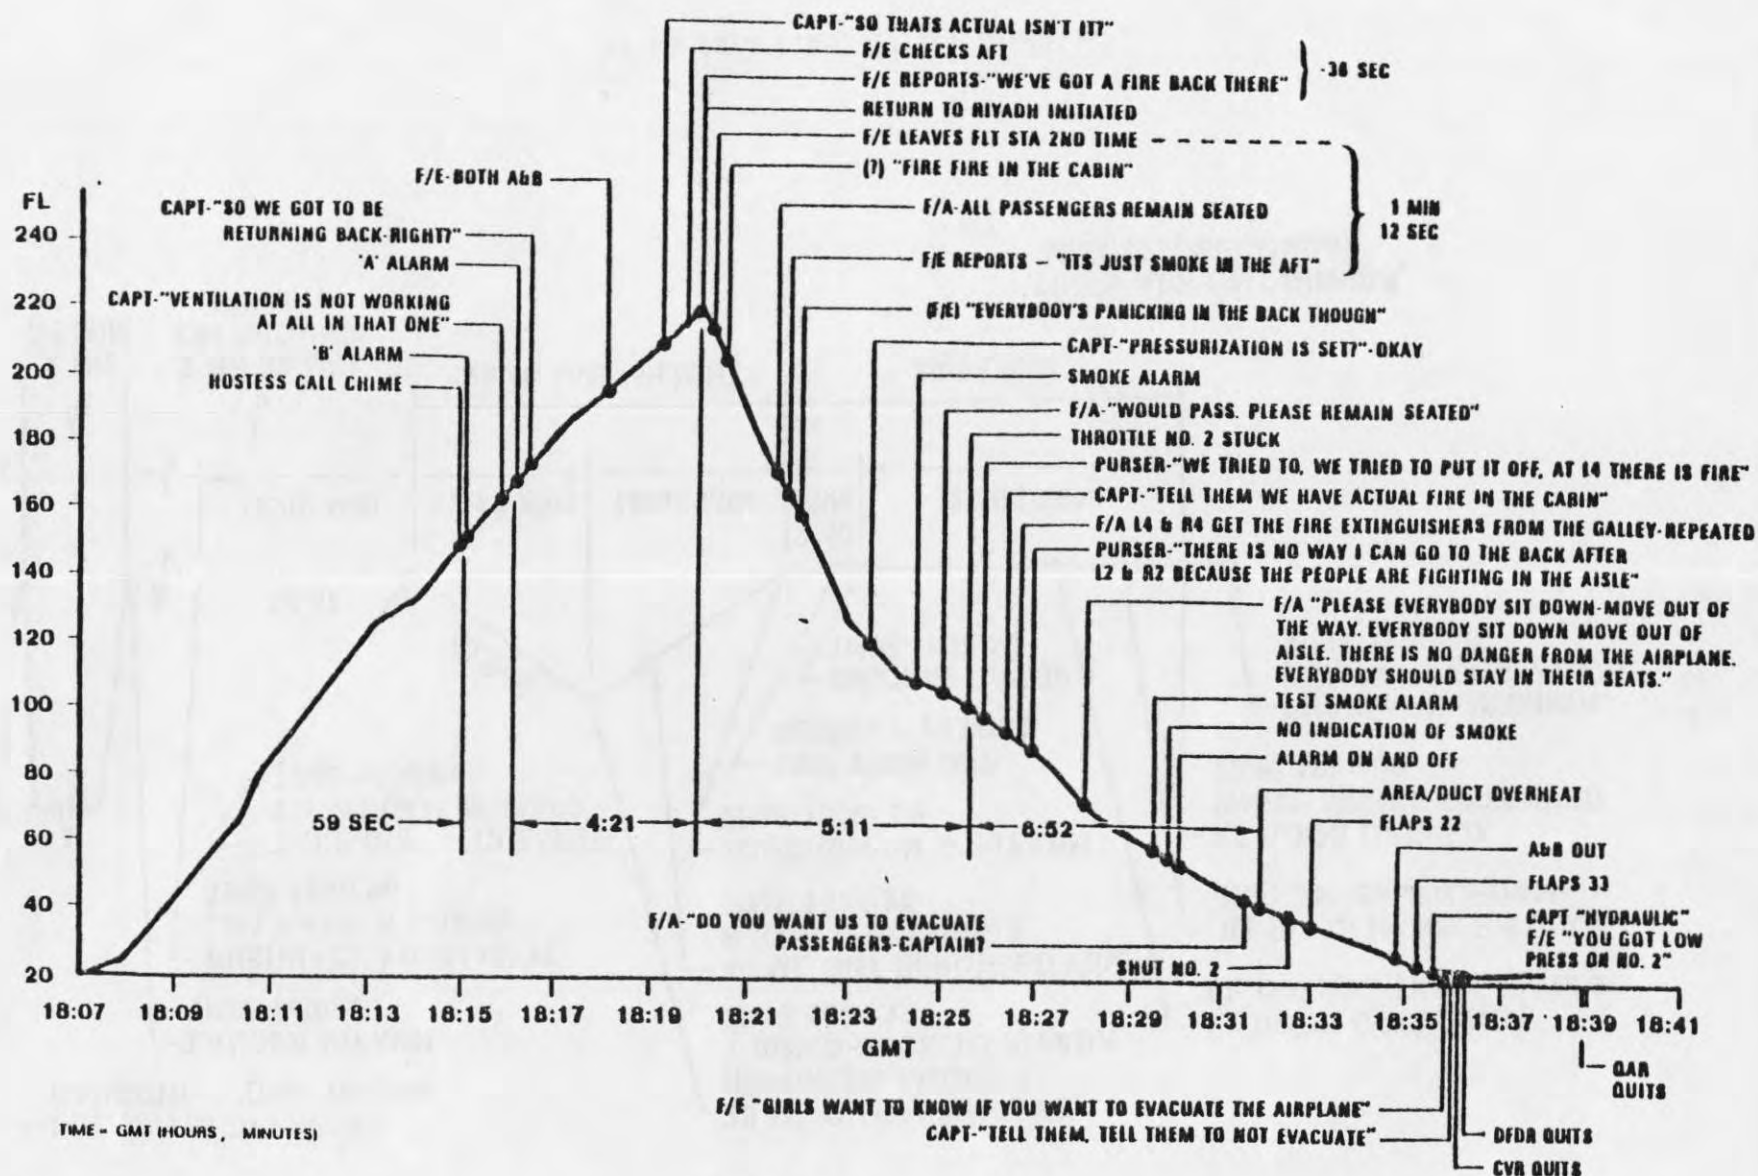
FIGURE 2

Figure 2  
Flight profile and sequence of events.

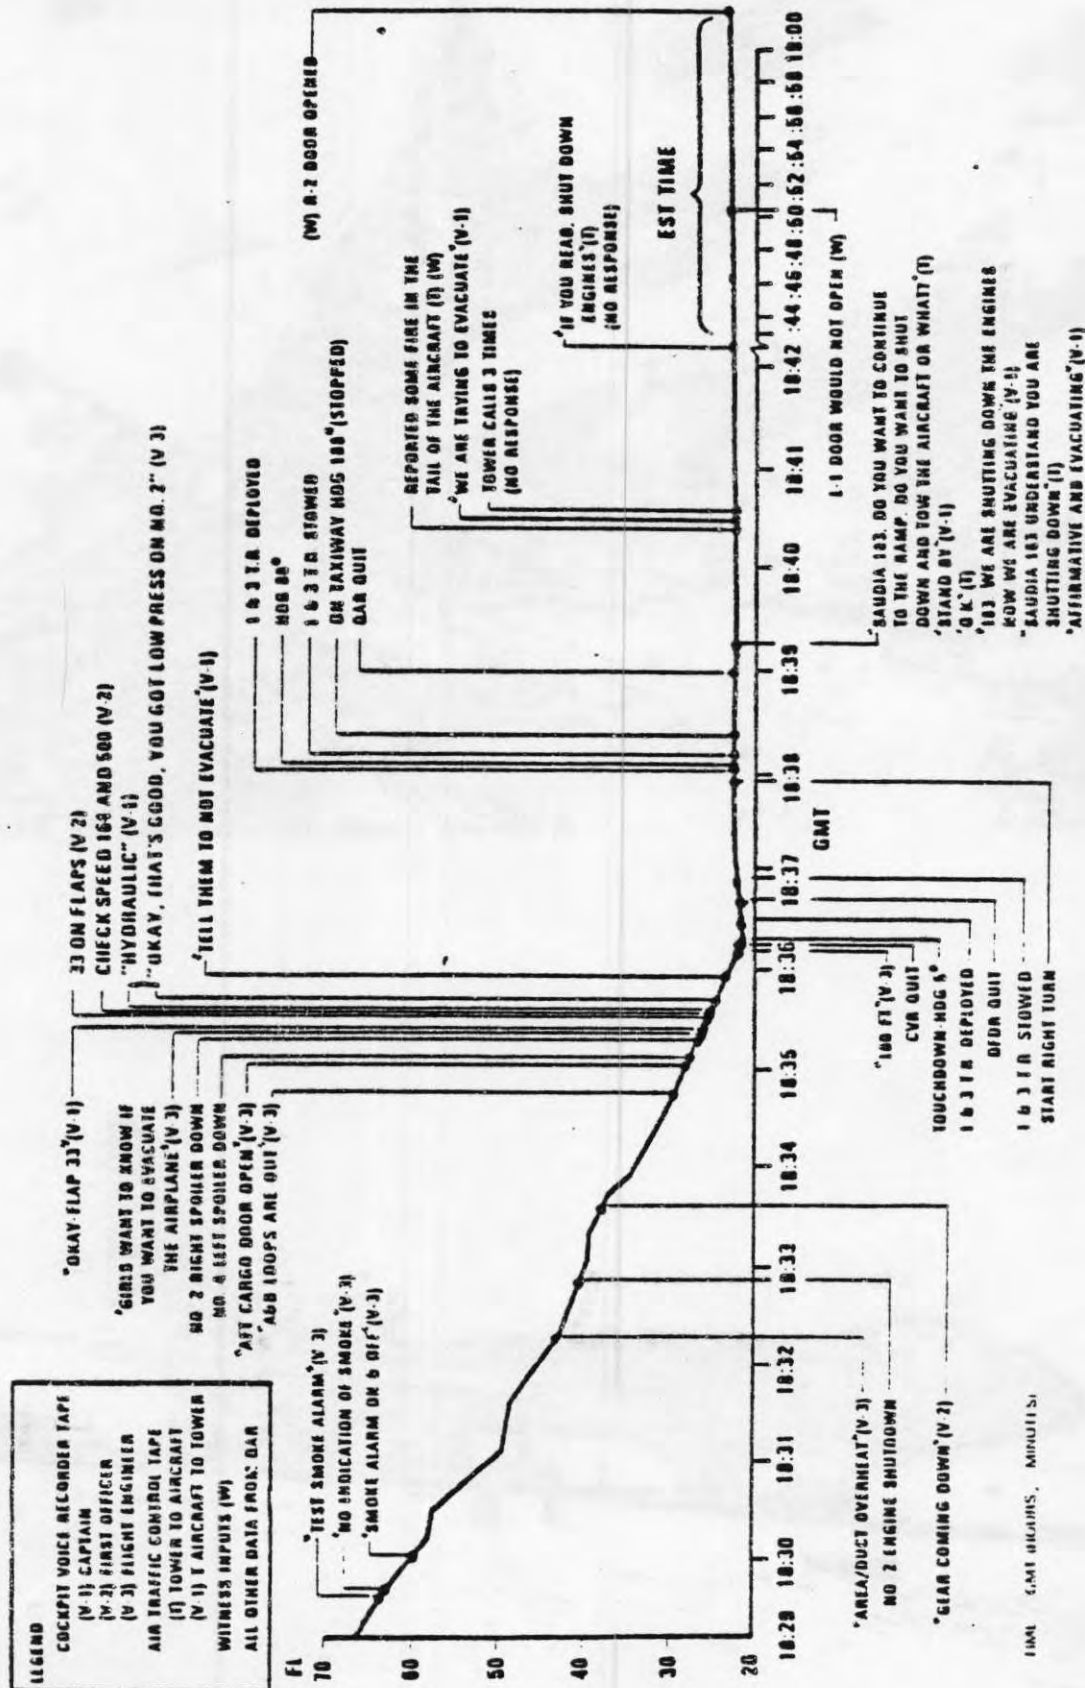
FIGURE 3

Attempts by the crash, fire, rescue personnel (CFR) to enter the aircraft and open the doors were unsuccessful until the No. 2 door on the right side of the aircraft was opened at about 1905, about 23 minutes after all engines had been shut down. At 1908, the fuselage interior was observed to be engulfed in flame. (see Figures 1, 2, and 3)

Sequence of events during approach to Riyadh and after landing.

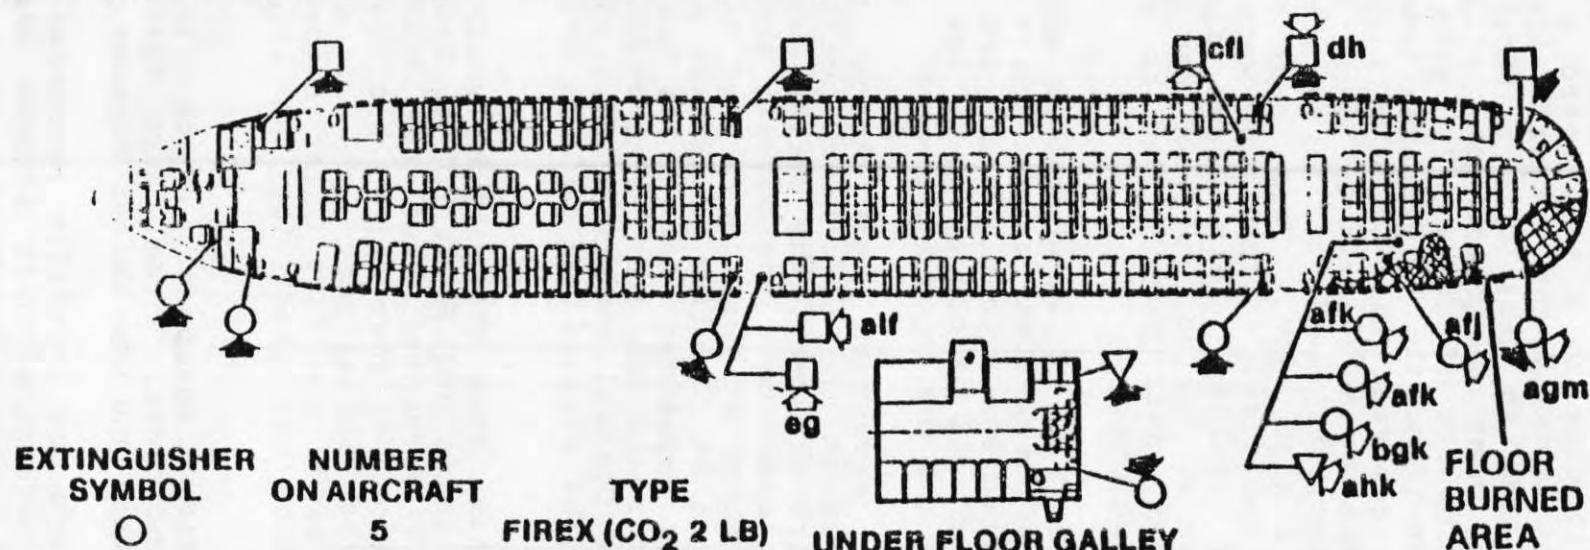
# **FIRE EXTINGUISHERS — NORMAL LOCATIONS AND AS FOUND AFTER FIRE**

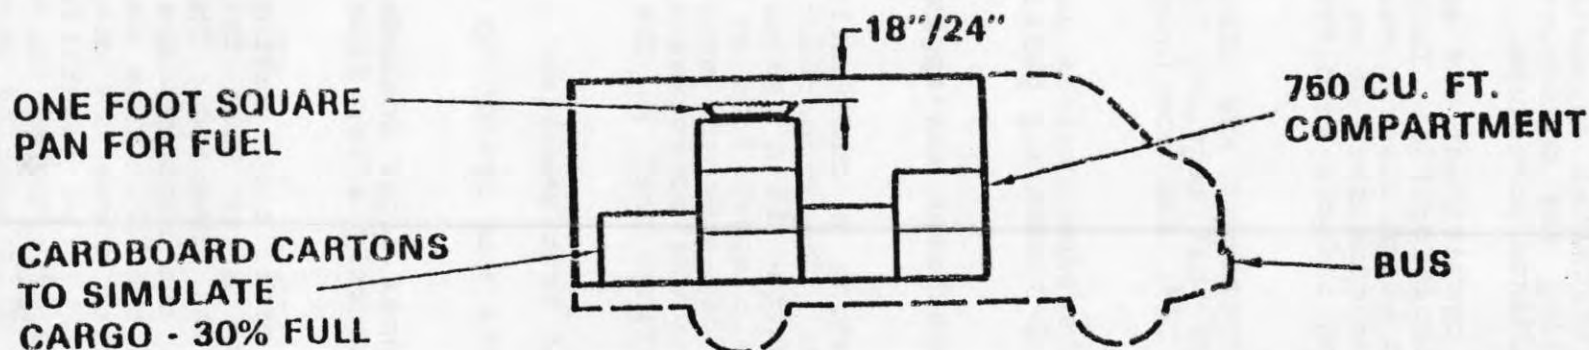
**TEST NO. 1**

- A - 1 PINT METHYL ALCOHOL
- B - AIR SUPPLY SHUT-OFF
- C - ALCOHOL IGNITED
- D - ALCOHOL CONSUMED IN 5-MINUTES
- E - NO EFFECT FROM LACK OF AIR
- F - CEILING TEMP 1700°F

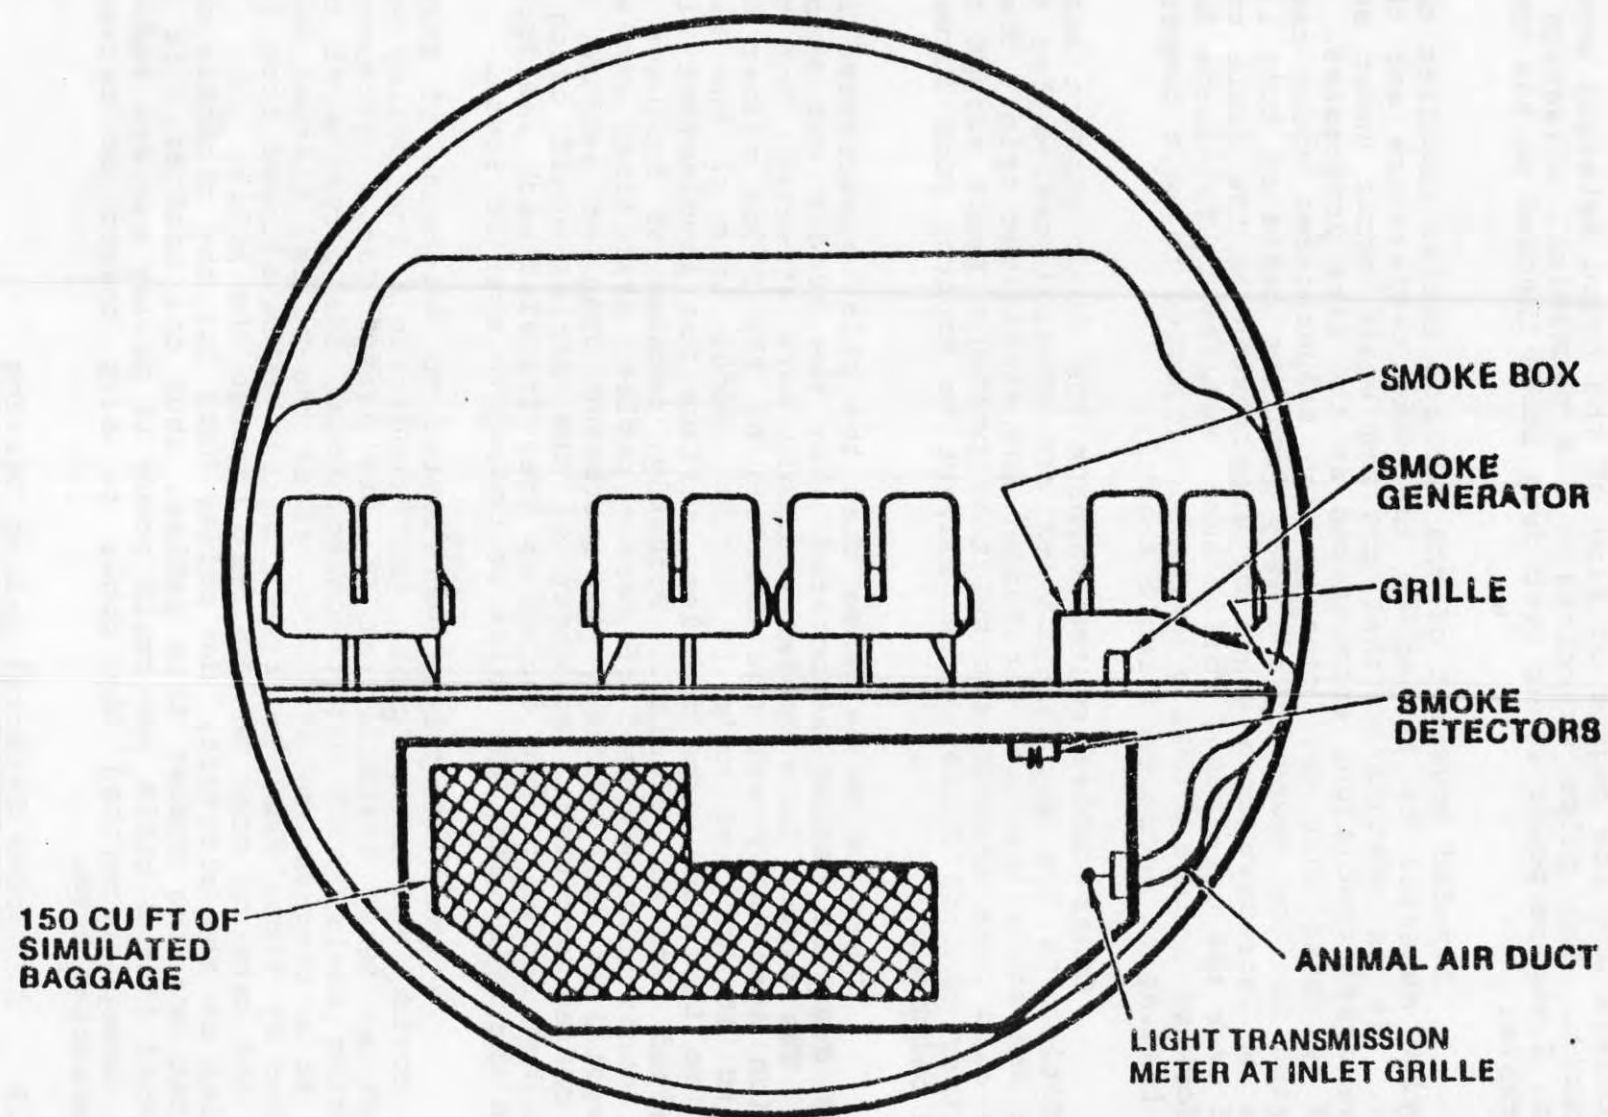
FIGURE 14

Smoke detector test arrangement.

To evaluate the response of the smoke detector system to smoke in the aft passenger cabin, testing was performed by use of the arrangement depicted in figure 14. Test results
