*REPORT C 1993:57*

**Air Traffic Accident  
on 27 December 1991  
at Gottröra, AB county**

*Case L-124/91*

The Board of Accident Investigation (SHK) has investigated an aircraft accident which occurred on 27 December 1991 at Gottröra, AB county, involving an aircraft with registration OY-KHO.

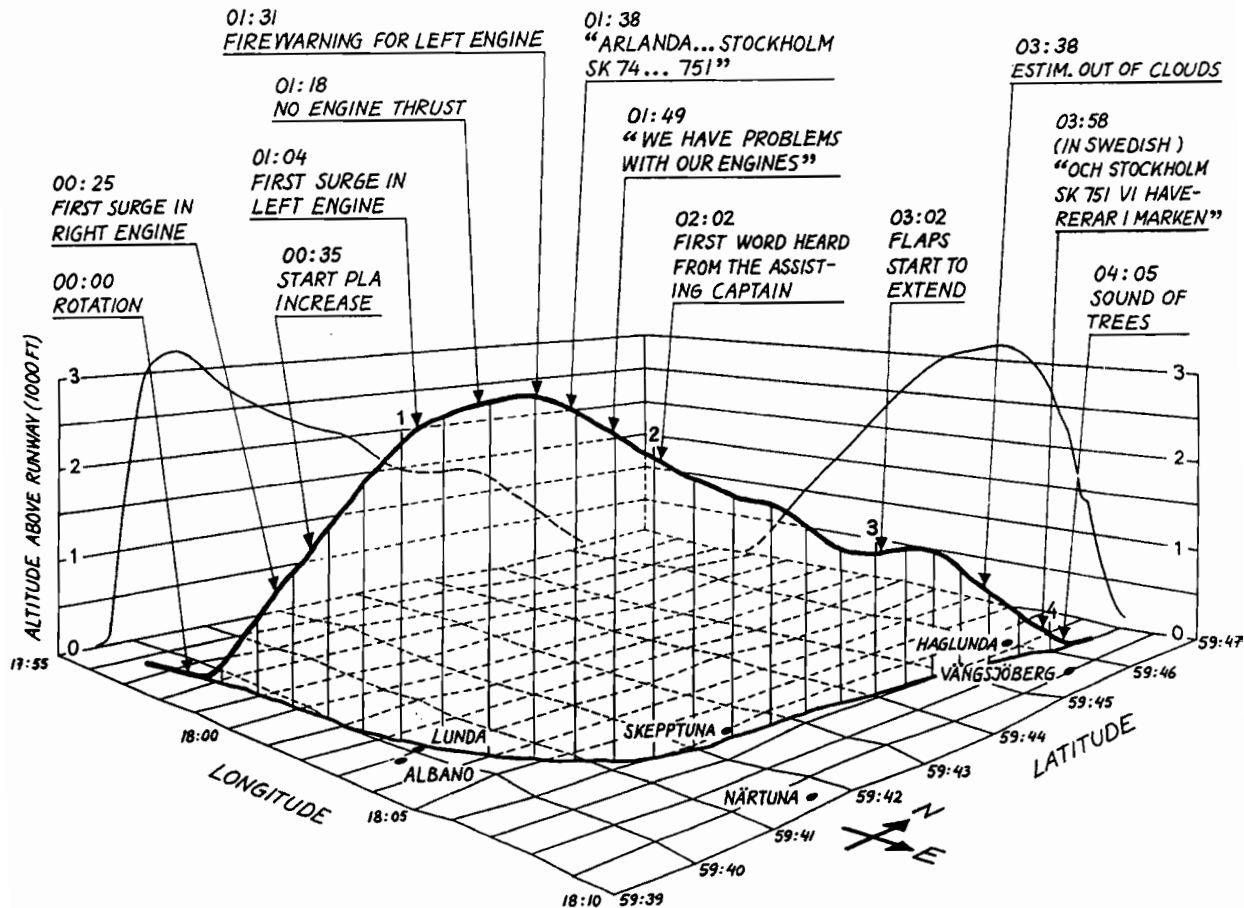
**Flight path**

When the aircraft was approx. 420 m above the ground and still in cloud the assisting captain started gradually extending the flaps. According to the flight recorders, speed was then approx. 165 kts. The flaps were fully extended approx. 30 seconds later at a height of approx. 300 m above the ground. At a height of approx 340 m (1,100 ft) above the ground the captain said: "Flaps eh ... eh", whereupon the assisting captain answered: "Yes, we have flaps, we have flaps, look straight ahead, look straight ahead!"

When the aircraft was entirely free of the cloud at 300 to 250 m (980 to 820 ft), the captain judged that a large field far to the right could not be reached. Instead he chose to attempt an emergency landing in a field more or less in his direction of flight, north-east of Stockholm/Arlanda. During the approach to the field the captain corrected his heading about 25° to the right to avoid houses further on in the intended direction of landing.

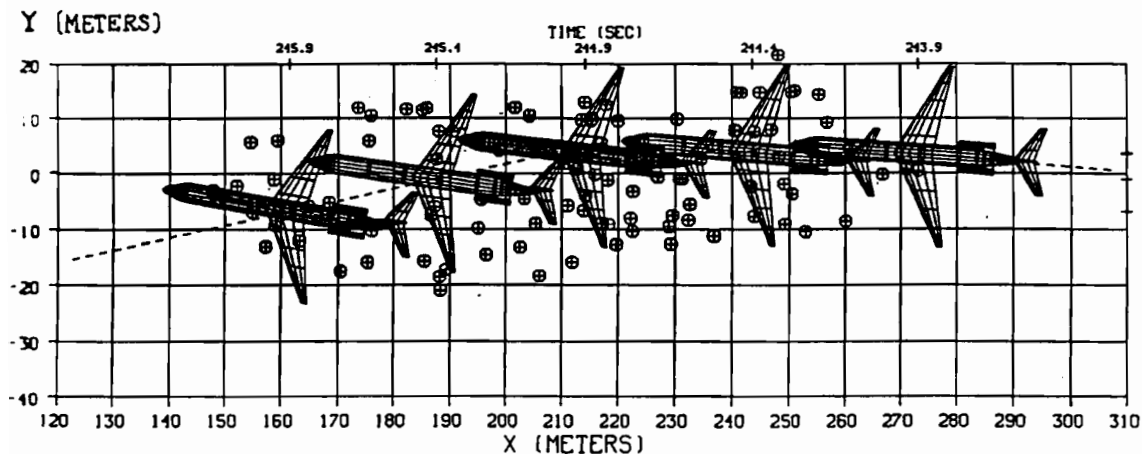
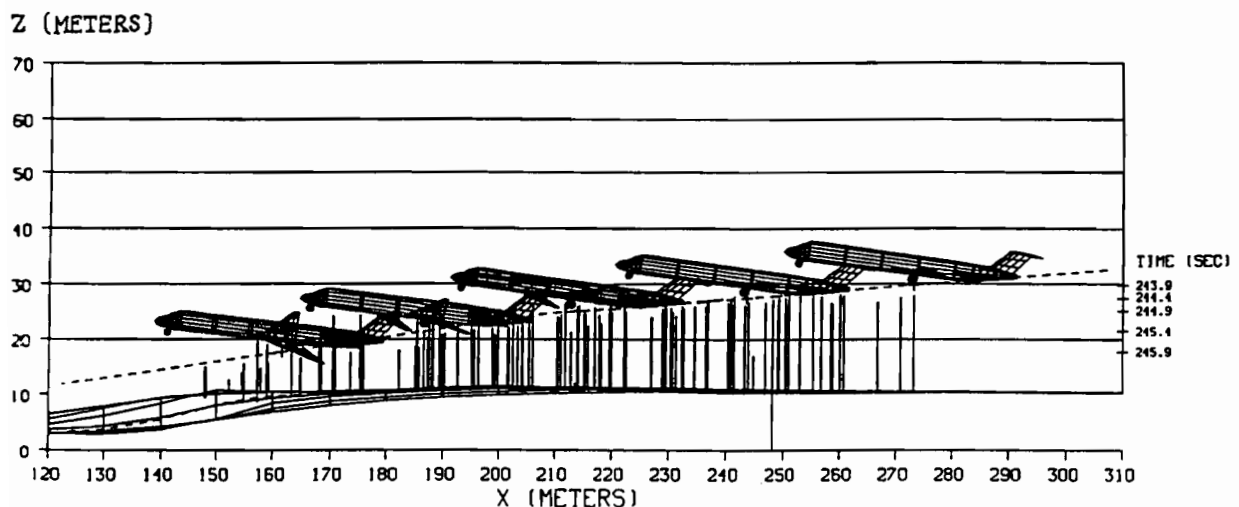
### *The final phase of the flight*

Seventeen seconds before the aircraft struck the ground the first officer asked "Shall we get the wheels down?" This was answered by the assisting captain with the call: "Yes, gear down, gear down." Eight seconds later, when height was 56 m, the first officer reported to Stockholm control: "and Stockholm SK 751 we are crashing to the ground now." A further seven seconds later the sound of contact with trees was recorded on the CVR.

Four minutes and seven seconds after rotation the aircraft hit sloping ground, first with the tail. On impact, a right bank of  $40.1^\circ$  was recorded. After impact the aircraft slid along the ground about 110 m before stopping. The fuselage was broken into three on impact and during the subsequent braking along the ground. There was no fire. All 129 on board survived. Except for four persons, all made their way out of the aircraft themselves.

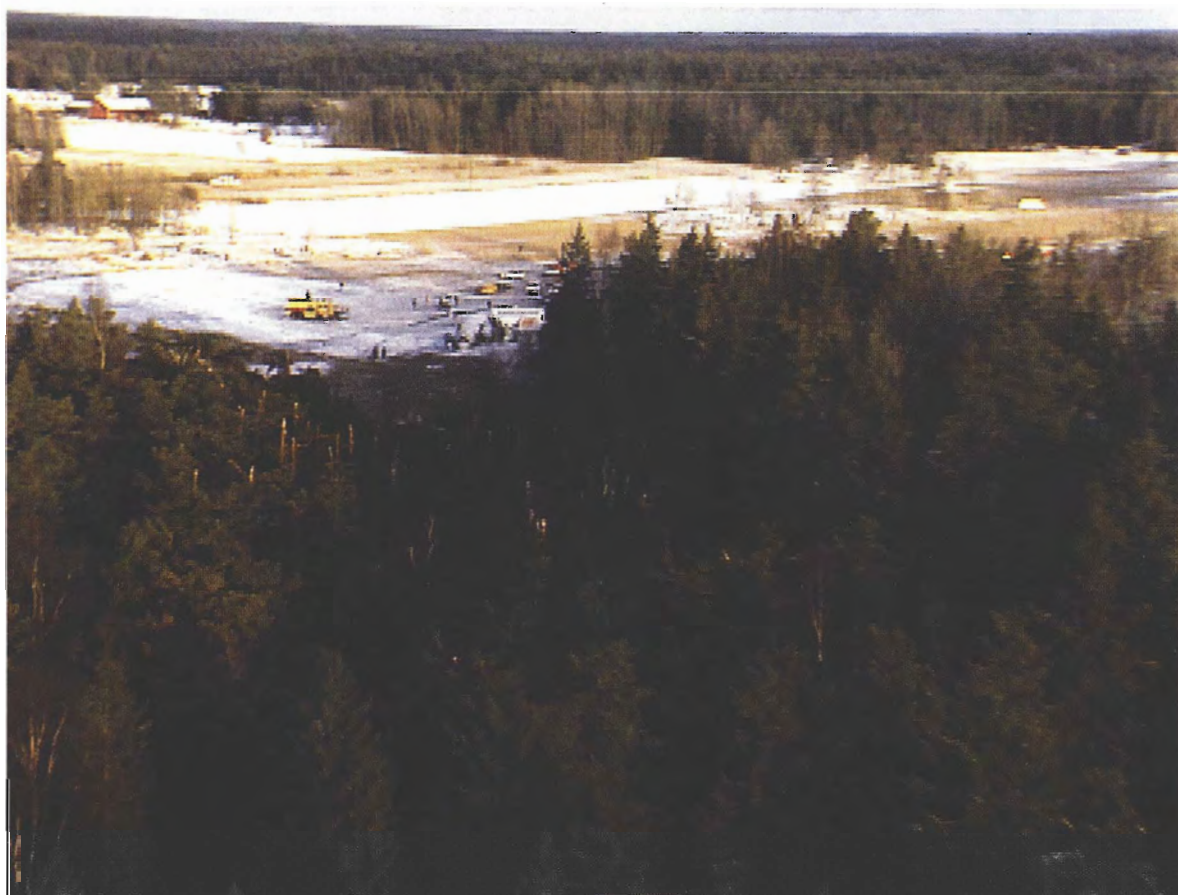
*Approach to accident site*

Shortly before striking the ground the aircraft collided with a number of large coniferous trees. Over an area of about 125 m in length and in breadth corresponding to the aircraft's wingspan, trees were broken.

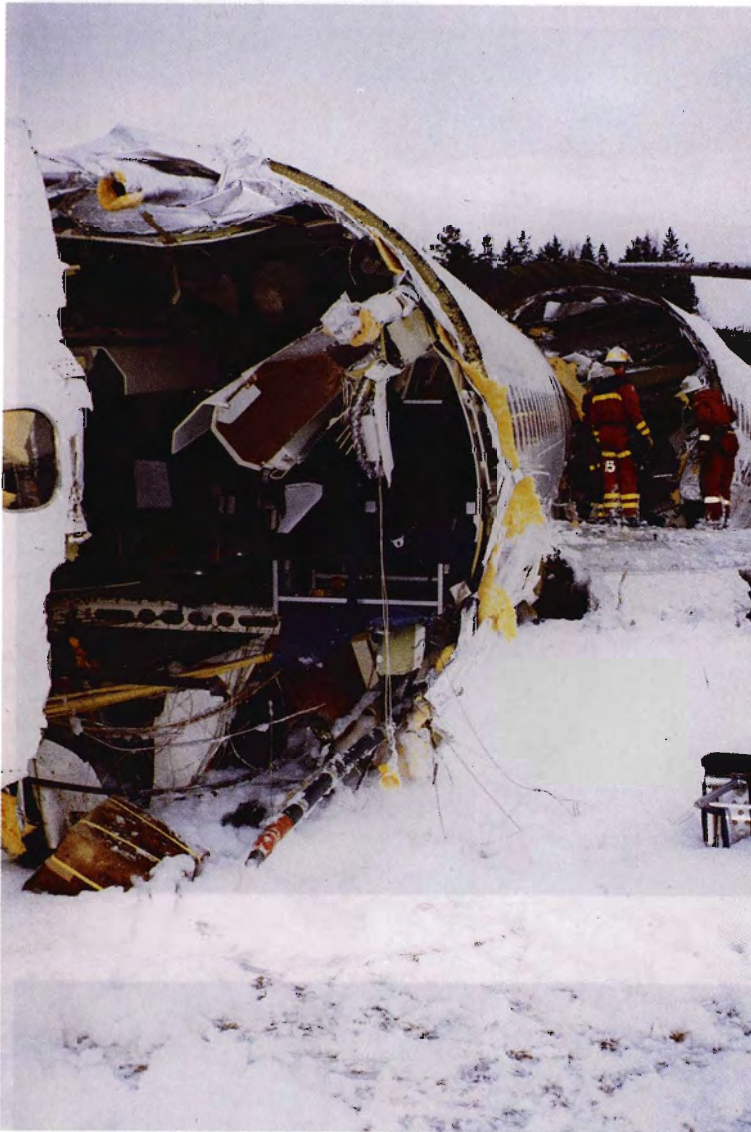
### *Openings in the fuselage*

Both forward emergency exits were open. The entrance door slide had not inflated. The service door slide had inflated but was punctured. The slides had been detached and used as somewhere for people to lie down. Both rear emergency exits were shut. According to information from the crew it was impossible to

open them immediately after the crash. The rear service door could be opened later. Three of the four emergency exit windows were open. According to information from witnesses, the rear right exit was blocked with loose seats, cabin luggage etc.

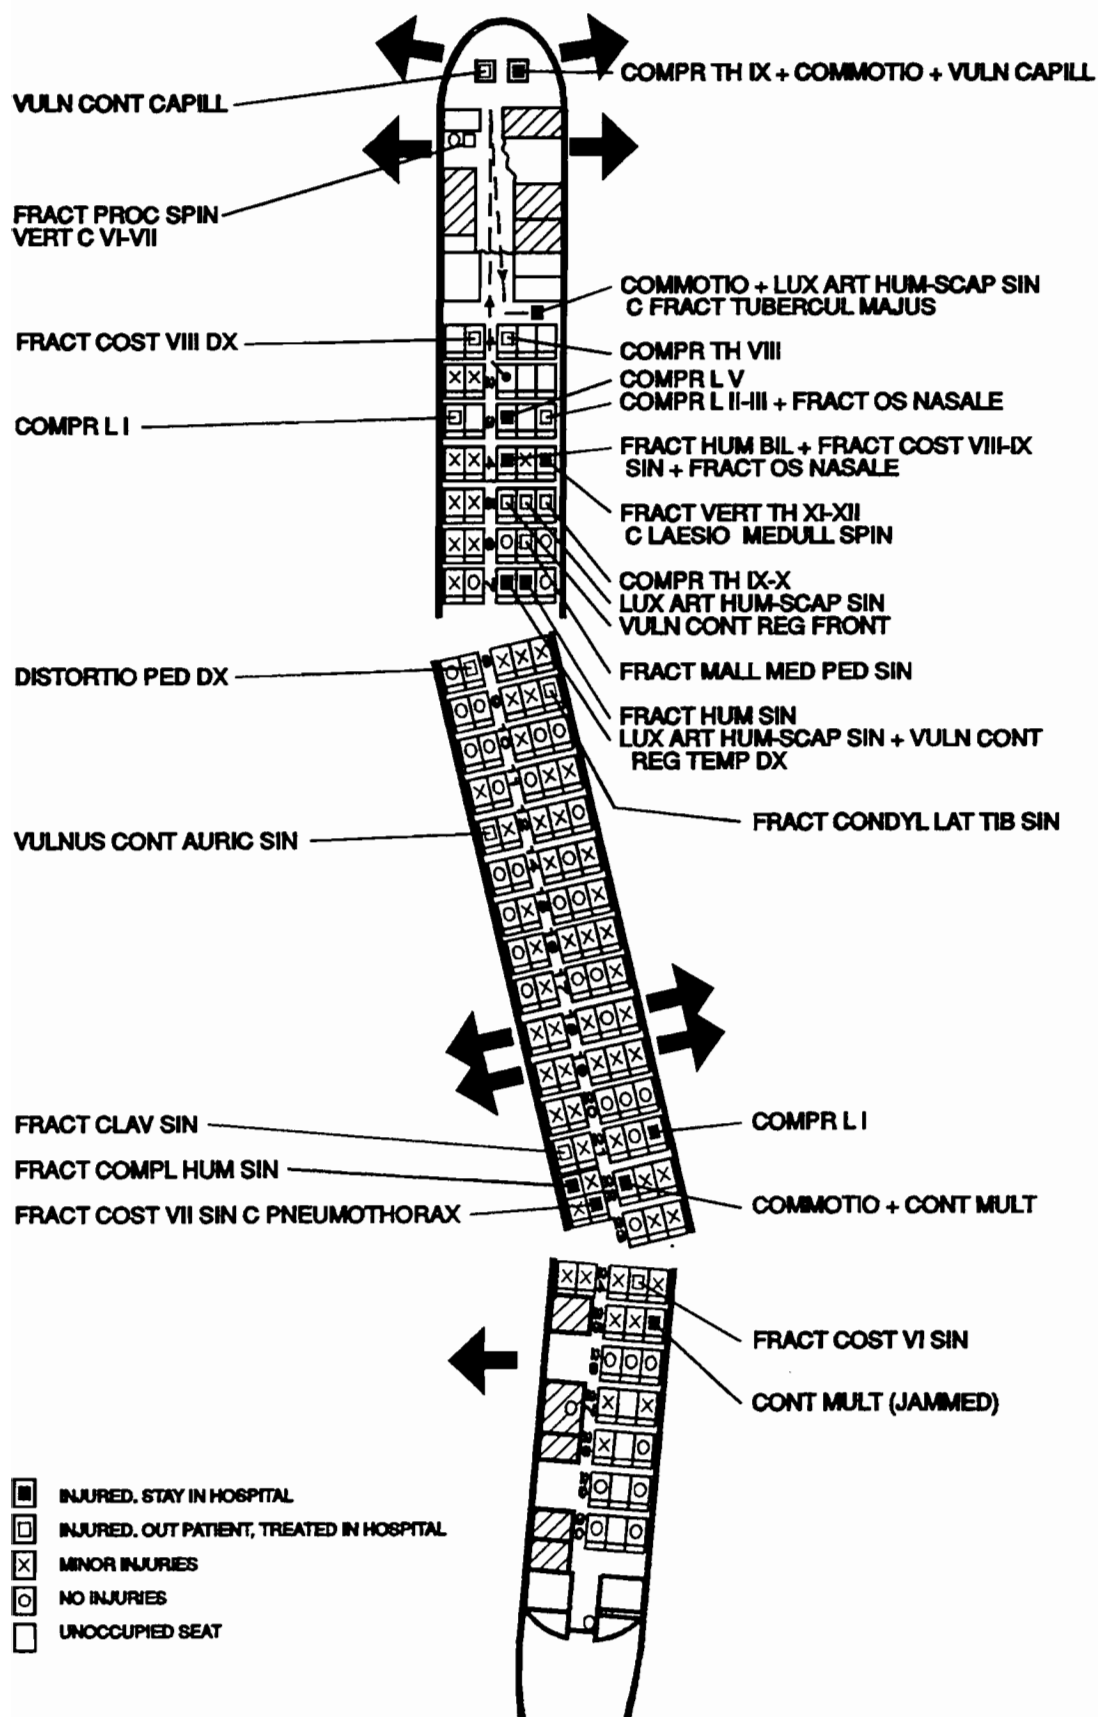
*Injury profile*

Most of those injured, and those with the most serious injuries, were sitting in the forward part of the aircraft, with a concentration to the right side. Here there were eight of totally nine cases of back injury and five of totally seven shoulder and arm injuries. Another concentration of injuries was among those sitting near the rear fuselage break. Those sitting in the middle and rear parts of the aircraft sustained slighter injuries or were uninjured.

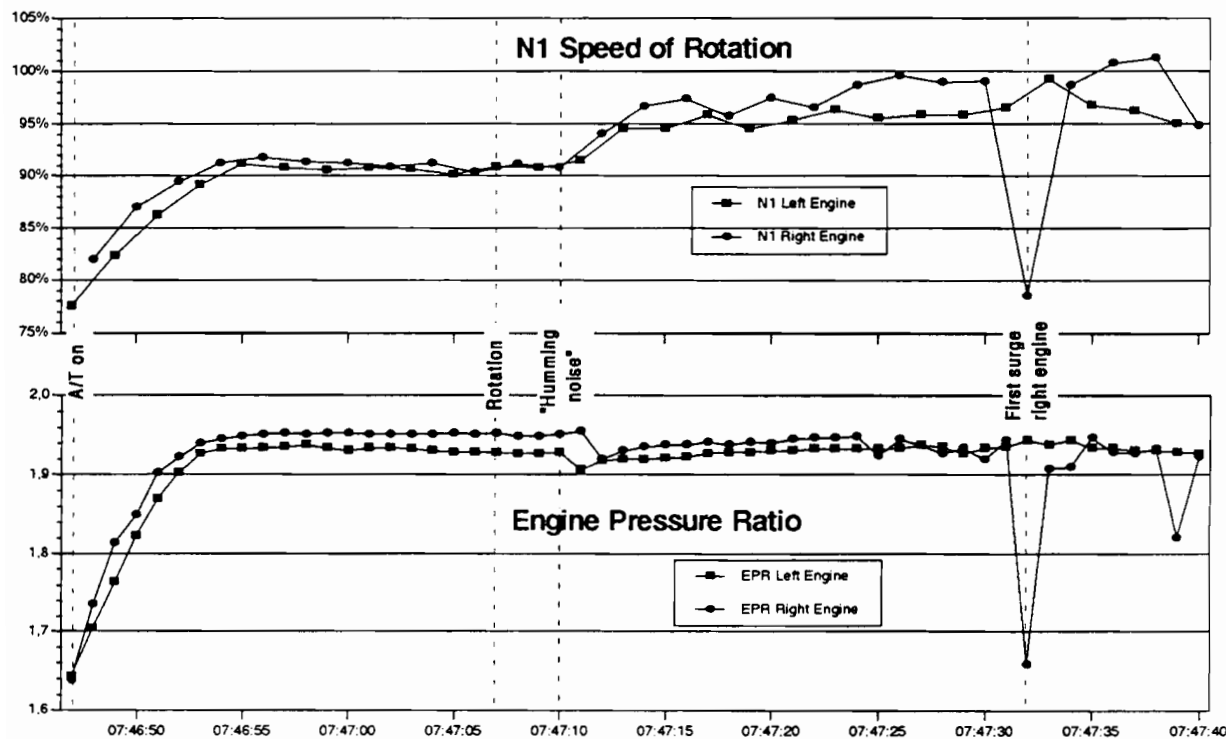
#### *Shift in $N_1$ and EPR at liftoff*

At liftoff an increase in engine  $N_1$  rotation speed by 4% in the left engine and 6% in the right engine was recorded in the QAR. At the same time EPR sank by 0.03 and 0.02 units respectively. These recordings have been compared with corresponding values from earlier takeoffs with OY-KHO and with other MD-81's. The comparison shows that the values at the relevant takeoff were not normal.

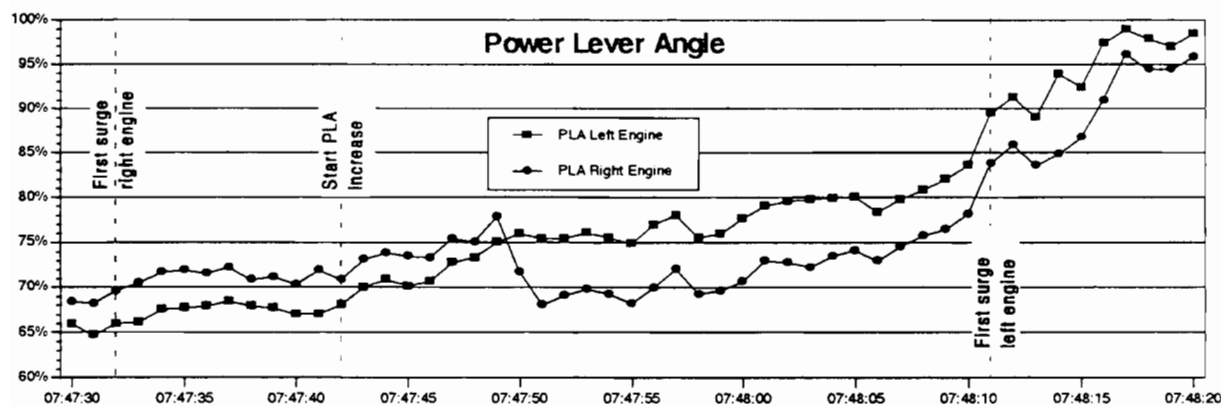
#### *Automatic PLA increase*

As the ATS went over to G/A it started to increase the throttle to enable engine thrust to attain the new higher EPR that applied for G/A. Since this EPR rose with increasing flight altitude, the throttle increase for both engines increased successively during the climb.

As will be shown under 2.3.2 the damage to the engines' fan stages caused aerodynamic disturbance which led to the engines' EPR decreasing somewhat in relation to the other performance parameters. This meant that more throttle than normal was required for the engines to attain G/A EPR.
