Auxiliary Power Unit Battery Fire
Japan Airlines Boeing 787-8, JA829J
Boston, Massachusetts
January 7, 2013

Incident Report

NTSB/AIR-14/01
PB2014-108867

Aircraft Incident Report

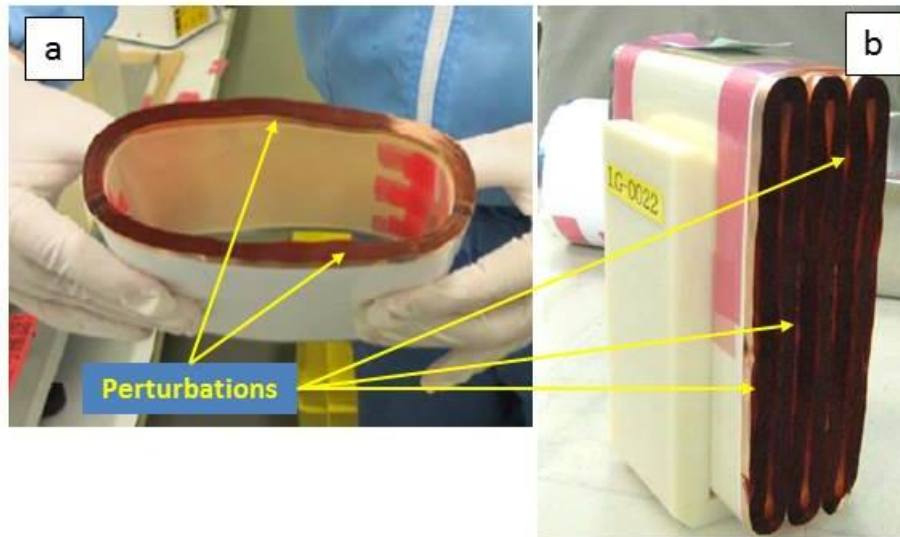
Figure 16. Winding flattening process.

Another machine used a cylindrical winding mandrel to wind the cathode and anode foils together with the separator sheets to create the cell windings. Afterward, the machine operator measured the alignment and weight of each winding. The machine operator then partially flattened each winding by hand compression, as shown in figure 16a, and positioned the three windings for final flattening. The final flattening process was accomplished using a compression jig with two flat plates facing the three windings. After final flattening, the machine operator attached heat-resistant plastic tape to the ends of the cell where the curves of the windings were located, as shown in figure 16b. Figures 16a and 16b also show perturbations of the electrode foil that were created during the flattening process.⁹²

Note: Figure 16a shows an electrode being hand flattened after winding and removal from the mandrel, and figure 16b shows the three-electrode assembly after final flattening and taping.

First, the manual cell winding flattening process can create perturbations (that is, electrode foil buckling) in the windings. Such perturbations (see figure 16) were visually consistent with the wrinkles found in the CT scans of LVP65-8-402 exemplar batteries and those
