# **AIRCRAFT ACCIDENT REPORT 2/2015**

## **Report on the serious incident to Boeing B787-8, ET-AOP London Heathrow Airport on 12 July 2013**

**Air Accidents Investigation Branch**

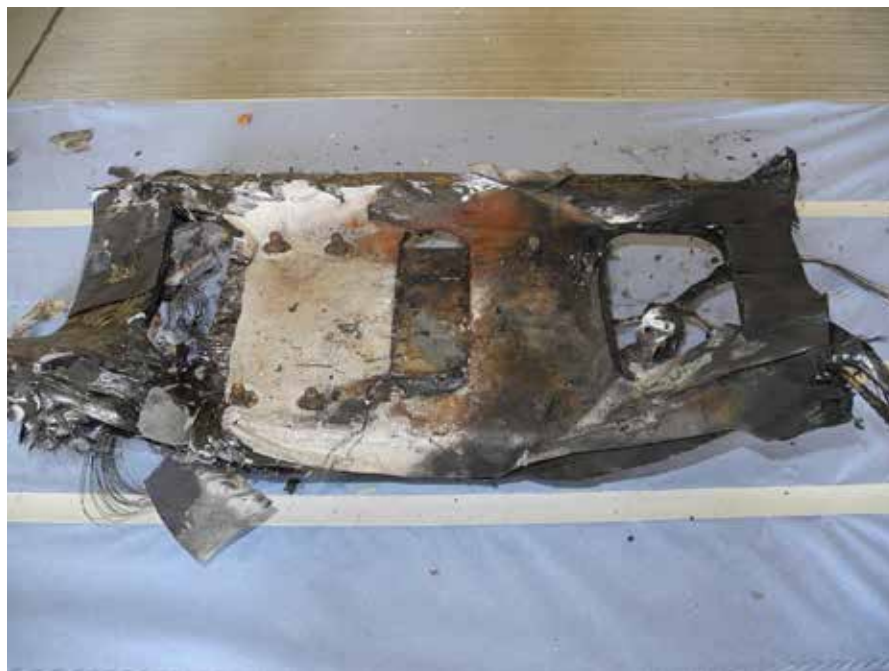
**Figure 11**

The ELT was removed from the aircraft for examination, together with its mounting plate and the sections of frames 1719 and 1744 to which it was attached. When the mounting plate was separated from the ELT it was found to have suffered almost total resin loss, with all the carbon fibre laminations separating readily (Figure 11). Both frame sections had also suffered from resin loss but remained substantially intact.

ELT composite mounting plate

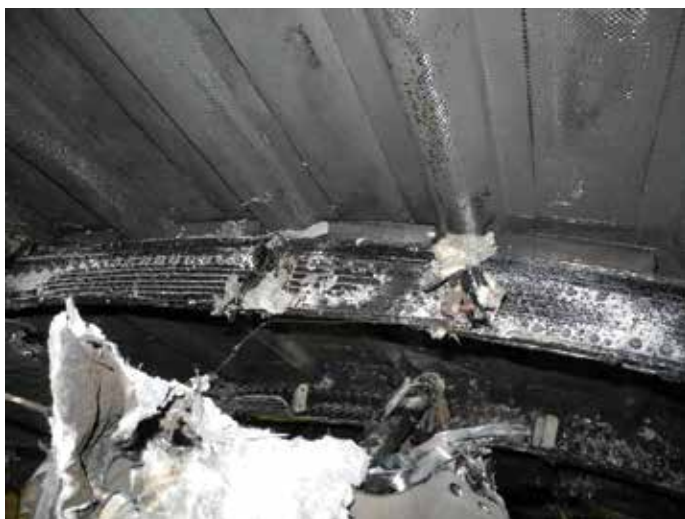
**Figure 13**

Examination of the removed skin confirmed that the areas showing large amounts of resin damage had lost a significant amount of rigidity and the exposed layers of carbon fibres readily separated. The frames exhibited varying degrees of damage. There was evidence of significant loss of resin to frames 1719, 1744 and 1769 between stringers 2R and 6L which resulted in a loss of rigidity in the affected areas. Additionally, the carbon fibre layers had begun to separate at the edges of the frame (Figure 13).

The sections of frame 1719 and 1744, which had been removed with the ELT mounting plate, were subject to laboratory analysis, to determine the temperature to which they had been exposed. The examination confirmed that all the resin had been lost from the frame sections closest to the ELT and that significant resin loss had occurred in the surrounding sections of the frame. However, it was not possible to determine the maximum temperature or duration of heat exposure.

Damage to frame 1719 in the region of the ELT mounting plate (looking aft)

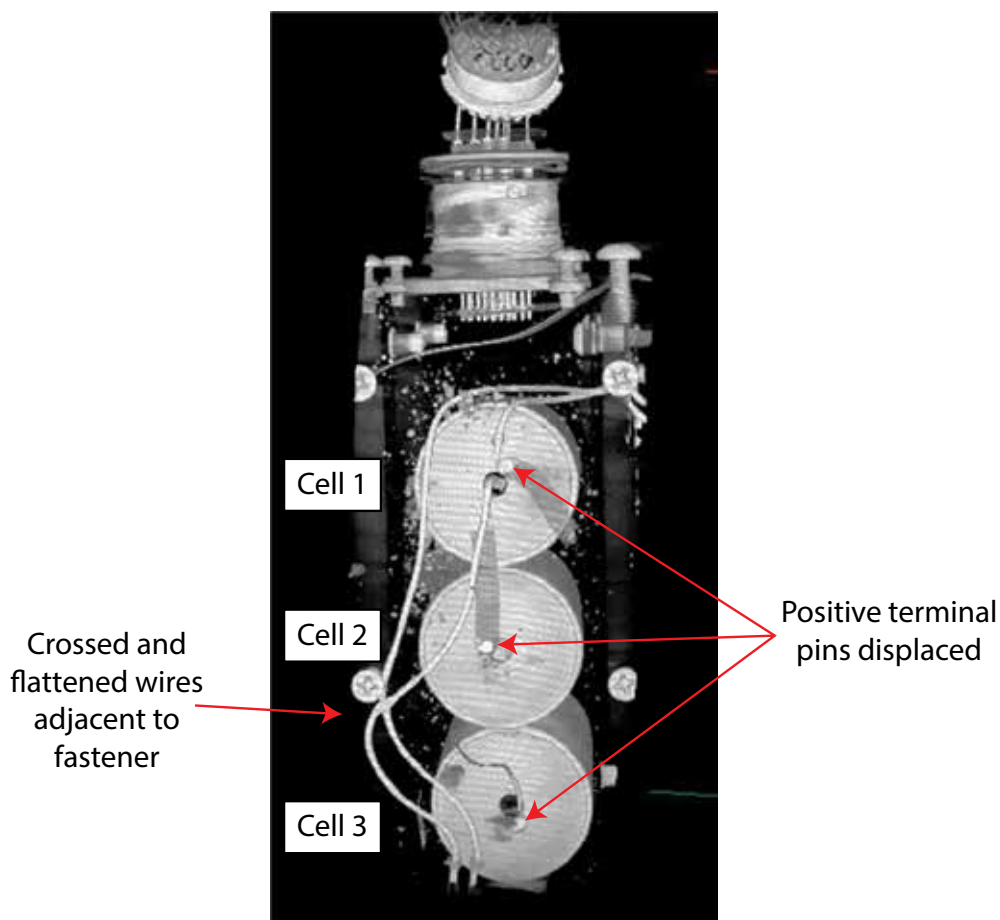
**Figure 15**

The CT images of the ELT showed large breaches in the cell walls of Cells 1 and 2, on the outboard side, and ruptures in the base of Cells 1, 3, 4 and 5. The CT scans also showed that the positive terminal pins on all five cells had been displaced from the cell headers, and that there was a substantial amount of debris in the ELT battery compartment. Significantly, as shown in Figure 15, the ELT battery wires appeared to be crossed and flattened, adjacent to one of the fasteners for the battery cover-plate. The scans also showed that this fastener was not fully inserted in its fastener hole.

CT image showing top-down view of ELT battery cells 1 to 3

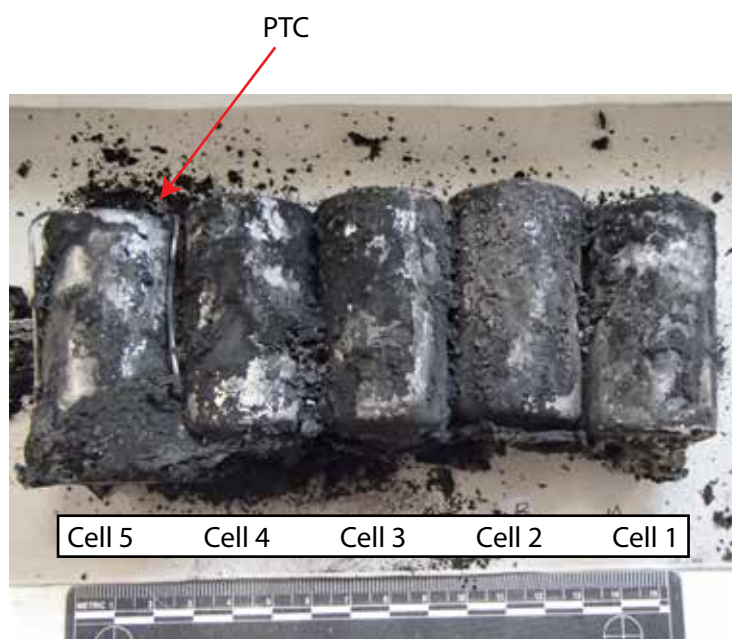
**Figure 18**

Upon removal of the battery it was confirmed that all five cell cases had been breached and battery material had been ejected into the battery compartment. The cells were burnt and blackened and encrusted in charred debris (Figure 18). The remains of the PTC were evident on the negative wire, where it normally terminates on the Cell 5 header, but due to thermal damage it was not possible to determine its pre-incident condition or electrical connection.

View on inboard side of ELT battery, immediately after removal from ELT

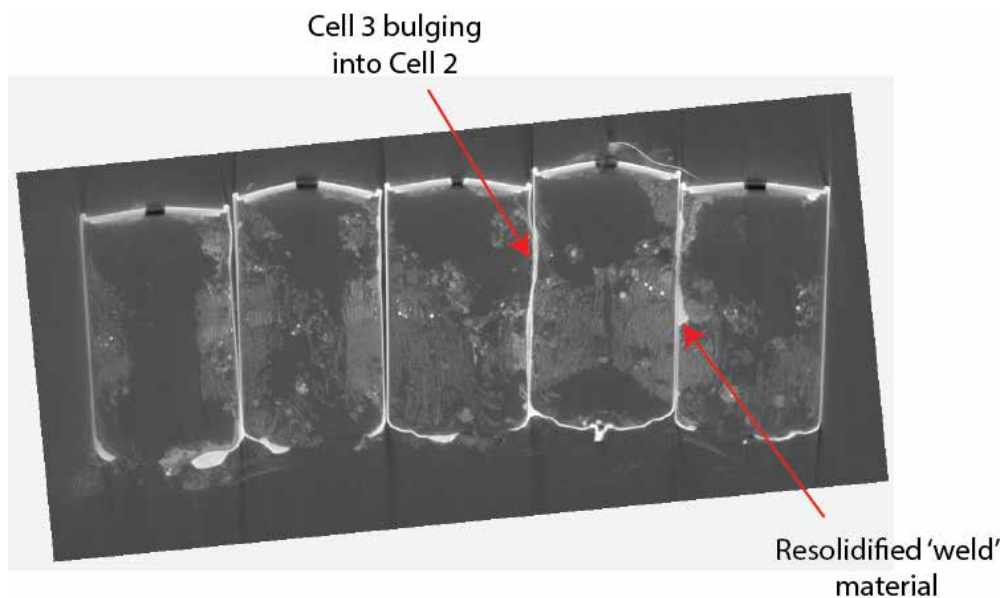
**Figure 21**

Examination of the CT scans showed that the cell walls in the vicinity of the large sidewall ruptures on Cell 1 and 2, had melted and re-solidified, fusing the two cells together (Figure 20). The melting point of the steel cell-can material is approximately 1,500°C. Solidified debris had accumulated around the sidewall ruptures between Cells 1 and 2, both inside and outside the cells. Smaller ruptures in the sidewalls of Cells 2 and 3 were evident and these had caused localised fusing of the cell walls in two locations. A bulge in the upper half of Cell 3 protruded into Cell 2, causing deformation of the Cell 2 sidewall (Figure 21). The cells were not vertically aligned, particularly Cell 2, which had shifted upwards from the rest of the pack. This suggested some relative movement between the cells during the battery fire. Some horizontal misalignment between the cells was also evident.

Slice through battery from CT scan showing Cell 5 to Cell 1 (left to right)

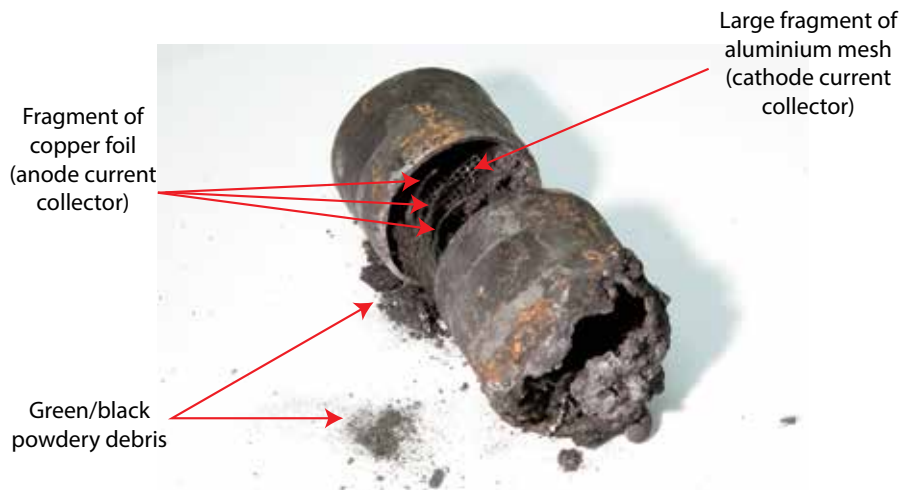
**Figure 22**

Removal of external debris revealed that there were, in fact, two separate apertures in the base of Cell 5. A pipe-cutter was used to open the cell, with some difficulty as the cell was no longer perfectly cylindrical. Large fragments of aluminium mesh (cathode current collector) were present in the upper half of the cell. A few coils of copper foil (anode current collector) were present at the expected position, around the 'equator' of the cell, but they were in a fragile condition (Figure 22). The lower half of the cell contained debris, some of which was solidified.

Cell 5 disassembly showing remaining cell winding components

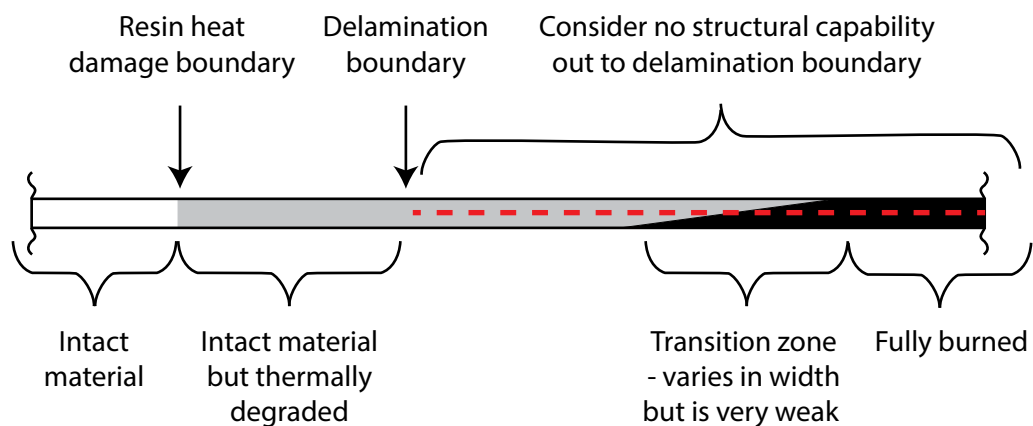
**Figure 23**

vaporisation of the B787 CFRP typically occurs at approximately 300°C and ignition could occur when the temperature reaches 330°C to 360°C. Figure 23 illustrates a typical cross-section of a CFRP skin panel after exposure to fire. Typically in 'open air' conditions, after ignition has occurred and the heat source is removed, CFRP will self-extinguish. Sustaining combustion within CFRP requires a combination of sustained elevated temperatures and sufficient thermal input to cause adjacent CFRP to reach ignition temperature.

Typical cross section of burned CFRP (Boeing)

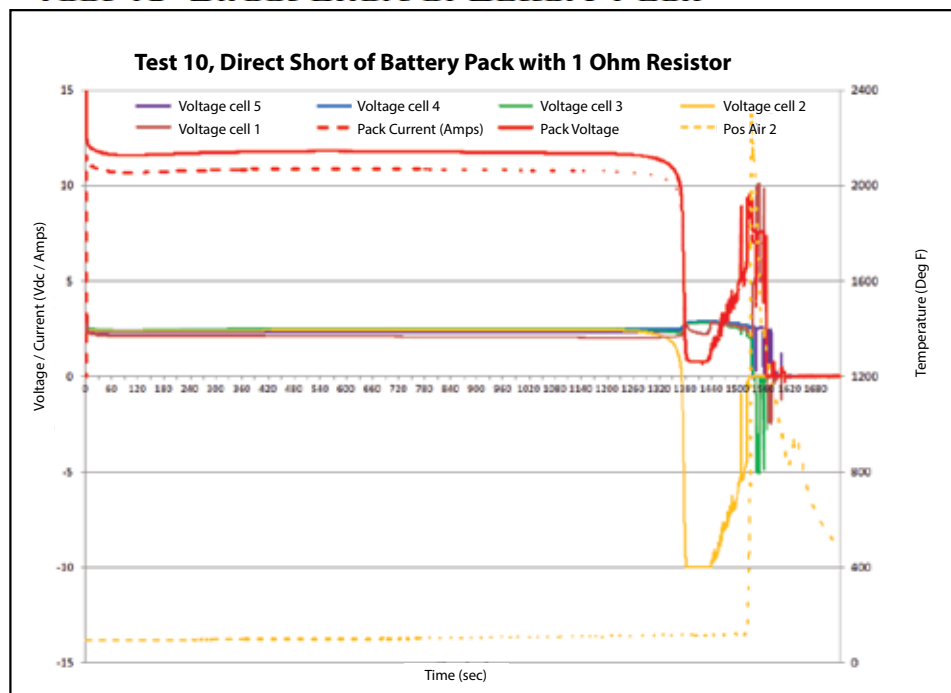
**Figure 26**

Twenty three minutes after the battery pack was shorted, Cell 2 experienced a 'voltage reversal'<sup>19</sup> to -10V, becoming resistive (Figure 26). Approximately 2½ minutes later, Cell 2 experienced a rapid rise in temperature and decomposed under thermal runaway, exhibiting violent venting of gas, sparks and flames. The failure propagated to the remaining four cells, which all failed in a similar manner.

Honeywell Test 10, low resistance short of ELT battery pack with 1 ohm resistor (PTC bypassed)

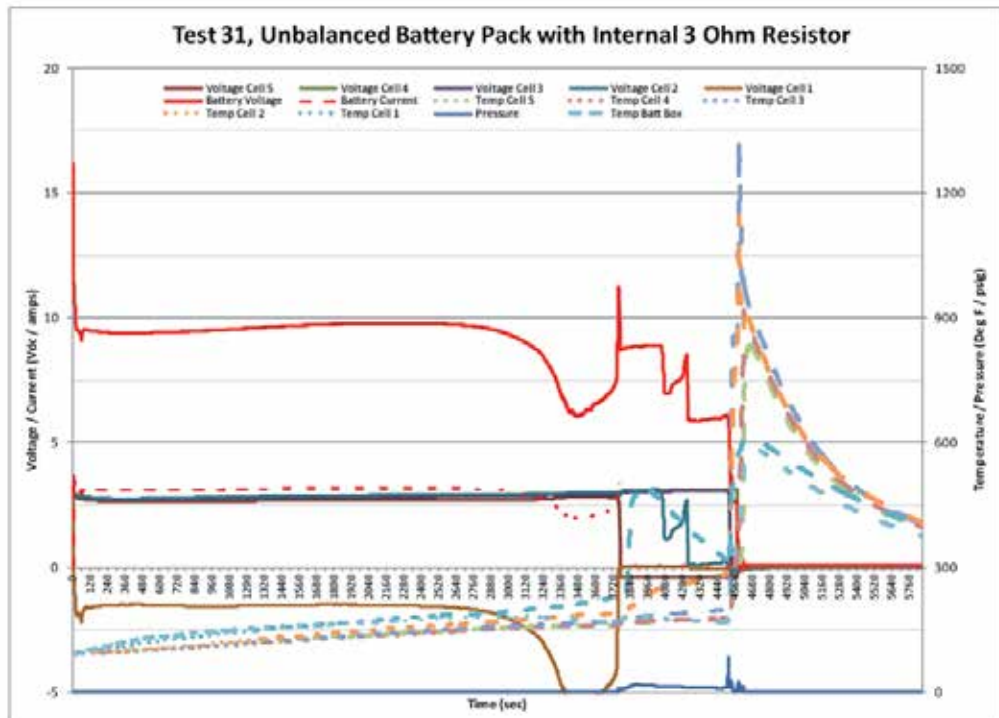
**Figure 28**

Immediately after initiating the short, the depleted Cell 1 voltage reversed to -2V. One hour later, Cell 1 voltage dropped further to -5.5V and it then experienced a significant thermal event, which cascaded to the other cells over a 15 minute period (Figure 28). Cell 1's maximum temperature at failure (260°C) was noticeably lower than the temperature of the remaining four cells during their subsequent failures (426 – 649°C), most likely because it had been depleted prior to the test.

Honeywell Test 31 results,  
moderate-resistance short of unbalanced battery pack installed in ELT

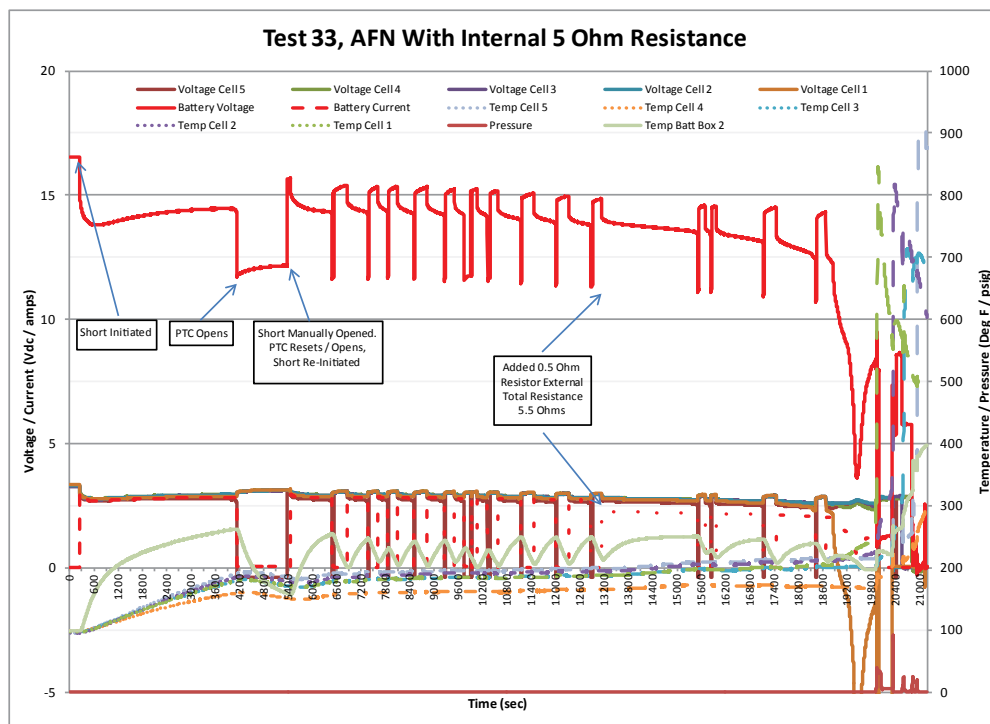
**Figure 29**

With the high resistance of the tripped PTC in the circuit, the battery pack voltage dropped to approximately 12V (Figure 29). 22 minutes after the PTC tripped the circuit was manually opened, resetting the PTC to its low resistance state. The circuit was then reconnected to re-create the short circuit. After a short period the PTC tripped again. This process of opening and closing the circuit was repeated; the time required to trip the PTC decreased with each cycle.

Honeywell Test 33 results, moderate-resistance short of balanced battery pack installed in ELT with manual PTC resets

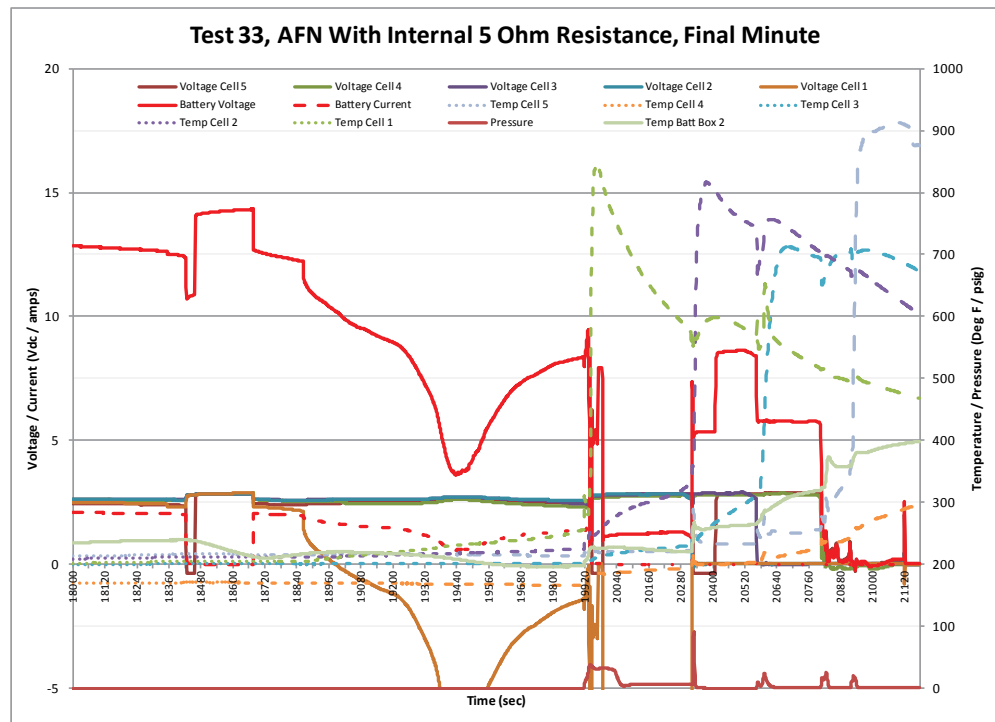
**Figure 30**

After 11 cycles of opening and closing the circuit as a means of getting the PTC to reset, an additional 0.5 ohm resistor was added, outside the test chamber. This reduced the current to 2.2A and increased the time between PTC trips. After a total of 16 cycles, Cell 1 experienced a voltage reversal (Figure 30) and decomposed under thermal runaway. This propagated to the neighbouring cells in a cascading thermal runaway, over the next 19 minutes.

Honeywell Test 33 results, expanded view showing final failure

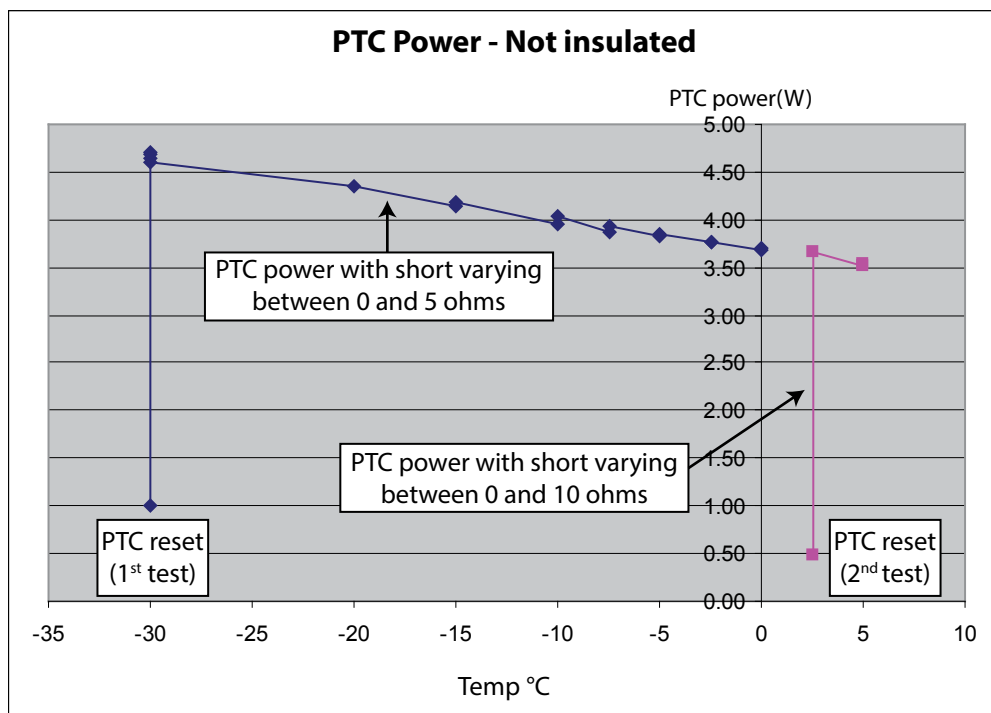
**Figure 34**

A second, similar test was run, with the external load varying between a short and 10 ohms. The results indicated similar PTC behaviour, however the PTC reset at a much higher temperature (+ 2.5°C), due to the reduced current under the higher resistance load. For both PTC reset tests, it was observed that the PTC resistance,  $R_{PTC}$ , varied considerably while in the tripped state. Also, as shown in Figure 34, the PTC power value was relatively constant, while in the high-impedance state, and linearly proportional to ambient temperature.

PTC reset test: PTC power versus temperature

The PTC reset testing indicated that, once tripped, the PTC would change its resistance as required, to deliver the power necessary to maintain the high-impedance mode. This condition was met for the three PTC reset tests conducted in the thermal chamber. If a change in the electrical circuit or the ambient temperature occurred which made it impossible for the PTC (regardless of its resistance) to maintain the required power, the PTC would reset.

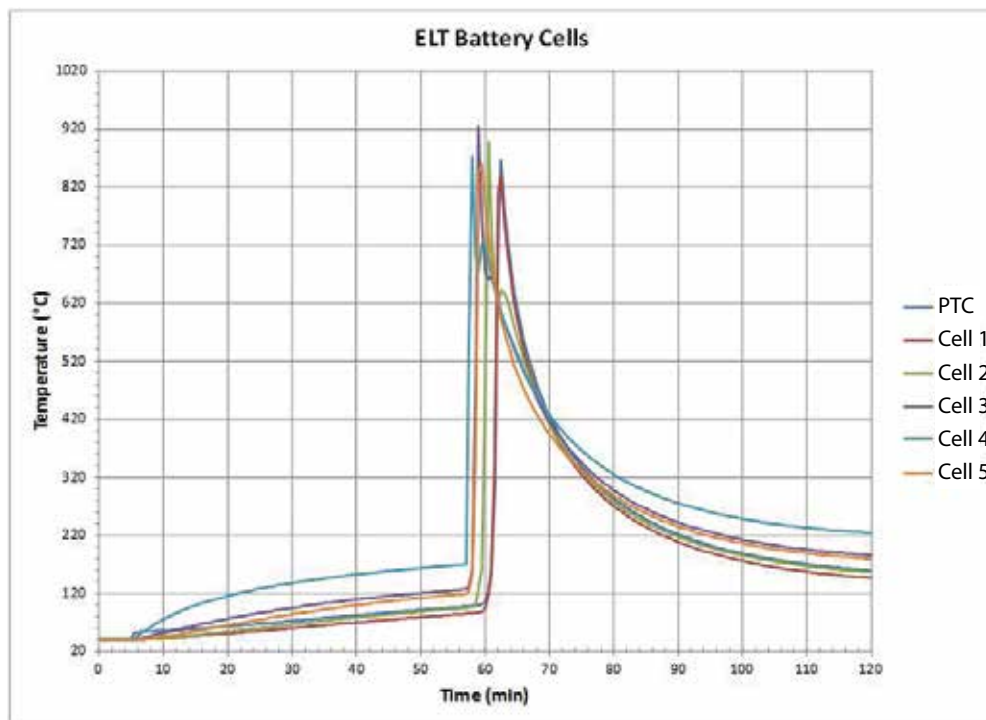
**Figure 36**

The model was run, and following the Cell 2 failure, it predicted a propagating thermal failure through the cell stack, with cell temperatures peaking at 920°C (Figure 36). The time from the initial cell failure to that of the last cell was 5 minutes. The model provided good correlation with the test results from the Root Cause testing.

Thermal model prediction of an event initiated by a short-circuit at the location of the pinched wires

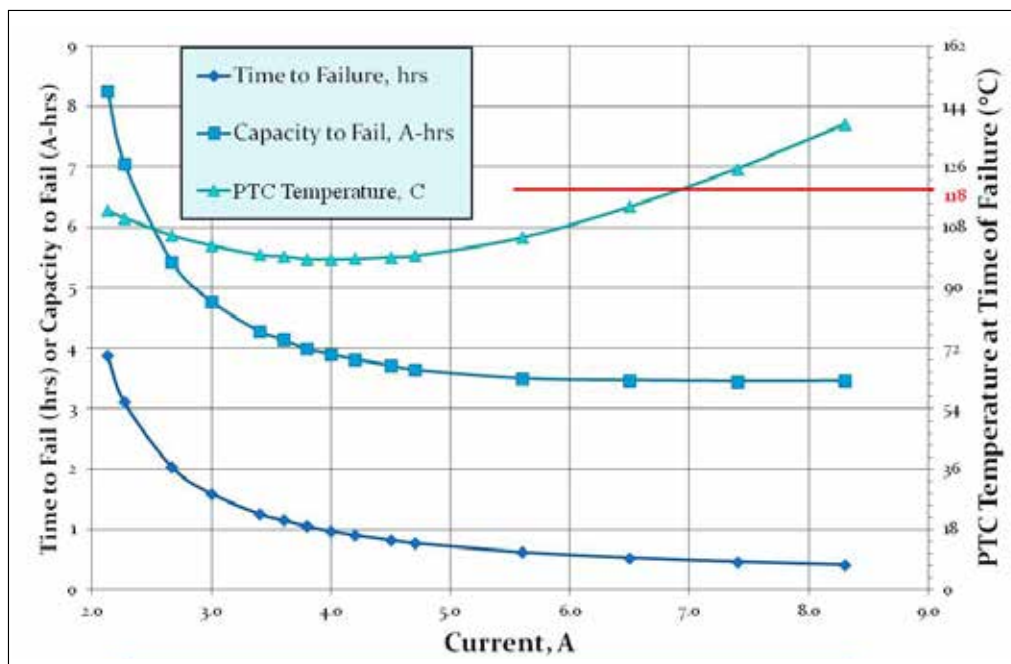
**Figure 37**

The model predicted that if the short-circuit current was less than approximately 2A, the heat from the short-circuit can conduct through the cell stack and ELT chassis. This would cause the temperature to exceed the PTC switching temperature (118°C). The PTC would therefore trip and protect the battery. (Note: the Capacity and Time-to-fail curves in Figure 37 become asymptotic at 2A).

PTC and cell temperature thermal analysis

As the short-circuit current was increased above 2A, the model predicted that Cell 2 could fail when the PTC temperature was below the switching temperature. It showed that the time to failure would drop from 4 hours to 30 minutes as the current increased.

The model showed that the predicted PTC temperature at the time of Cell 2 failure would reach a minimum, at a short-circuit current of approximately 4A. The PTC temperature would then increase as the current increased, due to the dissipated power losses ( $I^2R$ ) within the PTC.

In summary, a short-circuit current of between 2A and 7A could lead to a cell failure without activation of the PTC. The results of this modelling broadly matched the results of the Root Cause testing, which indicated that a short current below 2A would not result in the PTC tripping.

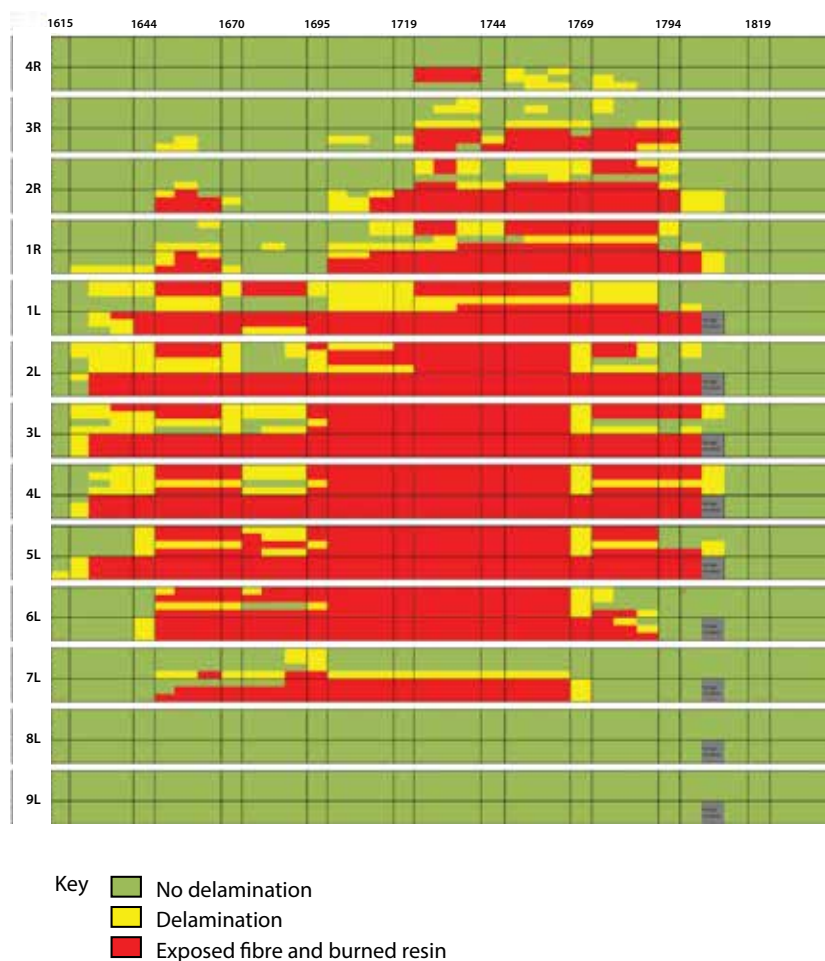
**Figure 40**

The two sets of results were combined to produce a composite picture of the condition of the crown skin and stringers (Figure 40).

Composite plot of crown skin-stringer ultrasonic test results

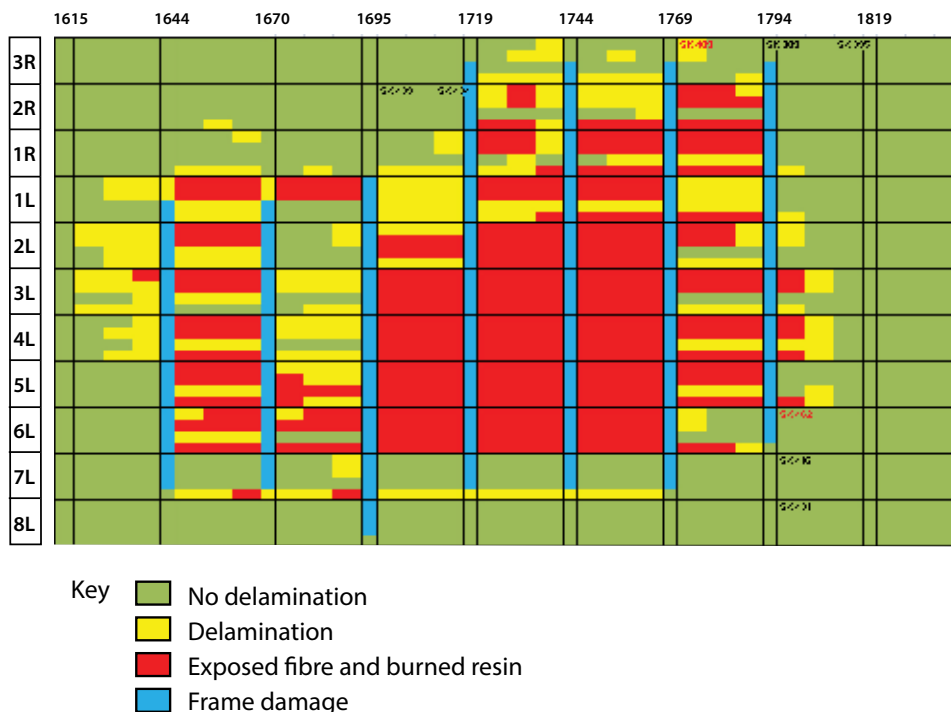
**Figure 41**

All the frames were manually scanned with ultrasonic probes and the damage boundary for each frame was identified. The transition area from heavily burnt sections of the frame to sections with no damage, was typically less than one to two inches.

The data provided by these tests was overlaid on the data obtained during the skin and stringer testing (Figure 40), to produce a combined representation of the delamination of the damaged fuselage structure (Figure 41).

Combined composite plot of skin and frame delamination

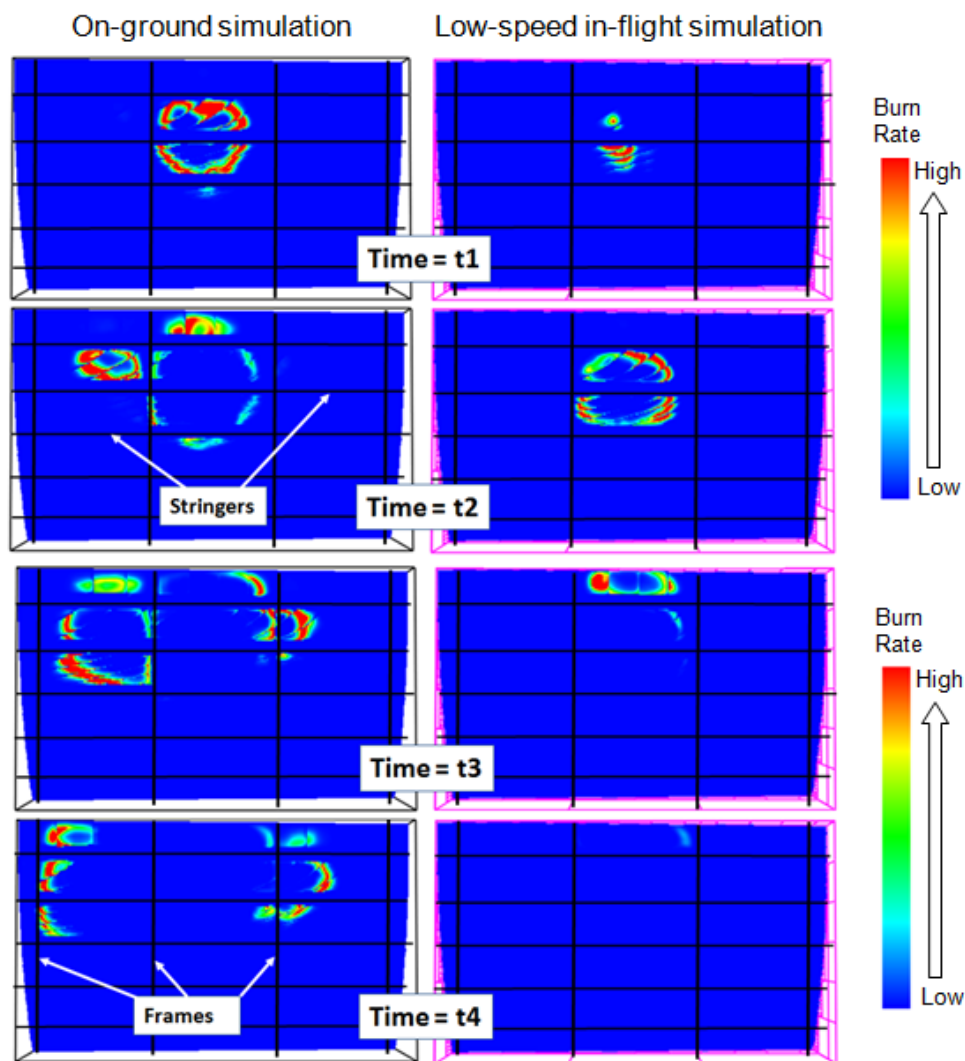
**Figure 46**

The fire progression in the on-ground and in-flight simulations at four arbitrary times, t1, t2, t3 and t4, are shown in Figure 46. The results show that the effect of external in-flight cooling decreases the flame propagation rate within the structure and limits the damage. It also demonstrates that when the heat transfer rate is high, the fuselage frames become a more effective barrier to fire progression, and the in-flight fire is restricted to a single bay before self-extinguishing. Had the model used a heat transfer rate more representative of cruise conditions, it is likely that this damage would be limited further.

FDS fire model results

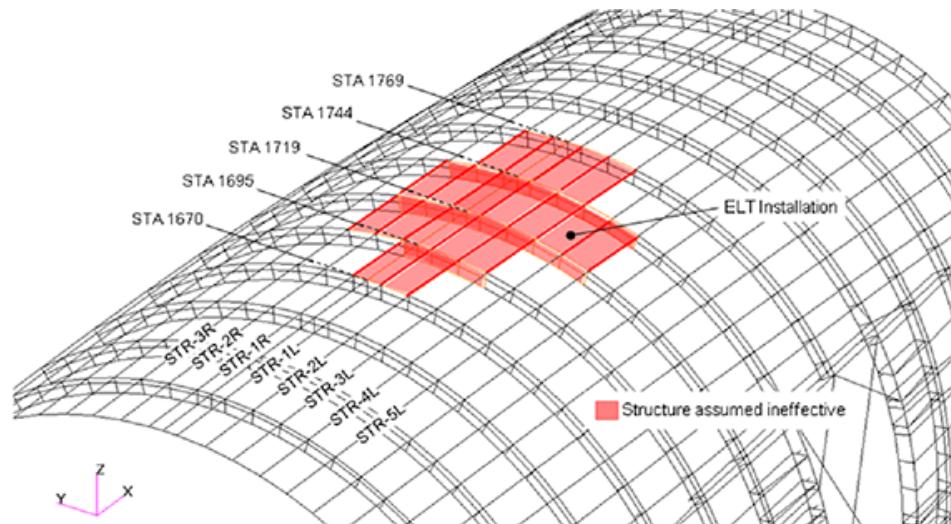
**Figure 47**

The first, a worst-case scenario, assumed that an area of structure equivalent to 18 stringer-frame bays (Figure 47), had no remaining structural strength and the adjoining bays had reduced strength. The results of the finite element modelling indicated that for this scenario cabin pressure would not be maintained but the fuselage would remain capable of carrying flight loads.

In-flight fire - large area of skin damage

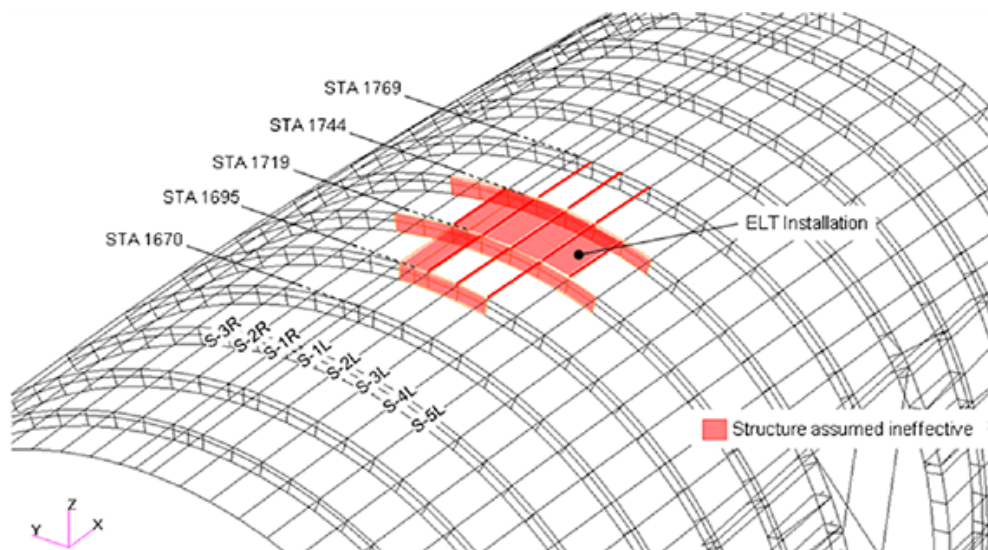
**Figure 48**

The second scenario, assumed that a smaller area of damage, equivalent to 5 stringer-frame bays, was unable to carry structural loads (Figure 48).

In-flight fire - small area of skin damage

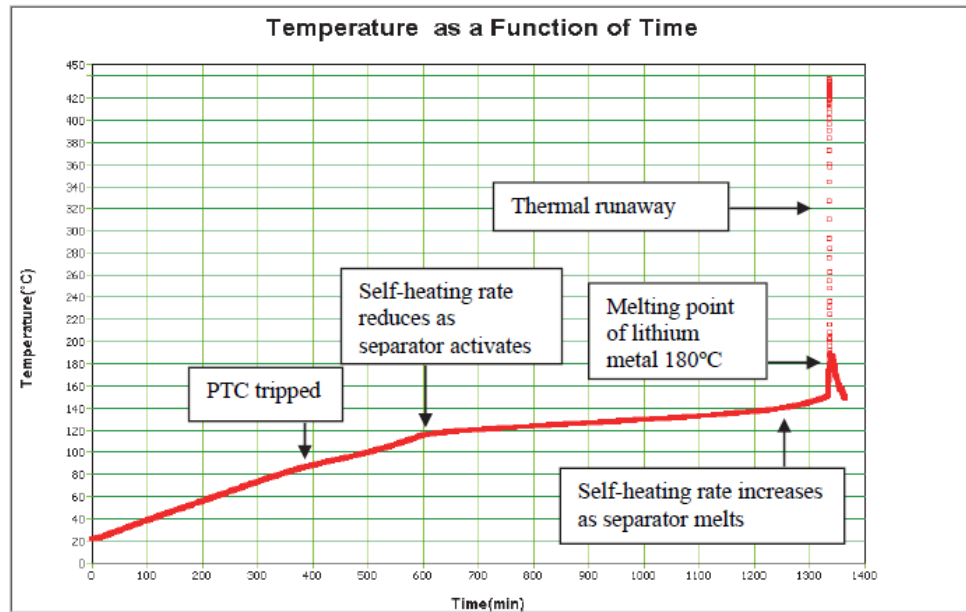
**Figure B3**

During discharge the battery temperature gradually increased over a period of approximately 8 hrs from an ambient starting temperature of 20°C, until at approximately 98°C, when the battery was 70% discharged, the PTC tripped. The self-heating rate up to this point had been between 0.1 and 0.2°C/min. The test configuration did not allow for measurement of the PTC leakage current or battery pack voltage after the PTC tripped.

At this point the Cell 2 temperature rose sharply, and as the temperature approached the melting point of lithium-metal (180°C) its voltage dropped to zero. This was accompanied by venting and decomposition of the cell under thermal runaway. The failure rapidly propagated to the neighbouring cells in the following order: Cell 1, Cell 3, Cell 4 and Cell 5. The maximum cell temperature measured during the test was 454°C on Cell 2 and the maximum self-heating rate was in excess of 1000°C/min. The results of this test are presented in Appendix B (ii).

Temperature (°C) versus time (min) for Battery Discharge Test 1
