AIRCRAFT SERIOUS INCIDENT INVESTIGATION REPORT

AIR NIPPON CO., LTD.
BOEING 737-500, JA8419
OVER THE SEA APPROXIMATELY 60 NM SOUTHEAST OF
KUSHIMOTO VORTAC
JULY 5, 2006

June 27, 2008

Aircraft and Railway Accidents Investigation Commission
Ministry of Land, Infrastructure, Transport and Tourism

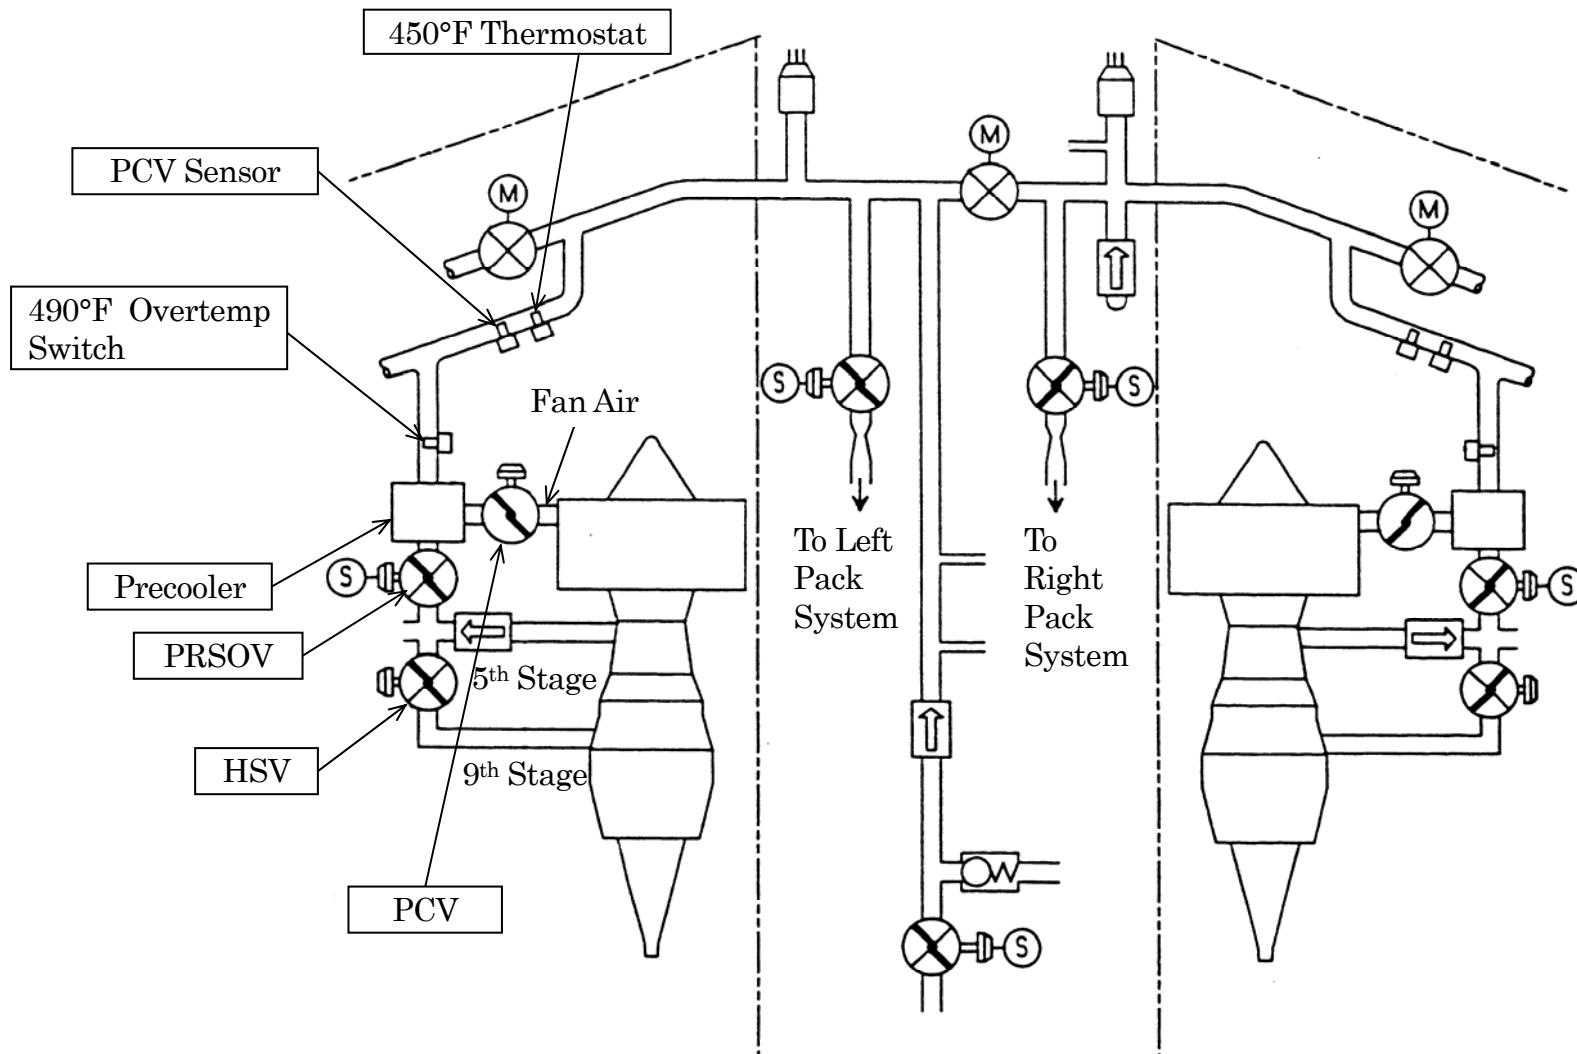
Figure 2 Schematic diagram for bleeding-air related components

The valve linkage hinge was corroded with granular contamination on it.
(See Figure 2 and Photographs 1 and 2.)

It is estimated that, when higher-temperature 9th-stage bleed air flowed into the pre-coolers, both the No. 1 and No. 2 PCVs, the role of which is to control the fan air, operated sluggishly due to contamination deposits and thus failed to allow sufficient fan air to flow to the pre-coolers, causing insufficient cooling and the No. 1 and No. 2 overheat switches to trip, which then caused both bleed valves to close (as indicated by illumination of both BLEED TRIP OFF lights), resulting in an abnormal drop in cabin pressure.
