**Turkish Airlines DC-10 TC-JAV**  
**Report on the accident in the**  
**Ermenonville Forest, France**  
**on 3 March 1974**

**ACCIDENT TO  
TURKISH AIRLINES DC-10 TC-JAV  
IN THE ERMENONVILLE FOREST  
ON 3 MARCH 1974**

**FINAL REPORT**

February 1976

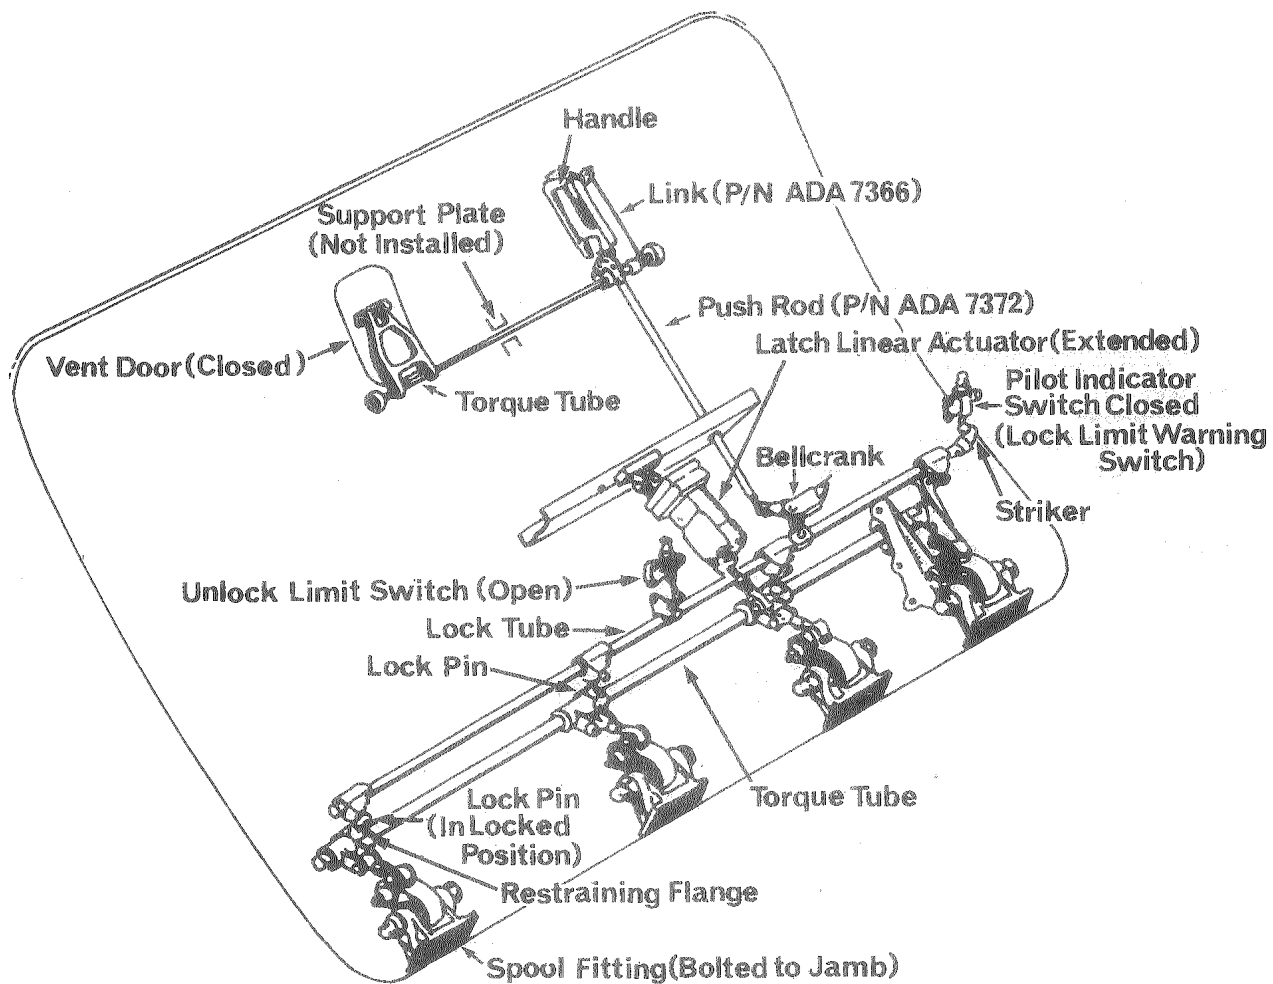
**FIG. 6**

This closure was possible only because of deformation of the mechanism providing control transmission for the operation of the lock tube. The principal deformation affected the vent door shaft. The additional support plate specified by SB 52-37 (fig 6) was designed precisely to prevent such deformation.

**CLOSING AND LOCKING MECHANISM  
(CLOSED AND LOCKED POSITION)**
