**Statens haverikommission**  
Swedish Accident Investigation Board

## ***Report RL 2009:14e***

**Incident involving aircraft OE-LRW  
at Åre/Östersund airport, Z län  
(Jämtland county),  
Sweden on 9 September 2007**

Case L-27/07

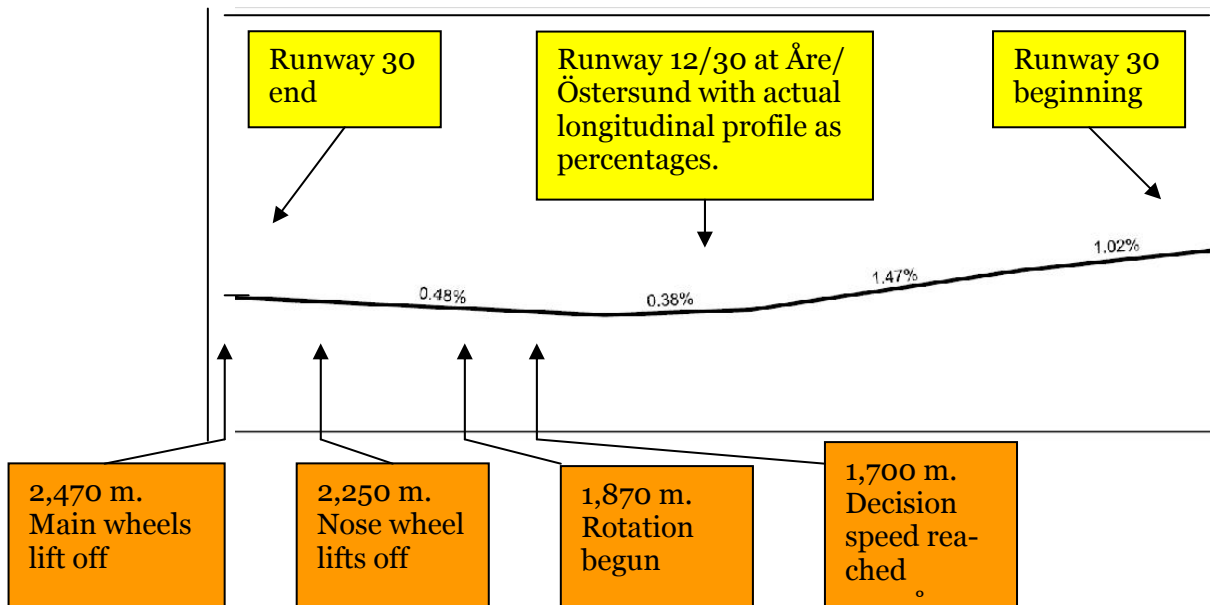
The aircraft rolled for about 47 seconds along the runway before the nose wheel lifted off. This took place at about 164 kt (CA), and after a further 3.5 seconds, approximately, the main wheels left the runway. During the subsequent second the aircraft collided with the two transverse light bars closest to the runway 12 threshold, at a height of about 45 cm above ground.

The rolling distance was calculated from the CA recording, time and most recent known wind information (120/8). Runway 30 has a length of 2 500 m. The calculations show that the aircraft reached decision speed  $V_1$  at about 1 700 m from the start of the runway, rotation began at about 1 870 m, the nose wheel lifted at about 2 250 m and the main wheels left the runway about 30 m from the end of the runway.

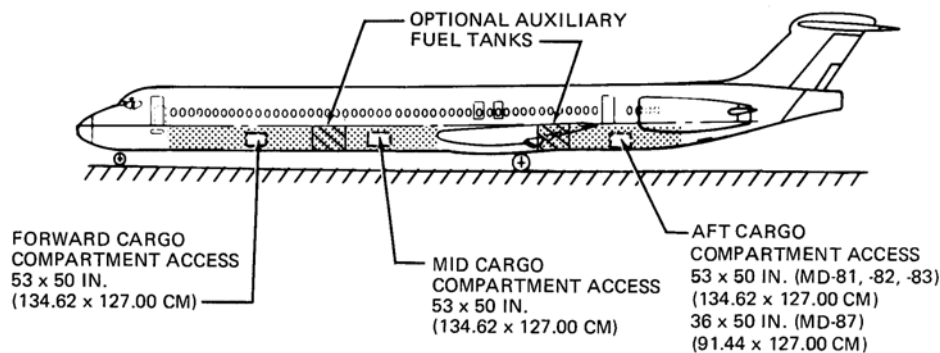
Fig. 10. Cargo compartment divisions in the MD-83.

No written loading instructions were provided from the aircraft crew to the loading personnel in respect of how the baggage should be distributed between the various load compartments. The verbal instructions from the commander were to "load from the rear forwards".

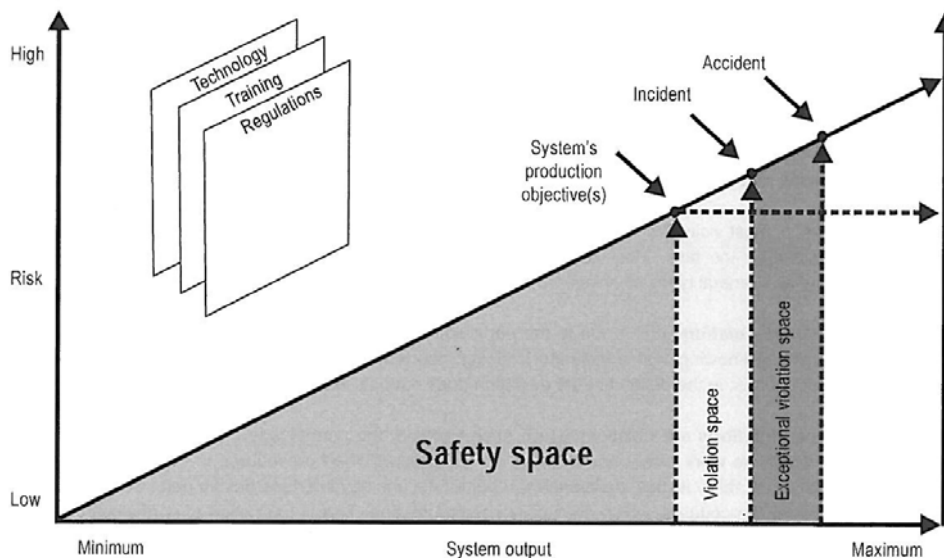
Fig.12. “Understanding violations”. Illustration from the ICAO Safety Management Manual.

A third form of deviation, that is often neglected, is the company’s role in maintaining the balance between production and safety. As illustrated in Figure 12, the risks to safety increase as the production objectives are raised. In a charter company, where marginal operations tend to be standard, the borderline to violations provoked in the area of operations is often very small.

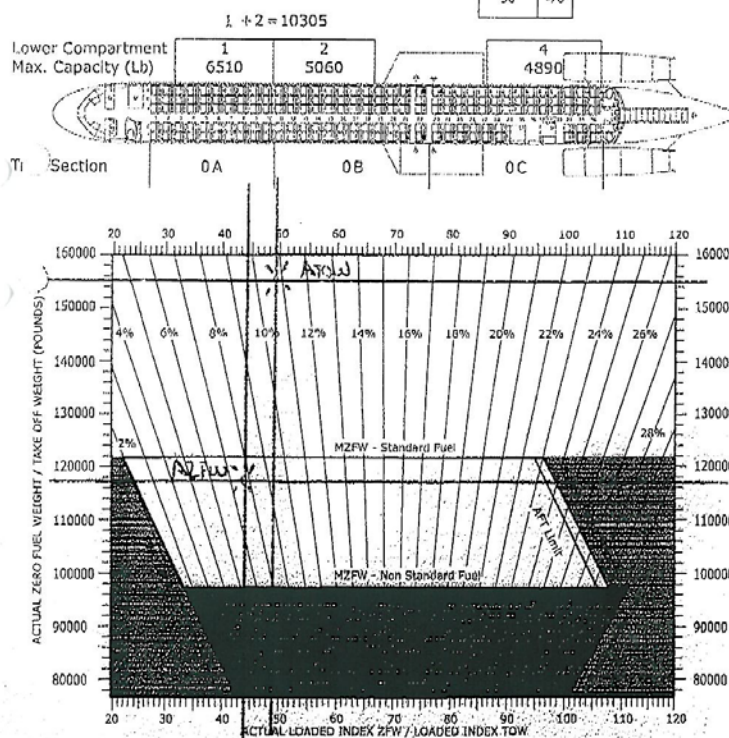
Index Calculation Table	
(-)	(+)
DOI / adj. DOI	10.7
COMP. 1	
COMP. 2	3
COMP. 4	1.5
Total	12.2
DLI	1.13
Sect. OA	7.5
Sect. OB	3.5
Sect. OC	3.5
Total	11.0
Loaded Index ZFW	9.9
Take-Off Fuel +/-	5
Loaded Index TOW	4.9
MAC	7.5% 10.6%
