PB89-910406  
NTSB/AAR-89/04

## **AIRCRAFT ACCIDENT REPORT**

DELTA AIR LINES, INC.  
BOEING 727-232, N473DA  
DALLAS-FORT WORTH INTERNATIONAL  
AIRPORT, TEXAS  
AUGUST 31, 1988

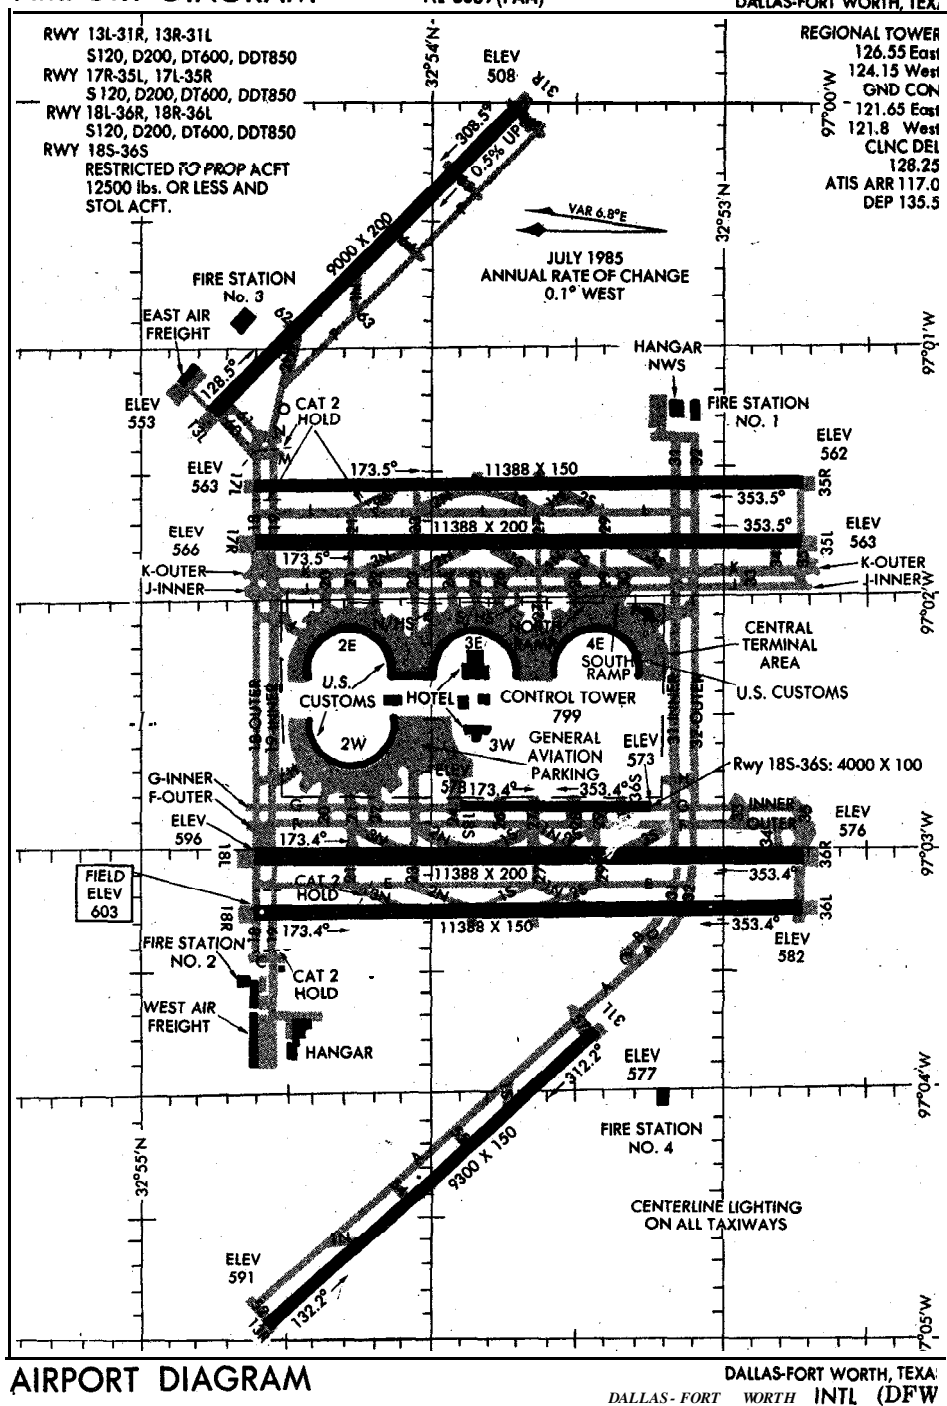
*Figure 1 . - - Airport Diagram.*

*The last 600 feet of the wreckage track indicated that the remaining airplane structure slid sideways; most of the right wing structure outboard of the center fuel tank had disintegrated, until it came to rest near the airport boundary fence located approximately 3,200 feet from the departure end of runway 18L. (See figure 1.)*

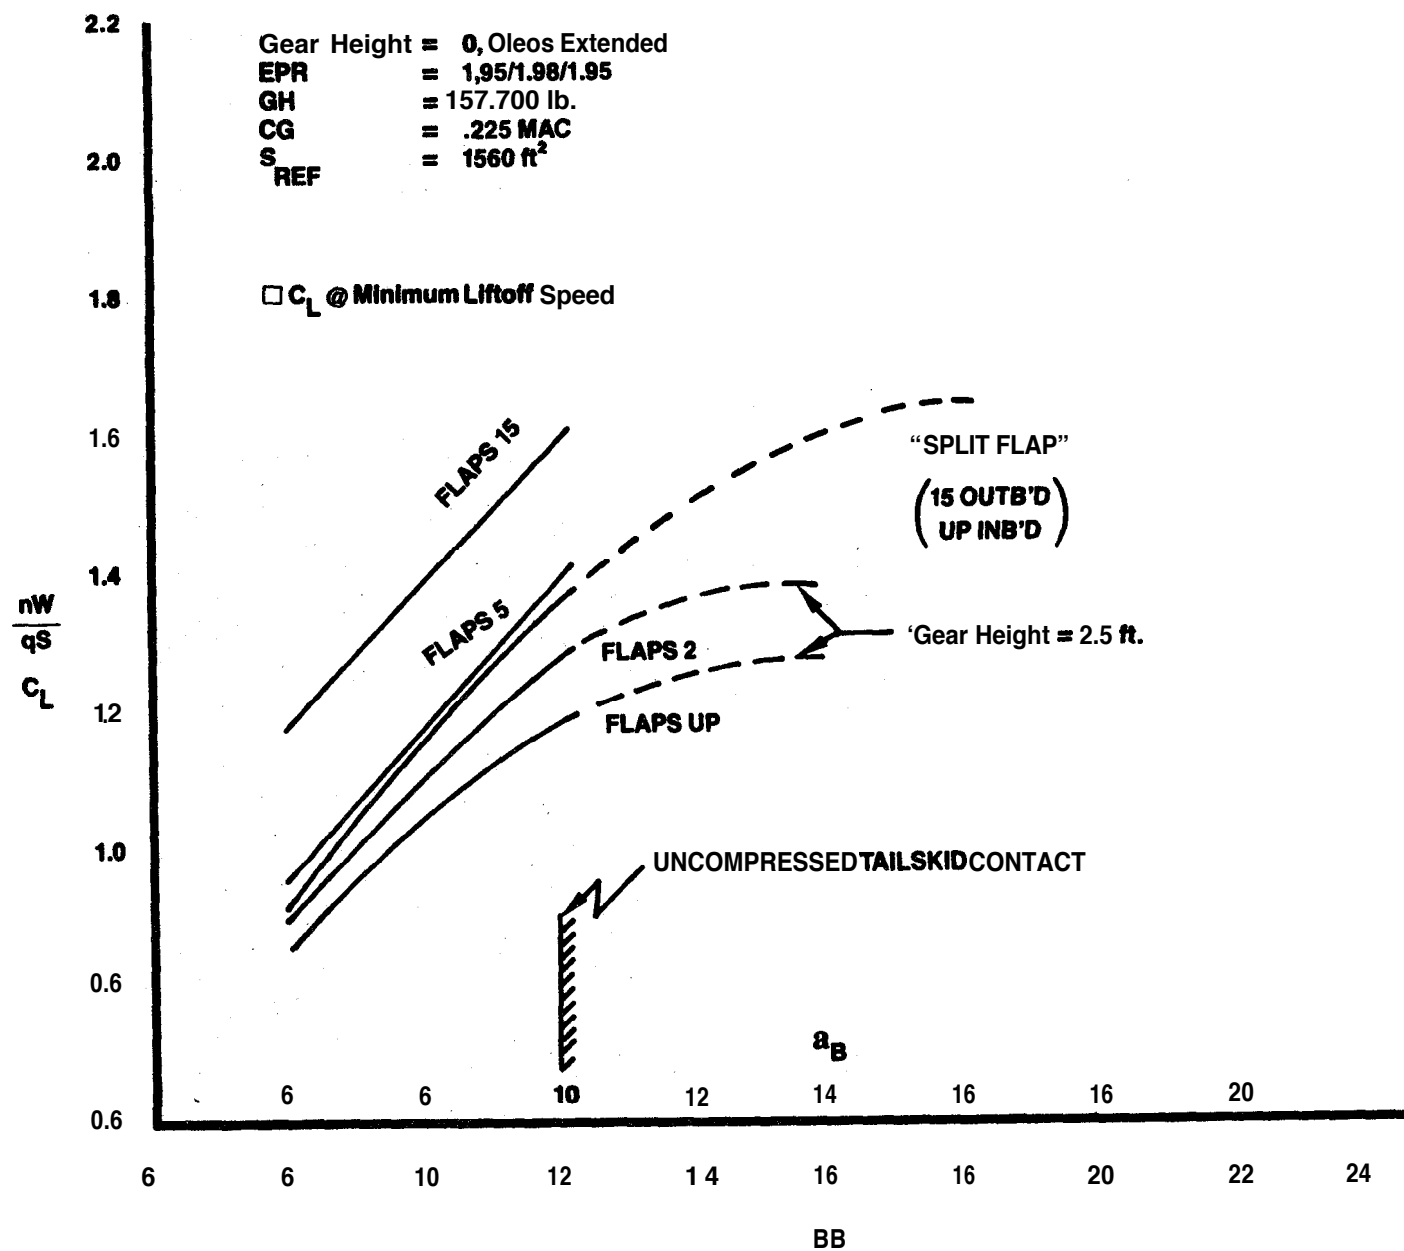
Figure 10.--Boeing 727 city curves, in ground effect zero altitude.

with a normal flap setting of 5°. The stall AOA for "split flaps" is about 9° higher than the stall AOA for flaps at 15° or 5°. (See figures 10 and 11.) The "split flaps" scenario will be discussed later in this report.
