FINAL
KNKT.12.05.09.04

NATIONAL TRANSPORTATION SAFETY COMMITTEE

Aircraft Accident Investigation Report

**Sukhoi Civil Aircraft Company
Sukhoi RRJ-95B; 97004
Mount Salak, West Java
Republic of Indonesia
9 May 2012**

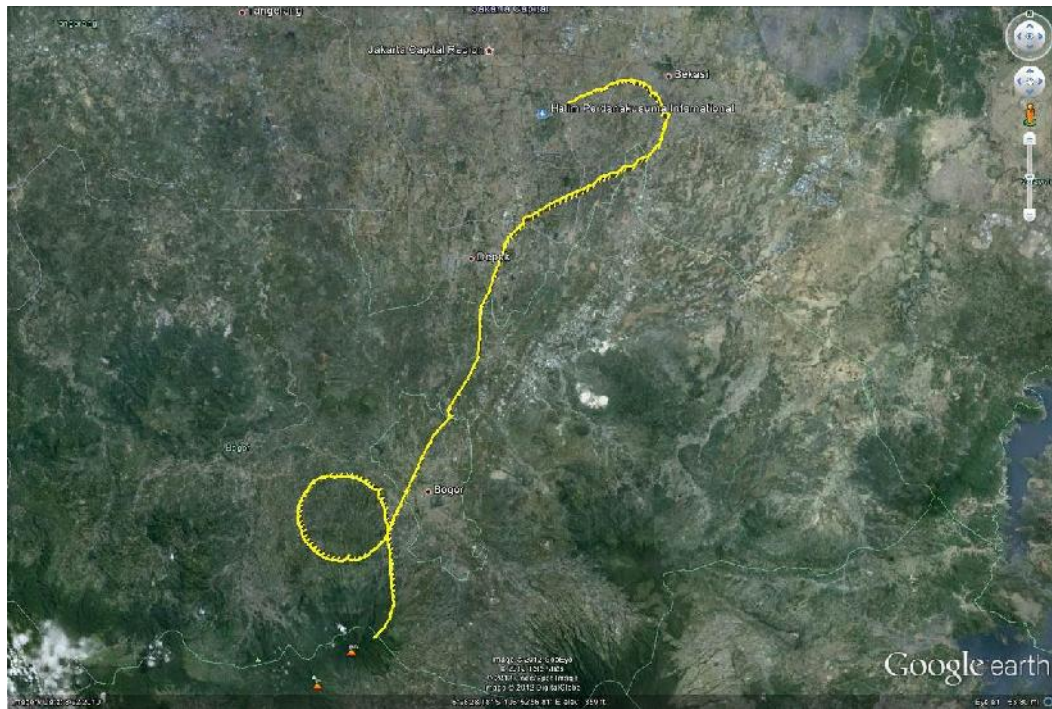
Figure 7: Plot from the radar replay

The following plot was captured from radar replay of the Jakarta Approach which was then superimposed onto Google-earth.

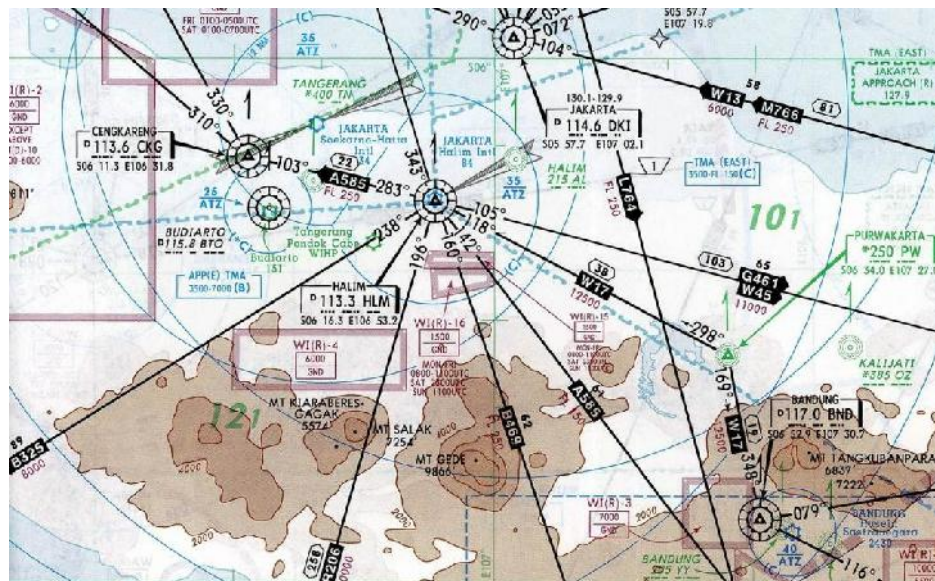
Figure 9: Navigation chart contains information of Atang Sanjaya Training Area and terrain contour

Figure 9 shows a sample of instrument navigation chart that provides information includes the Atang Sanjaya Training Area / WI(R)-4 and the terrain contour. This chart was not carried on the aircraft.

The instrument chart, shown as figure 9, contained terrain contour and "Bogor Area", and the visual chart, shown as figure 10, may have provided a better understanding to the pilot that the point they intended to fly to was close to a mountainous area. These charts were not carried on board the aircraft.

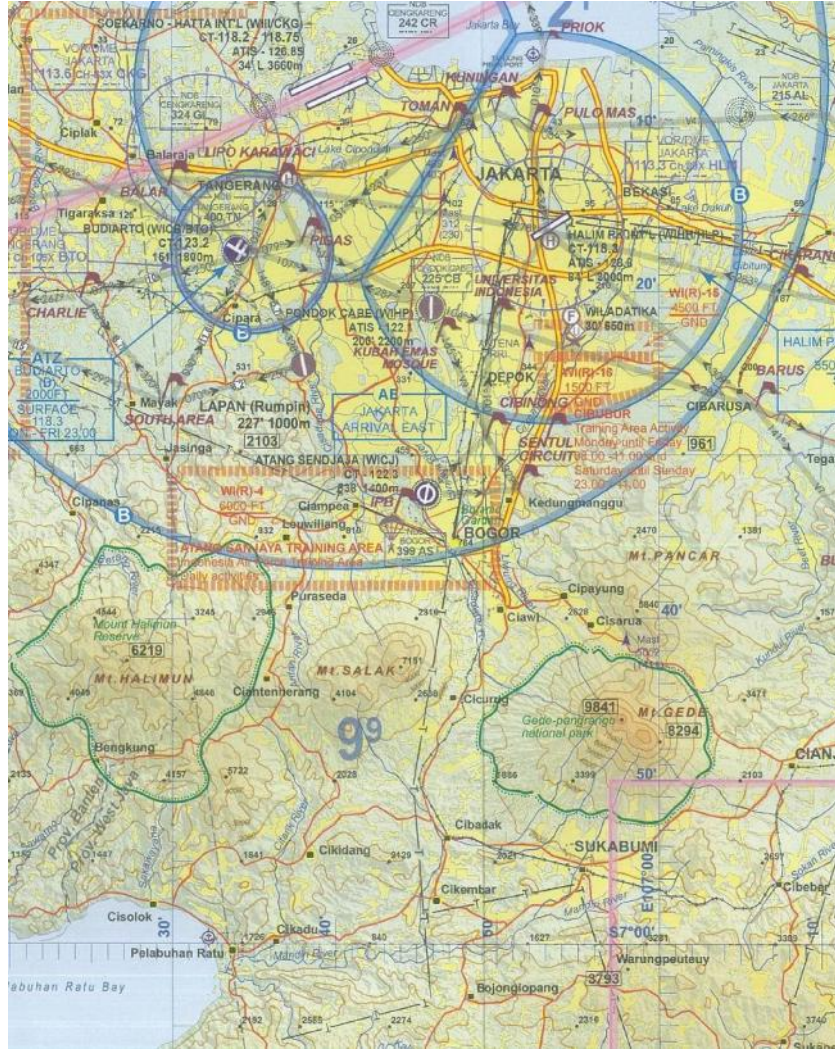
Figure 10: Visual chart

This typical visual chart (figure 10) contains information of the Atang Sanjaya Training Area / WI(R)-4 and the terrain contour which is normally provided by the local government. The investigation was unable to determine if this chart was carried on the aircraft.

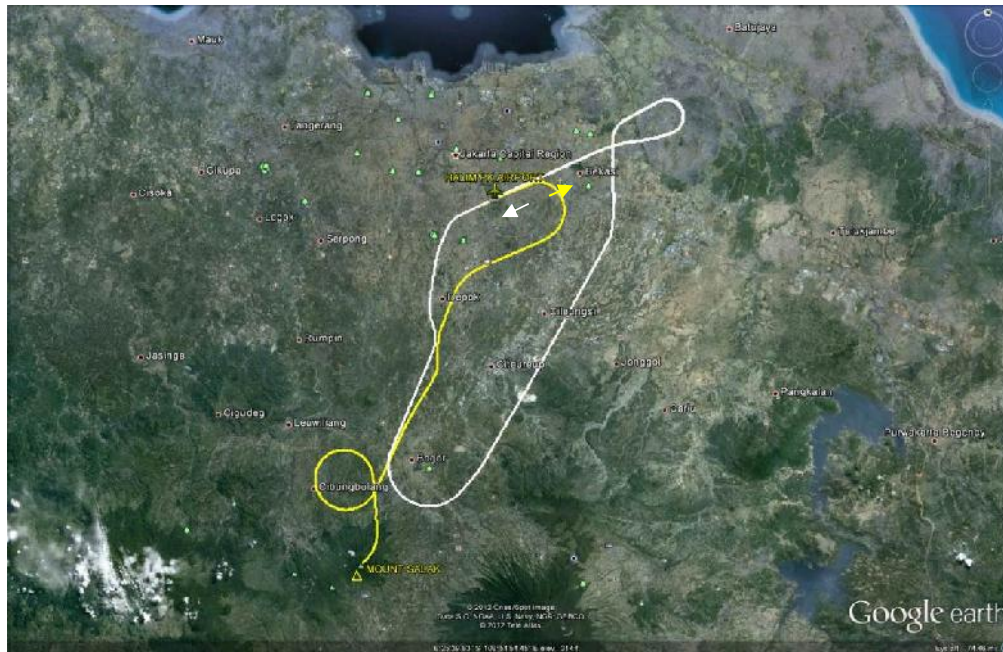
Figure 15: The first and second flight paths

The flight path of the first (white line) and second demonstration flight (yellow line) based on FDR data (figure 14).

This limited information may have given the pilot the understanding that the approved route was toward the point on the 200 radial at 20 Nm from HLM VOR and return to Halim. Evidence from the FDR data as shown on figure 14, showed that the first and the second demonstration flights reached this point. Understanding that the approved route was to a point instead of an area, may have contributed to the pilot's lack of awareness of the "Bogor" area.
