AIRCRAFT ACCIDENT REPORT

Uncontrolled Descent and Collision With Terrain

United Airlines Flight 585

Boeing 737-200, N999UA

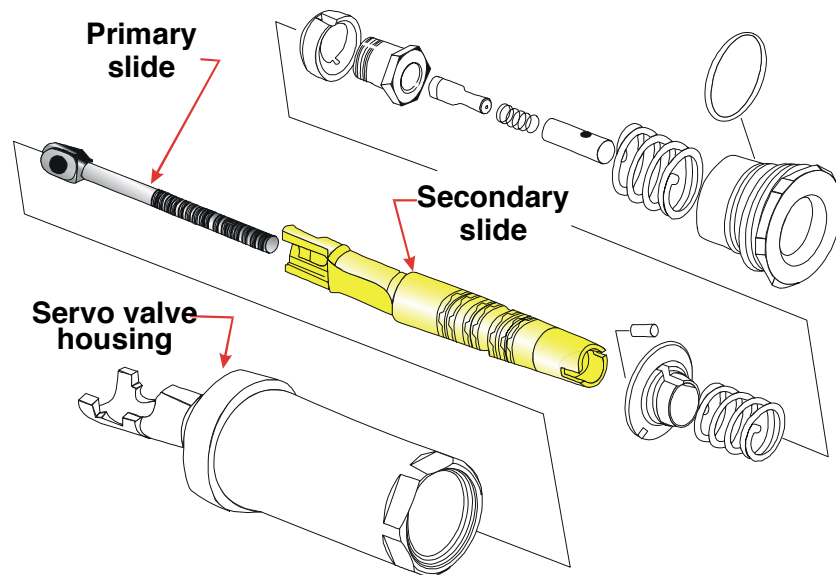
Figure 7. Boeing 737 main rudder PCU servo valve.

The 737 main PCU servo valve was designed by Boeing and is manufactured to Boeing specifications by Parker Hannifin Corporation. It is a dual-concentric tandem valve composed of a primary slide that moves within a secondary slide that, in turn, moves within the servo valve housing. The primary and secondary concentric slides are moved by primary and secondary internal summing levers, which translate inputs from the yaw damper¹⁵ and/or the external input crank (which moves when a pilot steps on the rudder pedals) into axial movement of the slides. Figure 7 shows an expanded view of the servo valve.

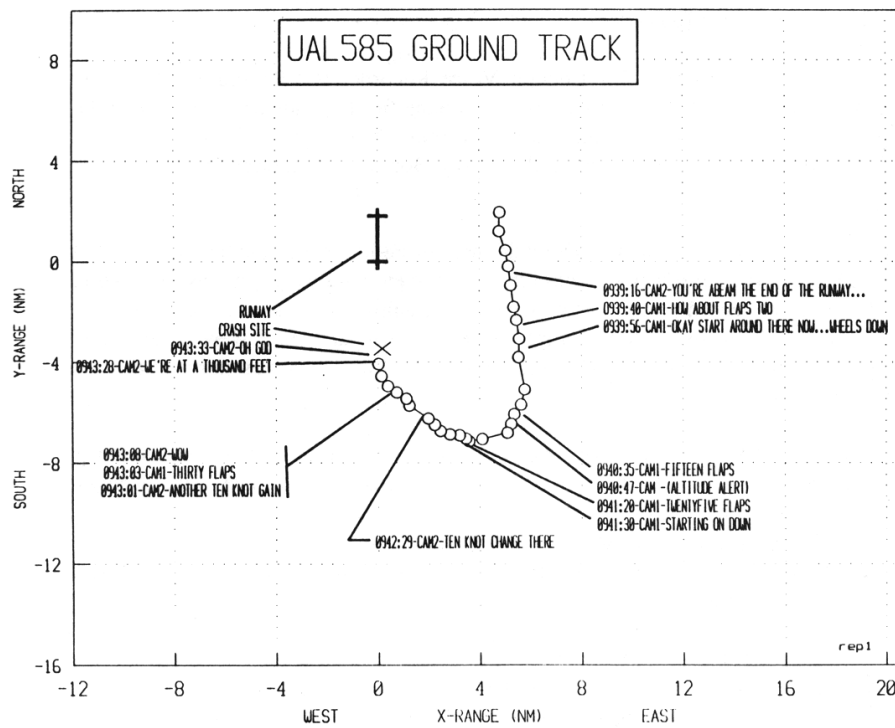
Figure 9. Ground track with selected CVR data

Figure 9 shows the ground track with selected CVR data. Figure 10 is a profile view of the flightpath with selected CVR data.

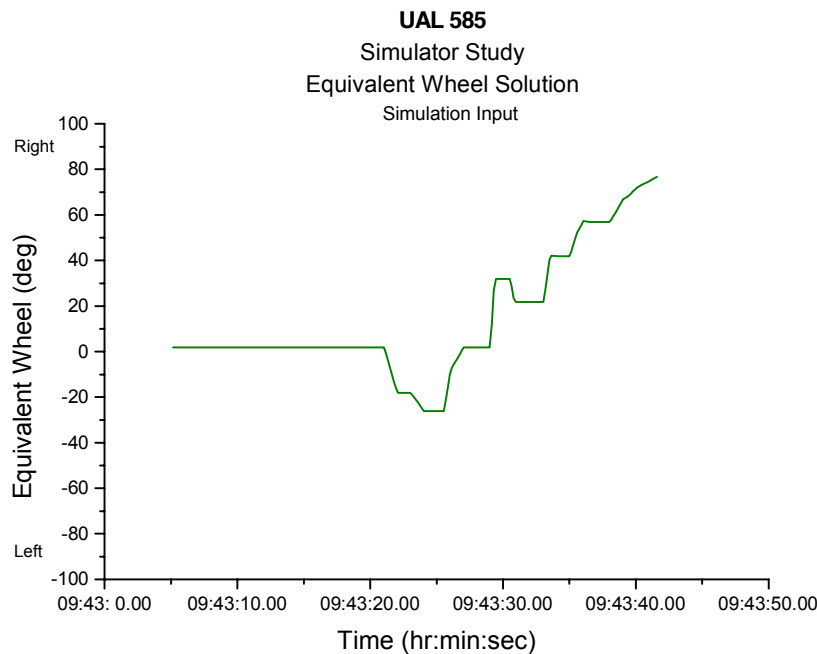
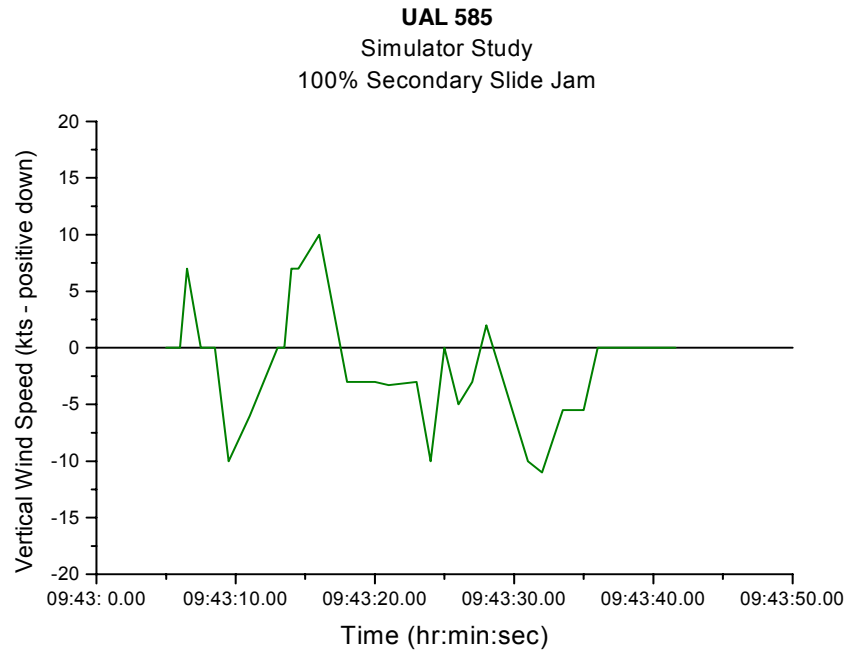
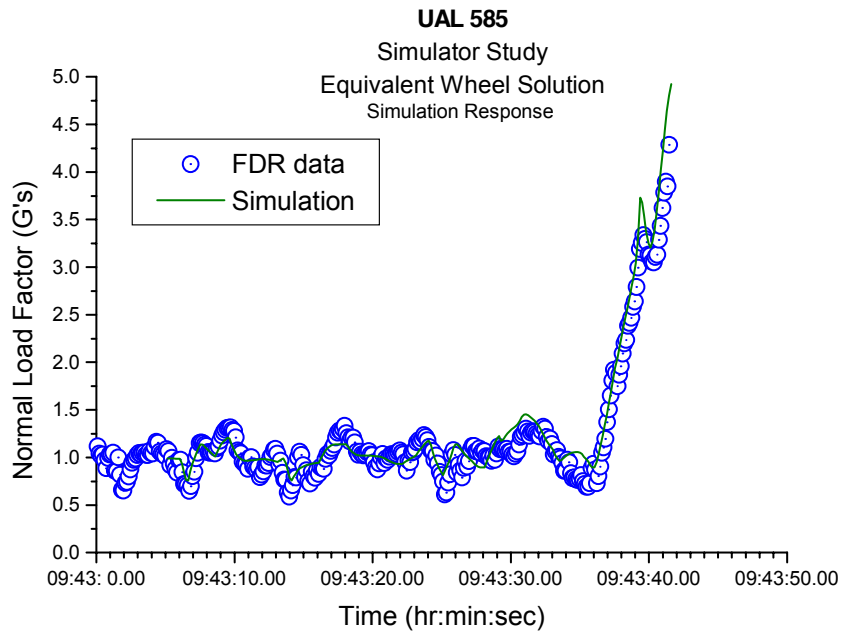
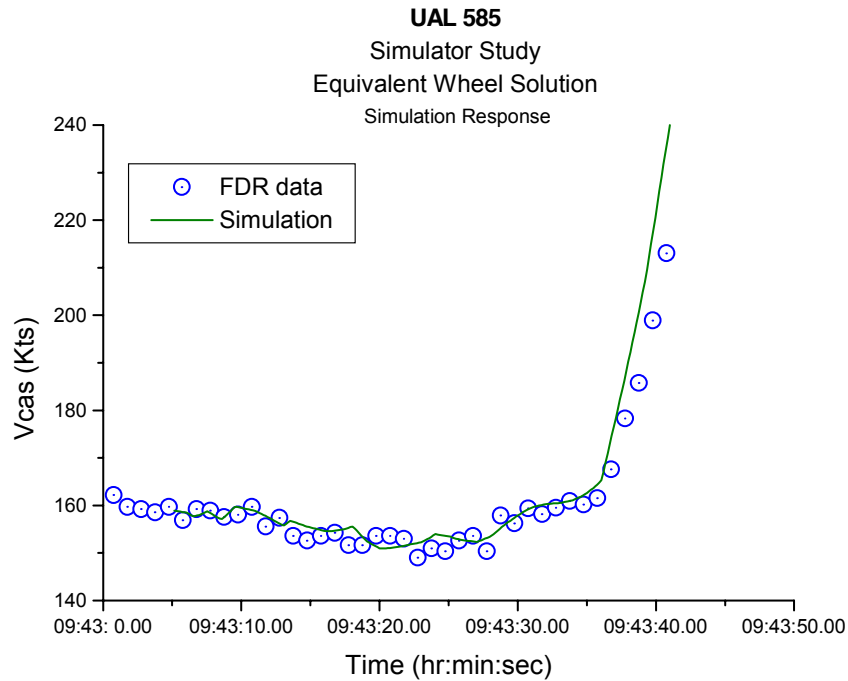
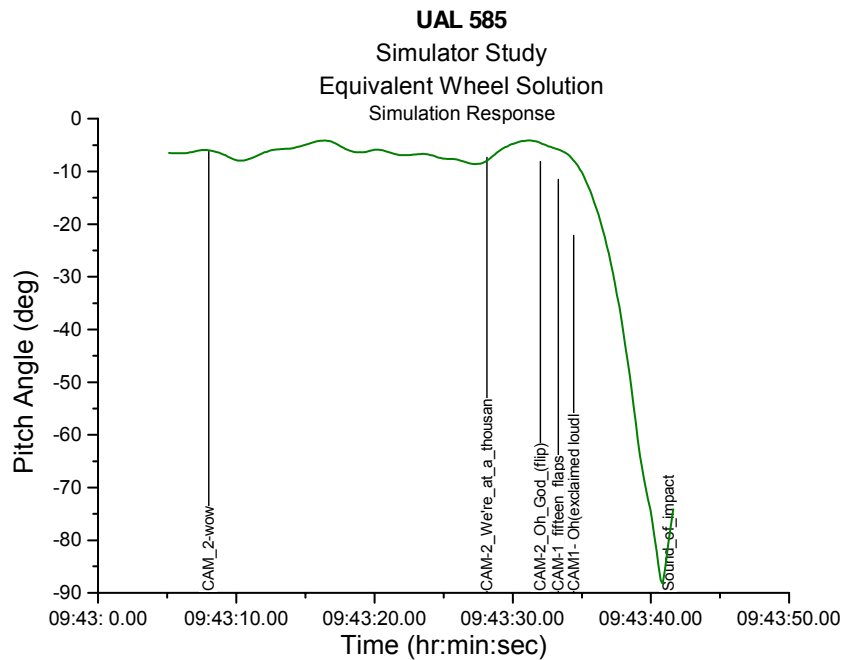
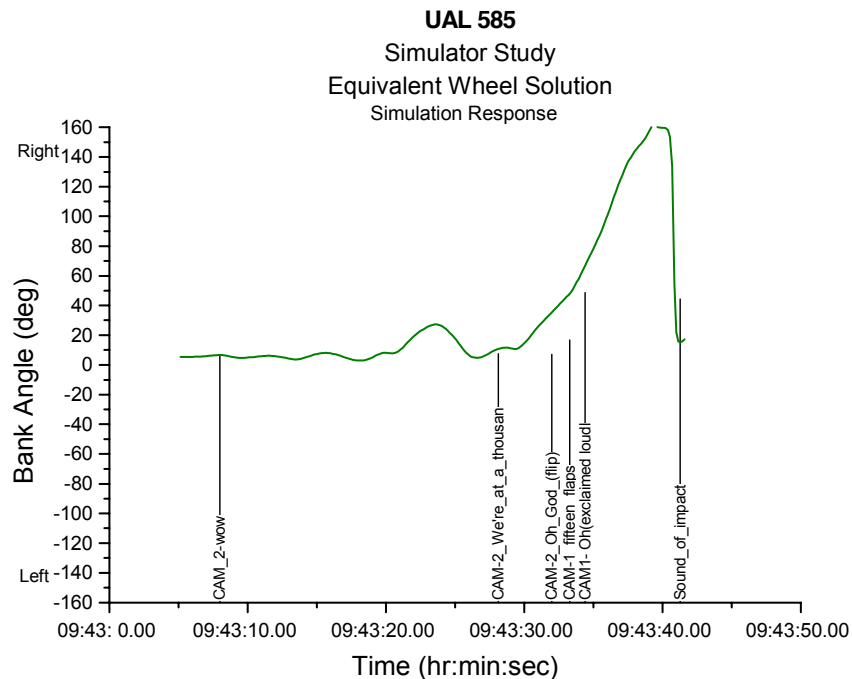
One of the Safety Board simulation scenarios that produced a good match with the FDR data and other physical evidence assumed a sustained equivalent control wheel input

to the right with no rudder input. The equivalent control wheel input could represent a pilot command, a rotational wind, or a combination of the two. Figures 17 through 17f show the resultant data for rudder surface and control wheel positions and heading, normal load factor, calibrated airspeed, pitch angle, and bank angle data, respectively. Figures 17e and 17f also show CVR data.

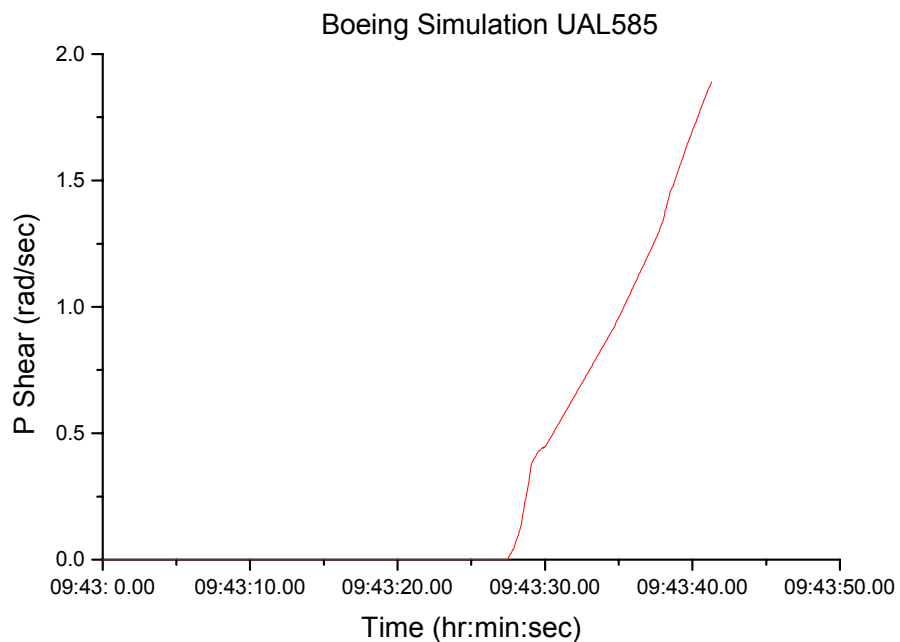
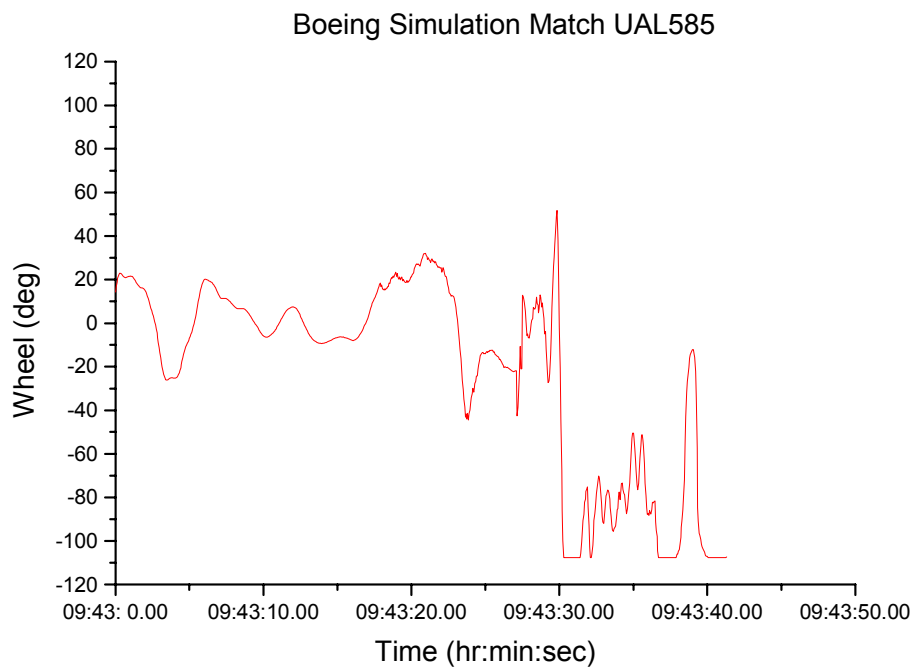
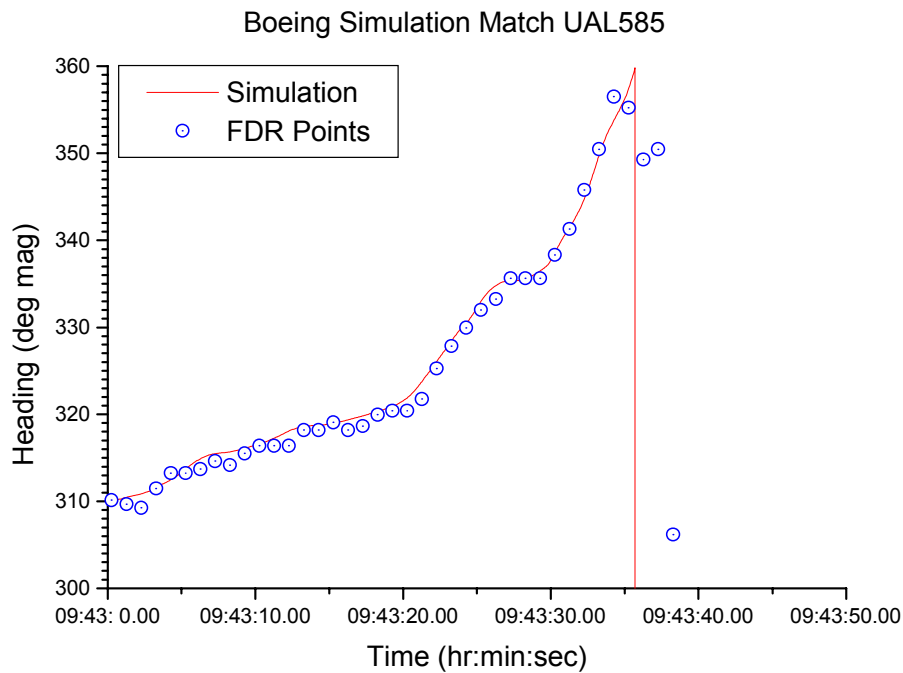
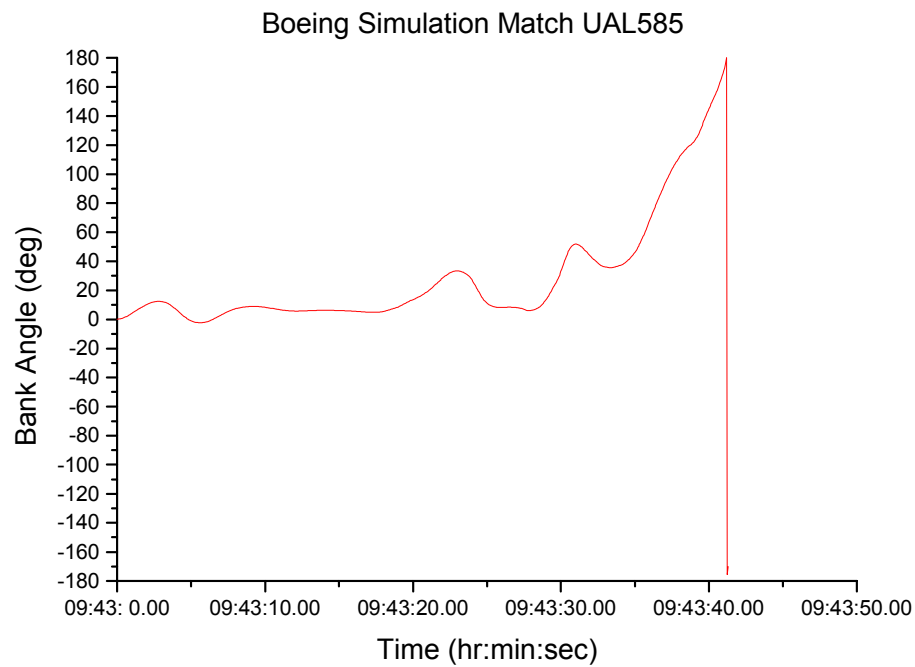
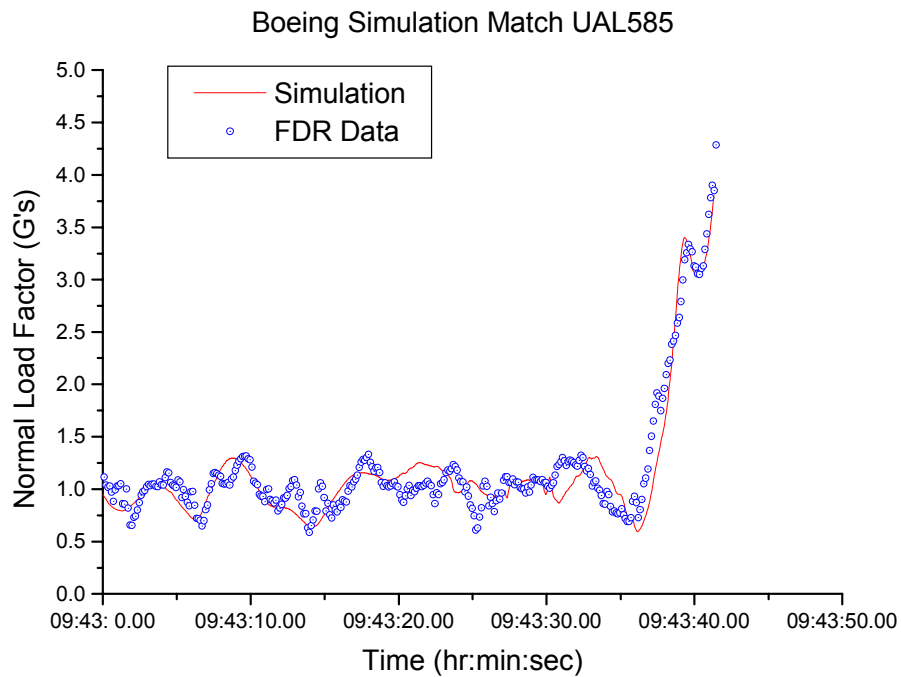
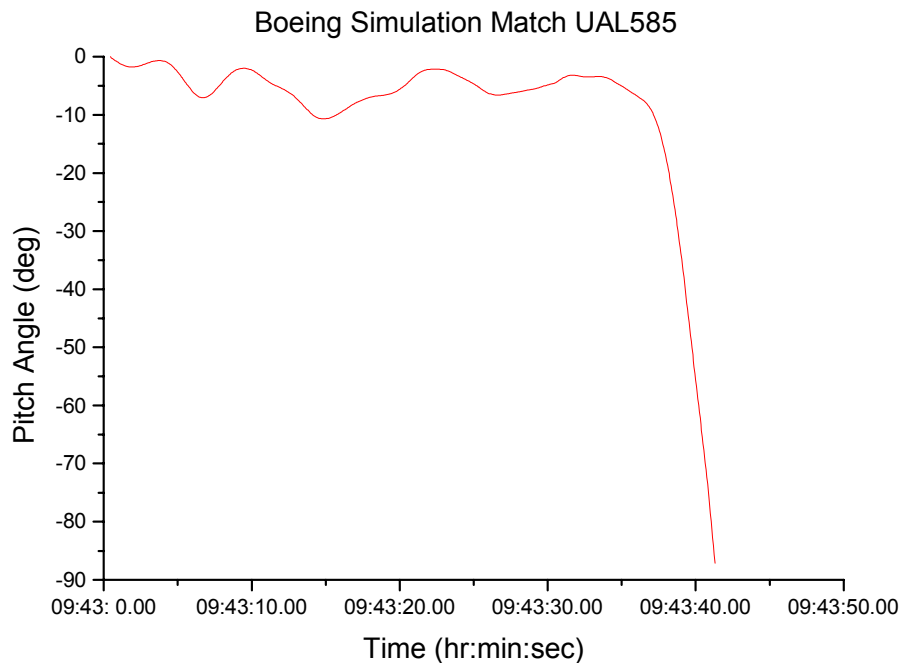
In a June 23, 1997, letter to the Safety Board, Boeing provided its analysis of the United flight 585 accident.⁷³ Boeing's analysis concluded that a rudder hardover scenario did not fit the FDR data and that a "new rotor model" did match the data.⁷⁴ Further, Boeing derived this new rotor model to match the available data and introduced a rotational effect of near zero just before 0943:28, which increased linearly to about 0.4 radians per second just before 0943:29 and then increased linearly to about 1.8 radians per second about the time the airplane impacted the ground (just before 0943:42).

Boeing's simulation using the new rotor model produced the data shown in figures 18 through 18f for rudder surface positions, windshear, control wheel positions, heading, bank angle, normal load factor, and pitch angle, respectively. As shown in figure 18b, Boeing's simulation assumed a left control wheel input by the flight crew just after 0943:30.

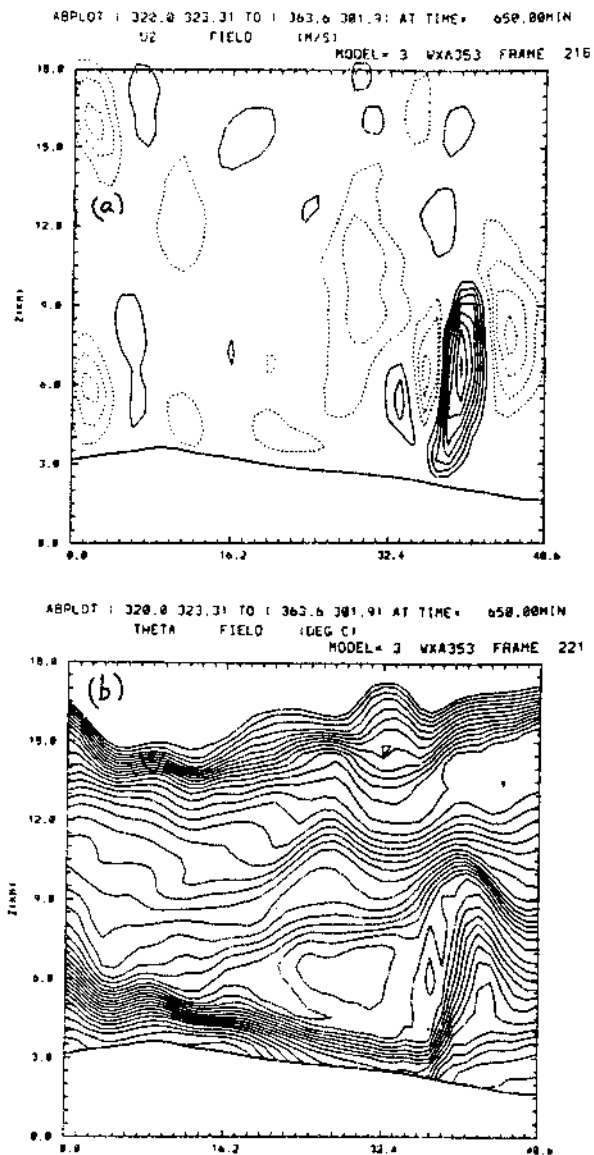
Fig. 3 Vertical cross sections of w and θ along line A-B shown in Fig. 2. The contour interval for w is 5 m/s and for θ is 3 degrees Kelvin. Both plots are for $t=650$ minutes.

Fig. 3 shows vertical cross sections of w and θ (potential temperature) for the solid line marked A-B in Fig. 2. Note how the width of this updraft is about $4 \Delta x$ wide which means it is resolution limited. The plot of θ along A-B gives a good approximation of the air motion. Since θ is approximately conserved, the contours of θ represent trajectories of the air. The rebounding nature of the flow can be seen in this figure.
