**THE DANISH  
ACCIDENT INVESTIGATION BOARD**  
The Aviation Unit

**Report**  
**HCLJ510-000721**

Incident involving ATR72-212A  
Registration OY-CIN  
Bornholm Airport (EKRN)  
27 January 2010

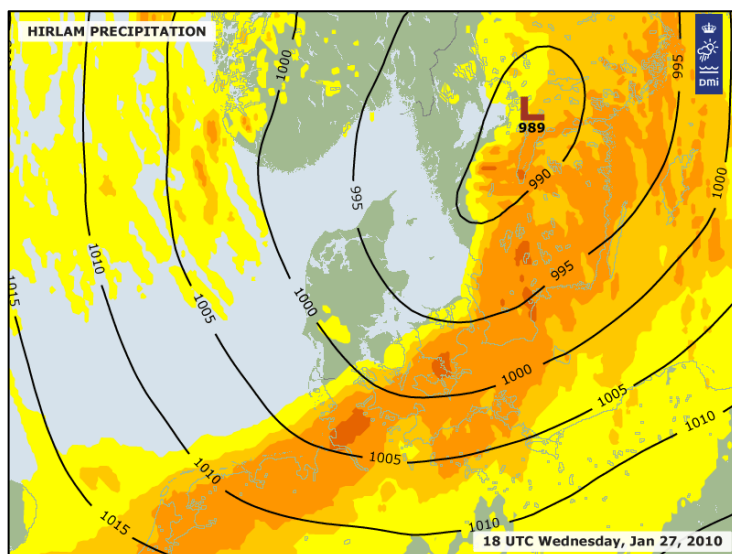
A cold front with extensive snow moved in from the west over Bornholm during the period. On the front (east side) of the weather front there was a strong wind coming from the south west.

Dense snow fall and, due to the wind, drifting snow.
