Final Report

EgyptAir Boeing 777-200 aircraft cockpit fire

On 29th July 2011

Registration SU-GBP

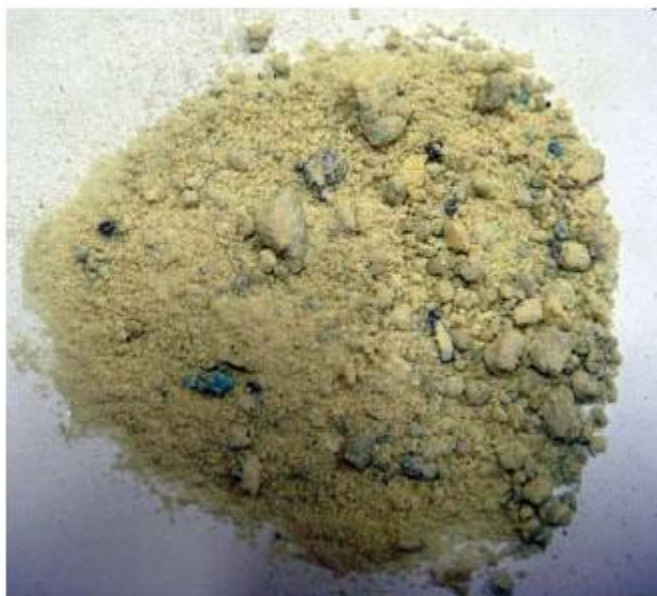
Sample No.1: Yellow Powder (Flight Deck R.H.S. SU-GBP)

The test results showed that the yellow powder is mainly consists from Sulfaguanidine $C_7H_{10}N_4O_2S$ and Mascagnite $(NH_4)_2SO_4$.

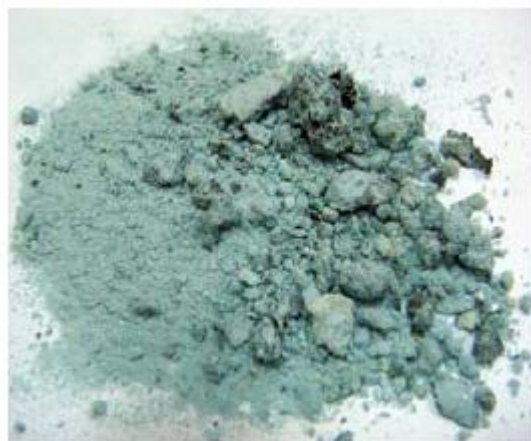
*Sample No.2: Blue Powder (Flight Deck R.H.S.)

The test results showed that the blue powder mainly consists of Mascagnite $(NH_4)_2SO_4$ and Barite $BaSO_4$.

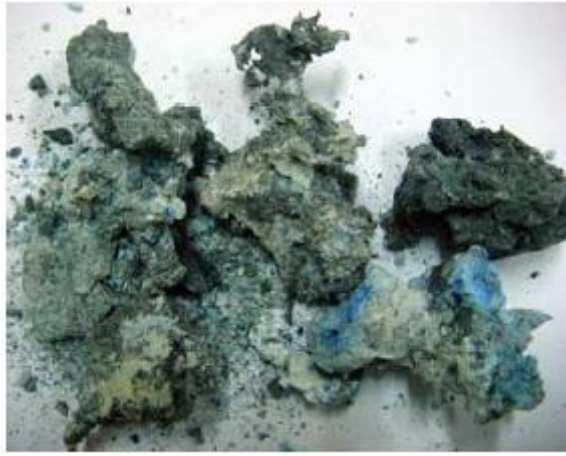
Sample No.3: Charred Material and Powder (R.H.S.)

The test results showed that the charred material mainly consists of Iron ammonium Nicotinate N-Oxide Sulfate Decahydrate $C_{21}H_{31}FeN_7O_{17}S_2 \cdot 10H_2O$, Aluminum Boron Molybdenum Oxide $B_3.26Al_4MoO_{14.96}$ and Hydrogen Deuterium Aluminum Silicate. $(H_{0.13}D_{0.87})(AlSi_2O_6)$.

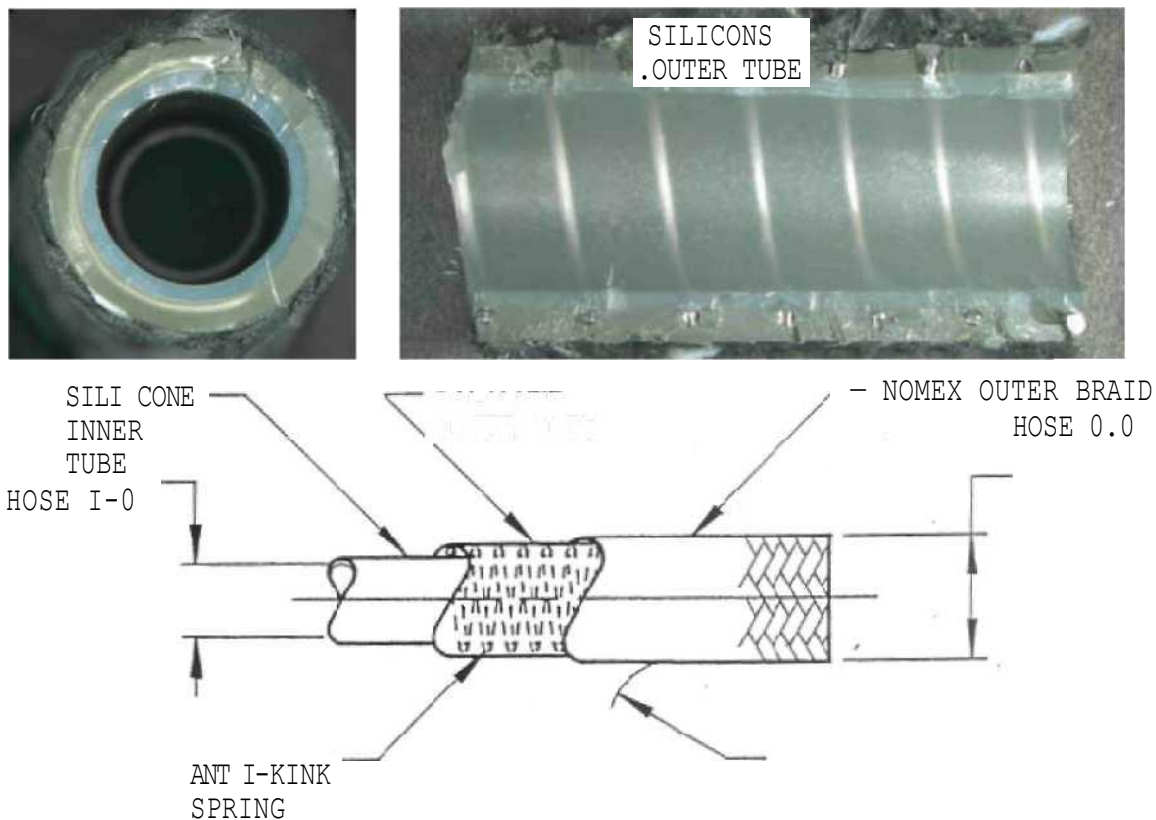
Flexible Oxygen Hose Construction

The hoses tested by the NTSB in 2008/2009 were comprised of clear polyvinyl chloride (PVC) with an internal stainless steel anti-kink spring. The hoses used on accident airplane (SU-GBP) were different in that they were comprised of two layers of silicon tubing with the anti-kink springs embedded in the outer layer.

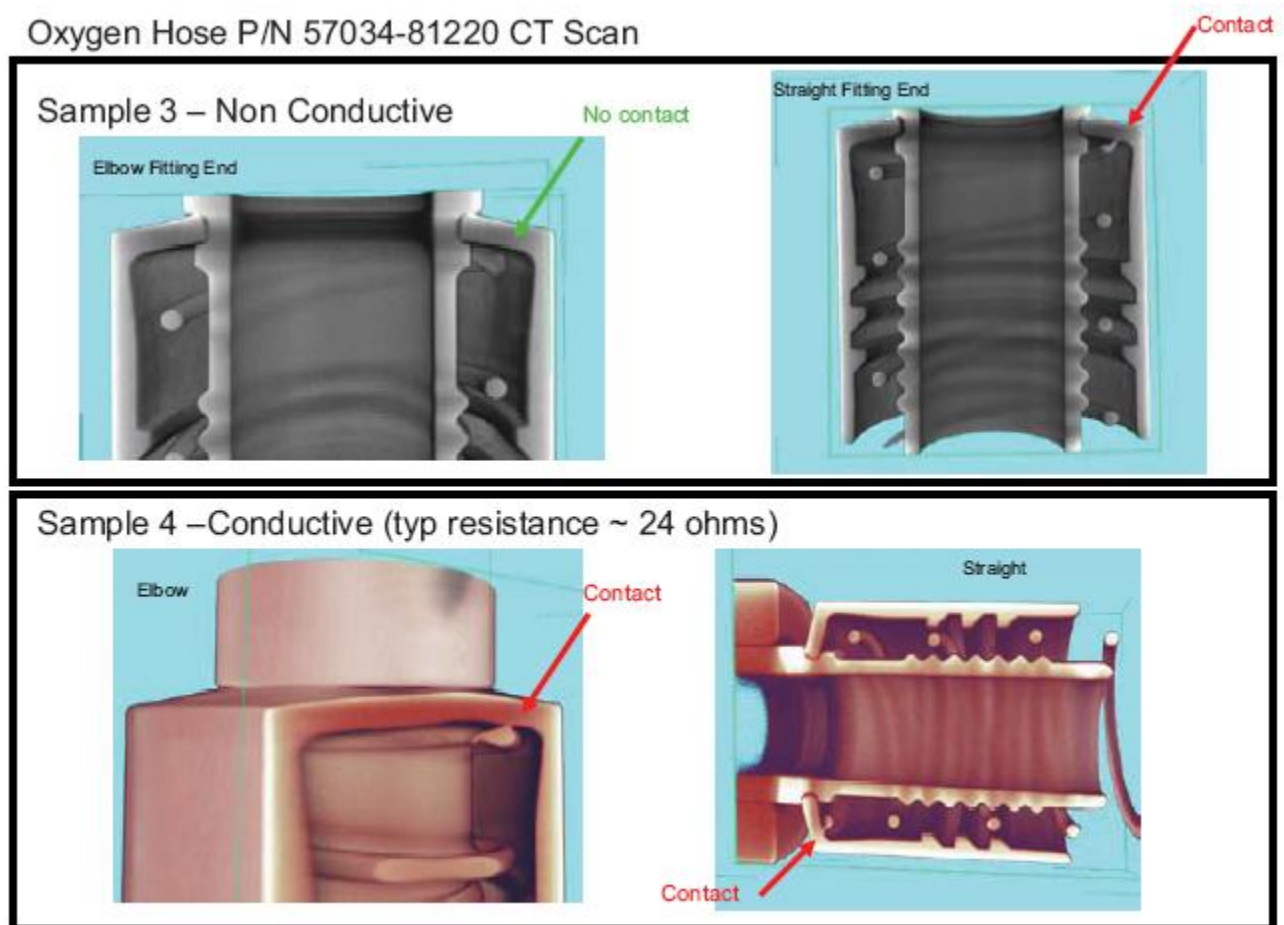
Hose End CT Scan Images

The hoses used in the manufacture of the 777 do not have any design requirements related to conductivity. Seven exemplar flexible oxygen hoses were tested for conductivity. Of the seven hoses tested, two were found to be conductive and the remainder were non-conductive. The hose end fittings were imaged via computed tomography (CAT scan) to determine the reason for the variability. Variations were found in the details of the cut end of the hose. Specifically, in some samples, the cut end of the embedded spring was in contact with the end fitting and in other cases it was not. The two hoses that were found to be conductive had both ends of the spring in contact with their respective end fittings. Some of the non-conductive samples were found to have one end of the spring in contact with the end fitting, but were not conductive because the other end was not in contact.
