Aircraft Accident Investigation Report KNKT/07.06/07.02.35

NATIONAL TRANSPORTATION SAFETY COMMITTEE

BOEING 737–497 PK–GZC ADI SUCIPTO AIRPORT, YOGYAKARTA INDONESIA 7 MARCH 2007

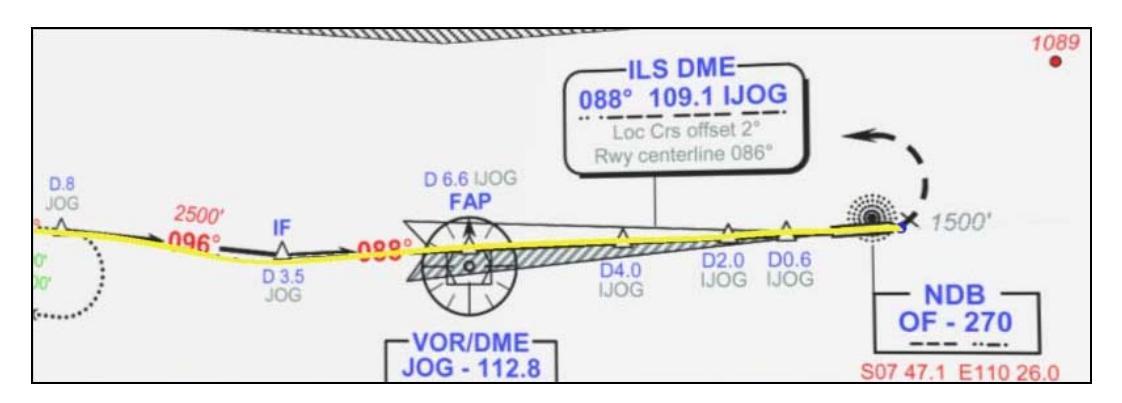
Figure 7: Screenshot of the animated flight path (yellow) over the Garuda Yogyakarta approach plate (plan view)

The plan view of the Garuda approach plate was also applied to the animated flight path. The approach ground track flown approximately followed the approach on the Garuda instrument landing approach chart (Figure 7).

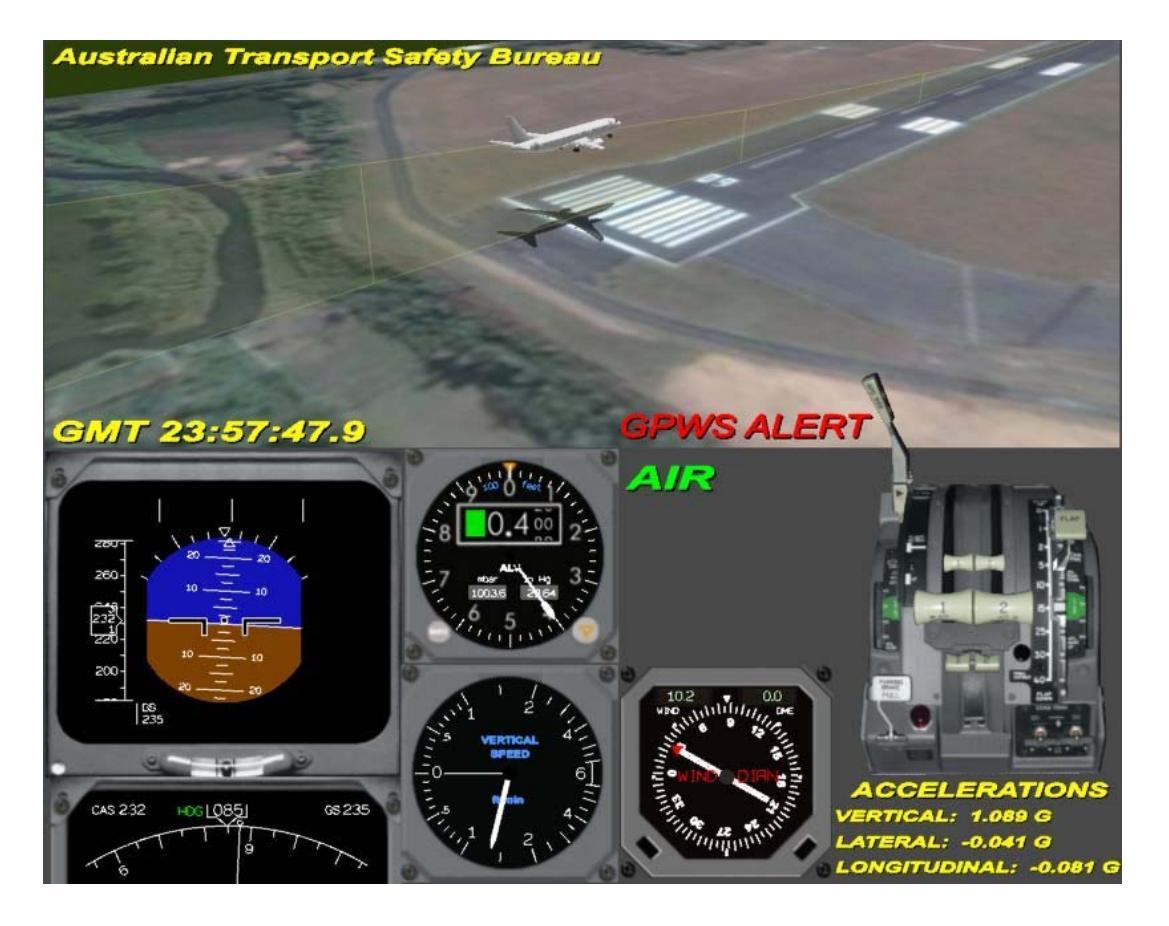
Figure 14: Picture taken from the SSFDR animation

23:57:47 Seven seconds before touchdown, the rate of descent was 1,400 feet per minute and decreasing. The aircraft crossed the runway 09 threshold (Figure 14) 89 feet above the ground (704 feet pressure altitude), at an airspeed of 234 knots (groundspeed of 236 knots).

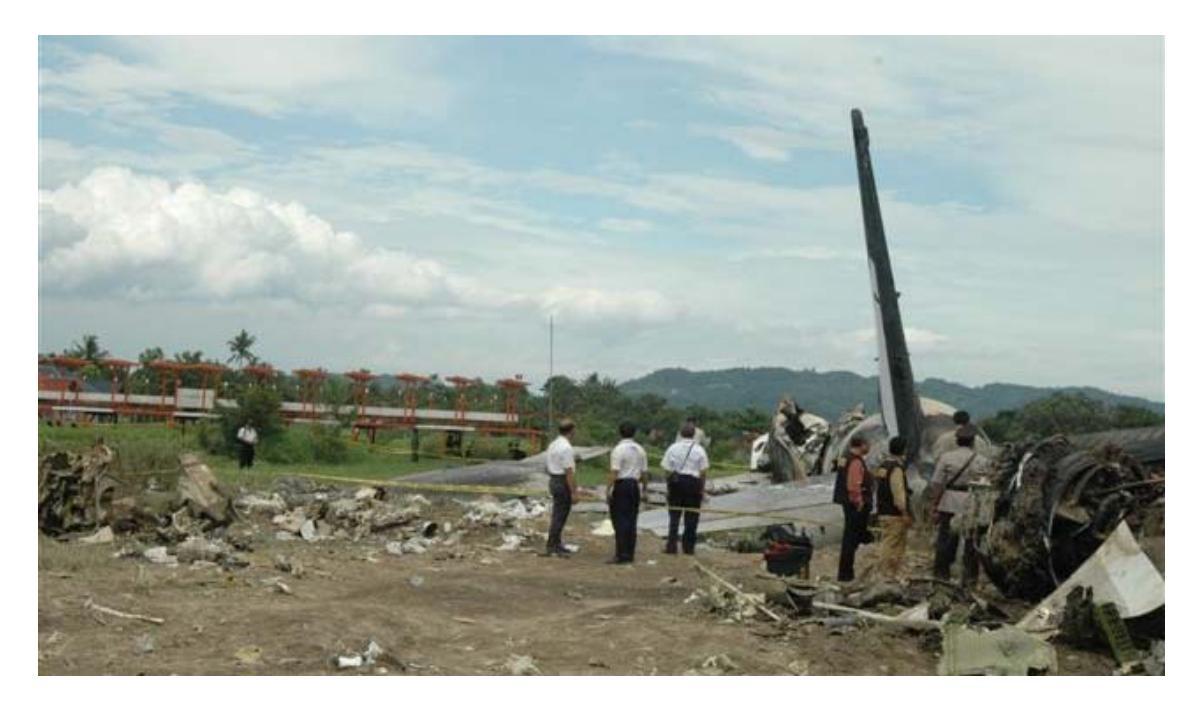
Figure 16: Runway approach lights adjacent to the accident site

The accident site was located in a rice field about 252 meters beyond the departure end of Yogyakarta Adi Sucipto runway 09. It was an open field with airport approach lighting infrastructure. The aircraft stopped adjacent to the runway approach lights, and to the right of the runway extended centerline. The approach lights were not damaged (Figure 16).

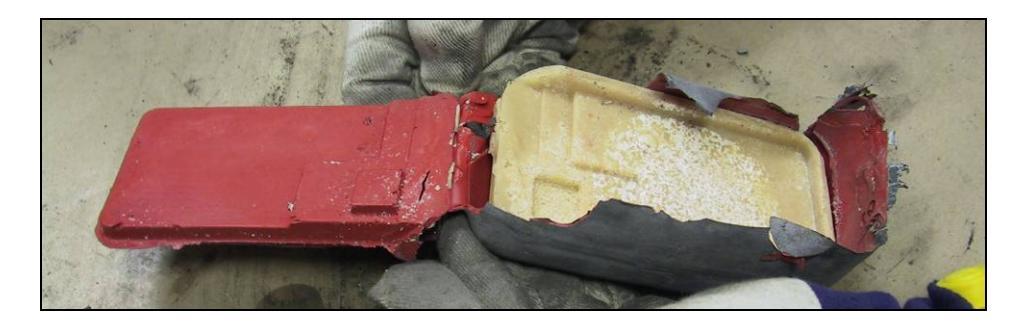
Figure 3: Memory board from PK-GZC SSFDR

The memory board was carefully removed from the CSMU on 09 March 2007 (Figure 3).

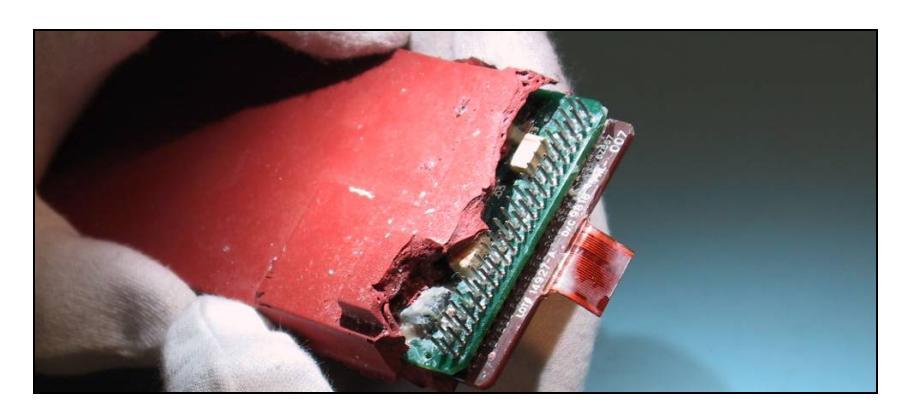
Figure 5: Connector pins and cable prior to download

The memory board connector pins were cleaned and the flex cable replaced (Figure 4 and Figure 5)

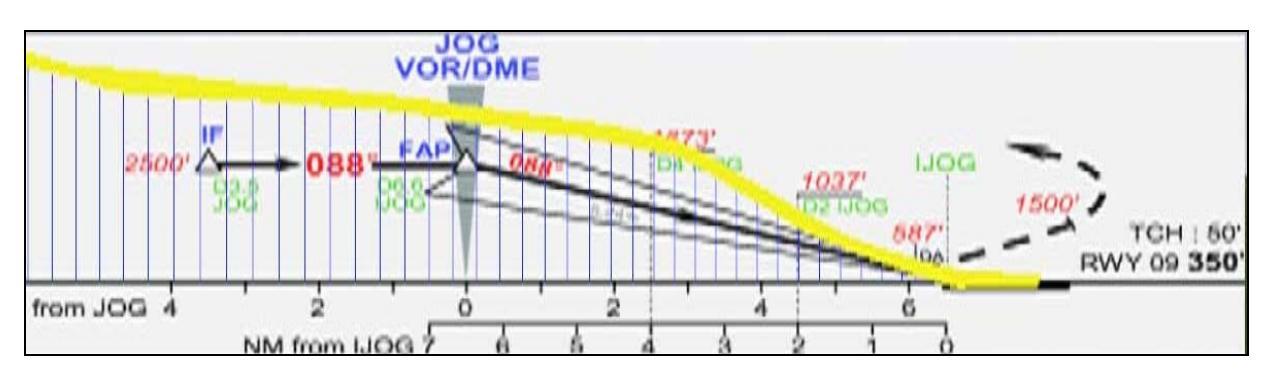
Figure 8: Screenshot of the animated PK-GZC flight path (blue) over the Garuda Yogyakarta approach plate (elevation view)

The approach flight path was derived using the groundspeed, drift angle, heading and corrected altitude. An elevation profile view of the flight path was overlaid on the Garuda JOG approach plate using Insight animation (Figure 8). The PK-GZC approach profile was considerably higher than the 3 degree glideslope approach profile.

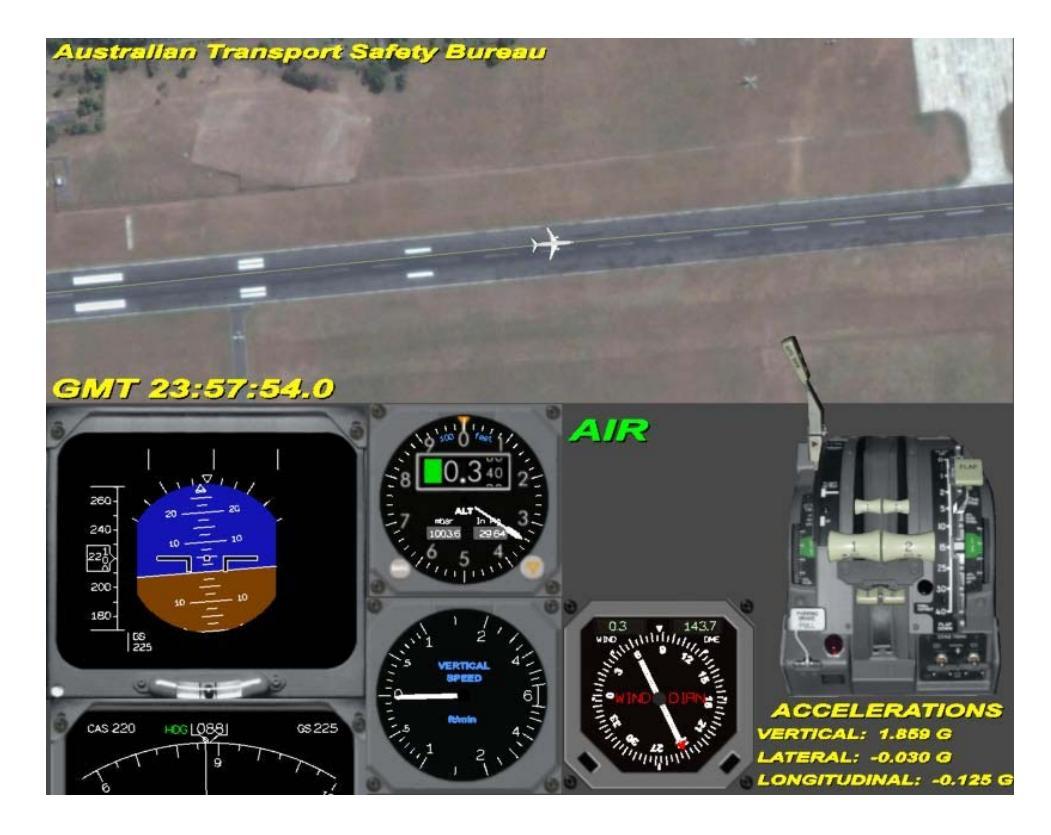
Figure 11: Initial touchdown location (+1.86G)

The initial touchdown was further along the runway than the touchdown zone for runway 09. The animation touchdown locations matched both the calculated touchdown points and physical evidence observed on the runway considered to be associated with PK-GZC accident landing.
