**FINAL**  
KNKT.13.08.22.04

# NATIONAL TRANSPORTATION SAFETY COMMITTEE

**Aircraft Serious Incident Investigation Report**

**PT. Lion Mentari Airlines (Lion Air)  
Boeing 737-800; PK-LKH  
Djalaluddin Airport, Gorontalo  
Republic of Indonesia  
6 August 2013**

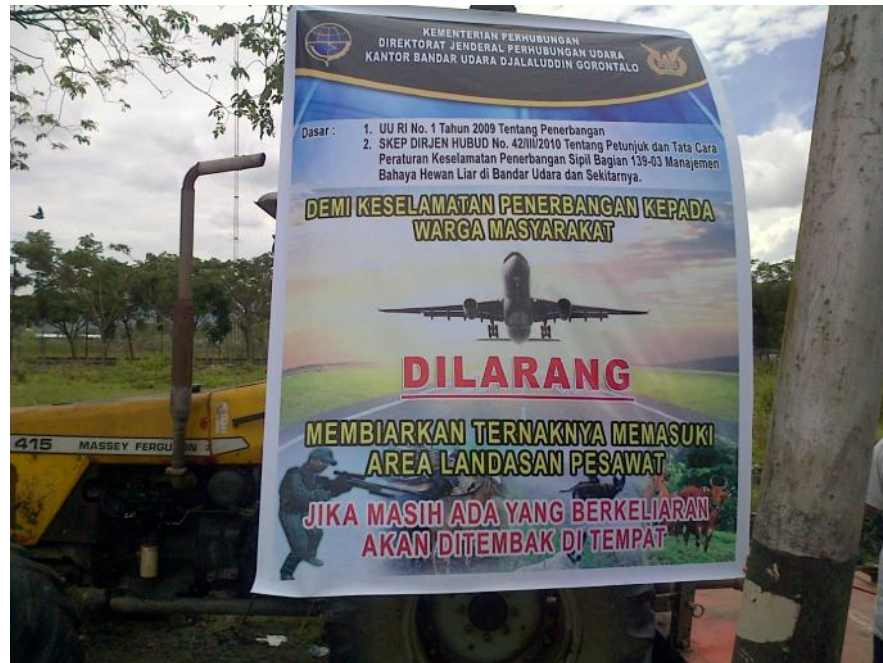
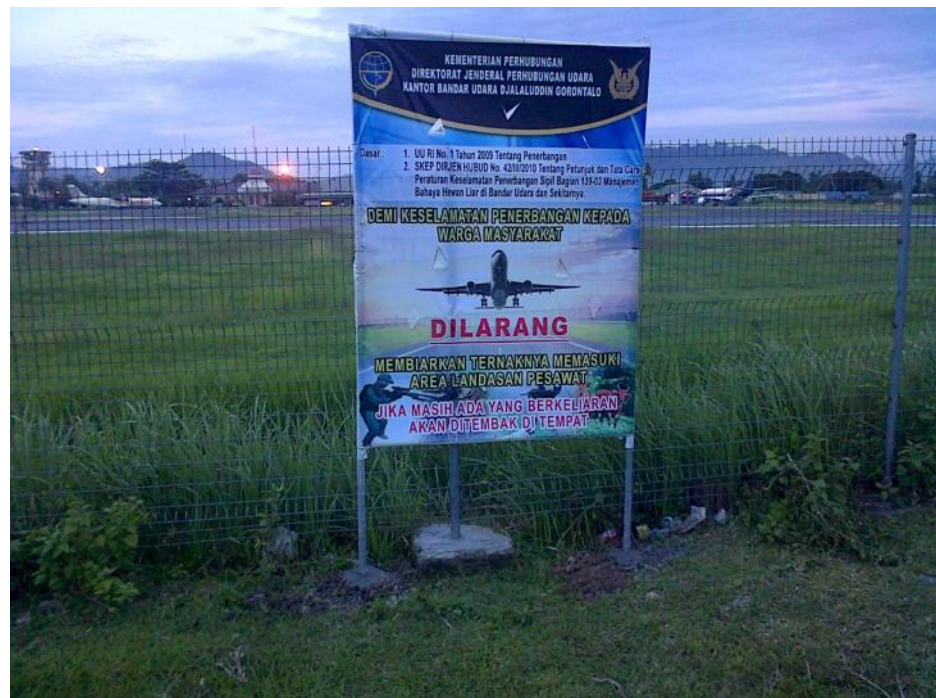
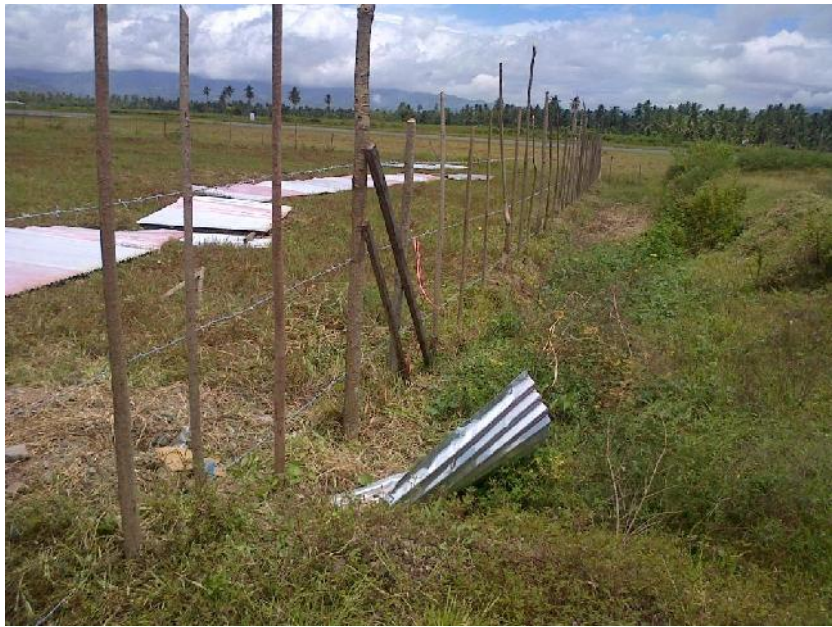
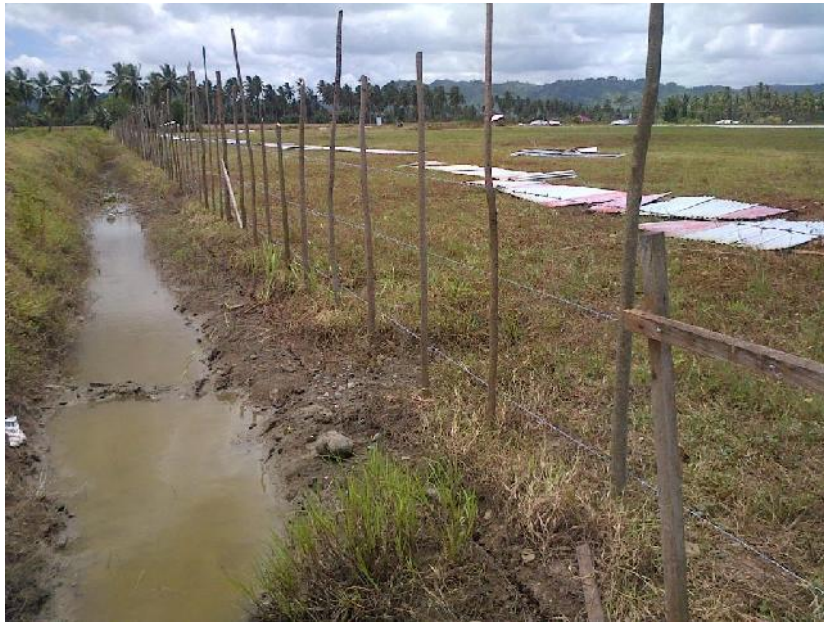
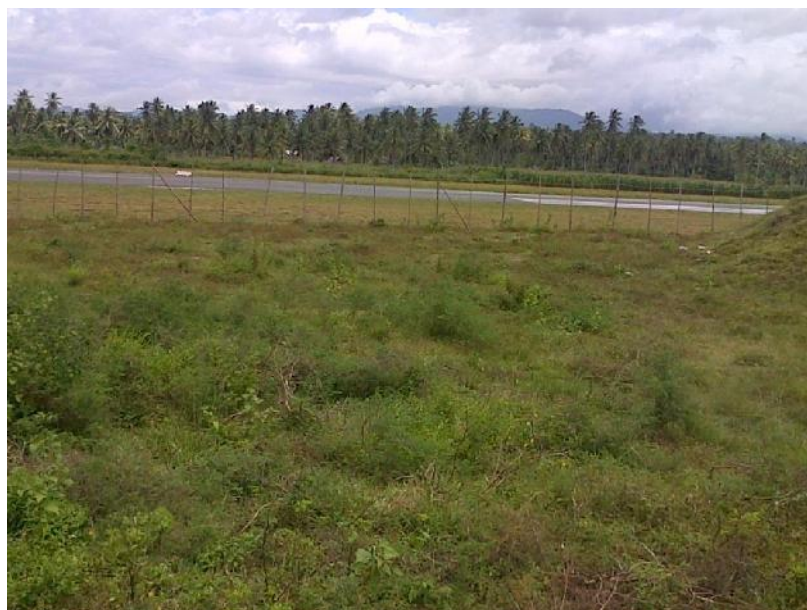
### 6.1 The design Airport authority Safety action

- Some fences at the north and south of the runway approximately along 500 meters were broken and some parts were not installed with the fences.
- The Djalaluddin Airport has been audited, as the findings: some Airport perimeter fences broken and the corrective action program did not perform.

- The broken fence that accessible for the animal, person, vehicle to the runway is classified as an extremely hazard. If such condition exists, it is recommended to promptly correcting.
- To ensure the Aerodrome Manual especially chapter 4.12 subject: wildlife hazard management is well implemented.
