AI2011-3

**AIRCRAFT SERIOUS INCIDENT
INVESTIGATION REPORT**

Japan Transport Safety Board

**KOREAN AIR
AIRBUS INDUSTRY A300B4-600R, HL7240
AT AN ALTITUDE OF APPROXIMATELY 33,000 FT, OVER THE
VICINITY OF HIKARI CITY, YAMAGUCHI PREFECTURE,
JAPAN
AT ABOUT 19:36 JST, JUNE 23, 2009**

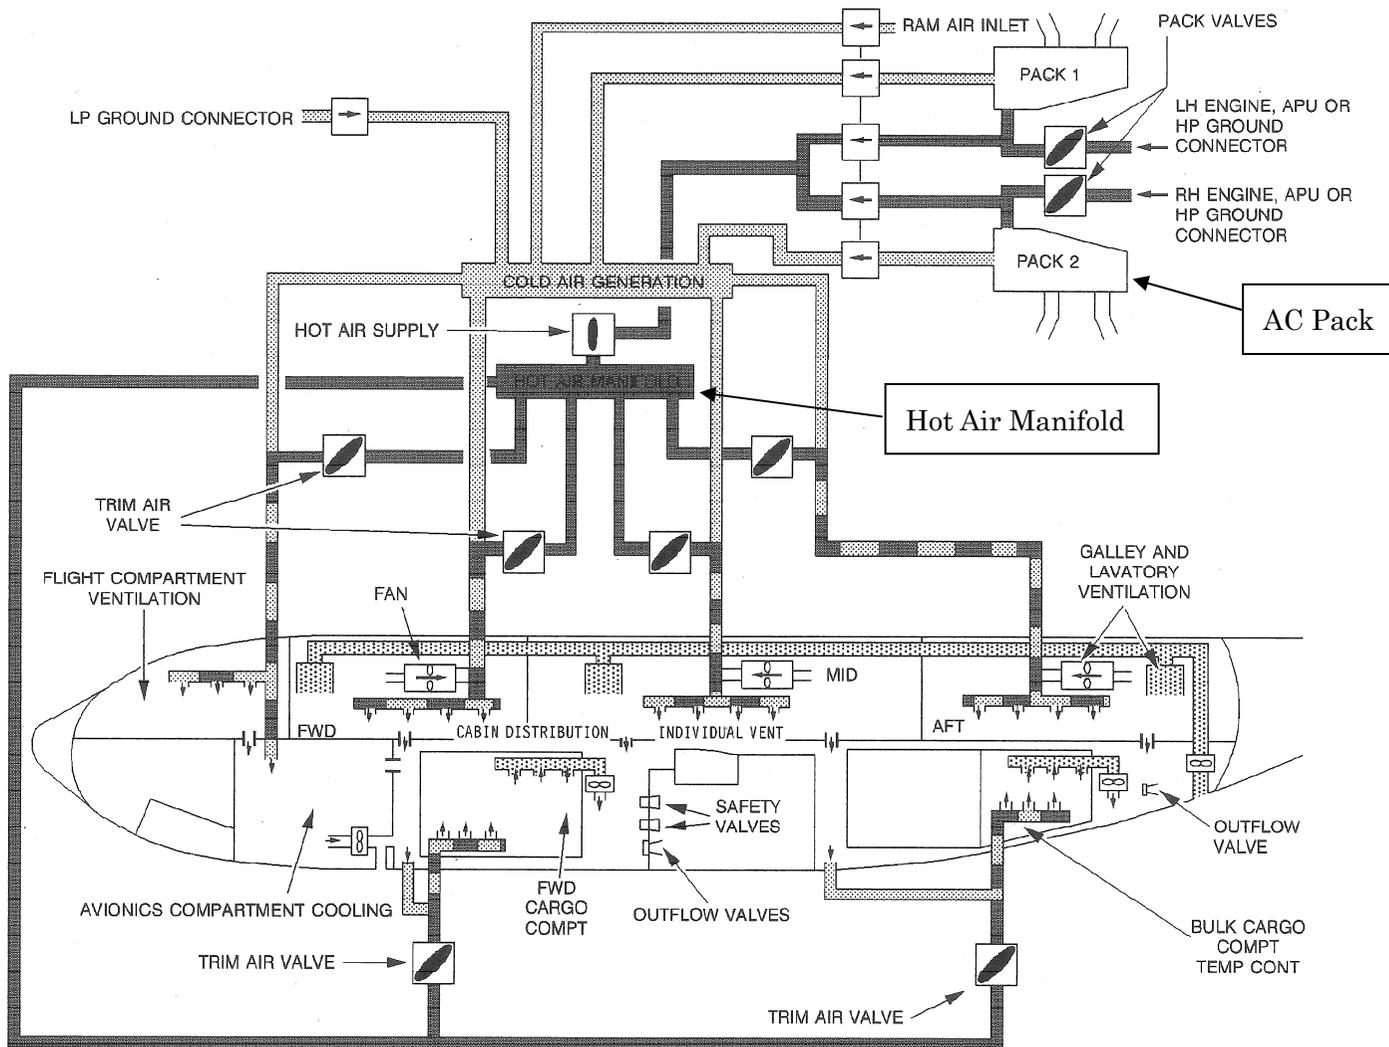
Figure 4 Air-Conditioning, Pressurization and Ventilation Systems

- (2) According to the A300-600 aircraft maintenance manual (AMM) issued by the manufacturer of the Aircraft, the temperature of the pre-cooler is controlled by adjusting the opening of the fan air valve, thereby adjusting the flow rate of the cold air. This control is managed by the pneumatic controller based on signals from the temp. control sensor downstream of the pre-cooler. Normally, the opening of the fan air valve is adjusted so that the temperature of the pre-cooler outlet is maintained at $177 \pm 12^\circ\text{C}$. When bleed air from one of the engines ceases to be supplied or the wing anti-ice switch is set to ON (hereinafter referred to as "temperature shift"), the temperature of the pre-cooler outlet is adjusted to $227 \pm 12^\circ\text{C}$. At the time of temperature shift, the pneumatic controller adjusts the opening of the fan air valve to provide higher temperature. In addition, the pre-cooler has an overheat detection function, which closes the bleed valve of the relevant system when the outlet temperature reaches $207 \pm 3^\circ\text{C}$ in normal operation or $255 \pm 3^\circ\text{C}$ in temperature shift. After the pre-cooler, the air adjusted as described above is sent to the AC pack (air cycle machine) system, the anti-ice system and other components. (See Figure 4 - Air-Conditioning, Pressurization and Ventilation Systems; Figure 5 – Pneumatic System)

(See Figure 4 – Air-Conditioning, Pressurization and Ventilation Systems)
