# **AIRCRAFT SERIOUS INCIDENT INVESTIGATION REPORT**

**KOREAN AIR LINES CO., LTD.  
H L 7 5 9 9**

RUNWAY OVERRUNNING  
KOREAN AIR LINES CO., LTD.  
BOEING 737-900, HL7599  
ON RUNWAY 10 AT NIIGATA AIRPORT  
AT 19:42, AUGUST 5, 2013

January 9, 2015

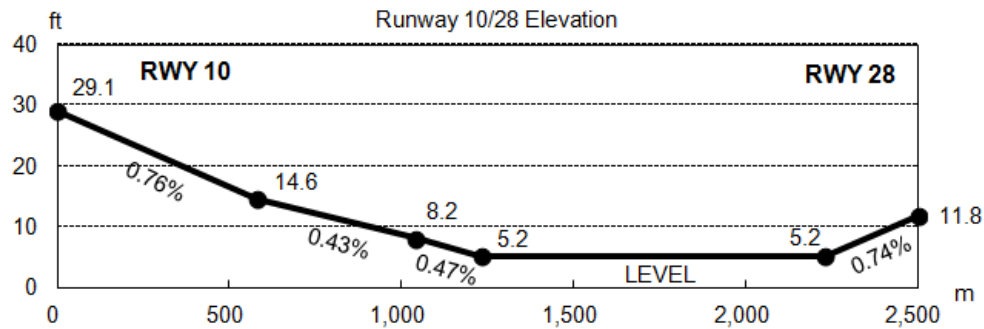
Figure A: Slope of RWY 10/28 (Prepared with AIP information)

45 m wide. The PAPI angle on RWY 10 is 3°, and it is placed on the left side of the runway 541 m from the threshold. As the below figure shows, RWY 10 holds a down slope of 0.21 % in an average between the threshold and the end.
