**Statens haverikommission**  
Swedish Accident Investigation Authority

***Final report RL 2012:21e***

**Serious incident on 16 of January 2010 to  
aircraft EP-IBB at Stockholm/Arlanda  
Airport, Stockholm county, Sweden**

Ref.no. L-02/10

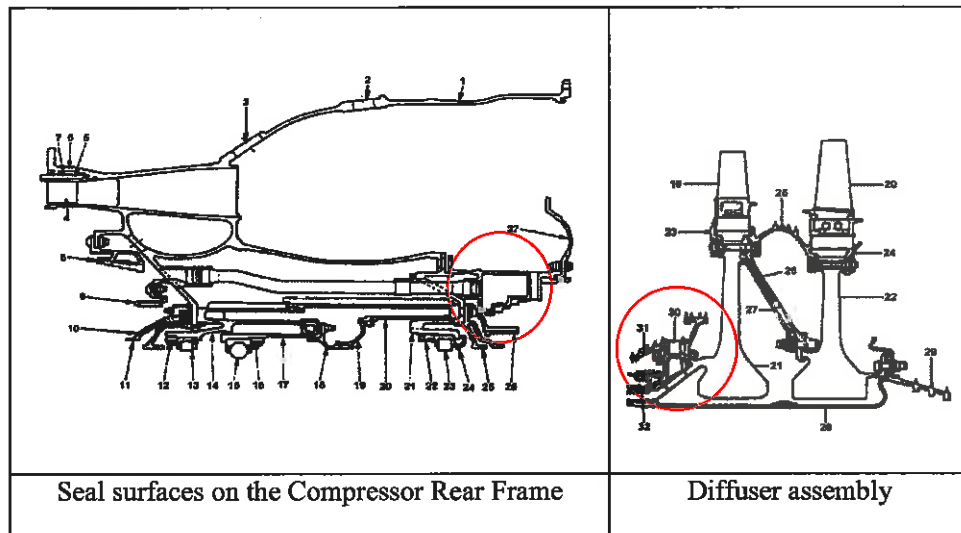
Fig.12. Diffuser Assembly and Compressor Rear Frame.

If the aft air seal separates, seal debris which enters the core flowpath in addition to the loss of pressure balance will result in an engine stall event by the result of the disruptive core airflow. In the investigated incident, the separated debris which entered the core flowpath resulted in significant downstream damage which resulted in high exhaust gas temperature (EGT) and loss of fan speed (N1 system) from the LPT blade damage.

In the drawing below, a red circle marks the static seal surfaces on the Compressor Rear Frame and the rotating Diffuser Assembly on the High Pressure Turbine.

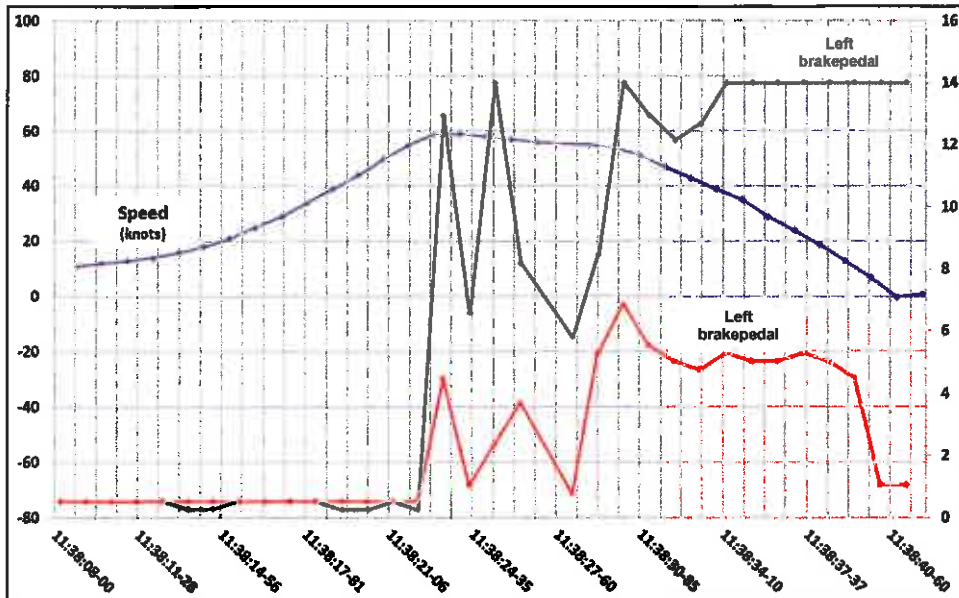
Fig. 21. Brake pedal angles.

From the diagram in Fig. 21, it can be noted that the recorded pedal displacements follow each other at different levels during the sequence, where the right pedal has been recorded with values corresponding to around half of the value for the left pedal.

Maximum displacement has been recorded from the left brake pedal during the final phase until the point when the aircraft stops. During this phase, the value from the right pedal decreases and approaches zero when the aircraft stops.

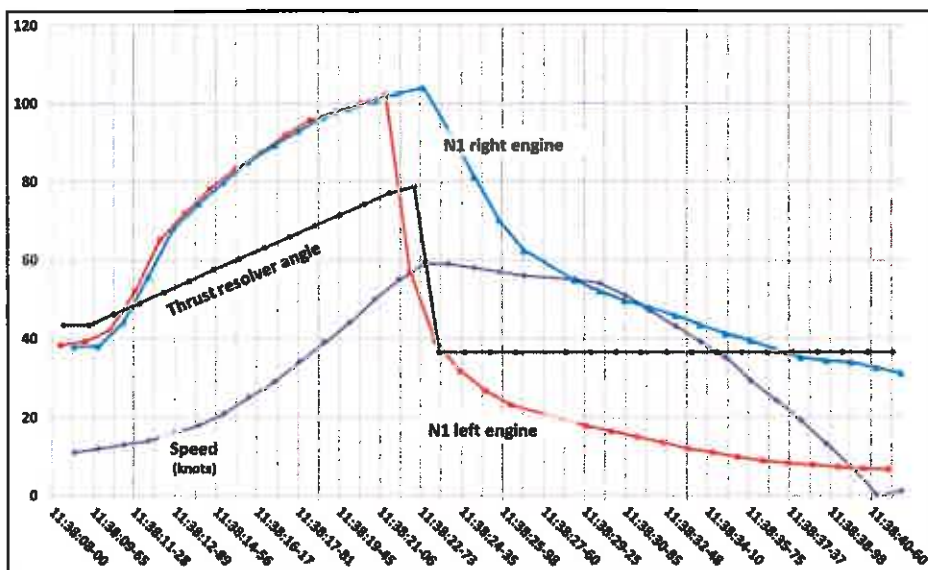
Fig. 22 Rpm N1, throttle angle, aircraft speed.

The engines' rpm N1, thrust lever angle, and the speed of the aircraft are presented in Fig. 22 below. The red line represents the left engine, i.e., the engine that failed.

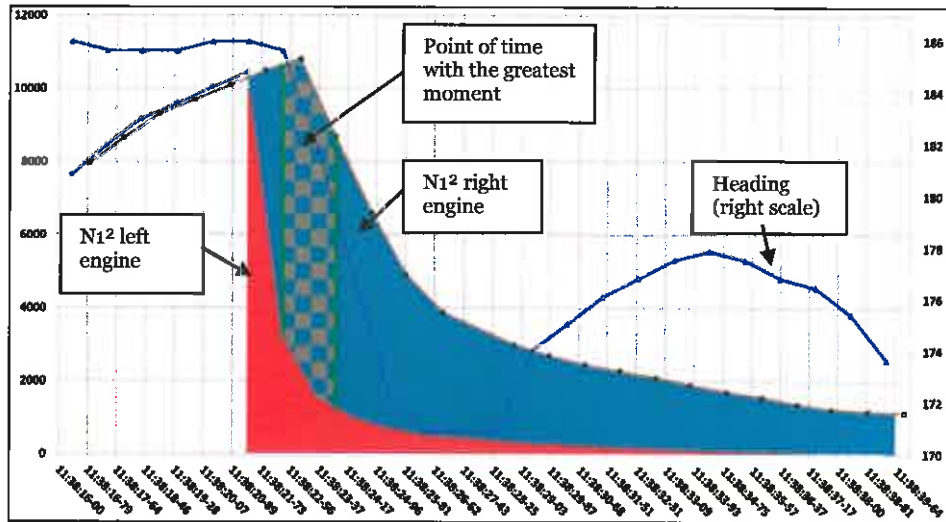
Fig. 23. Illustration of the energy from the engines.

Fig. 23 also shows N1 for the left and right engines, though it is the square of N1 that is presented as this better represents the amount of energy developed by the engines. The red area represents the energy output of the left engine from the loss of engine power until the aircraft was close to a standstill. The blue area represents the energy output of

the right engine over and above that of the left engine, i.e., the energy which contributed to the yawing moment of the aircraft.

The greatest yawing moment was at the time when the right engine's rpm was at its highest, i.e., when the thrust lever angle was reduced to minimum and the right engine's rpm began to decrease. Between 38:22.34 hrs and 38:23.84 hrs, the yawing moment was greatest, followed by a rapid decrease as the right engine's rpm decreased. This area is marked as a checked area in Fig. 23 below.

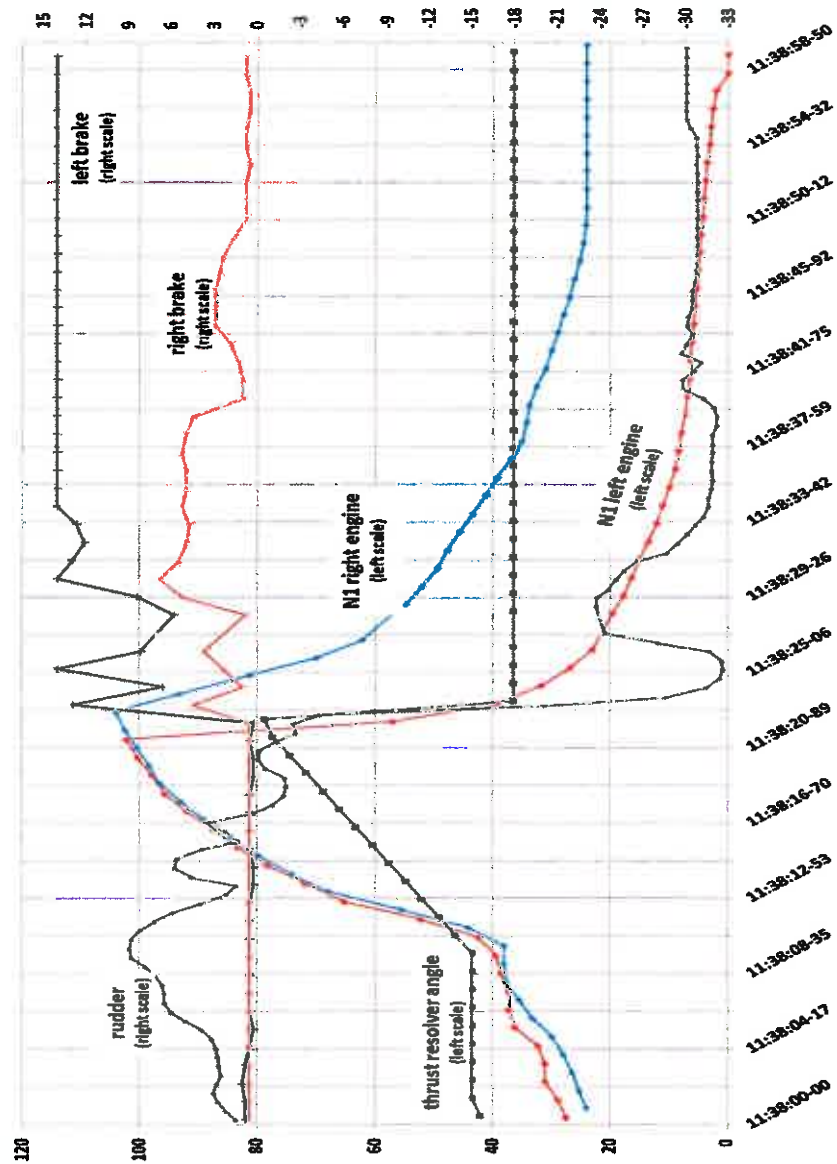
Fig. 24. Data from the FDR.

The enlarged diagram overleaf – Fig. 24 – illustrates the times with raw data from the FDR at the time of the loss of engine thrust itself, from 38:21 to 38:25. The first point on the N1 line is also the highest point (102.25%). Among other parameters which could be noted from the FDR readouts, it can be seen that aileron was applied (the steering wheel on the steering column was moved to the right),

and that the steering column was pulled back a little. These actions were initiated when the aircraft had already begun the veer to the left.

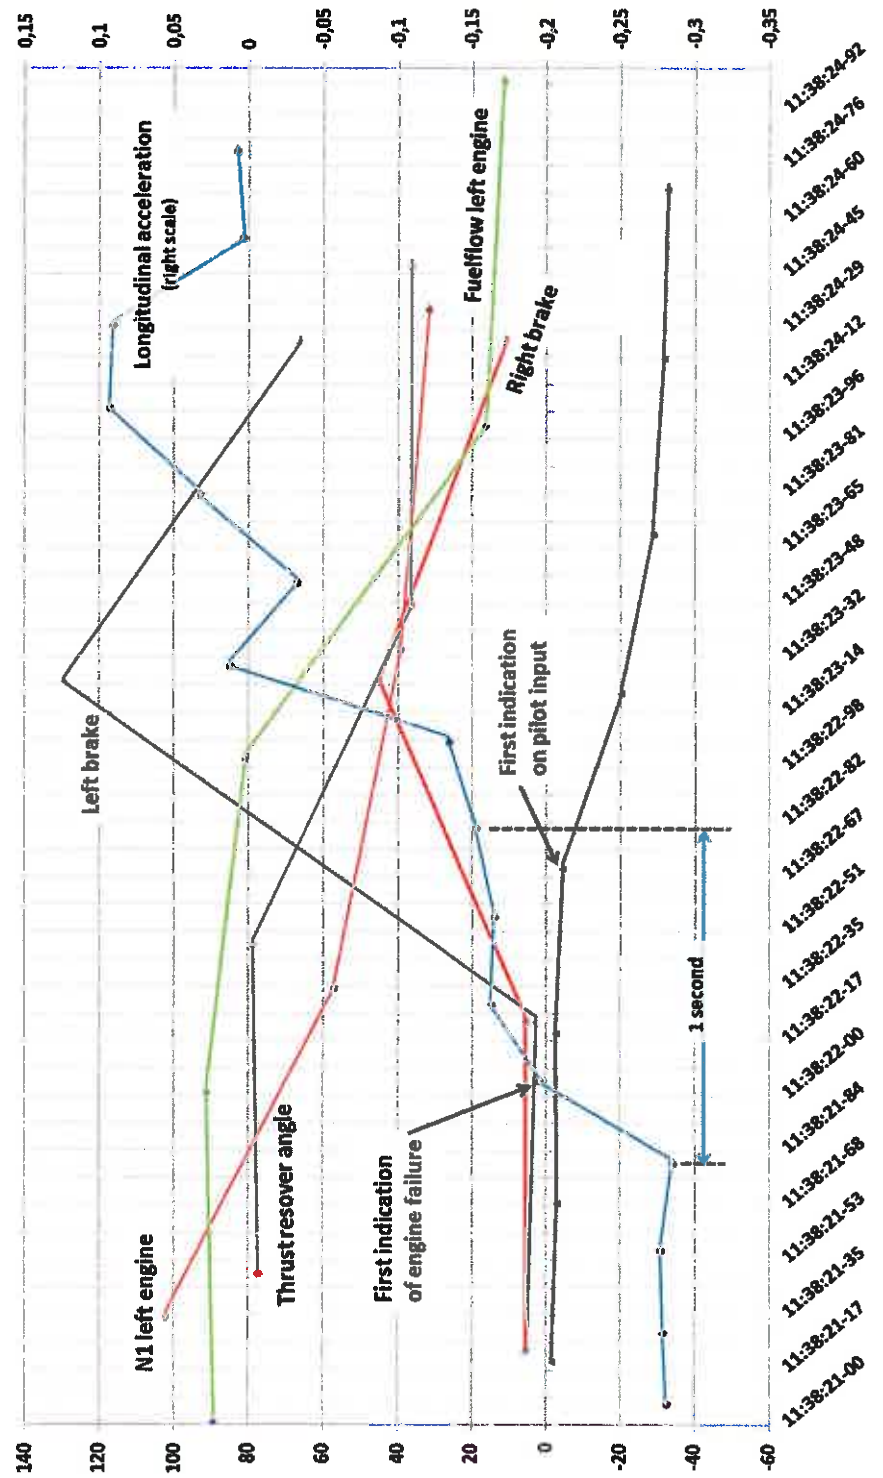
Fig. 25. Data from the FDR.

The pilots' reaction to the loss of engine thrust can be seen in the thrust lever angle, rudder and the brake pedal angles. The pilots' reaction begins at 38:22.18 hrs at the earliest (rudder) and at 38:22.68 at the latest (rudder position recorded at 2 Hz, i.e., two times per second). At 38:22.18 hrs, the rudder passes  $-20^\circ$  (turn right). The first value recorded when the brake pedals had begun to be used is at 38:23.25 hrs (they are recorded at 1 Hz). The left brake pedal was at that point depressed at around 92% of maximum displacement, and the right pedal at around 29%. The thrust lever angle is recorded at 1 Hz, and at 38:22.46 hrs, the thrust lever positions were still unchanged. At 38:23.46 hrs, the thrust levers had been retarded down to ground idle. The sequence can be seen in Fig. 25.

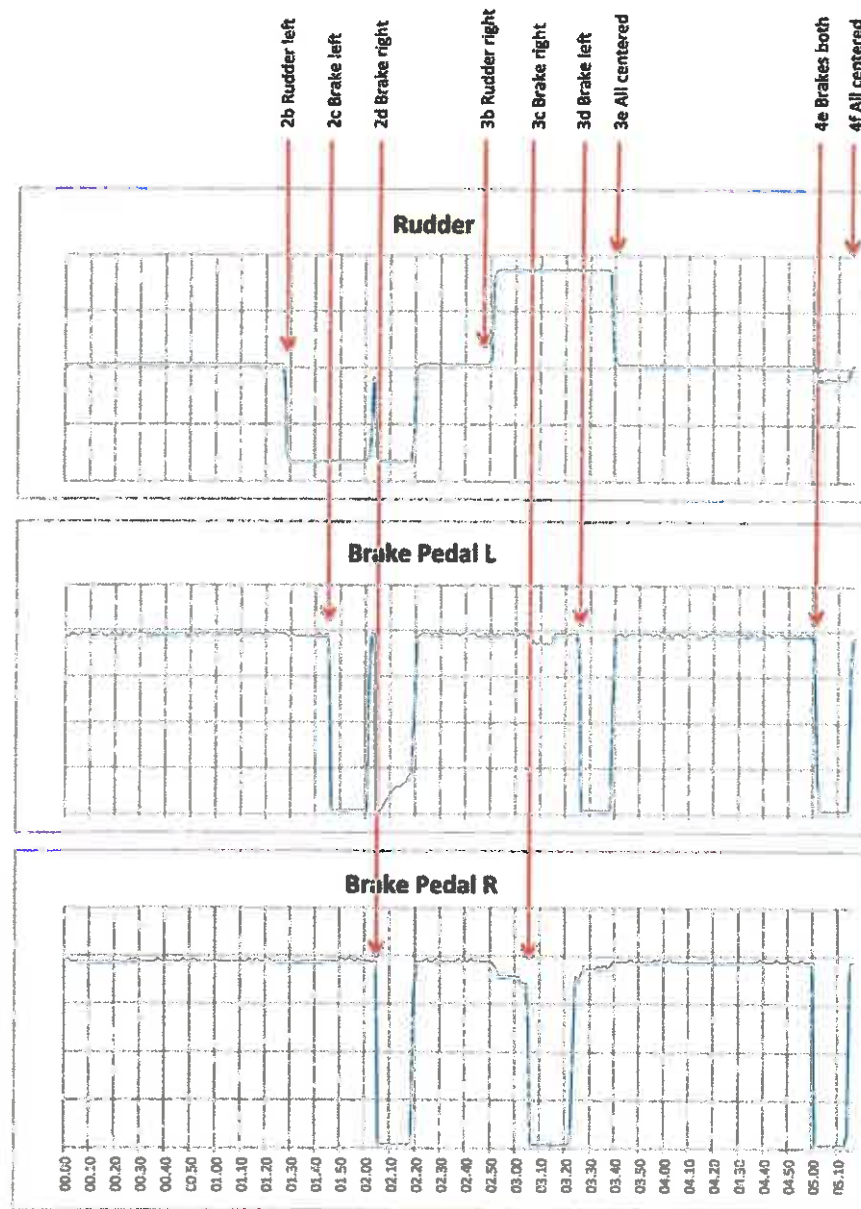
Fig. 26. Section of a graphical presentation of the data recorded during testing. Terms on the upper edge refer to SHK's test schedule. The bottom scale represents a time axis.

When the recorded data were extracted, it was established that there were no malfunctions or deviations, compared with the original recordings from the incident. Upon full displacement of left and right brakes, the corresponding maximum values had been recorded in the FDR. In the illustration above, it can also be understood that full brake displacements were registered irrespective of whether the rudder pedals were in left, right or neutral position. All recorded values corresponded fully to the movements and manoeuvres carried out by the test persons in the cockpit.

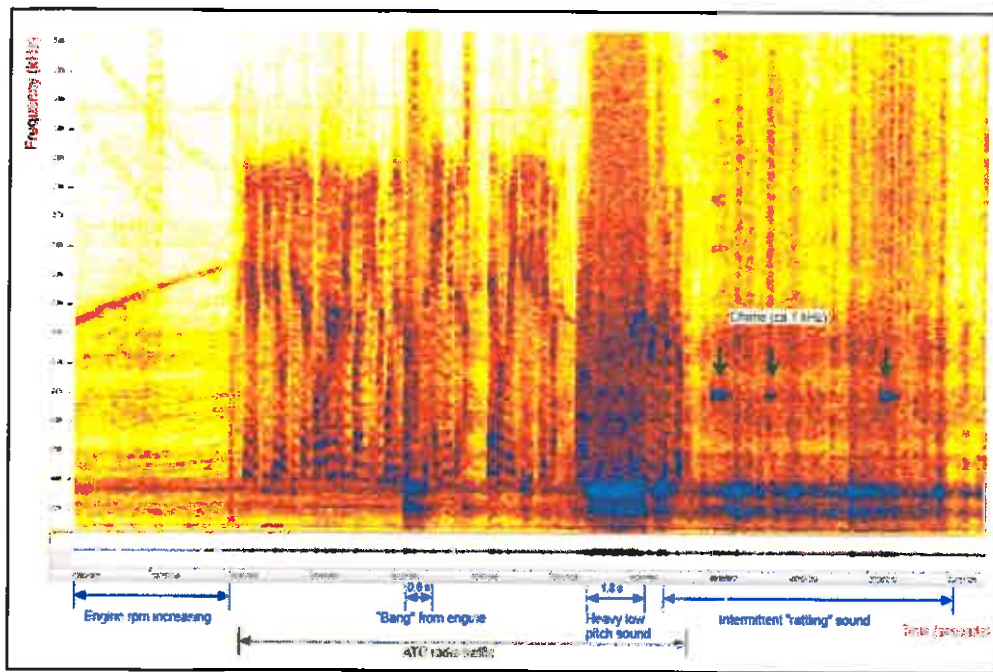
Fig. 27. Sonogram from channel 2 of the CVR. Graphics: Magnic AB.

The sonogram describes how sound can be visualized in the frequency plane, with time on the horizontal axis, where in addition to the “bang”, the low-frequency sound recorded approximately 4.5 seconds after the engine failure can also be noted.

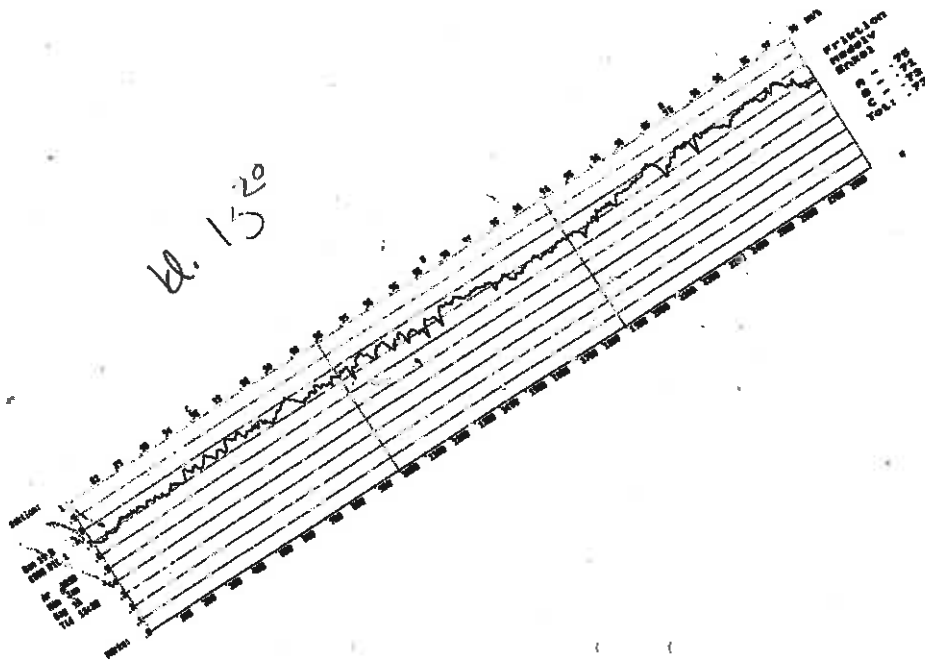
Fig. 33. Friction measurement at 13.20 hrs on runway 19R.

Approximately 35 minutes after the incident, a new friction measurement was carried out on runway 01L/19R, Fig. 33. This friction measurement shows generally higher values, 75, 71 and 73 for the respective sections and a mean value of 73. The difference between the highest and lowest friction values was on that occasion approximately 19.

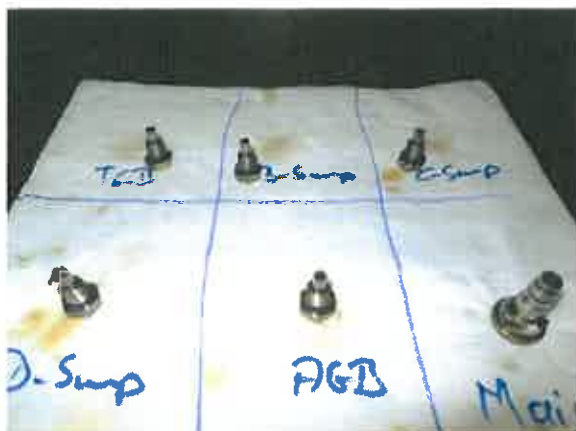
Initially, before the sequence of the engine failure was clarified, impurities in the oil system were a lead in the investigation. Inspection of the chip plugs<sup>46</sup> gave a clear indication that the oil system was not contaminated and that no bearing race was on the way to being damaged.

Fig. 41. The oil system's chip plugs; only the D sump (LPT) plug had traces of magnetic material. The number of chips was normal for the operating time. Photo: SHK.

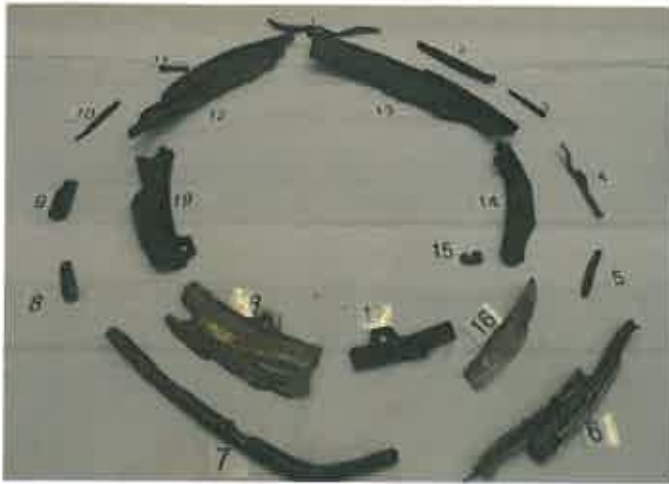
Of the parts analysed, it was discovered that the majority had secondary damage and that the sequence of failure on the diffuser aft air seal was the primary damage in a sequence of failure that is unknown at this time. LHT concluded that the seal came loose due to micro cracks in the nine attachment lugs that hold the seal against the diffuser. The attachment lugs are to have come loose, and the ring to have expanded radially outwards and come into contact with the stationary honeycomb seal. See Fig. 42.

Fig. 42. Fragments of the diffuser aft seal analysed by LHT.  
Photo: LHT.

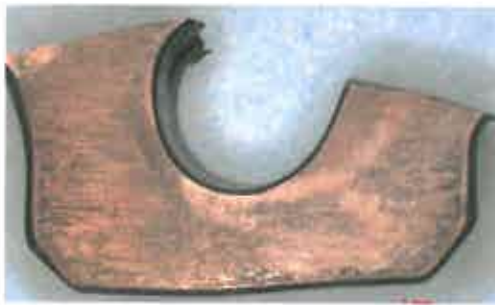
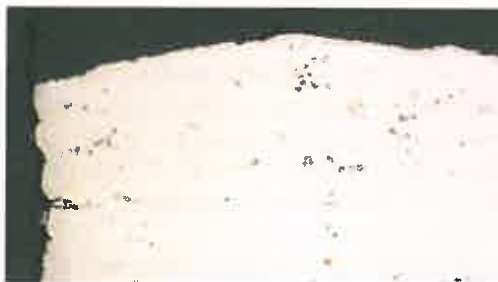
Fig. 43. Cross sections of the attachment lug with micro cracks, diffuser aft air seal. Photo: LHT.

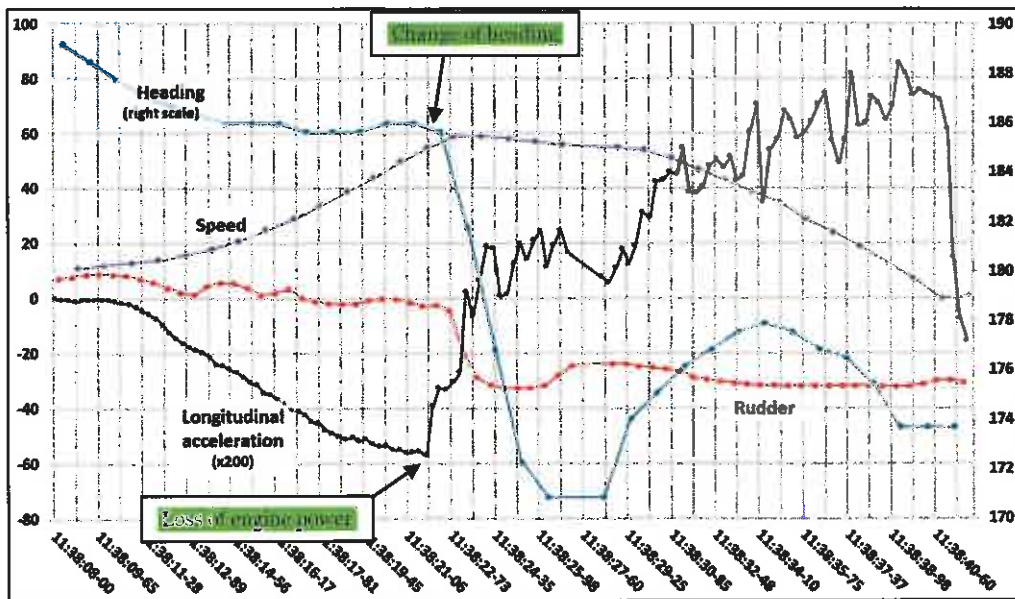
Fig. 53. Data from the FDR. (See also fig. 19.)

Following evaluation of the available parameters, SHK has chosen to use the decreasing acceleration as an indicator of the point in time of the engine failure. According to this parameter, the point in time of the engine failure can be established at 38:21.9 ( $\pm 0.12$  seconds). Apart from the higher frequency at which the values were recorded, this parameter can be verified in comparison with other data from the engine. In other words, the time of the engine failure has been determined as the point in time when the acceleration decreases due to reduced thrust from the left engine.

However, because the rudder deflection (see Fig. 53) is a pilot induced reaction to the change of heading, the latest point in time for the change of heading cannot be after the latest time of the rudder deflection. This reduces the possible interval for the change of heading to have taken place to between 22.46 and 22.68.

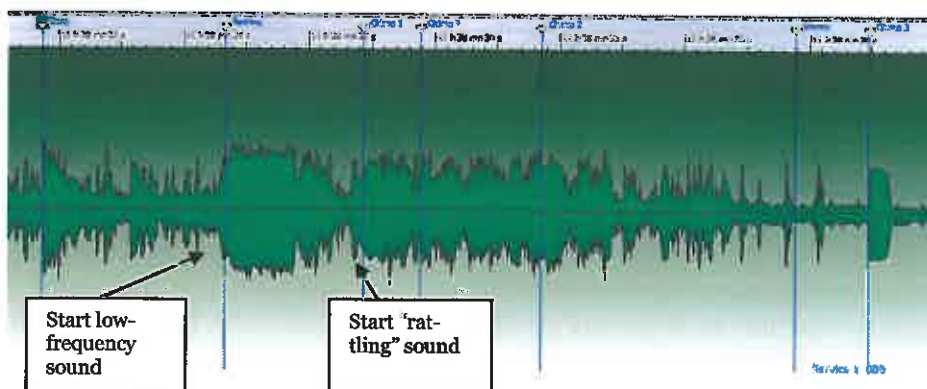
Fig. 54. Audiogram of parts of the incident. Graphics: Magnic AB.

At 26.5, a loud, low-frequency sound is recorded, which continues until 28.3. This sound is probably caused by the commander activating the nose wheel steering via the steering wheel at this point in time and turning the nose wheel to its maximum displacement angle. The increasing angle results in the nose wheel being more or less transverse against

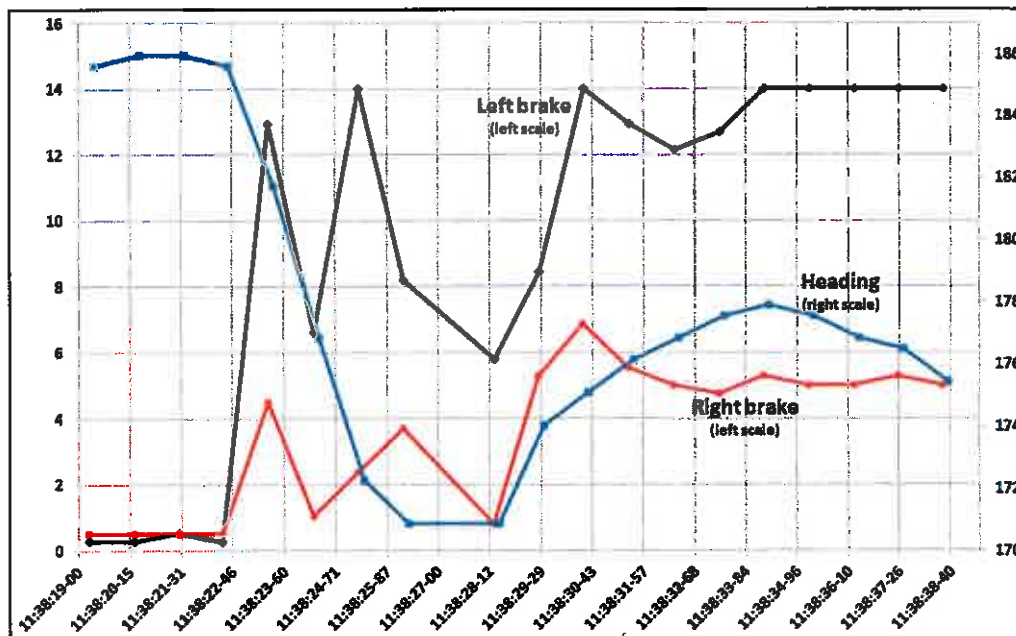
Fig. 55. Brake angles vs change of heading.

As can be seen from the graphical presentation in Fig. 55 above, the main change of heading – and the rate of the change of heading of approximately  $4^\circ$  per second – has not changed discernibly compared with the asymmetric braking values recorded during the same period. The first recorded change of heading began before the first recorded brake angle increases. After this first heading change, the heading follows an almost linear

The overall conclusion is that no measurable variation of the heading change rate is observable in connection with the recorded brake values. Even though the possibility that the asymmetric braking had a certain effect on the turning moment cannot be excluded, such an impact has, however, not been possible to determine with any reasonable degree of certainty.

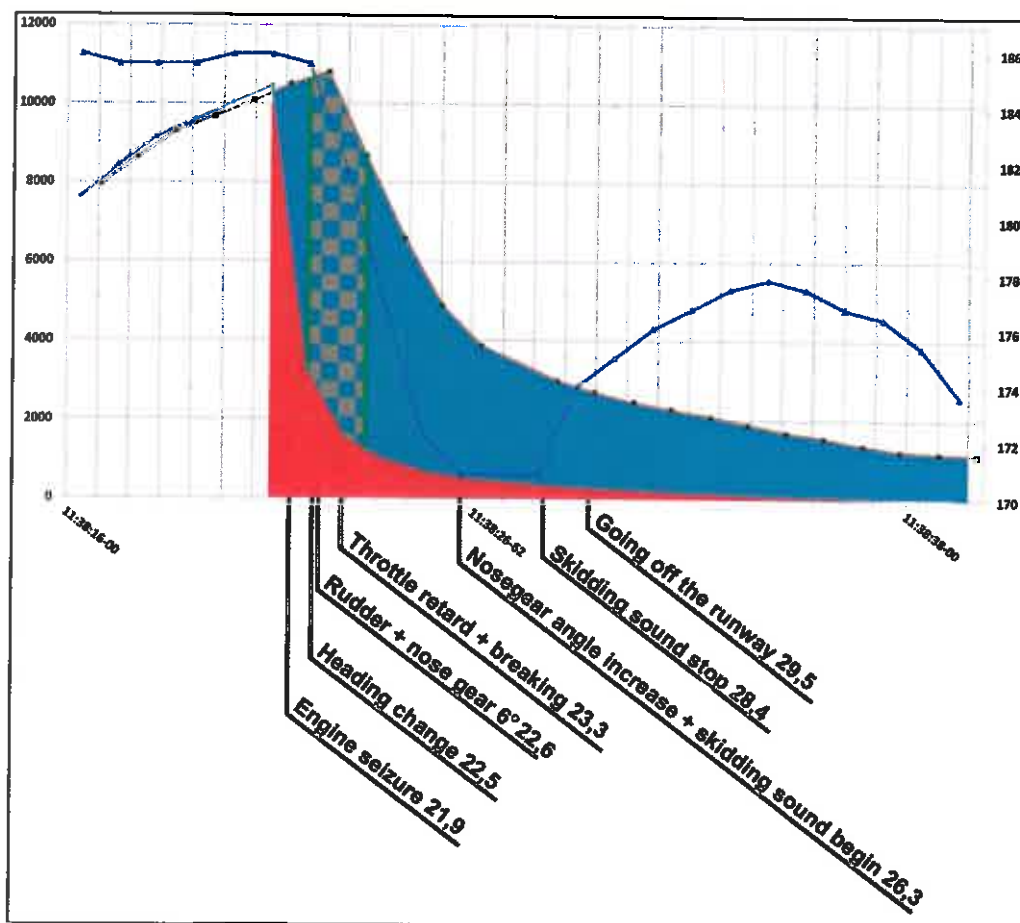
Fig. 56. Illustration of the energy from the engines including timeline. See also fig. 23.

In the diagram in Fig. 56, relevant data from the FDR, with the area of high yawing moment inserted, has been combined with the analysed timeline of the incident. The diagram shows clearly that the force from the excess moment from the situation of asymmetric thrust almost immediately produced the veer.

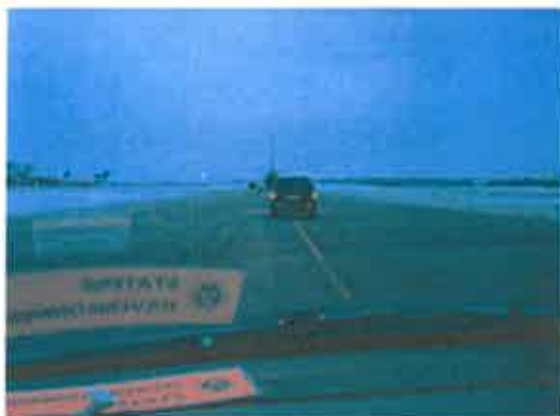
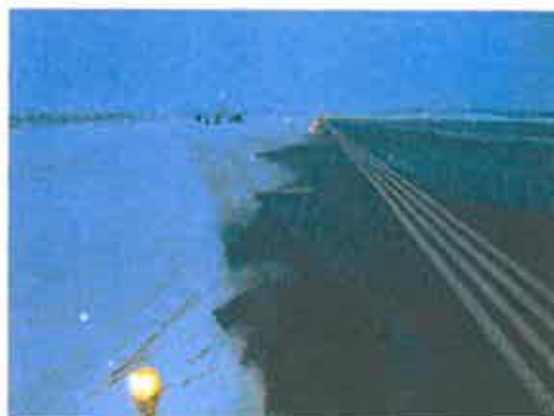
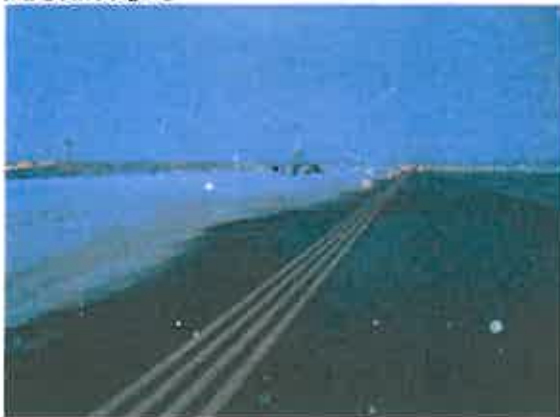
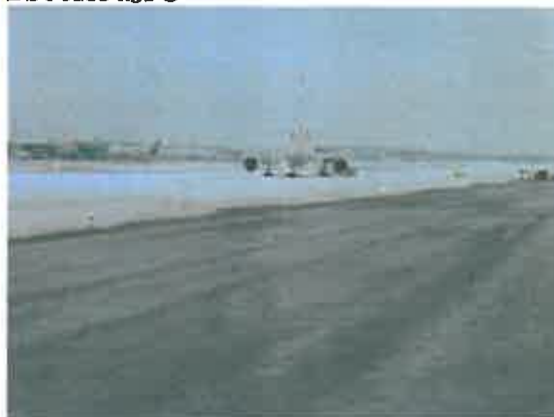
*Figur 1. De fyra digitala fotografierna.*

Bilderna DSC01834.JPG och DSC01835.JPG visar rullbana som mörkare än på bilden P1020238.JPG. Detta skulle kunna bero på att bilderna är tagna med olika kameror som exponerat bilderna olika. På bilderna iaktogs vita molnliknande områden på asfalten samt mörka hjulspår i dessa, se figur 1. Även ljusa hjulspår har iakttagits i de mörkare områdena på körbanan. Dessa observationer förväntas i större utsträckning om det är snö, is eller slask på rullbanan än om rullbanan är fri från beläggningar.

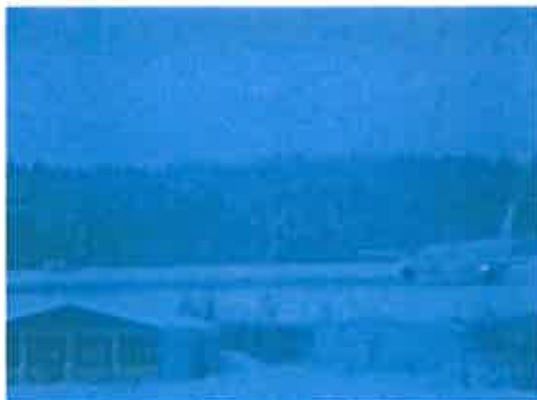
För att det ska vara möjligt att bedöma om snömolnet uppstår innan flygplanets hjul lämnar banan krävs det att båda banan och planets hjul är tydligt synliga i filmerna. I detta fall är filmernas kvalitet av sådant slag att laboratoriet inte kan uttala sig i frågan.

Figur 2. Bild från "Video takeoff.mp4" när planet lämnar banan.

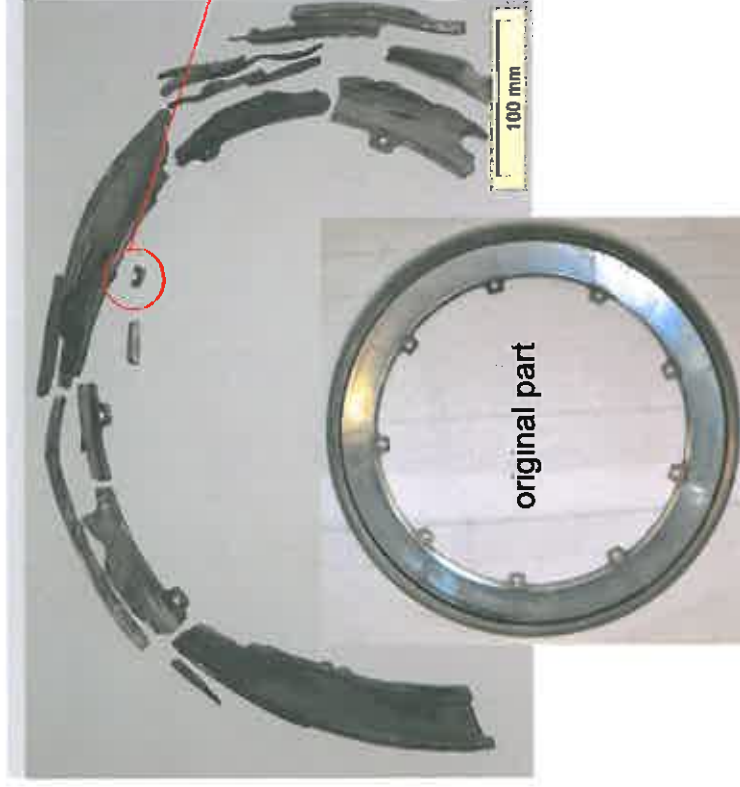
HPT Diffuser Aft Seal

Fractured lug with post fracture damaged fracture faces exhibiting internal mechanical damages

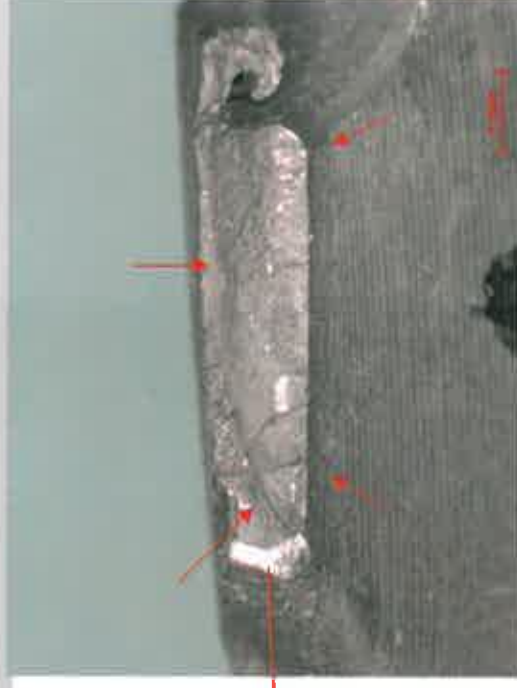
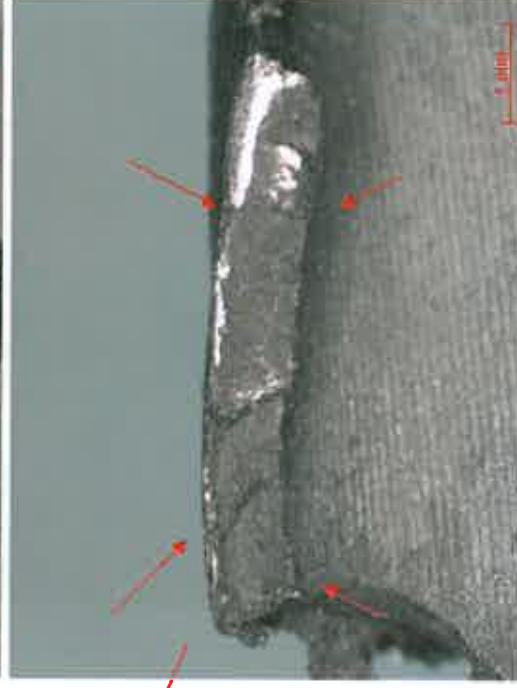
HPT Diffuser Aft Seal

Fractured lug with fatigue fracture indications

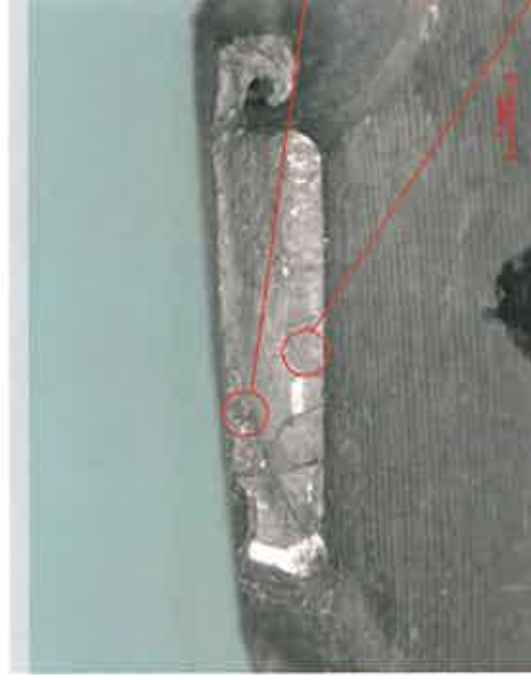
HPT Diffuser Aft Seal

Fractured lug with fatigue fracture indications

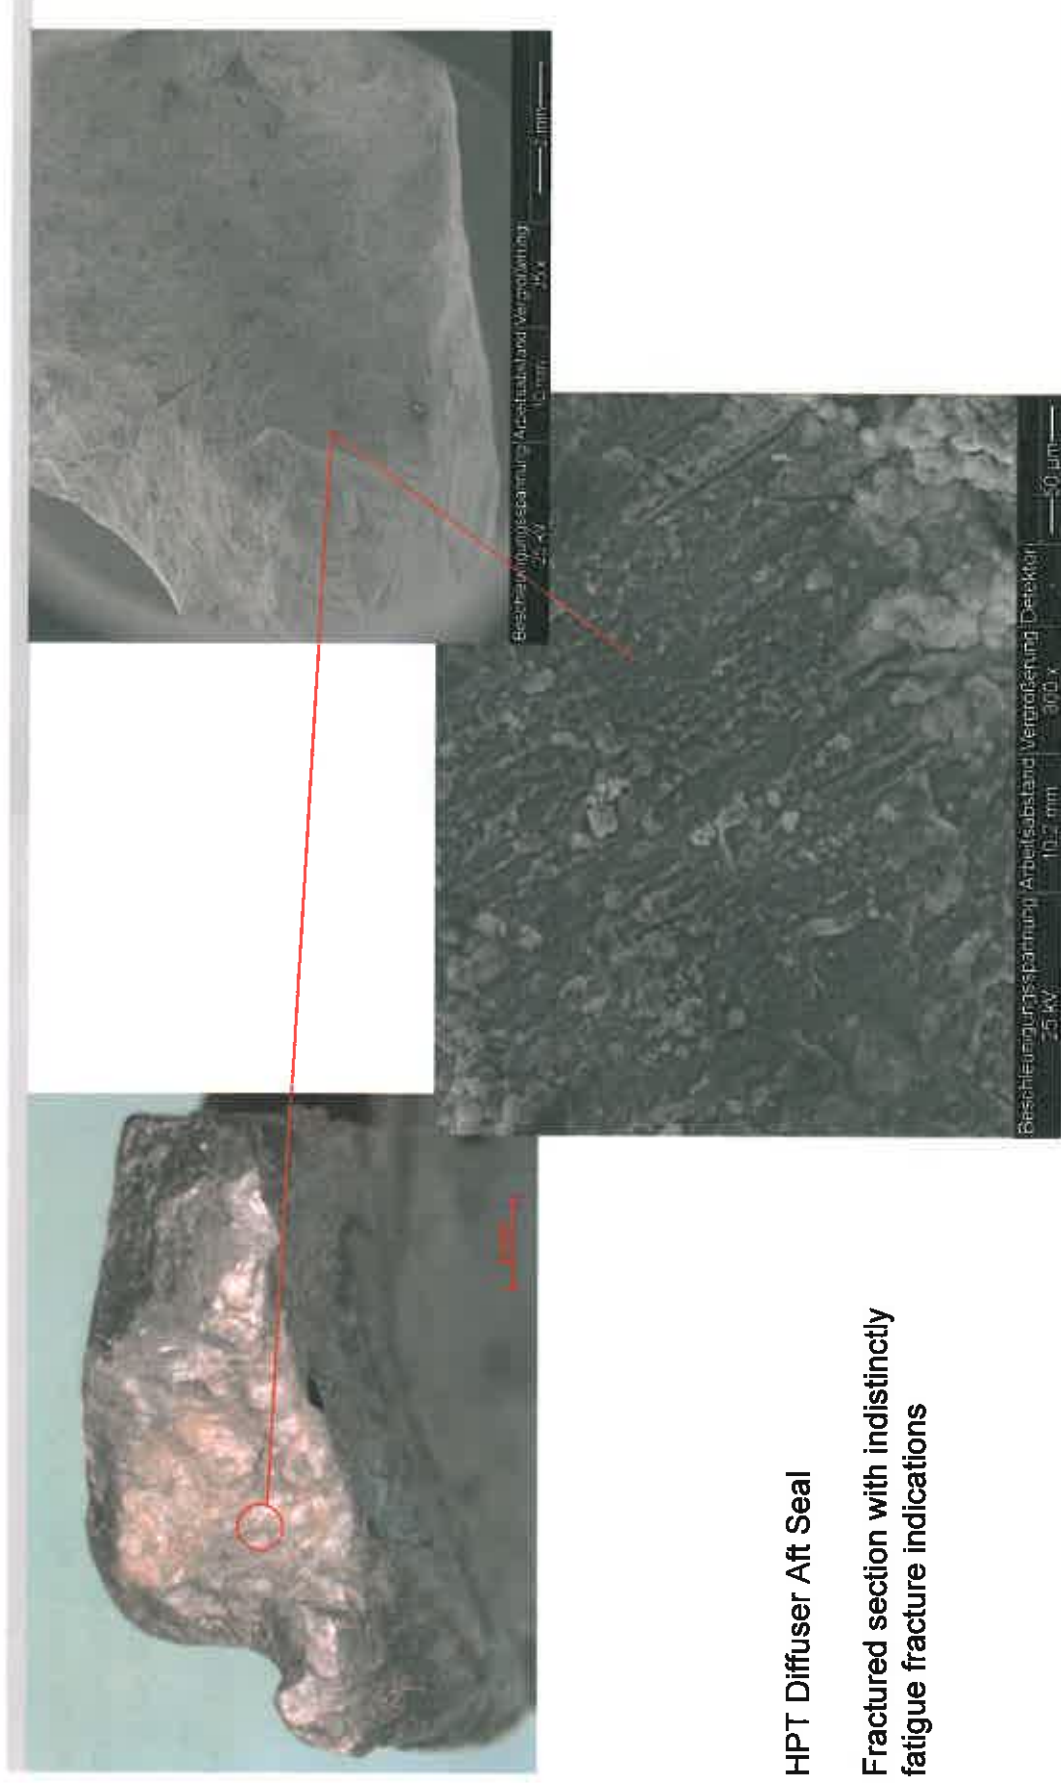
HPT Diffuser Aft Seal

Fractured section with indistinctly  
fatigue fracture indications

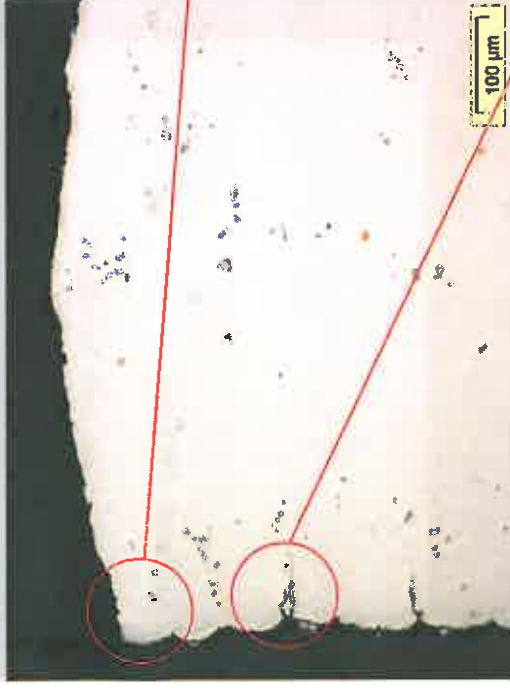
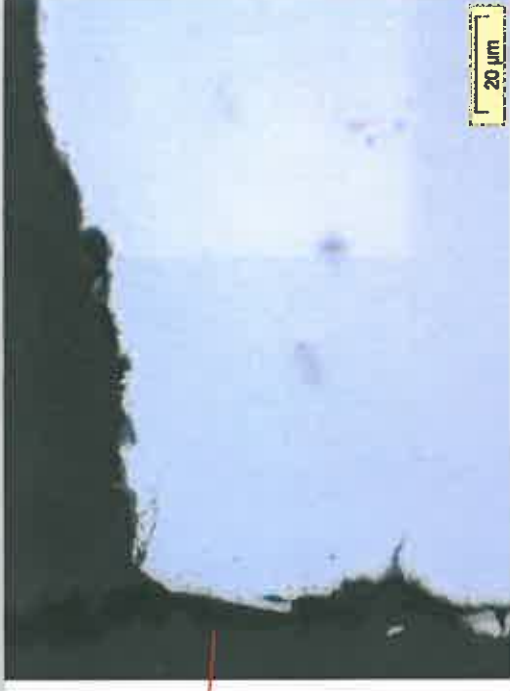
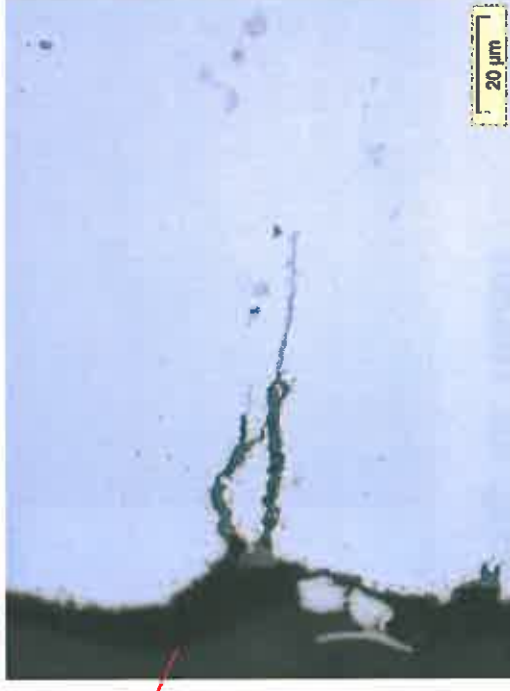
HPT Diffuser Aft Seal

Lug fracture origin exhibiting thermal fatigue and secondary thermal fatigue cracks next to fracture origin

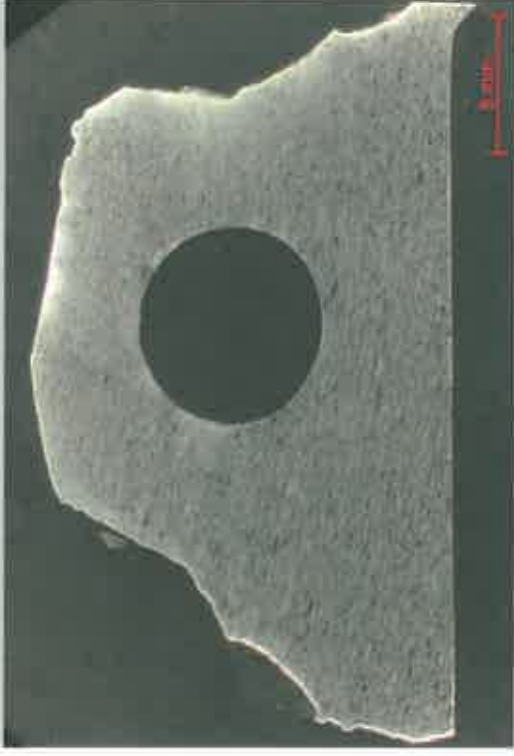
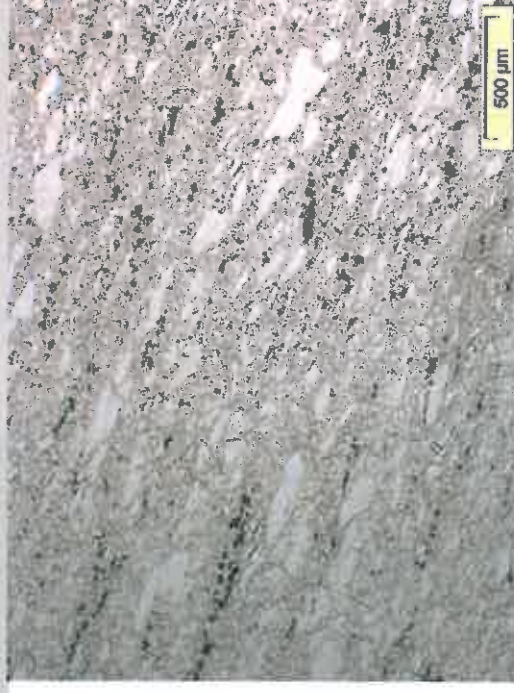
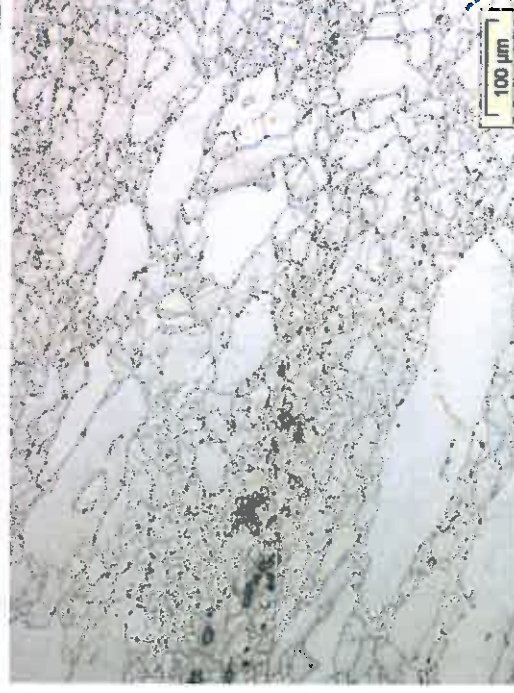
HPT Diffuser Aft Seal

Slightly ovalized seal lug (top left)  
and general microstructure (right)

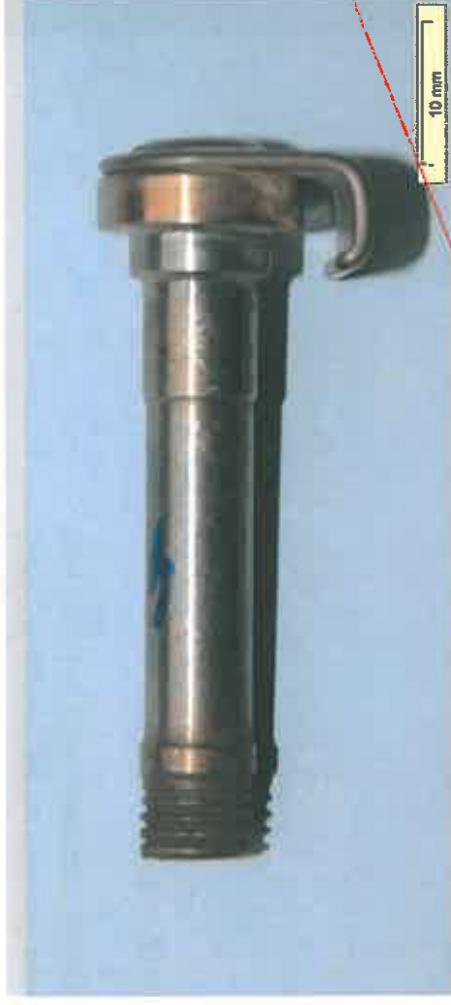
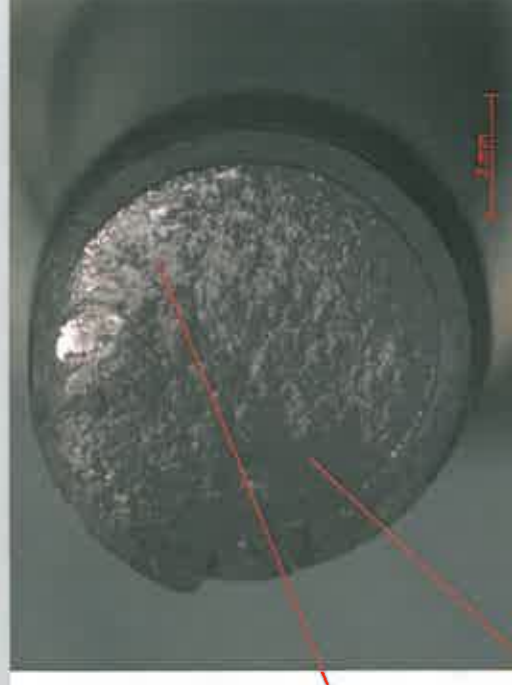
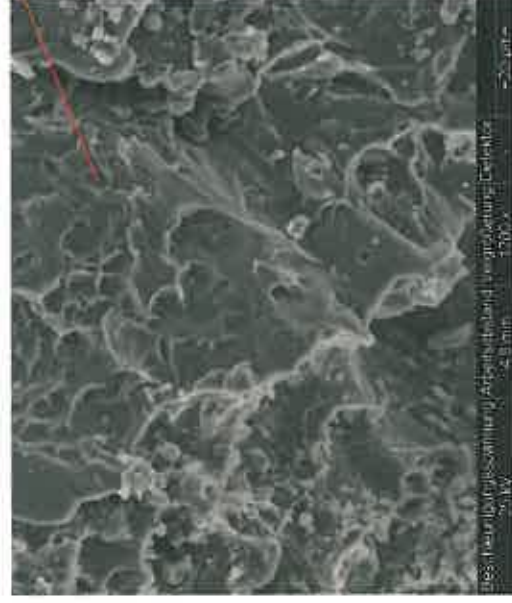
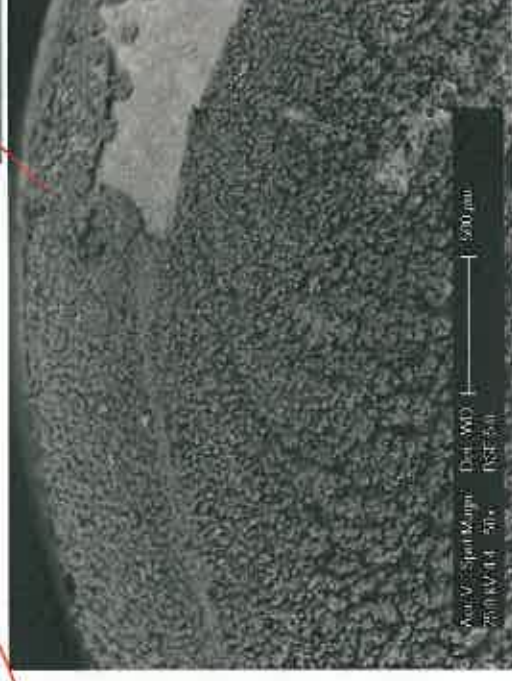
### Hookbolt

Fractured hookbolt and fracture face (top) detailed SEM views of shear structure (bottom left) and foreign material overspray (bottom right)

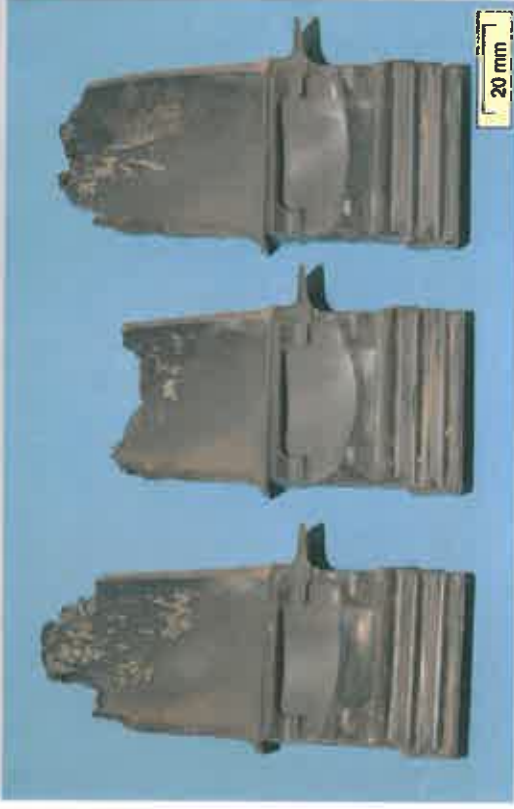
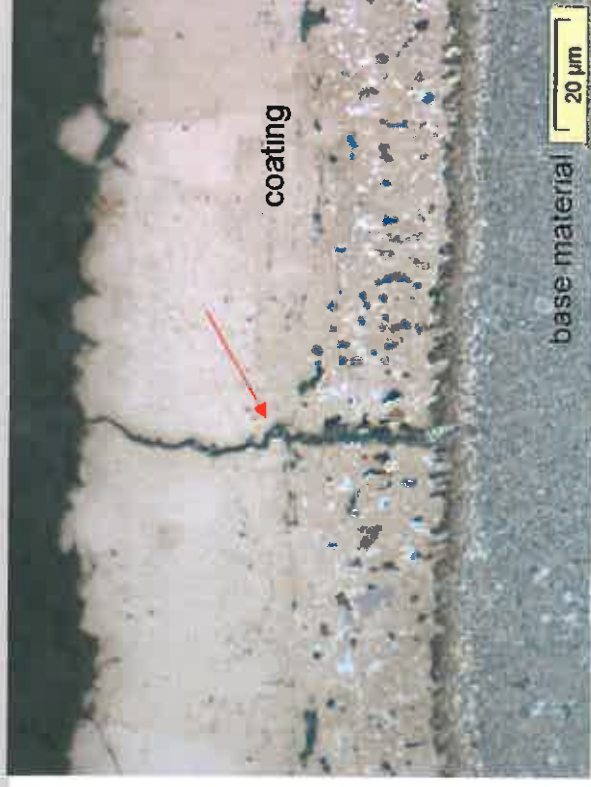
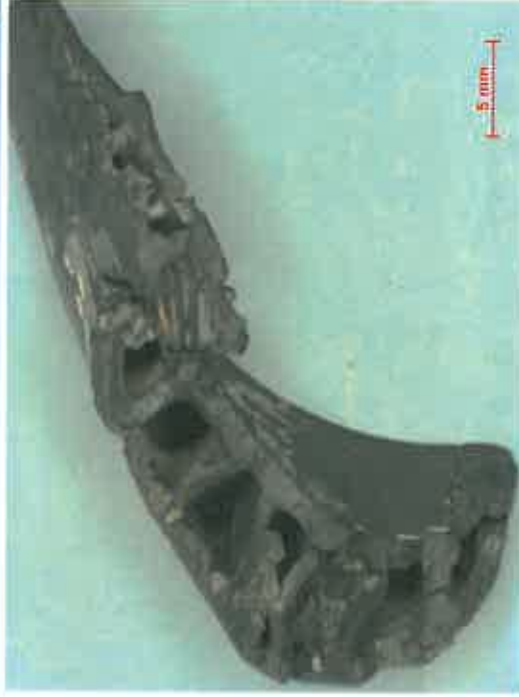
### HPT Blade

Fractured blades (top left), fracture face of blade airfoil (bottom left) and oxidized / sulfidized crack through the airfoil coating (top right)
