**Statens haverikommission**  
Swedish Accident Investigation Authority

***Final report RL 2012:21e***

**Serious incident on 16 of January 2010 to  
aircraft EP-IBB at Stockholm/Arlanda  
Airport, Stockholm county, Sweden**

Ref.no. L-02/10

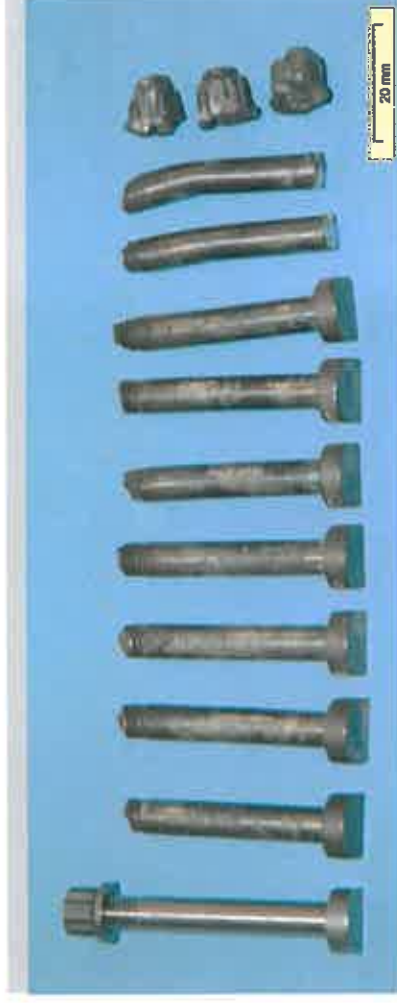
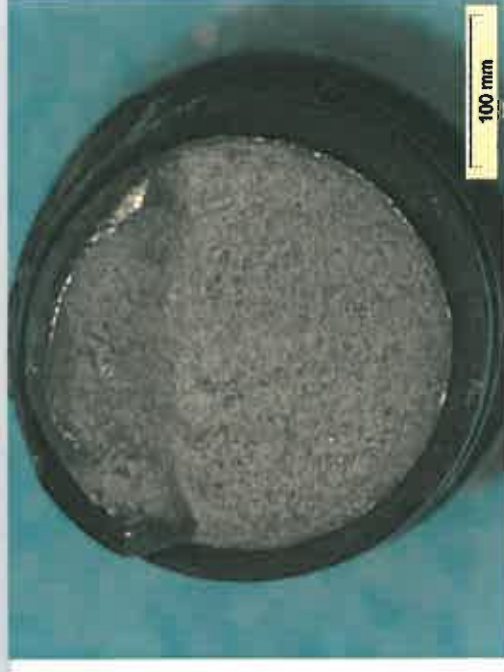
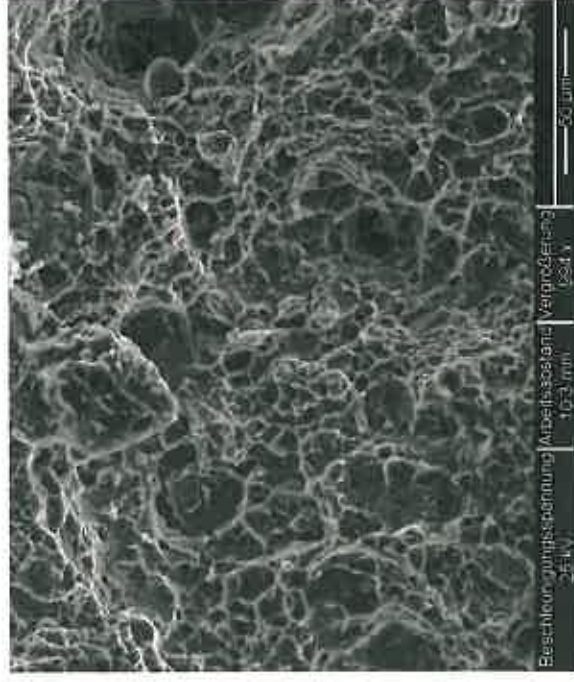
### Ring Bolt

Fractured ring bolts (top), typical fracture face (top right) and SEM view depicting the ductile structure of the fracture (bottom left)

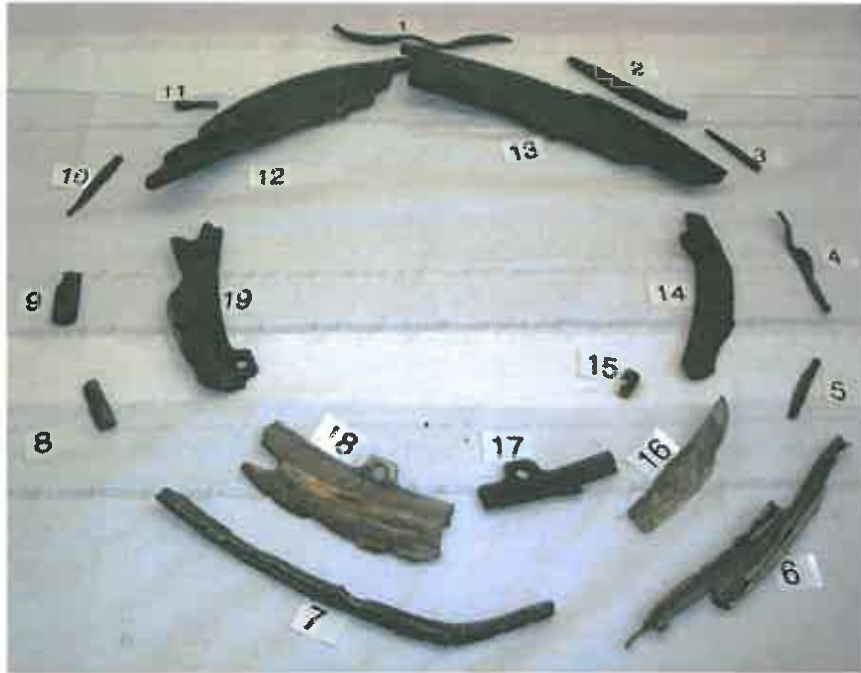
Photo No 2. LHT photo showing Diffuser Aft Seal fragments.

Pieces 4, 5, 9, 10 and 11, on photo no 2, are not believed to come from the Diffuser Aft Seal, based upon visual appearance and geometry.

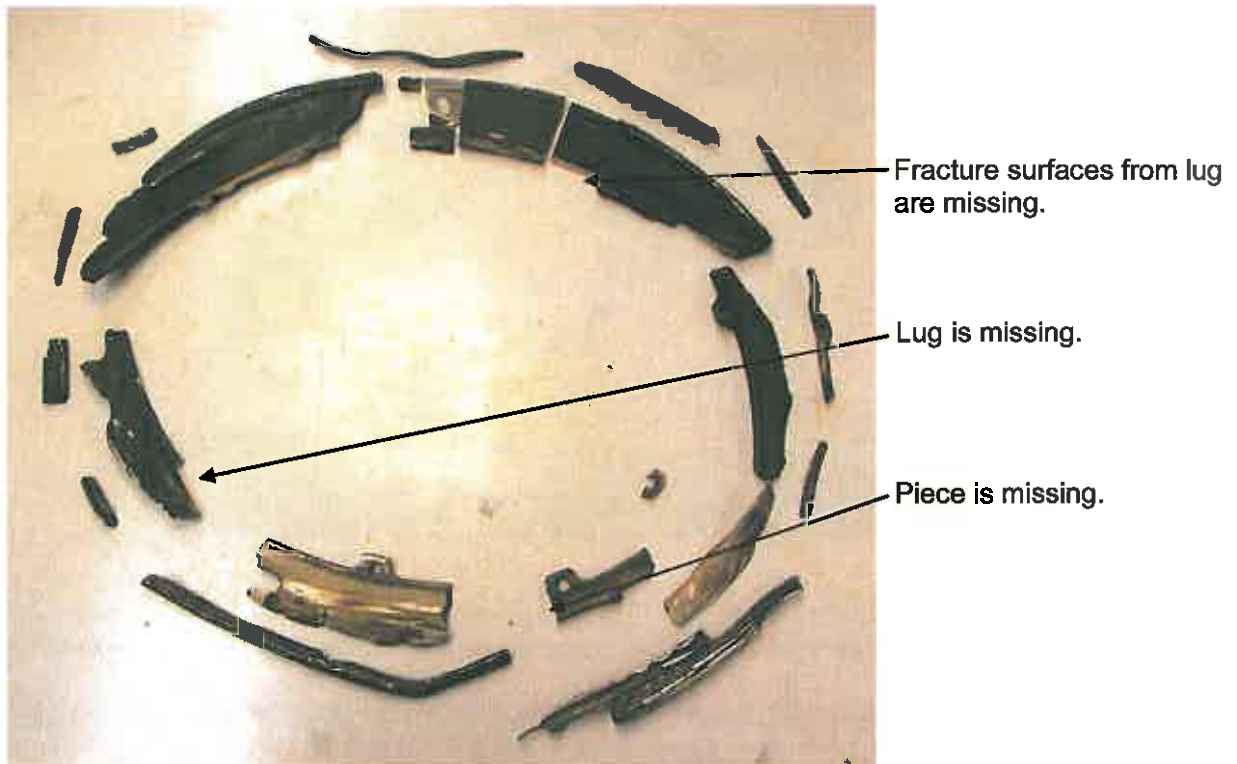
Photo No 3. All of the fragments were received. LHT have cut sections from No 13, 17 and 19.

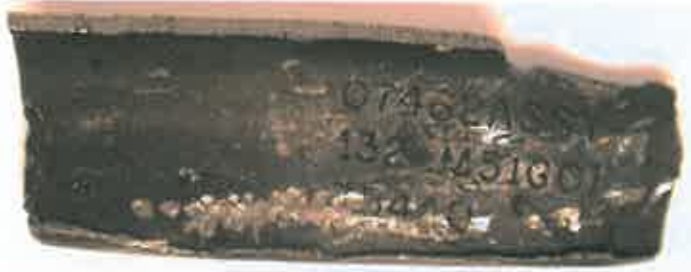
Piece No 9 is confirmed by GE Aviation to be a HPT Stage 1 Nozzle air cover baffle.

Photo No 4. Piece no 9, HPT Stage 1 Nozzle air cover baffle.

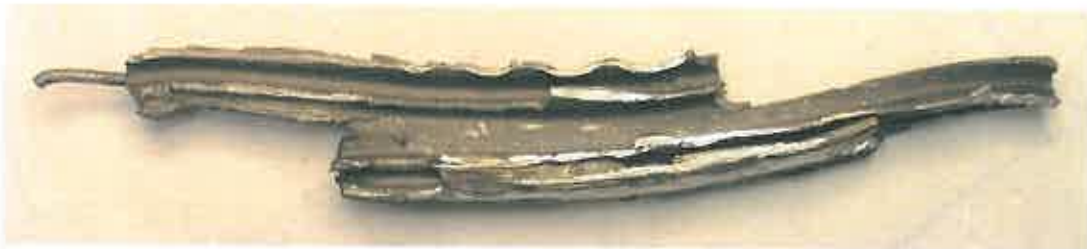
Photo No 5. Piece No 6 is the only fragment with the four seal teeth in the same piece.

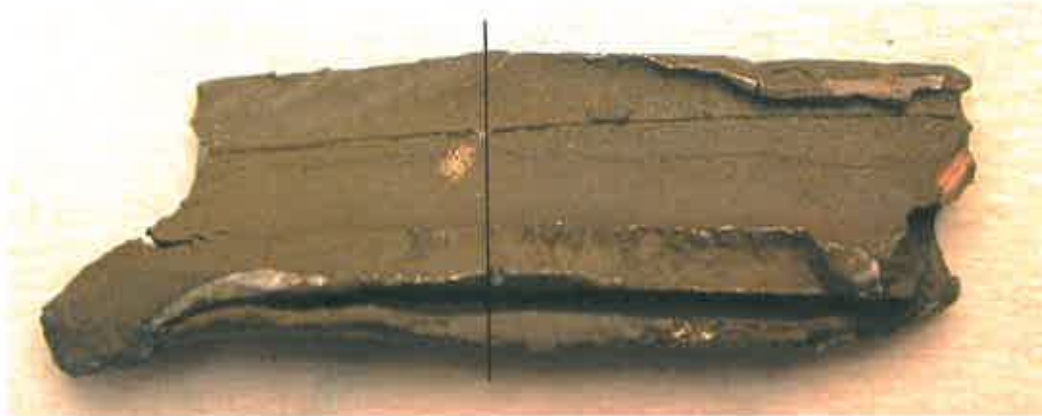
This tooth fragment has also a machining step on the FWD surface, between the repair weld and the original tooth, with a geometry which gives a stress concentration factor of about 2.5 for radial and bending stresses in this area.

This machining step may have contributed to initiate a fatigue crack in the seal tooth.

Photo No 7. The most interesting piece of the ones in photo No 1 is this 30 mm long fragment (labeled A) of the aft tooth of the seal (FWD surface shown on photo). This is the only piece of a seal tooth which is rather undamaged.

The line shows where a metallographic section was cut.

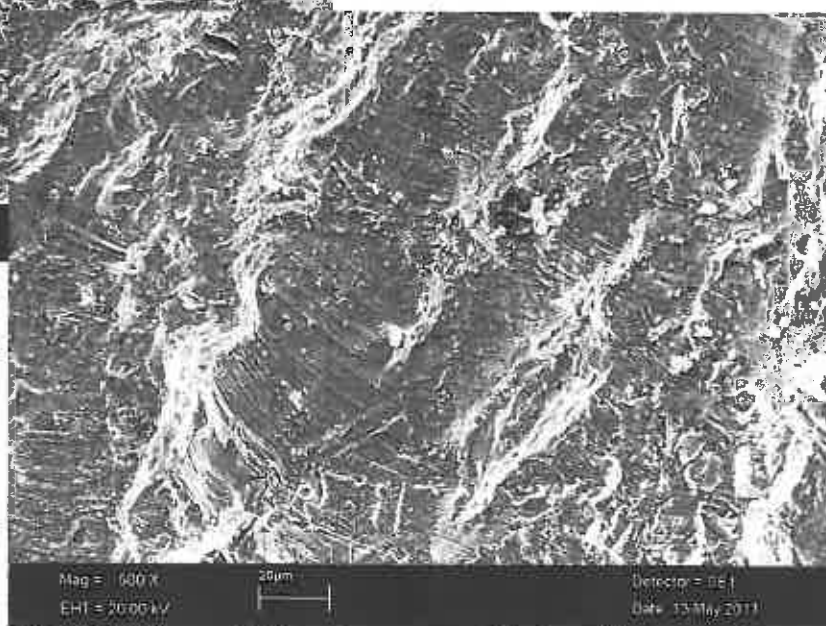
Photo No 11. Fatigue striations in a comparatively oxide free surface.

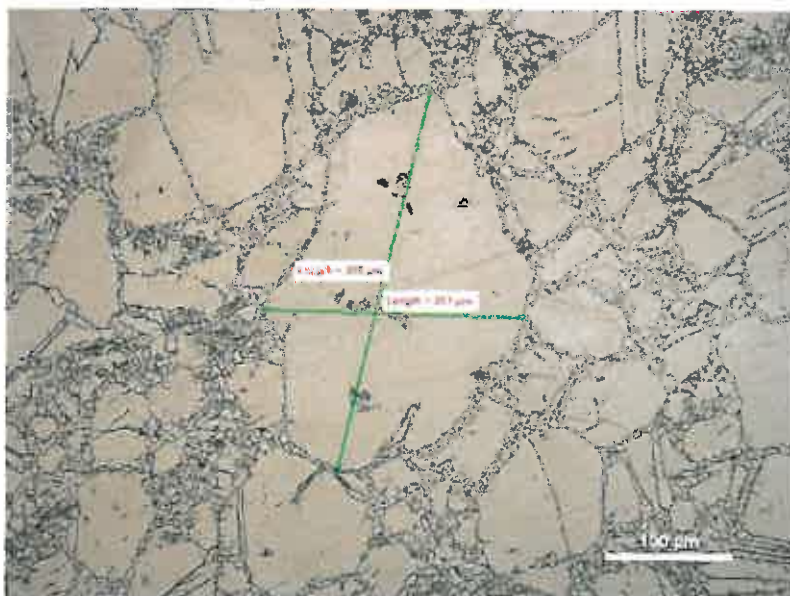
Photo No 18. The grain size of the seal tooth base material, about 3 mm from the weld interface, was evaluated per GE C50TF37 CL B per ASTM E 112.

Duplex, necklace structure is not permitted according to the requirements.  
The largest grain in photo No 18 is 0.30 x 0.20 mm which is not permitted.

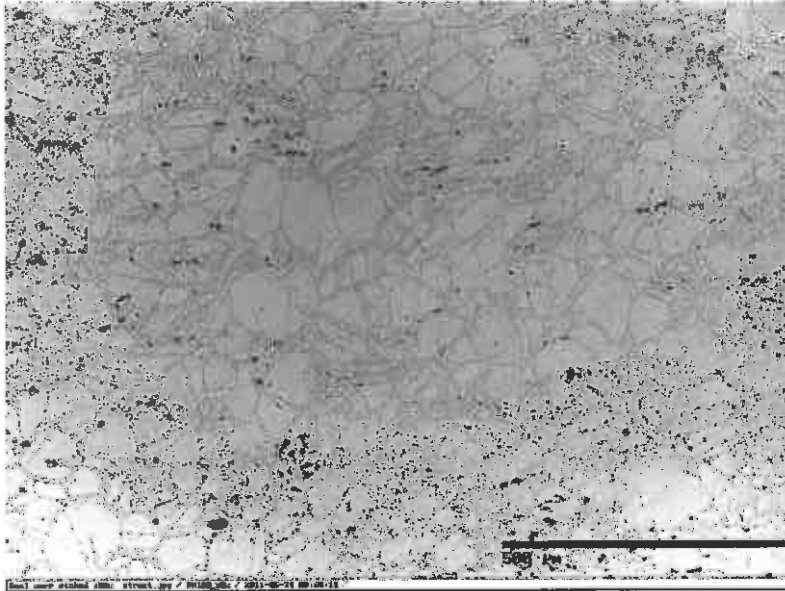
Carbide segregation check shows that the amount and distribution of particles do not exceed the extent shown i GEAE photo 317164, although the amount of particles is considered to be high for a premium quality In 718.

Photo No 19. Microstructure of the seal tooth, about 3 mm from the weld interface.
