## **AIRCRAFT ACCIDENT REPORT**

**UNCONTAINED ENGINE FAILURE/FIRE**

**VALUJET AIRLINES FLIGHT 597**

**DOUGLAS DC-9-32, N908VJ**

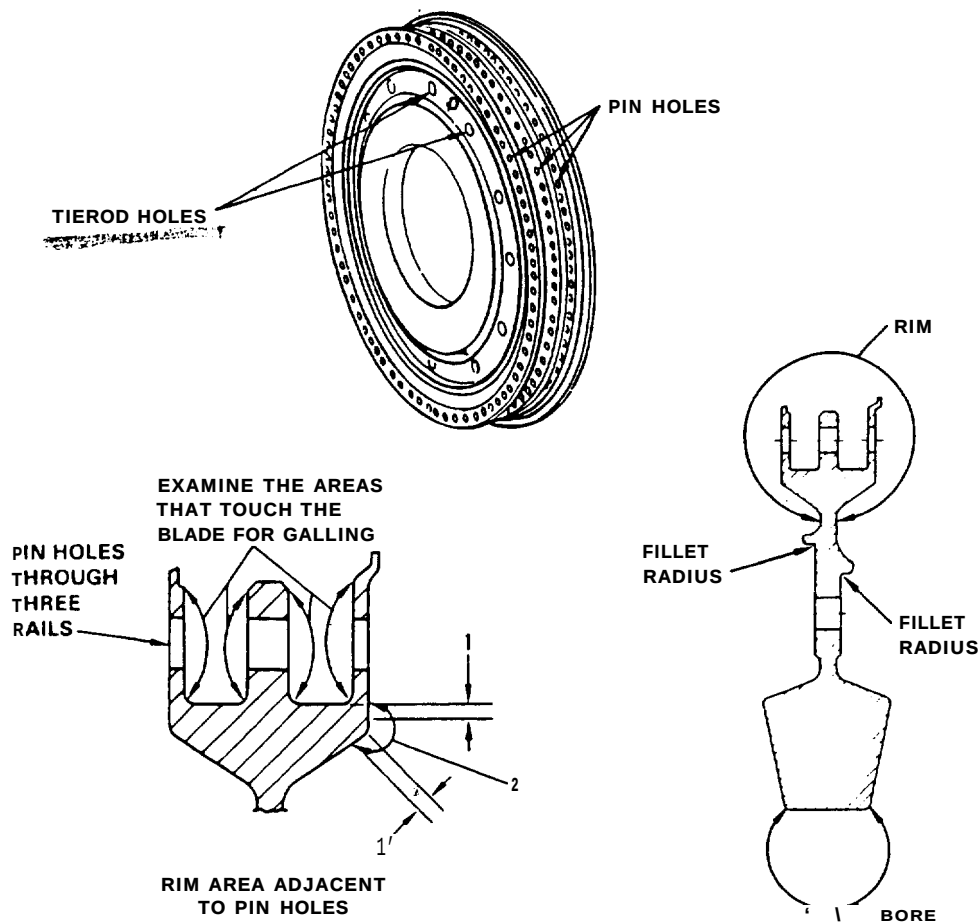
**Pratt & Whitney**  
**JT8D ENGINE (PN 481672 - RESTRUCTURED)**  
**COMPRESSOR DISK, STAGE 7 - INSPECTION-01**

The P&W engine manual specifies that for area 7 of the P&W figure 802 (see appendix D), which is depicted as a tierod hole, no unrepaired damage can be allowed in any hole, or within 0.125 inch of the edge of the hole on adjacent surfaces, and that damage can be repaired to a depth of 0.005 inch by blending. The instructions further indicate that damage up to 0.003 inch is acceptable in the web area of the disk without blending. The cross-section of the 7<sup>th</sup> stage disk in P&W figure 802 depicts the tierod holes, but does not have the hidden lines,<sup>29</sup> which would depict the smaller diameter SR holes behind the tierod holes, or a separate cross-section of the disk, just through the SR holes.
