# **AIRCRAFT SERIOUS INCIDENT INVESTIGATION REPORT**

**V N – A 1 4 6**

**Japan Transport Safety Board**

**VIETNAM AIRLINES  
BOEING 777-200, VN-A146 (VIET NAM)  
ON B TAXIWAY AT NARITA INTERNATIONAL AIRPORT  
AT ABOUT 07:44 JST, JULY 30, 2008**

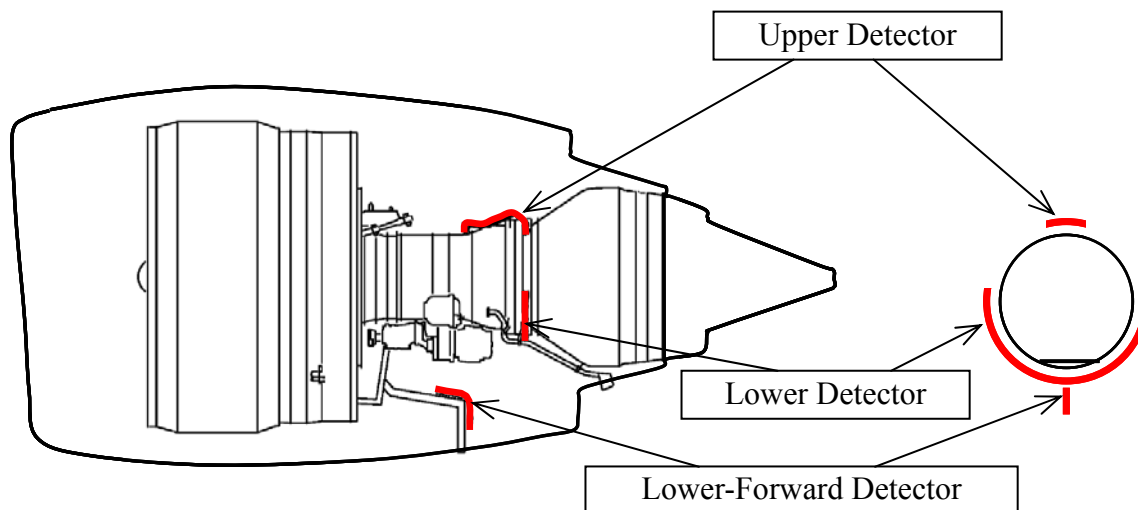
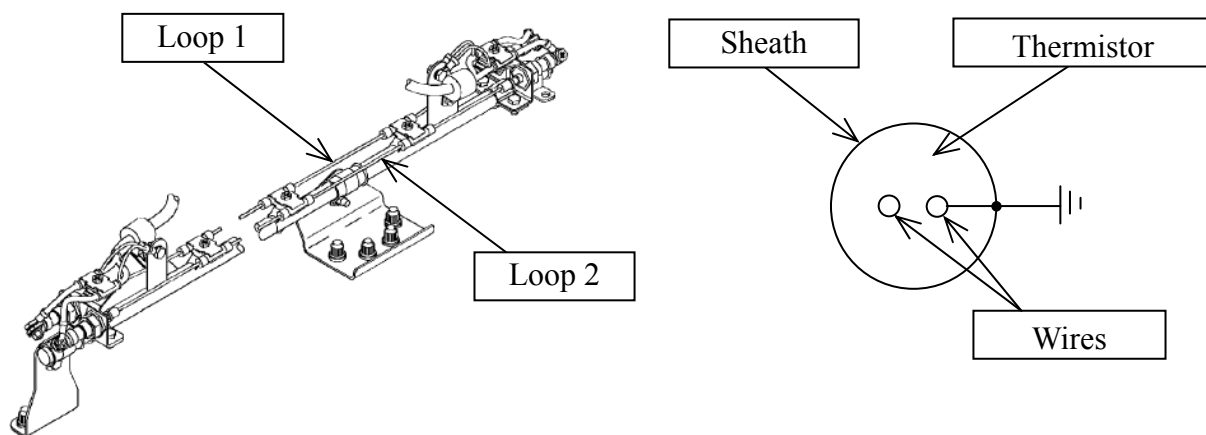
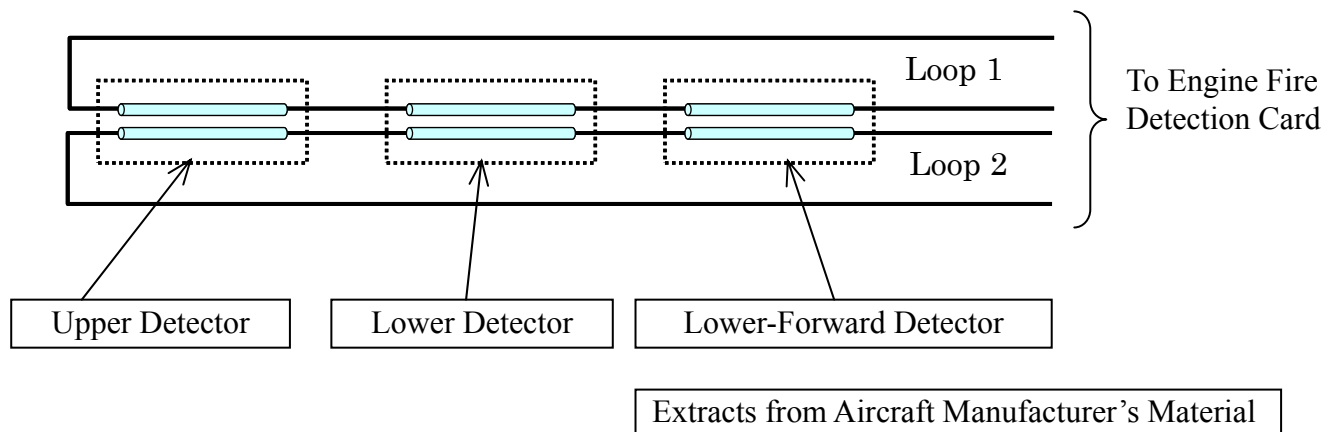
Figure 5 Engine Fire and Overheat Detection System

In addition, the exterior surfaces of the detectors had the signs that suggest damage resulting from exposure to high-temperature flames.
