# ACCIDENT REPORT

occurred to the aircraft  
ATR72-212A (ATR 72-500)  
registration marks YR-ATS

Rome Fiumicino airport  
February 02<sup>nd</sup> 2013

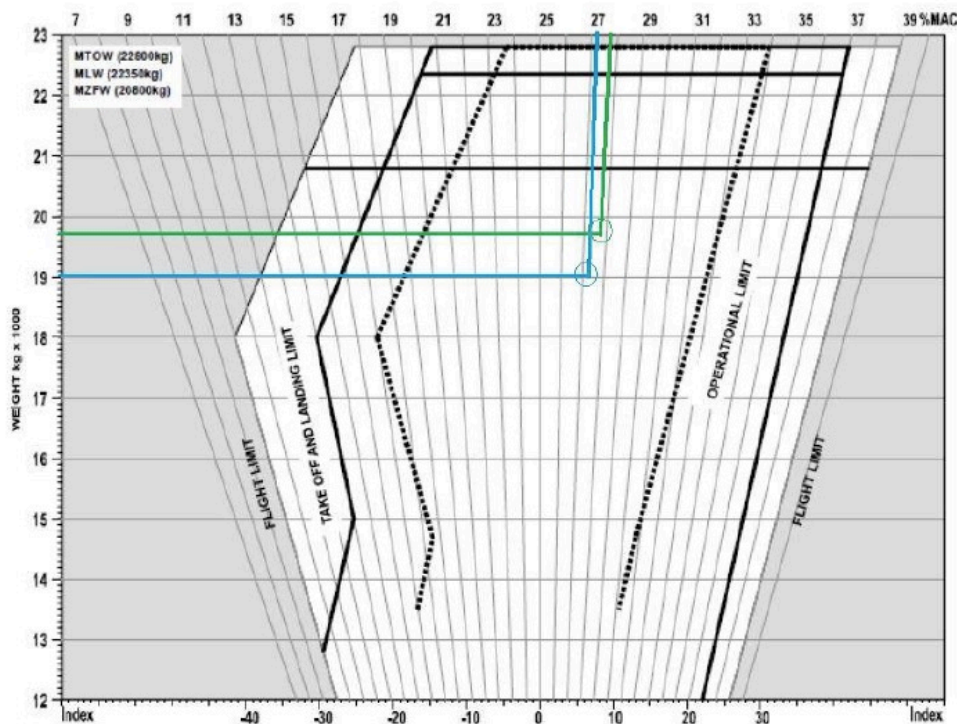
Figure 2: loadsheet of the weight and balance chart (take-off: green line, blue line: landing)

From the loadsheet chart of the Weight and Balance Manual, as shown in figure 2, it is shown that the positions of the center of gravity of the aircraft during the take-off and during the landing were within the acceptable limits.

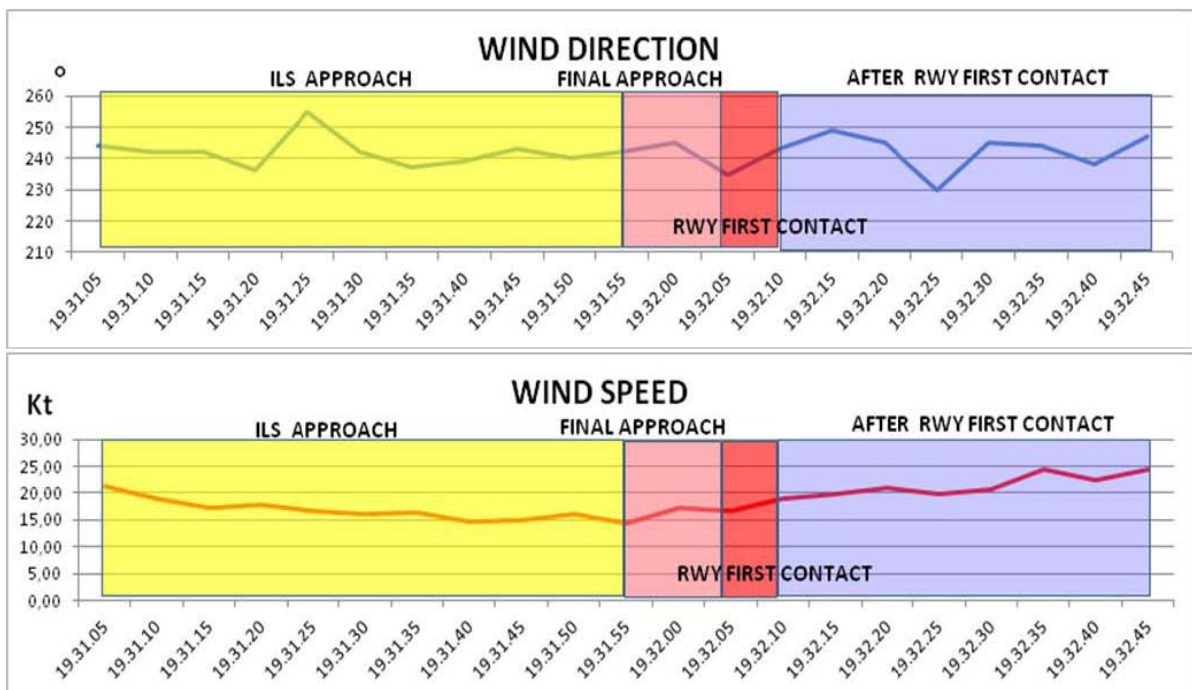
Figure 9: graphical representation of the changes in the wind on the runway 16L.

For all the phases of the accident, maximum variations of the wind direction of around 20 degrees were detected, with a variation from 245 degrees to 235 degrees during the five seconds before the first contact with the threshold and a variation from 235 degrees to 243 degrees during the next five seconds.

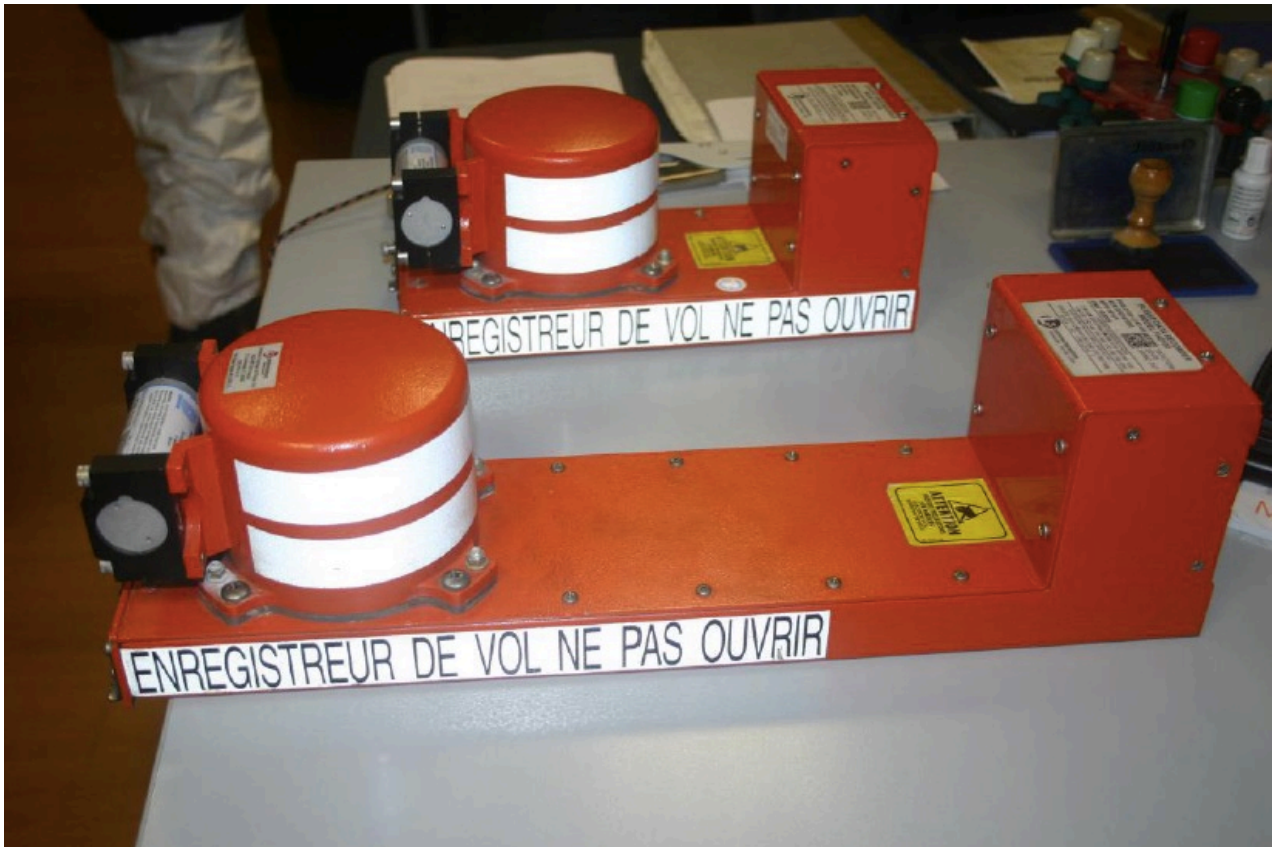
Picture 4: Aircraft flight recorders of the YR-ATS.

The extraction of data took place in February the 5<sup>th</sup> of 2013, inside the ANSV laboratories, attended by the technical consultant of the judicial authority.

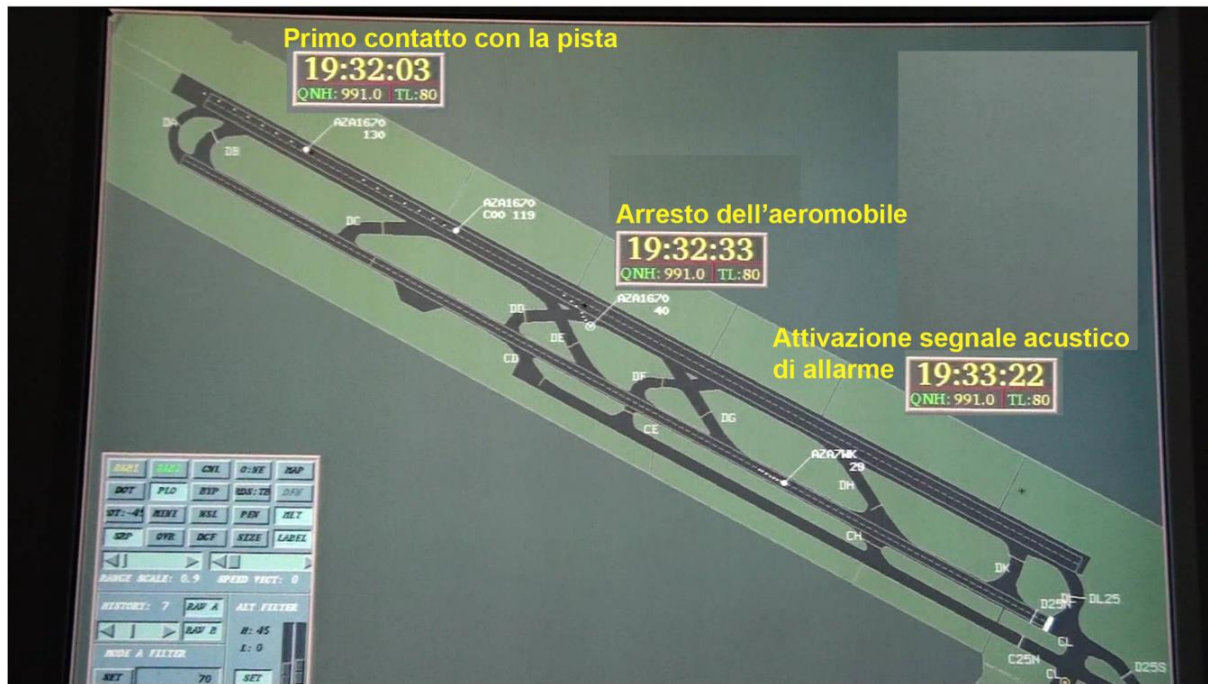
Figure 15: Image of the ground radar screen with some significant timestamps regarding the event.

At 19:32'50" the TWR, while not getting any response from the aircraft YR-ATS and while still being able to see it on the ground radar screen (*Figure 15*) in the same position, he instructed the other aircrafts that were approaching to conduct a missed approach procedure as the position of the YR-ATS made further landings on the 16L runway dangerous.

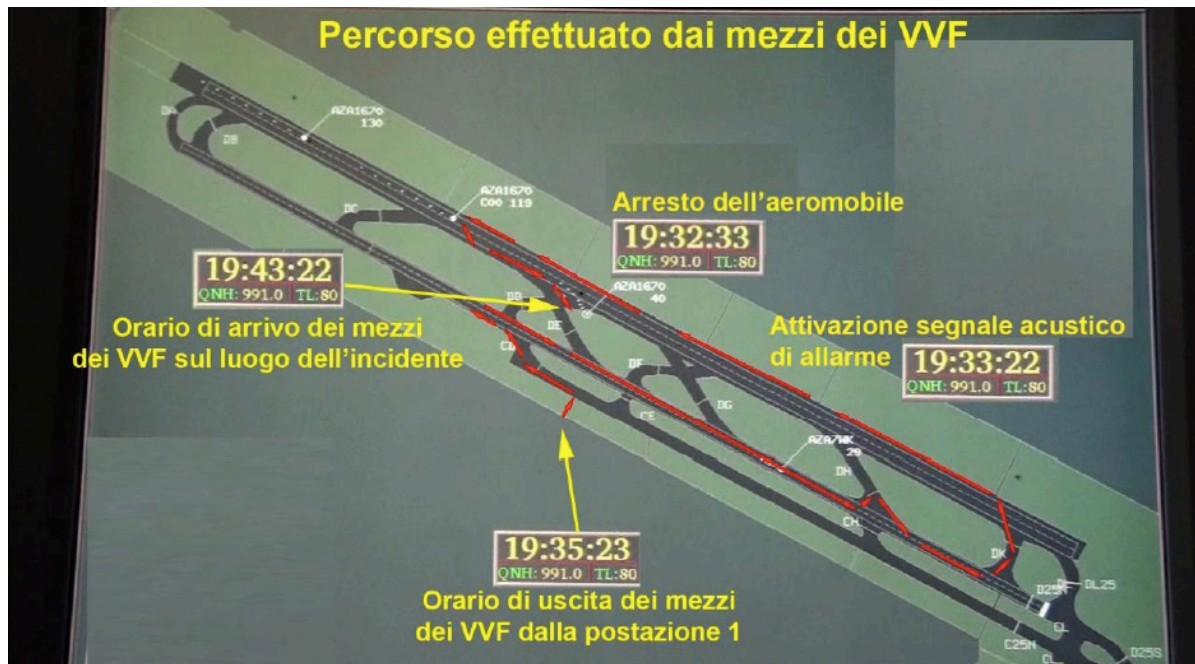
Figure 16: In red the path followed by the VVF.

At 19:35'22" on the ground radar screen was revealed the presence of the three outgoing fire trucks at the intersection "C" from station 1, located abeam the intersection, almost opposite the aircraft position (*figure 16*). After leaving their location, the three vehicles of the VVF turned onto the intersection "CD" next to the intersection "D" near the one named "DD", while heading north.

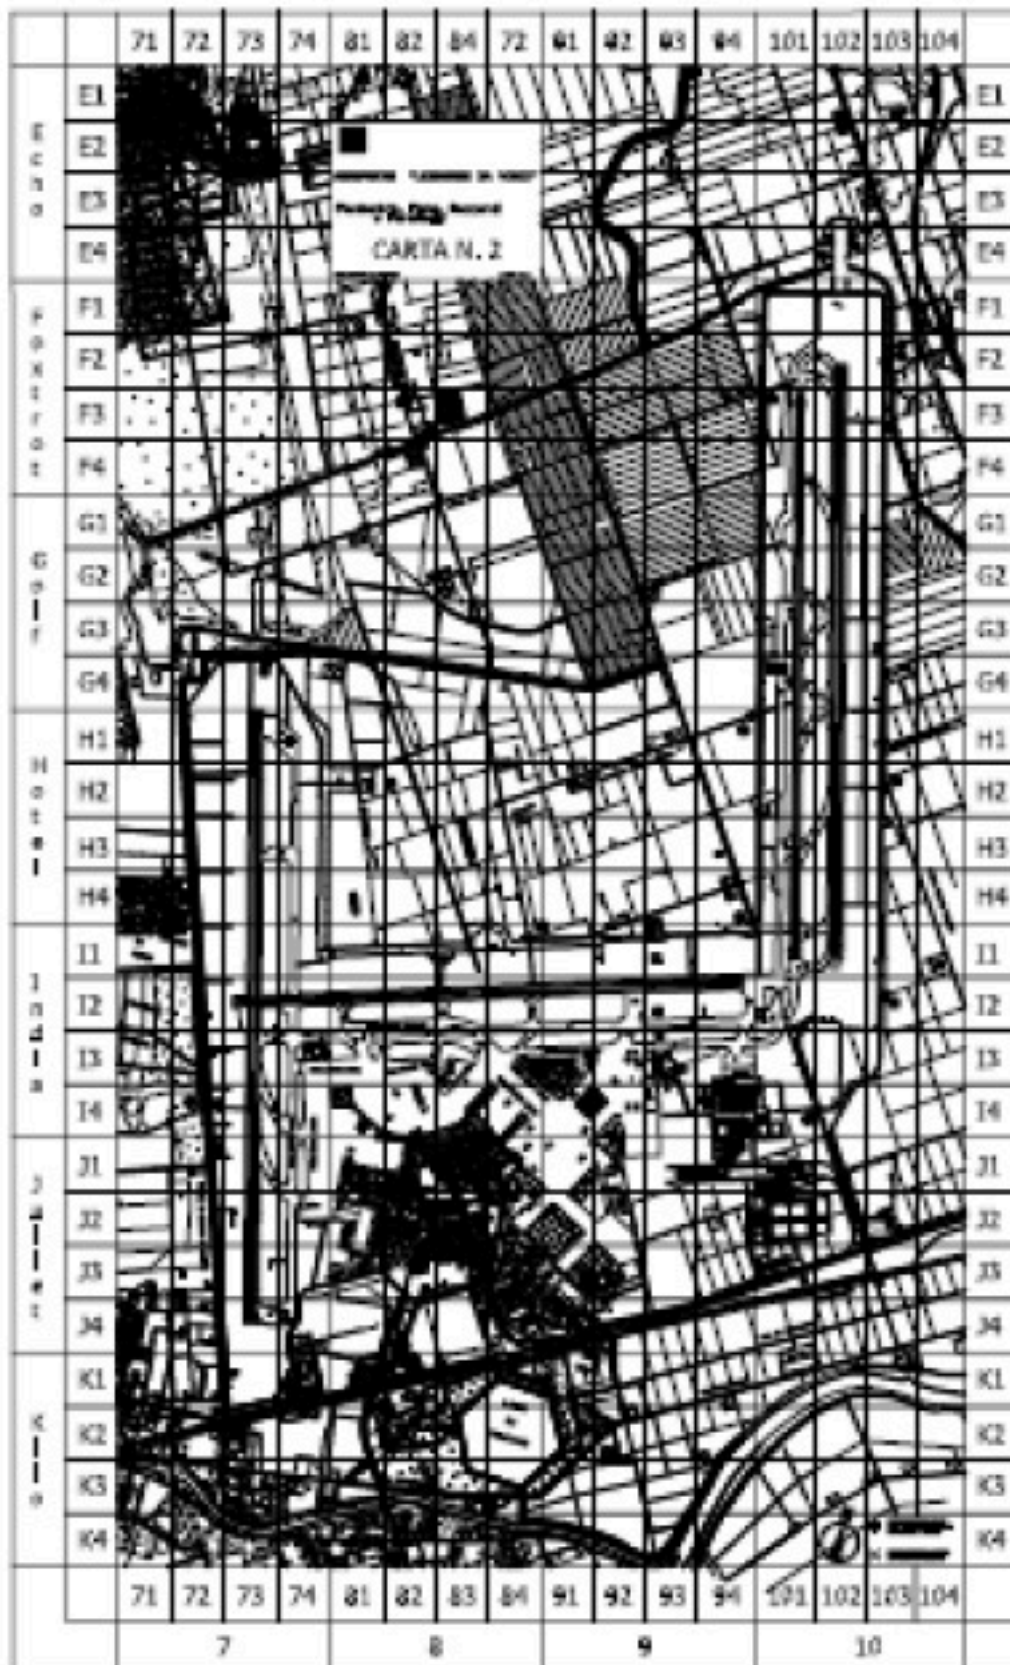
Figure 18: GRID-MAP of Rome Fiumicino's Airport is taken from the "Manuale rosso" at the time of the accident.

In the present case, the position of the aircraft YR-ATS corresponded to the square identifiable as “**102-G3**” (Figure 18).
