***This document is an English translation of the Preliminary Report on the fatal accident involving the Boeing 747-412F aircraft registered TC-MCL that occurred on January 16, 2017 at Manas International Airport, Bishkek, Kyrgyz Republic.***

**INTERSTATE AVIATION COMMITTEE  
AIR ACCIDENT INVESTIGATION COMMISSION**

**PRELIMINARY REPORT**

Type of occurrence	Fatal accident
Type of aircraft	Boeing 747-412F
Registration mark	TC-MCL
Owner	LCI Freighters One Limited (Ireland)
Operator	ACT Airlines
Aviation Authority	Turkish DGCA
Place of occurrence	Near Manas International Airport, Bishkek, Kyrgyz Republic, coordinates: N 43°03.248' E 074°2.271'
Date and time	16.01.2017, 07:17 local time (01:17 UTC), nighttime

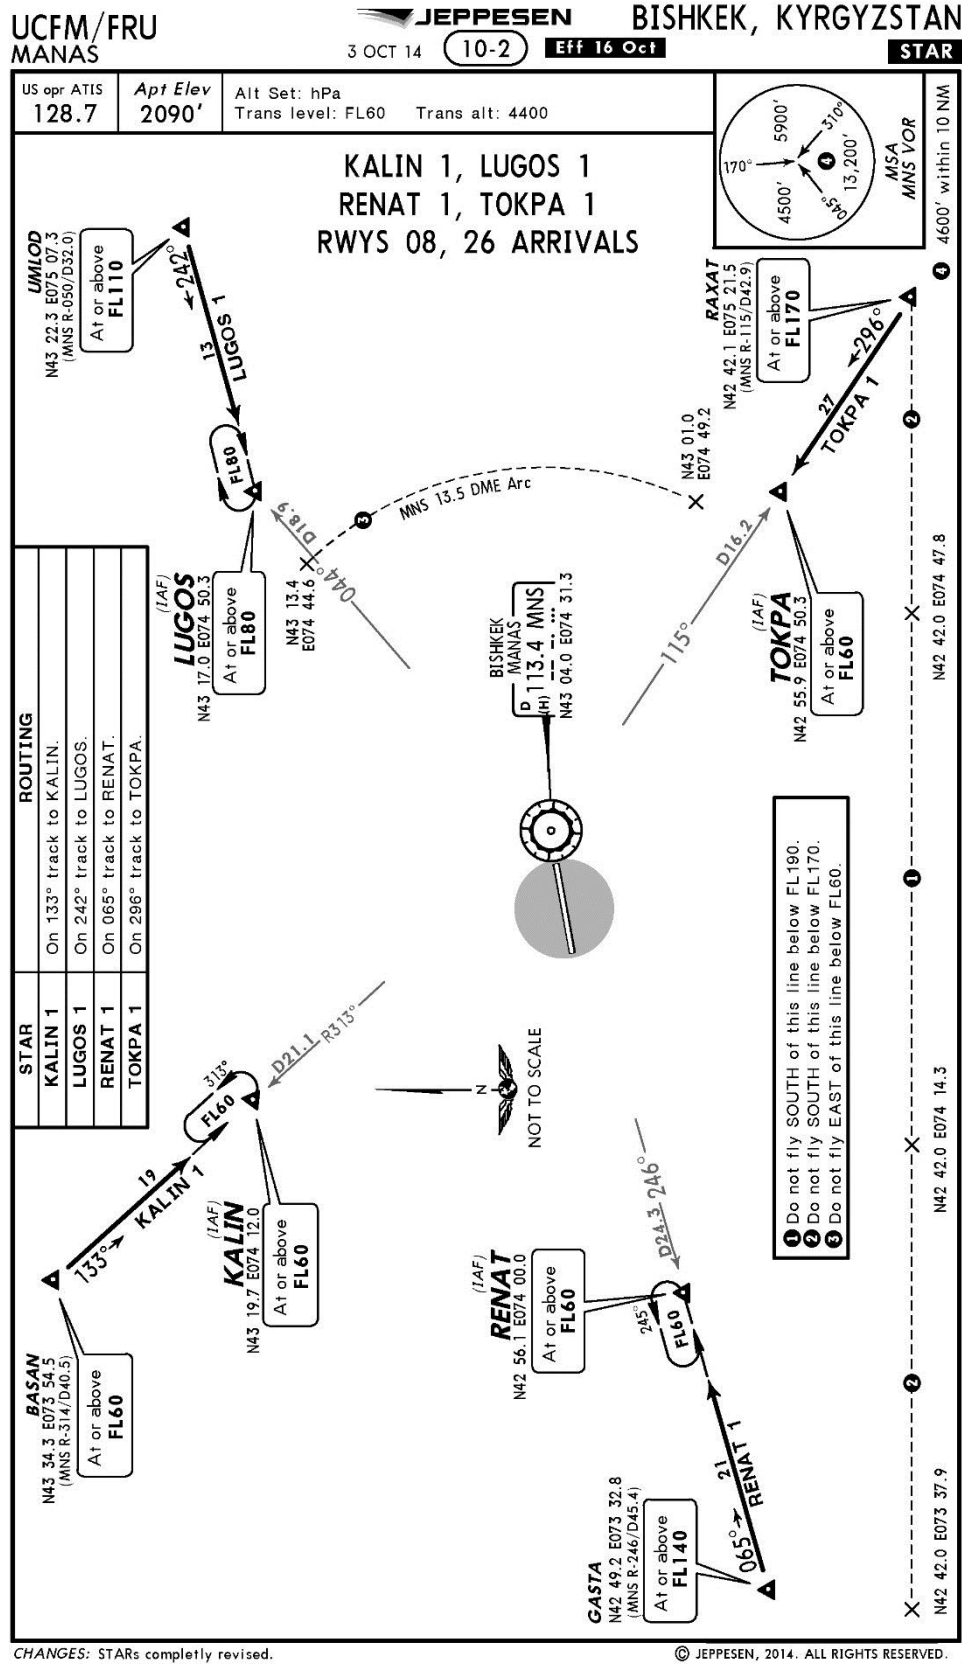
Figure 3. Standard Arrival Chart

At 01:03:10 the crew requested further descent. The controller cleared descent to FL 180 to RAXAT reporting point (Figure 3).
