Runway Excursion During Landing
Delta Air Lines Flight 1086
Boeing MD-88, N909DL
New York, New York
March 5, 2015

NTSB/AAR-16/02
PB2016-104166

Aircraft Accident Report

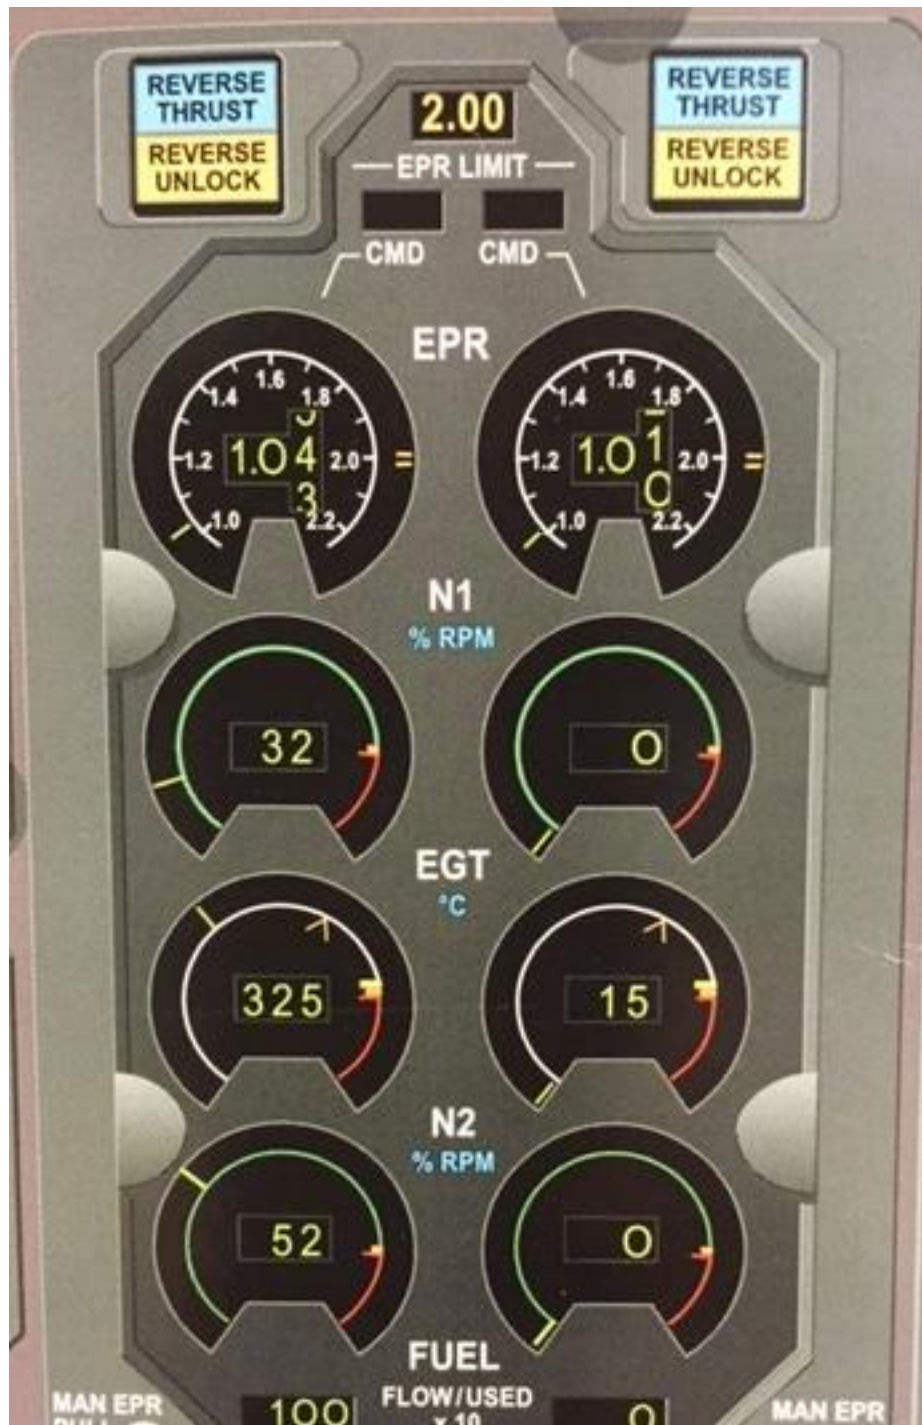
Figure 4. Engine pressure ratio gauges on engine display panel.

The thrust reverser settings are expressed as EPR values. The EPR gauges (also on the engine display panel) provide a digital readout in the center of each gauge of the EPR value, as shown in figure 4. Around the circumference of each gauge is a dial with incremental markings for EPR values between 1.0 and 2.2. A digital yellow pointer moves around the circumference of the gauges to provide a visual indication of both forward and reverse thrust values, but the engine display panel shows the EPR limit only for forward thrust.
