Uncontained Engine Failure and Subsequent Fire  
American Airlines Flight 383  
Boeing 767-323, N345AN  
Chicago, Illinois  
October 28, 2016

NTSB/AAR-18/01  
PB2018-100344

# Aircraft Accident Report

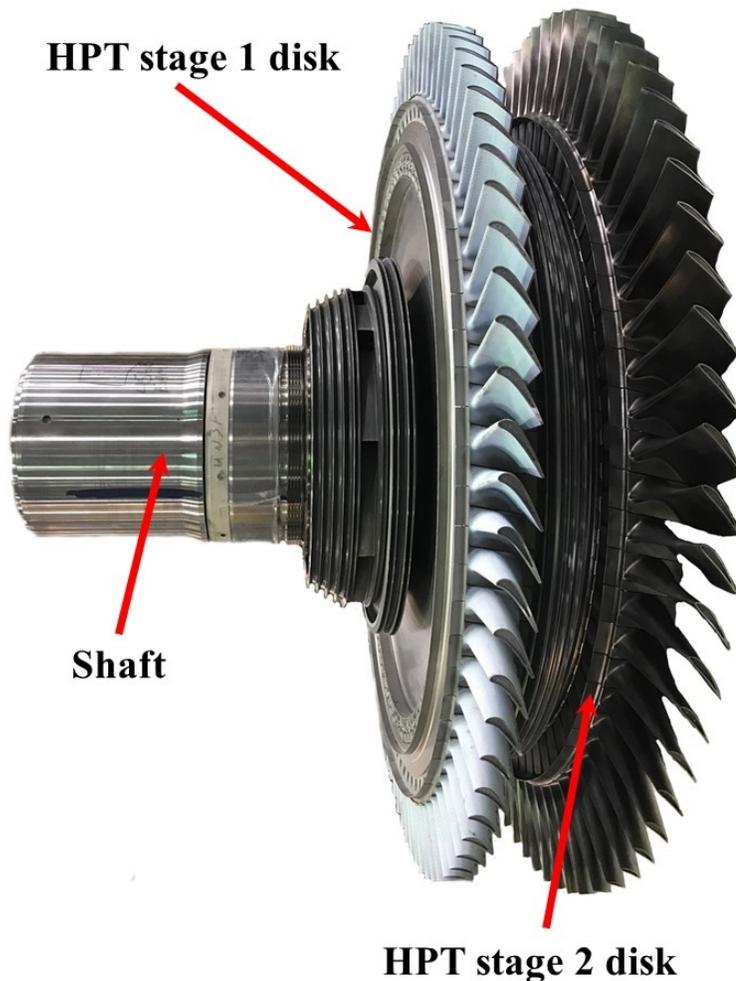
**Figure 2.** HPT rotor.

The CF6-80C2B6 is a dual-rotor, high-bypass ratio turbofan engine. The low-speed rotor (N1) consists of a large diameter fan and four low-pressure compressor booster stages that are interconnected to a five-stage low-pressure turbine rotor. The high-speed rotor (N2), which is located between the fan rotor/booster and the low-pressure turbine rotor, consists of a 14-stage high-pressure compressor and a 2-stage HPT. The HPT rotor drives the high-pressure compressor rotor by converting the combustor exhaust gas flow into mechanical force. The HPT stage 1 disk has 80 blades, the HPT stage 2 disk has 74 blades, and each blade has its own retaining post.<sup>24</sup> Figure 2 shows an HPT rotor for a CF6-80C2B6 engine.

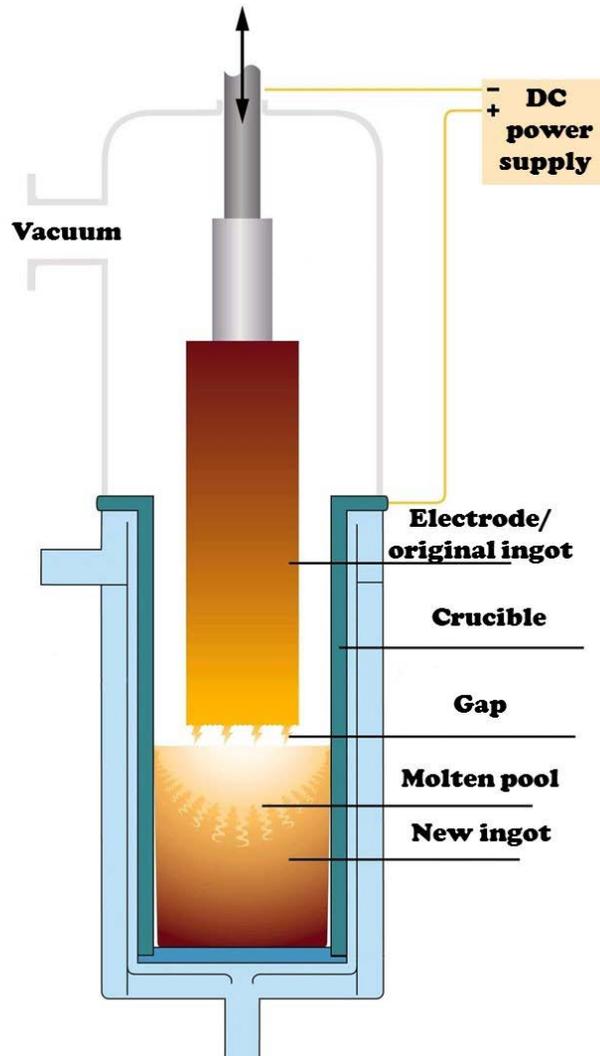
**Figure 3.** Vacuum arc remelting process.

In the nickel alloy manufacturing industry, it is generally accepted that discrete white spot formation is an inherent, yet infrequent, characteristic of the vacuum arc remelting process (described in section 1.3.1.1 and depicted in figure 3). A discrete white spot forms typically when a solid piece of either the original or the newly created ingot detaches from the outer edge, falls through a molten liquid layer, and becomes incorporated in the newly created ingot before the piece becomes completely molten. Although electroslag remelting and vacuum arc remelting (the second and third steps of the triple-melt process, respectively) both involve an original ingot that is consumed and a new ingot that is formed, discrete white spots are less likely to occur in an electroslag remelting ingot than in a vacuum arc remelting ingot. Specifically, according to a member of the Advanced Metallurgical Group in the Netherlands, with the electroslag remelting process, the molten superheated slag prevents the formation of crown material (solidified material above the liquid level) and gives the small detached pieces more time to become molten before solidification in a newly created ingot.<sup>59</sup>

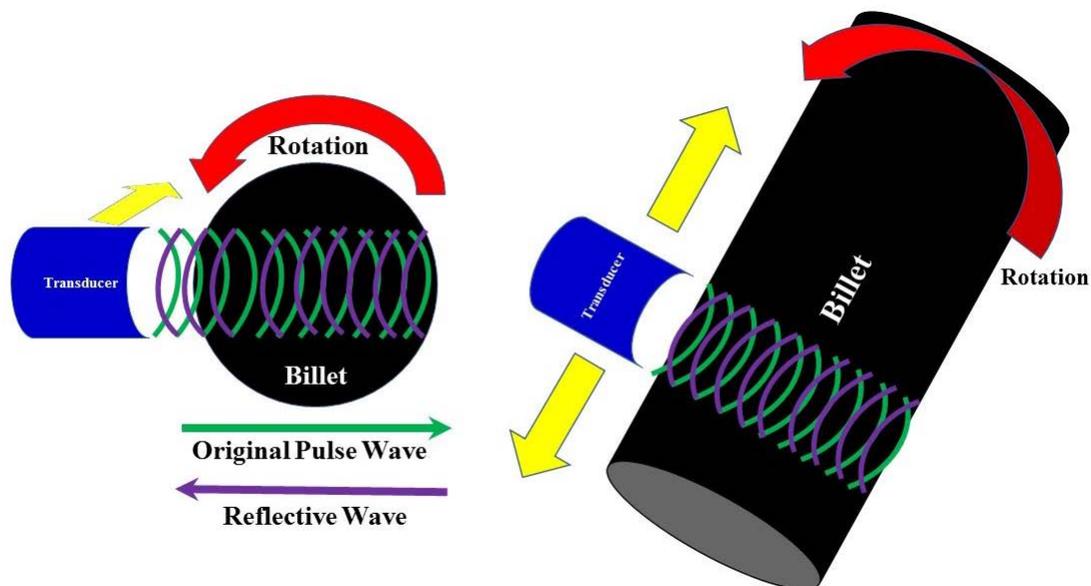
**Figure 4.** Longitudinal wave scan used during ultrasonic inspections.

The location of a discontinuity can be determined by comparing the amount of time for the echo to return to the transducer with the normal reflective wave from a known discontinuity. Although the size of a discontinuity can be determined by the strength (amplitude) of the echo return, this information must also be correlated with a known defect size. The advantage of this technique is the ease of moving the transducer along the material while both remain acoustically coupled.<sup>28</sup> Figure 4 shows a representation of a longitudinal wave scan.

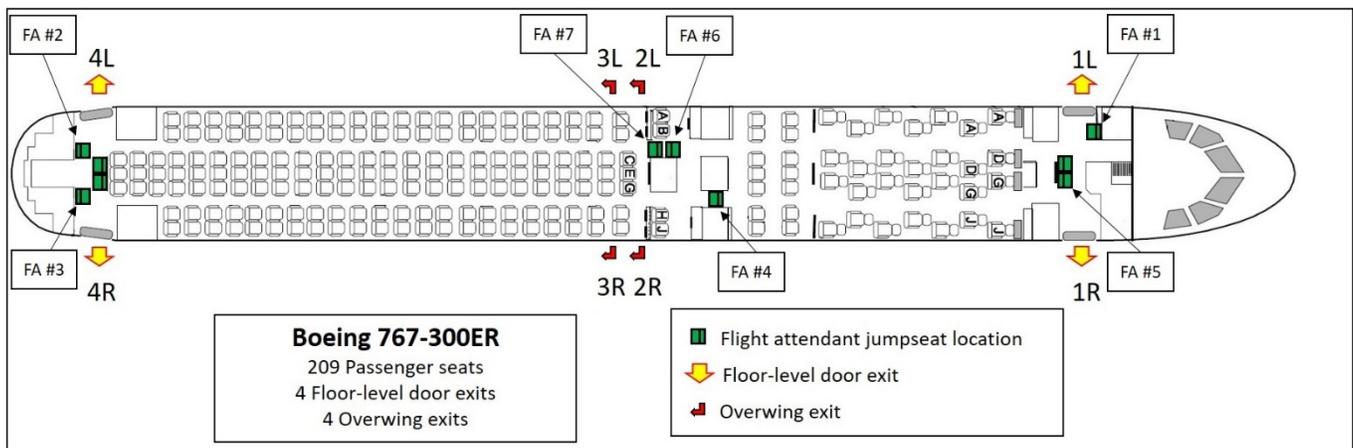
Figure 13. N345AN configuration.

The airplane was configured with 2 flight crew seats (and a cockpit jumpseat, which was unoccupied during the accident flight), 10 flight attendant jumpseats (3 of which were unoccupied), and 206 passenger seats.<sup>44</sup> The airplane had four door exits and four overwing exits. Figure 13 shows the airplane configuration and the seating positions within the cabin for the seven flight attendants.

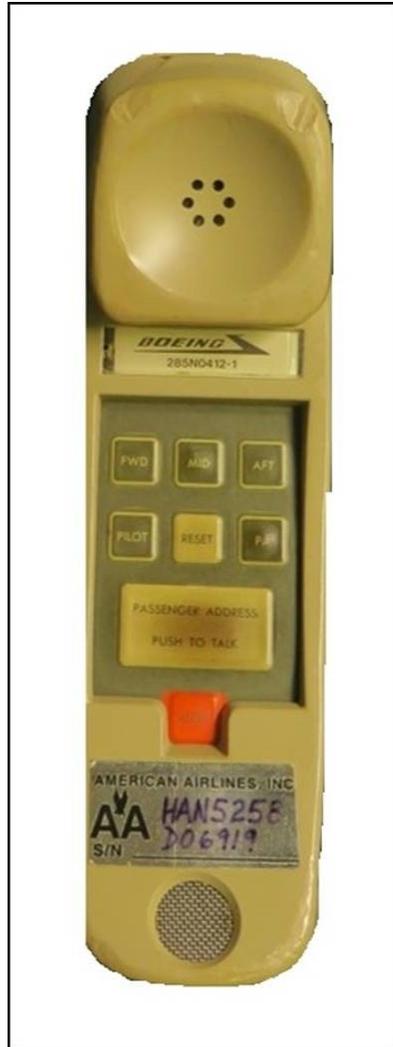
**Figure 14a.** Classic model interphone.

American Airlines 767-300-series airplanes have two different interphone models: the "classic" model, shown in figure 14a, which was installed on 767C-300ER airplanes delivered before January 2003, and the "new" model, shown in figure 14b, which is installed on 767N-300ER airplanes delivered beginning in January 2003. The accident airplane, delivered in April 2003, had the new model interphone system installed.

Depending on their delivery date, American Airlines 767-300-series airplanes either have a “classic” model interphone system (shown in figure 14a) or a “new” model interphone system (shown in figure 14b). As a result, flight attendants who are qualified on the 767 airplane need to know how to use both interphone system models. The new model interphone, which was installed on the accident airplane, requires additional steps to operate compared with the classic model interphone. To use the new model interphone, the flight attendant would need to turn over the handset and read the communication options for the location within the airplane to be called and then input the symbol (if required) and/or number(s) for that location on the key pad. In contrast, the classic model interphone has a key pad with buttons labeled for the pilot and forward, mid-, and aft cabin locations. Also, both interphone models have a “push to talk” button, but, for initial calls that do not go through, the new model interphone requires flight attendants to reset the interphone by either placing the interphone back into its cradle or pressing the reset button before pressing the “push to talk” button.

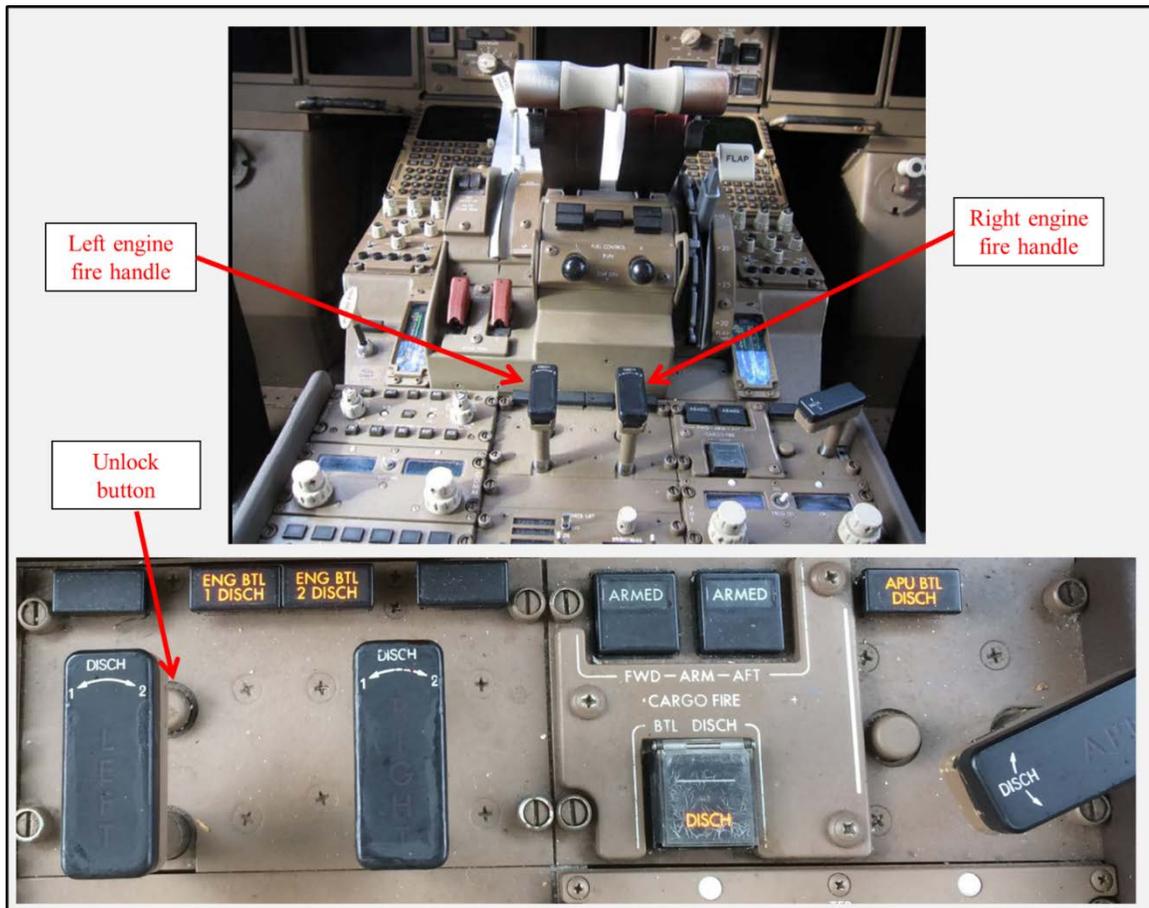
**Figure 15.** Engine fire handles.

Figure 15 shows the engine fire switches, also referred to as engine fire handles, as described in steps 4 and 5 of the checklist.

Note: Only the unlock button for the left engine fire handle is labeled. A similar unlock button appears forward of the right engine fire handle.
