INTERSTATE AVIATION COMMITTEE
AIR ACCIDENT INVESTIGATION COMMISSION

FINAL REPORT

Type of occurrence	Accident
Type of aircraft	Airplane, Boeing 737-500 (53A)
Registration	VQ-BBN (Bermuda)
Registered Charterer (according to the registration certificate)	AWAS (BERMUDA) LIMITED, Clarendon House, 2 Church Street, Hamilton HM 11, Bermuda
Operator	Tatarstan Airlines, JSC, Russia
Aviation Administration	Tatar ITO, FATA
Place of occurrence	Russian Federation, Kazan International Airdrome, coordinates: N 55° 36,5291' E 49°16,6111'
Date and Time	November 17, 2013, 15:24 UTC, 19:24 local time, night time

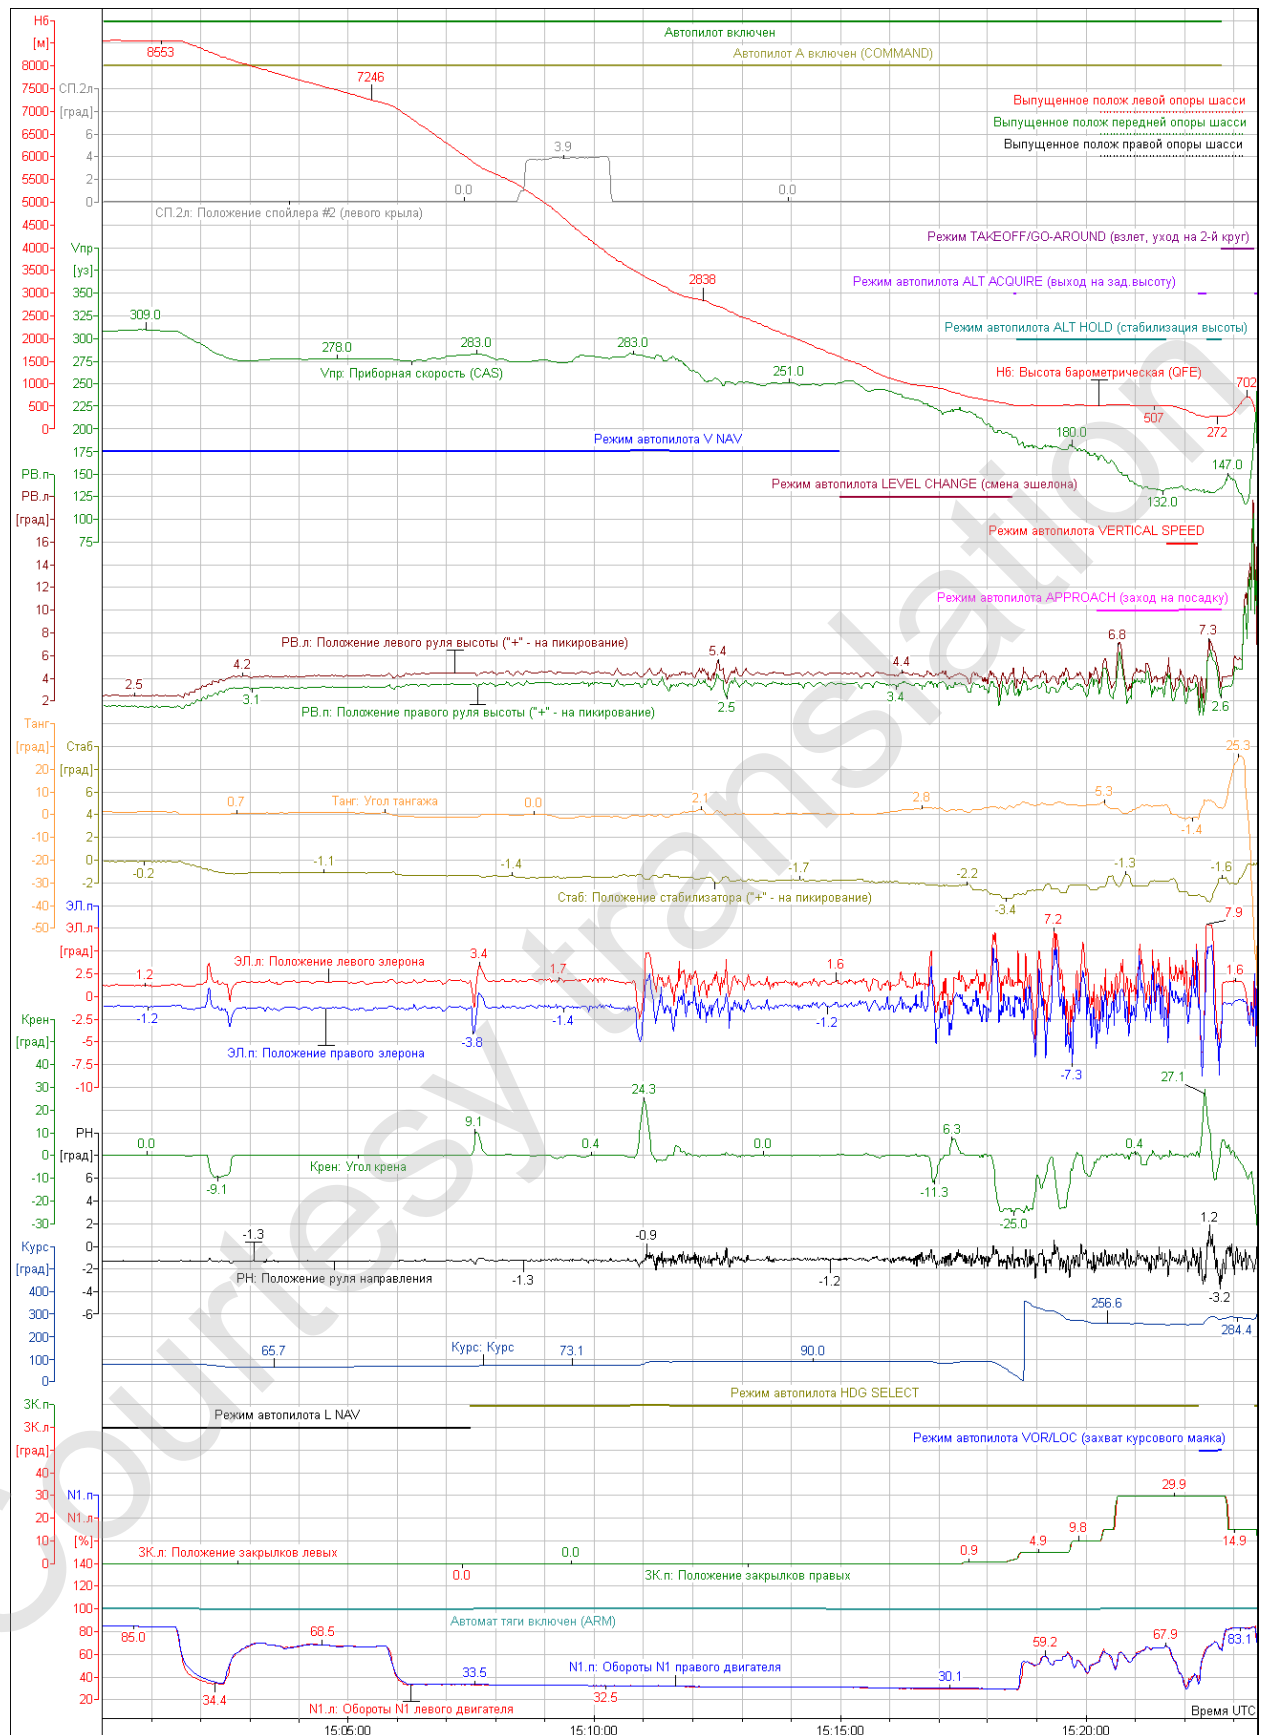
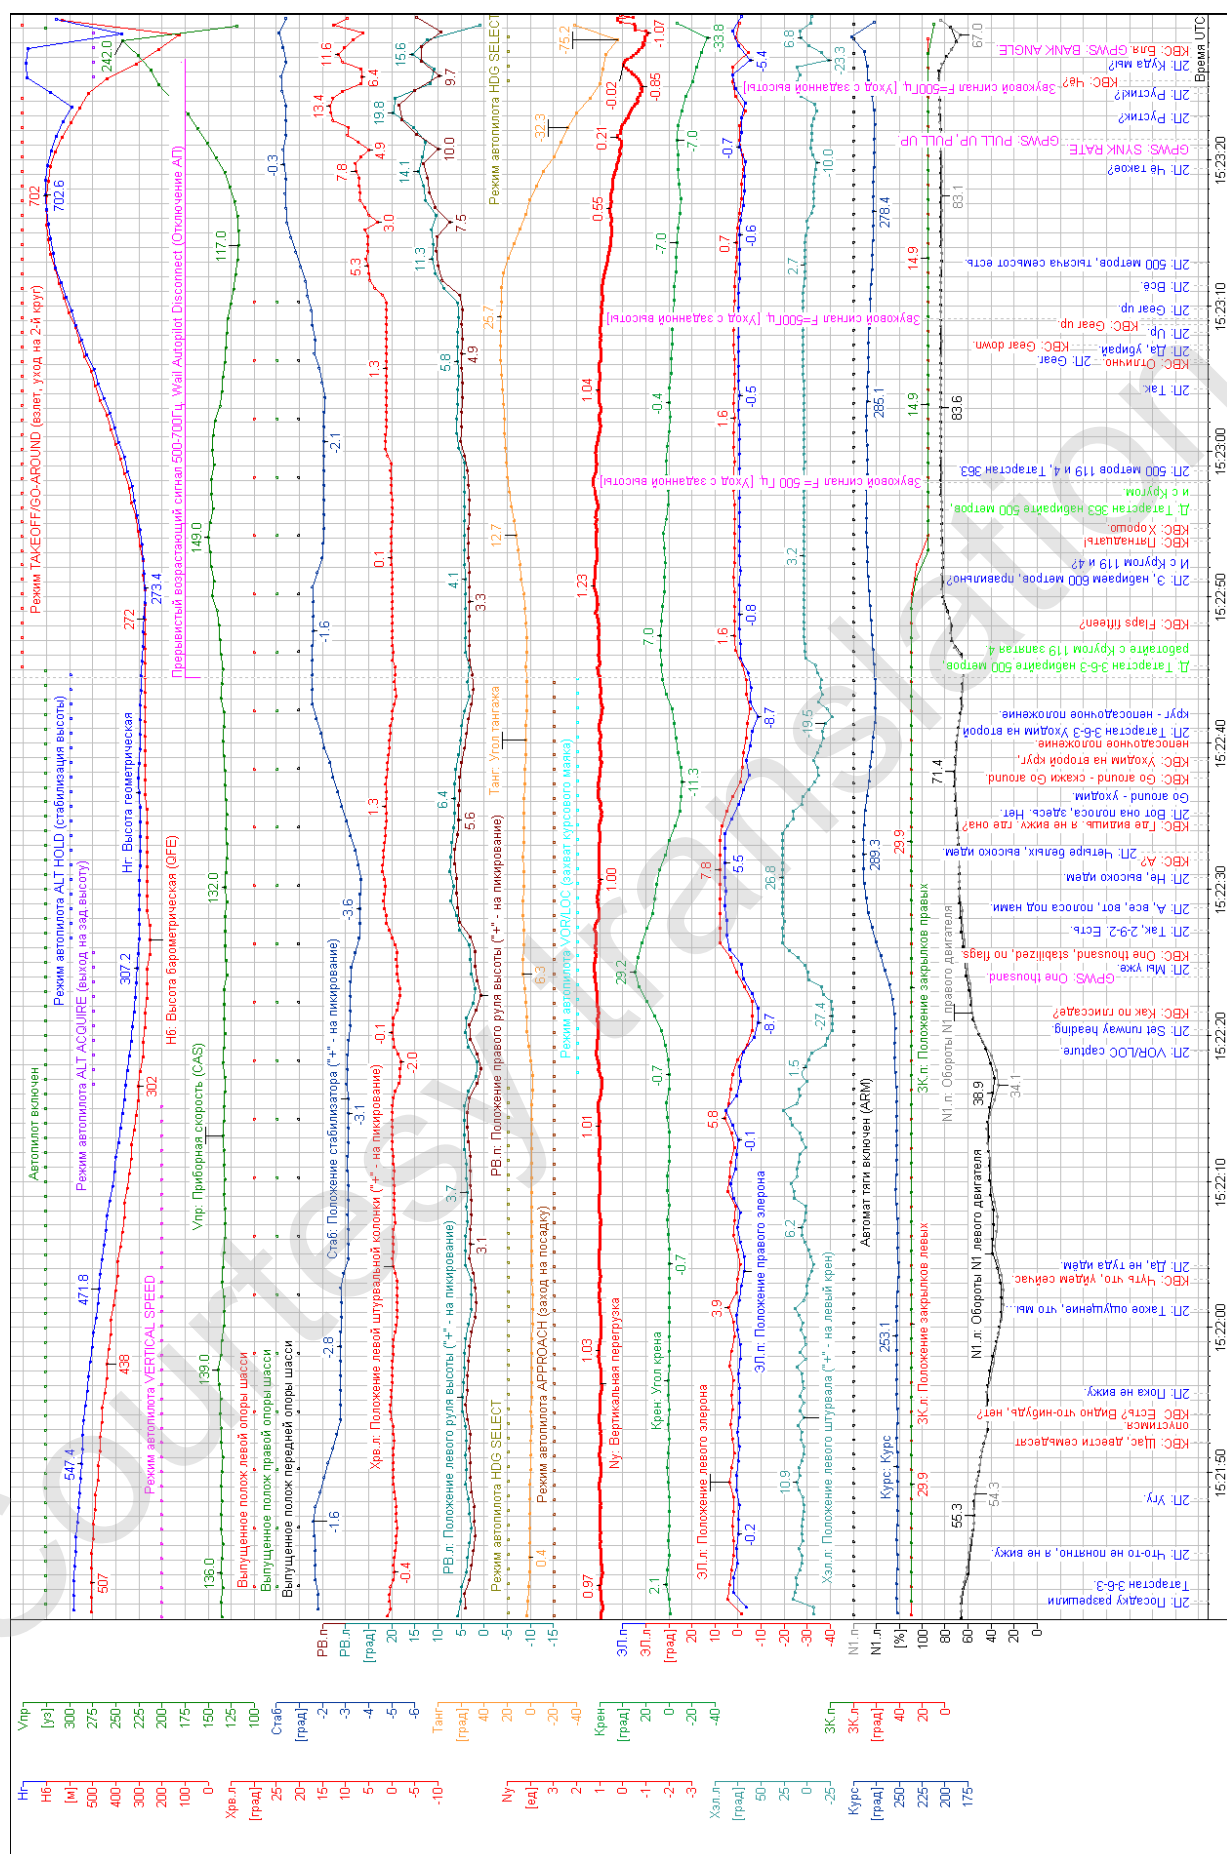
Figure 11 Boeing 737-500 VQ-BBN Flight Data for 17.11.2013 (descent)

- The FDR contained data of 34 flights of the Boeing 737-500 VQ-BBN (approx. 61 hours of records) including the accident flight record;
- The Boeing 737-500 VQ-BBN FDR was operative on the flight of November 17, 2013 and recorded analogue data in full compliance with the list of Boeing 737-500 recordable parameters as well as event signals compatible to the their generation conditions.

At 15:00 the aircraft passed SHUMERLYA waypoint and was handed over to Kazan Control. At 15:01 at FL 290 the crew contacted Kazan Control to report: “*Kazan Control, Tatarstan 3-6-3, good evening, Shumerlya, flight level 2-9-0, ready for descent*”. The ATC instructed them to descend to FL 70, “*Tatarstan 3-6-3, Kazan Control, descend flight level 7-0, identified*”. The descent was initiated at 15:01:30 (Figure 11).

The crew received the ATC information and spent a long time discussing the map shift and transitioned from L-NAV to HDG SEL mode. At 15:08 the heading was changed from 68° to 73° (Figure 11). However, this heading change was not enough to capture the track axis.

As the aircraft was approaching the base turn the flaps were set at 1° (Figure 11). As the flaps were being extended to 1°, at an altitude of 2600 ft (800 m) the Altitude alert was triggered. It alerted approaching the altitude set at the MCP (1700 ft).

In the course of the turn, at 15:18:30, the aircraft reached the MCP altitude of 500 m that was maintained by the A/P in the ALTITUDE HOLD mode. During the turn the Flaps were set to 5°, and by the end of the turn they were extended to 10° (Figure 11).

As the aircraft was heading approx. 250° the crew continued to prepare for landing, they extended the flaps to 15° and then to 30°, they extended the landing gear (Figure 11), while the HSI LOC deviation pointer was at the most left position. The crew completed the Landing Checklist. After the landing configuration was achieved, the aircraft was flown with an airspeed of 130-135 kt.

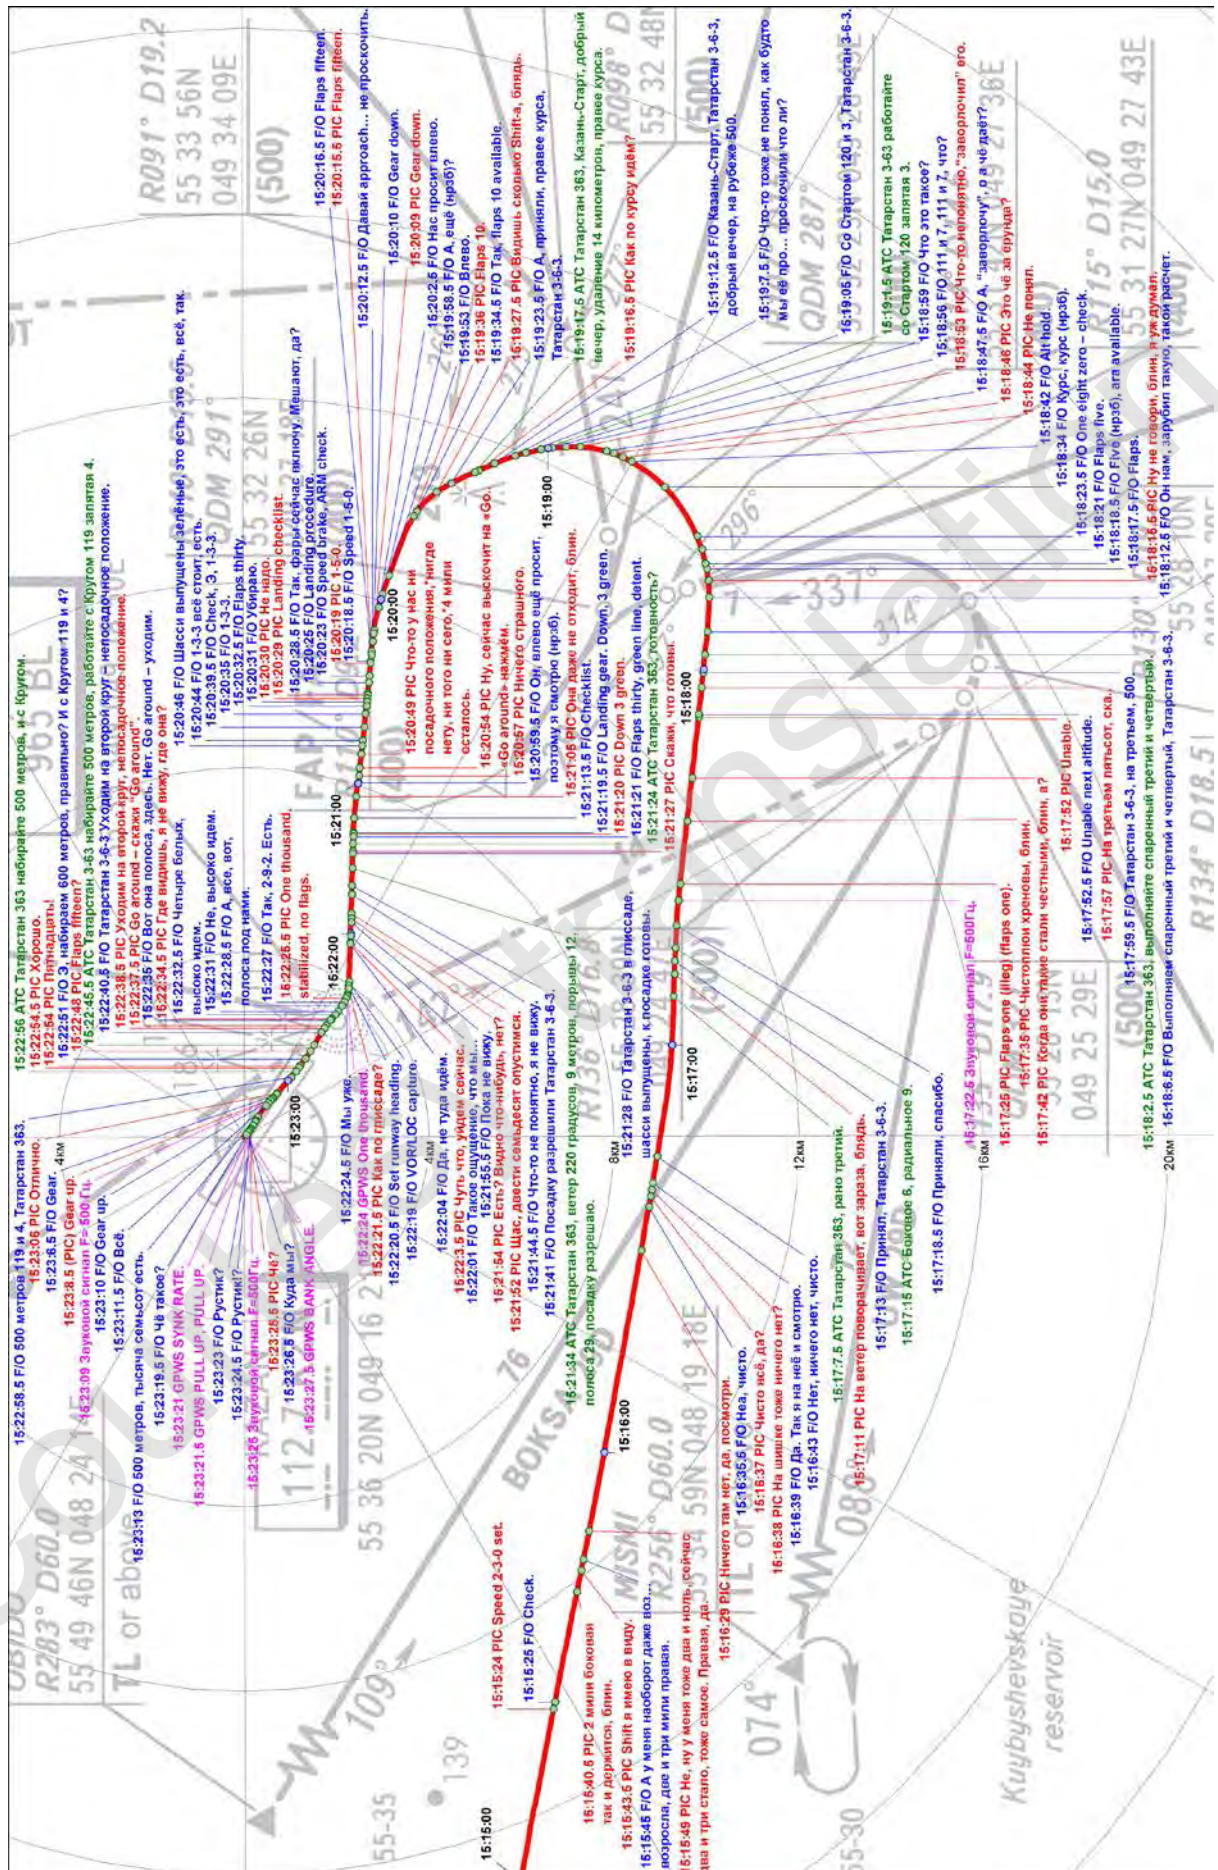
Figure 15 Boeing 737-500 VQ-BBN flight path on 17.11.2013 near Kazan Airport (there is a gap on the STAR pattern from the base turn point to MISMI waypoint, MISMI position is out of scale)

heading change was not enough either. The aircraft was approaching the base turn parallel to the standard approach pattern (Figure 15 and Figure 81).

After the crew informed the ATC on reaching the base turn point they were cleared for base and final turn. Actually the turn was initiated at 15:18 in the HDG SEL mode before the aircraft reached the altitude of 500 m with a significant deviation from the STAR pattern (Figure 15 and Figure 81), that the ATC could have seen on the radar, and the crew could have seen that using the VOR/DME.

The turn was completed with a significant “overtake” (Figure 15 and Figure 81). The cockpit communication analysis revealed that the crew was not completely aware of their position with regard to the approach pattern, which is confirmed by the following dialogue between the PIC and the FO at 15:18:46:

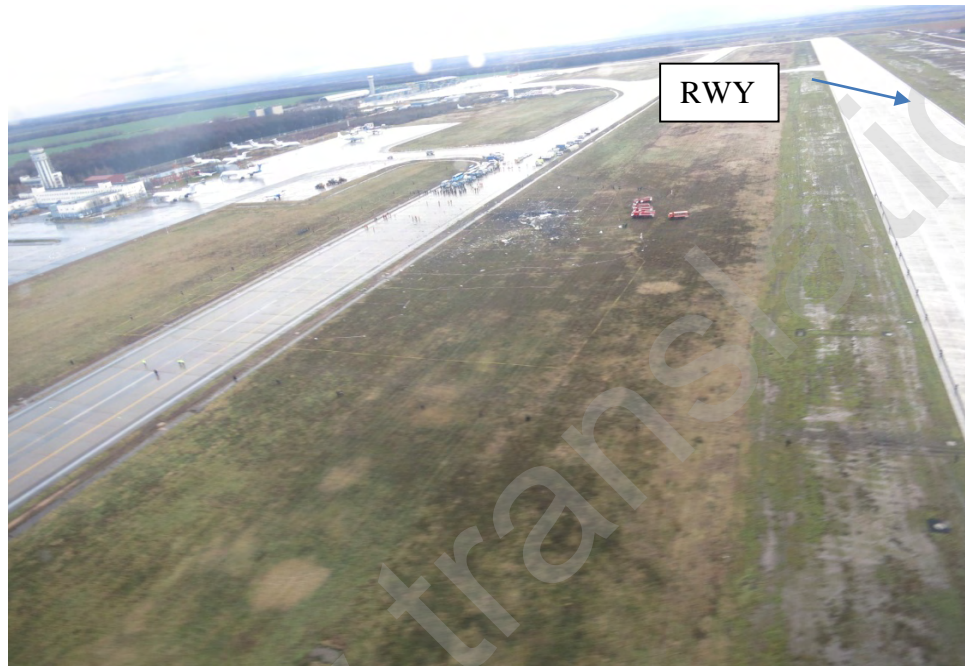
Figure 16 Accident site general view from opposite to the flight direction

The aircraft was approaching to land with magnetic heading 292 degrees. The accident occurred at the airfield of Kazan International Aerodrome between the runway, main taxiway, Taxiway C and taxiway B (Figures 16 and 17). The airport is located in the plain. The runway threshold elevation is 125 m for heading 292 degrees, and 106 m for heading 112 degrees. The elevation at the accident site is 115 m.

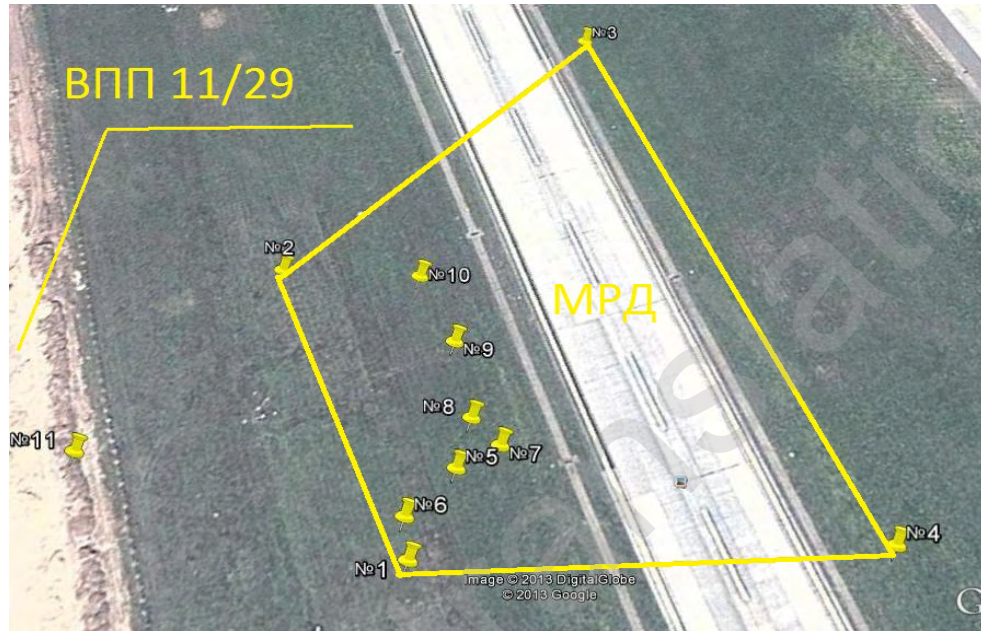
Figure 18 Wreckage plot

The aircraft impacted the ground between the runway in use (RWY 29) and the main taxiway at point 5 (Figure 18) (N55°36.5291' and E49°16.6111'). The wreckage spread area was

The largest structural fragments are marked with points 5 through 11.

The accident site examination revealed that the aircraft impacted the ground with a large nose down pitch angle. This is determined by the nature of the crater (Figure 18), as well as engine position being almost vertical in the ground.

After the impact the fuselage was destroyed with the tail cone detached (Figure 20), the latter being found 20 m ahead of the impact point in the direction where the aircraft was heading (point 8, Figure 18).

Forty meters ahead of the tail cone fragment in the flight direction (point 9, Figure 18) a rudder fragment was found (Figure 21).

At distance of 120 m from the first impact point and 25 m from the right edge of RWY 29 (runway in use) (point 11, Figure 18) a red fire extinguisher bottle was found (Figure 22). This fragment was the closest one to the runway.

The runway examination made immediately after the accident revealed no aircraft marks or fragments on the runway and beyond the fragment spread area (Figure 18). Thus, there were no signs of uncontained inflight damage.

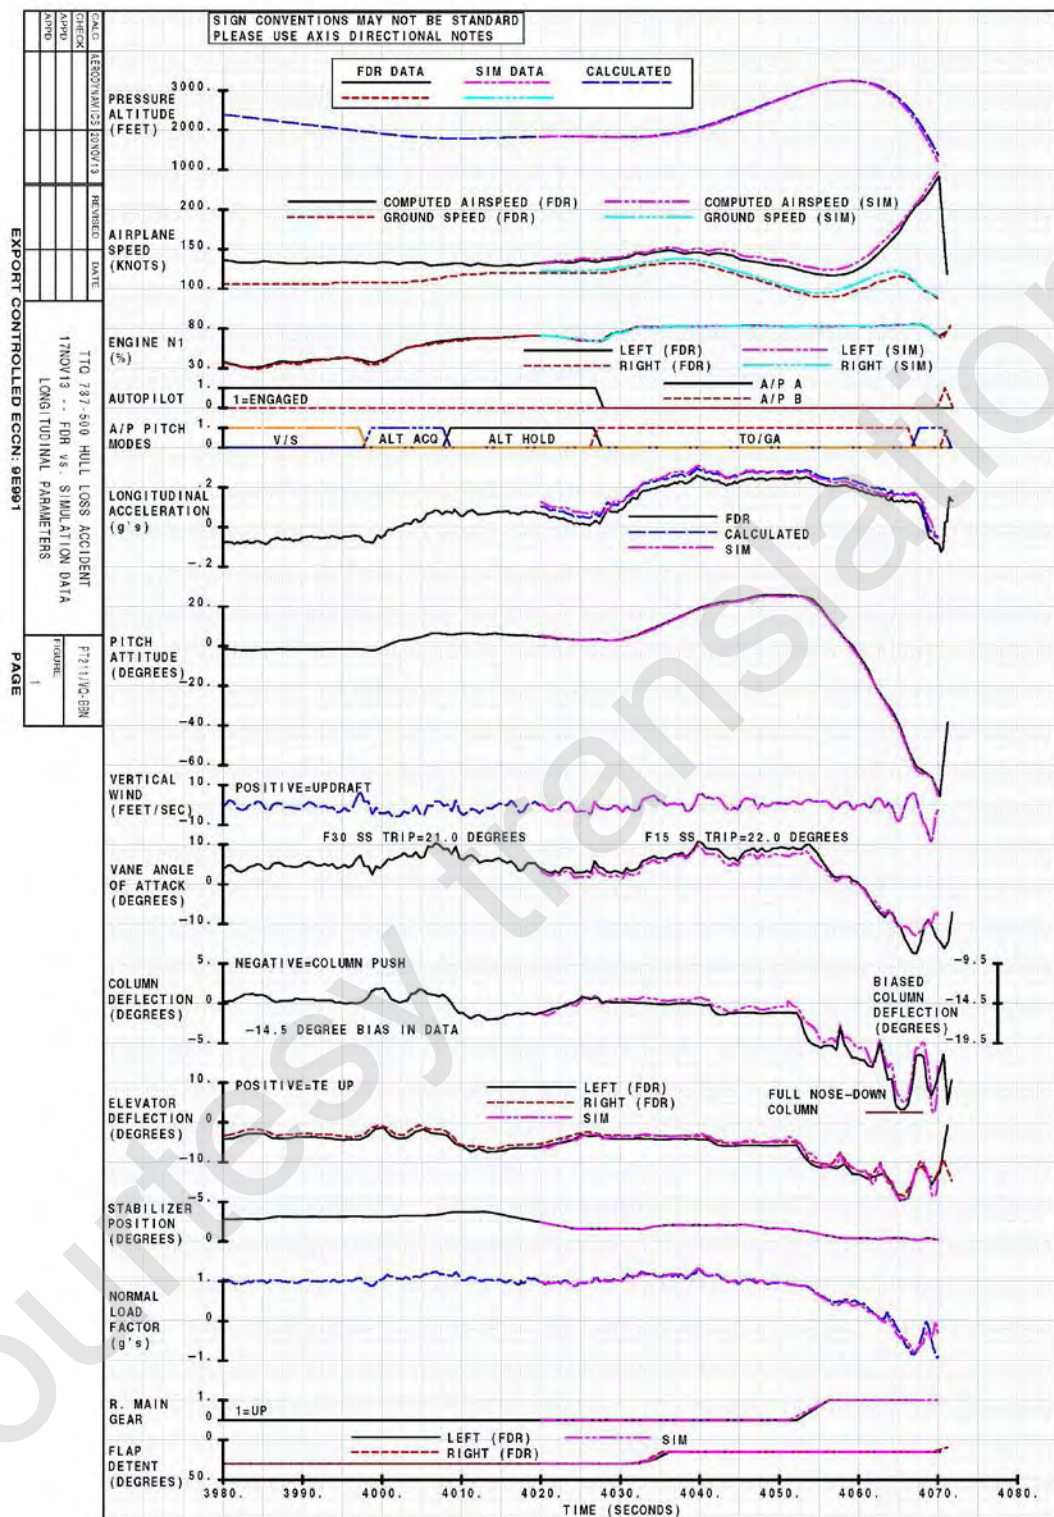
Figure 23 Simulation data (longitudinal parameters)

The analysis of the simulation match results shows that before the aircraft reached significant negative angle of attack values (about 5 to 7 seconds before the impact) the calculated data were well consistent with the FDR records for the flight controls (column, wheel and pedal deflections) as well as for the control surfaces (aileron, elevator and rudder deflections) respectively. Thus it can be concluded that during the final flight segment the aircraft movement corresponds to registered control inputs, actual engines power and actual wind profile. The stability and controllability parameters were well consistent with the type design. No additional external forces (wind shear, icing) were affecting the aircraft. The flight control system including the elevator was operating as per design. During the emergency situation development the angle of attack values exceeding the threshold level for stick shaker activation were not achieved.

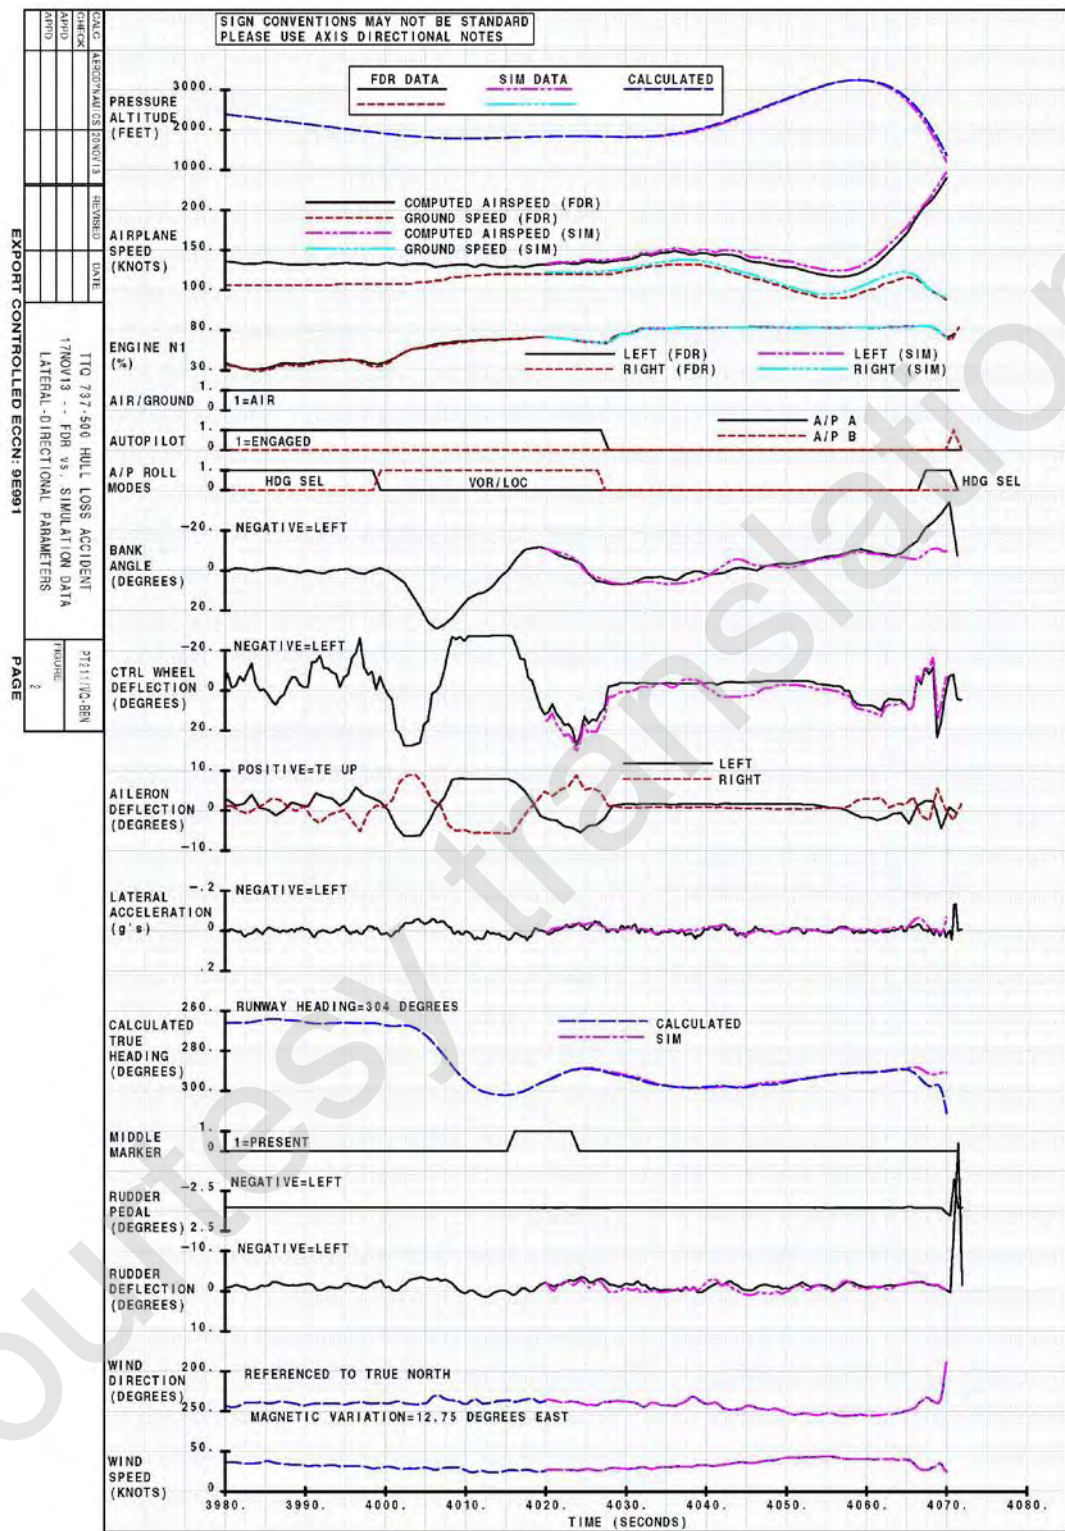
Figure 24 Simulation data (lateral-directional parameters)

Note: *Simulated control wheel position necessary to create registered bank angle values began deviating from the recorded values starting at 5 to 7 seconds before the impact. This difference is caused by the fact that the negative values of angle of attack experienced by the accident airplane exceeded the angle of attack range of the simulation lateral/directional aerodynamic coefficient data tables.*

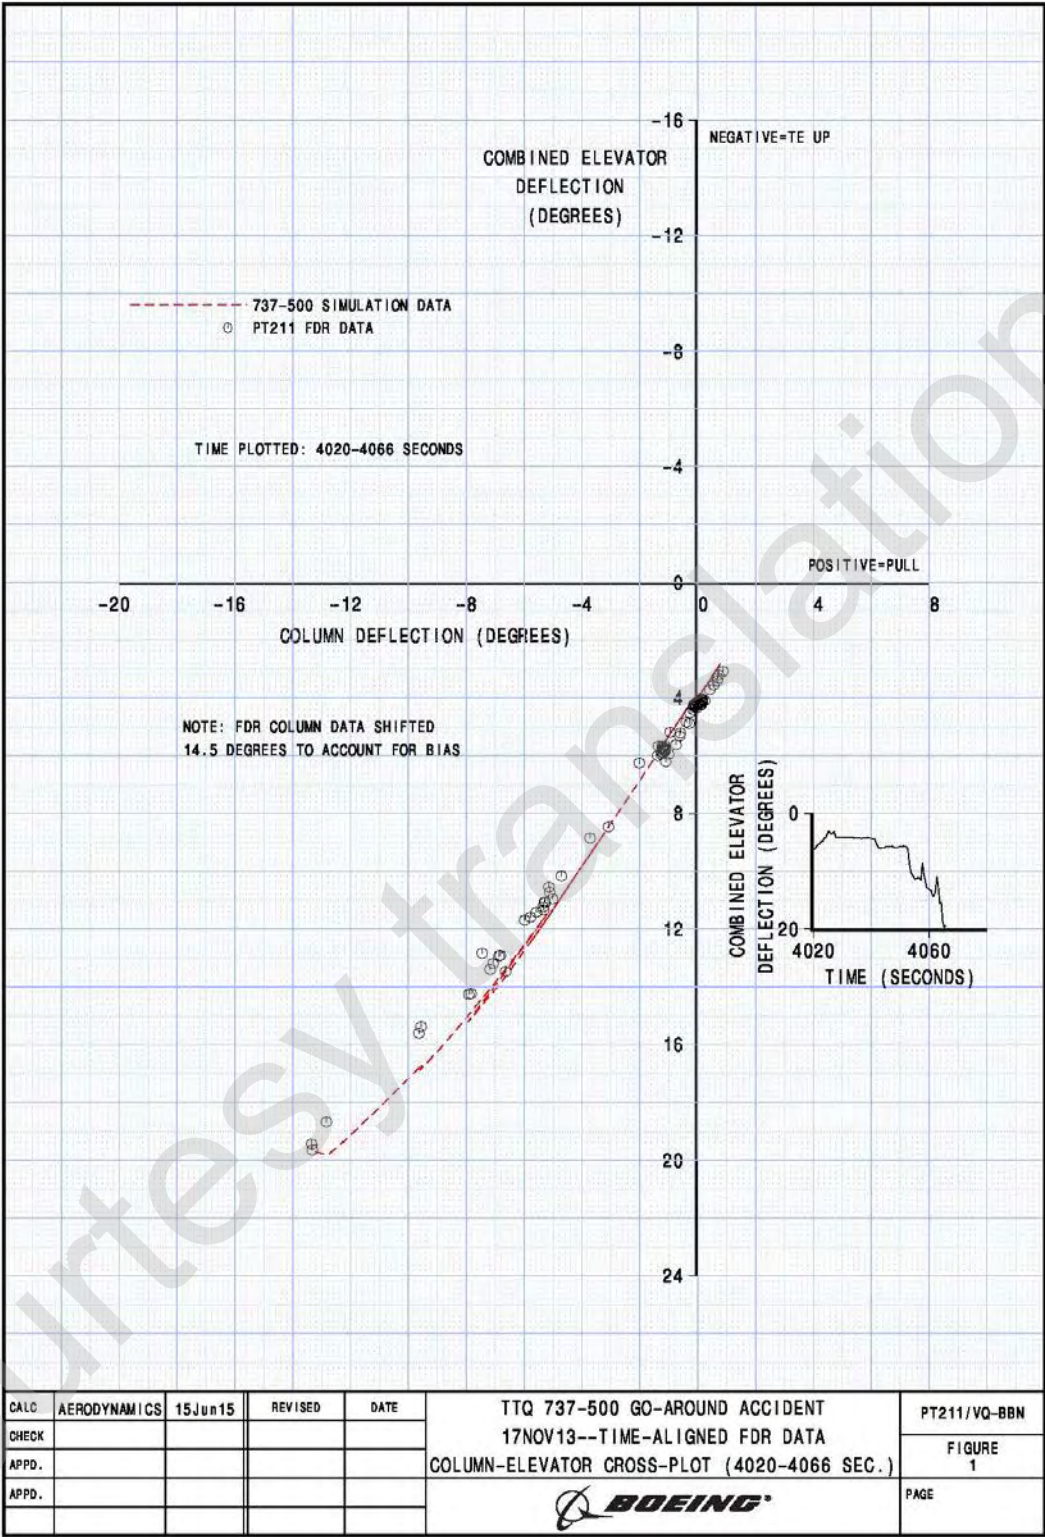
Figure 25 Column-Elevator cross-plot

An additional chart was created to correlate elevator deflections to the column inputs (Figure 25). The same Figure contains data calculated as a result of the simulation. The Figure shows that both the values and curve slope are well consistent, which confirms the normal operation of the flight control system without any extra resistance, that means without any jamming or seizure (no extra column forces that would have led to linkage extension resulting in inconsistency of the calculated and recorded elevator deflections at the same wheel position, see also 1.18.7).

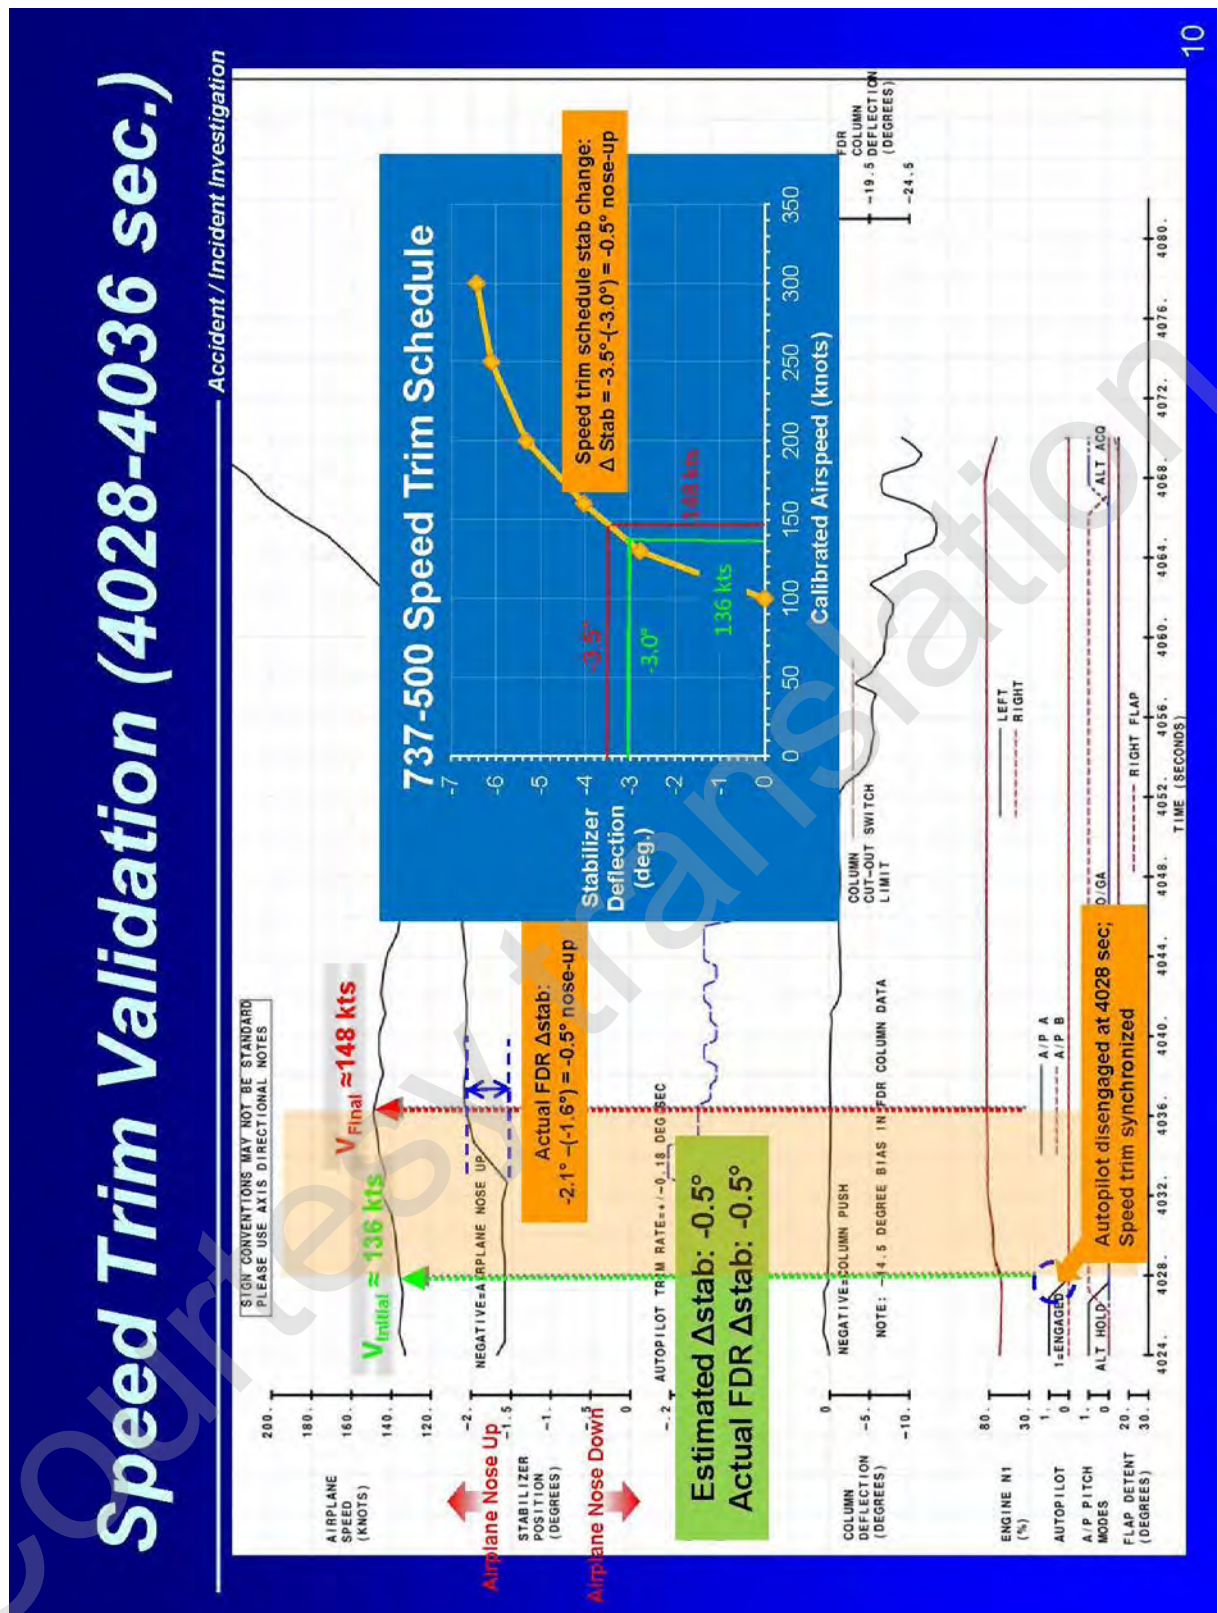
Figure 29 STS validation (15:22:46 – 15:22:44)

Figures 29 to 31 show the three specific segments of the final flight stage. In the first segment (Figure 29) as the airspeed increased from 136 knots to 148 knots the stabilizer made an increment 0.5° nose up deflection, which corresponds to the value determined by the chart on Figure 28. In the second segment (Figure 30) as the airspeed decreased from 145 knots to 118 knots the stabilizer made an increment 1.7° nose down deflection, which also corresponds to the value determined by the chart on Figure 28. In the third segment (Figure 31) despite the extensive airspeed increase the stabilizer did not deflect nose up as the crew deflected the column nose down to a value exceeding the threshold value, which deactivated the STS as per design.

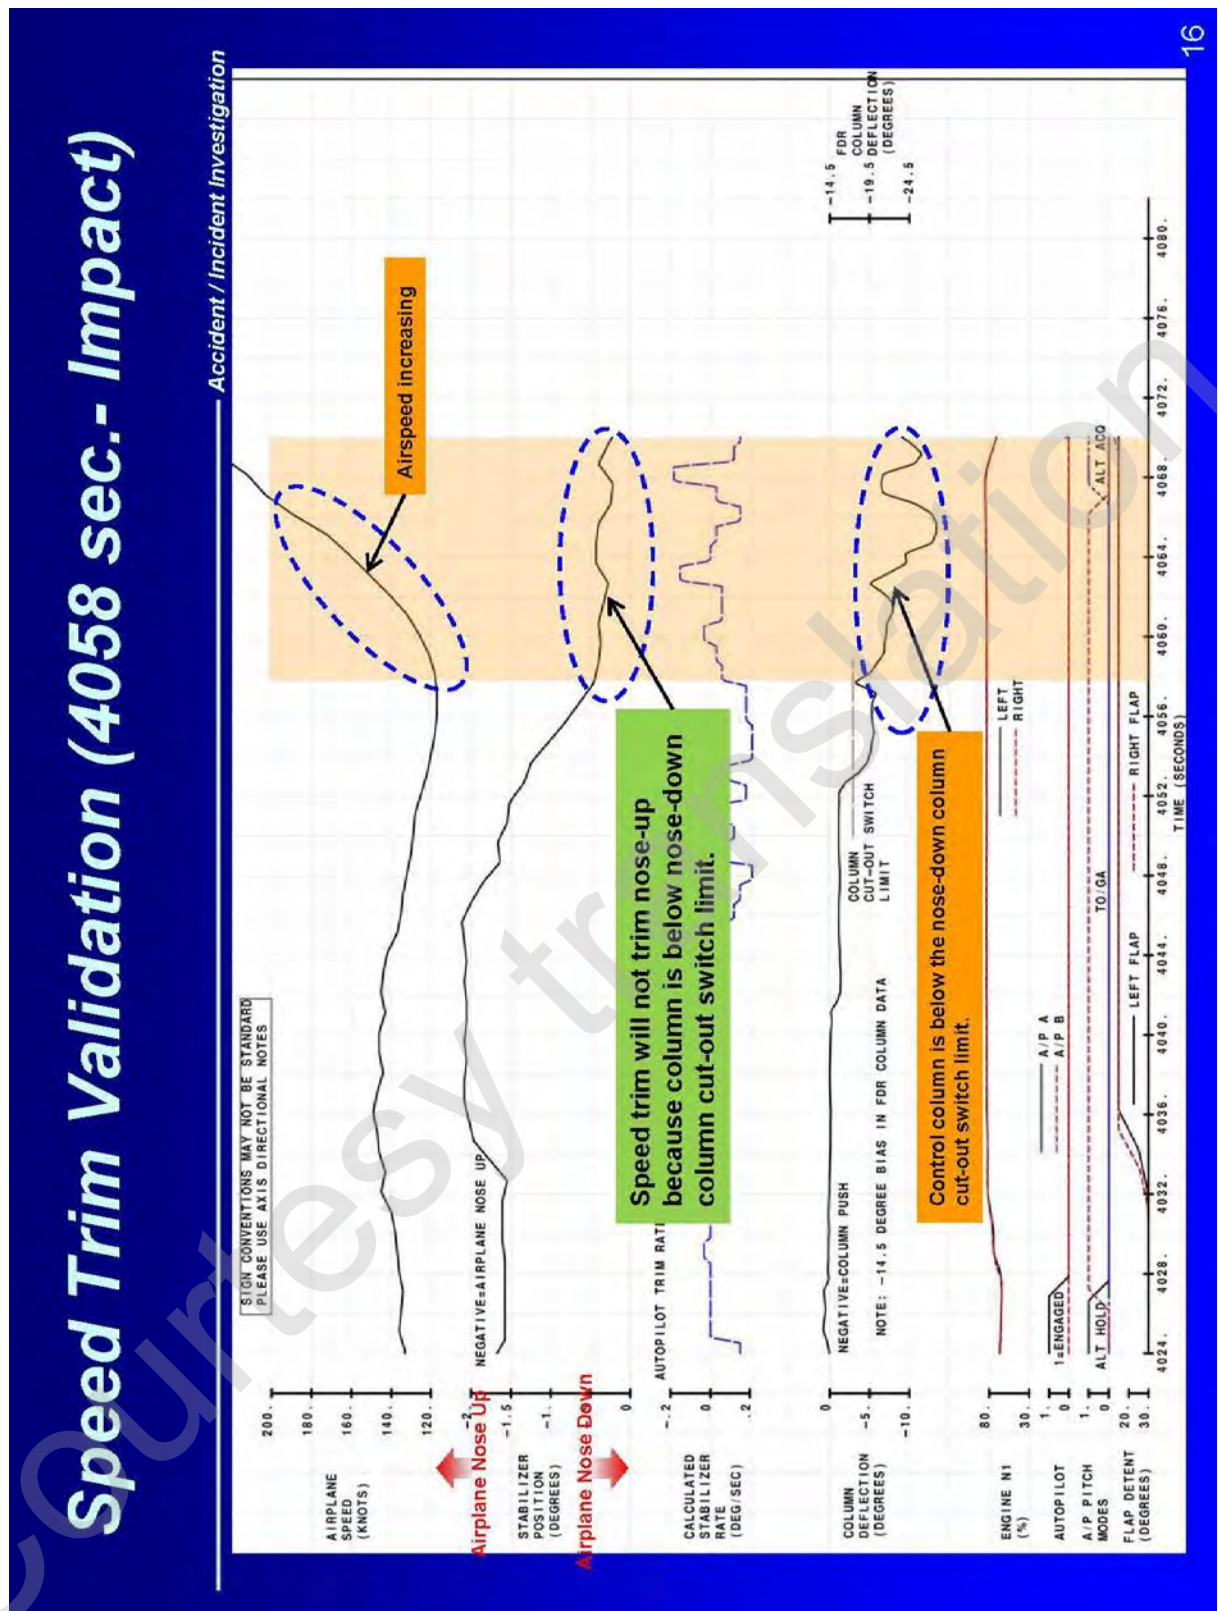
Figure 31 STS validation (15:23:16 – end of record)

Thus, the Speed Trim System was operating normally in the accident flight.

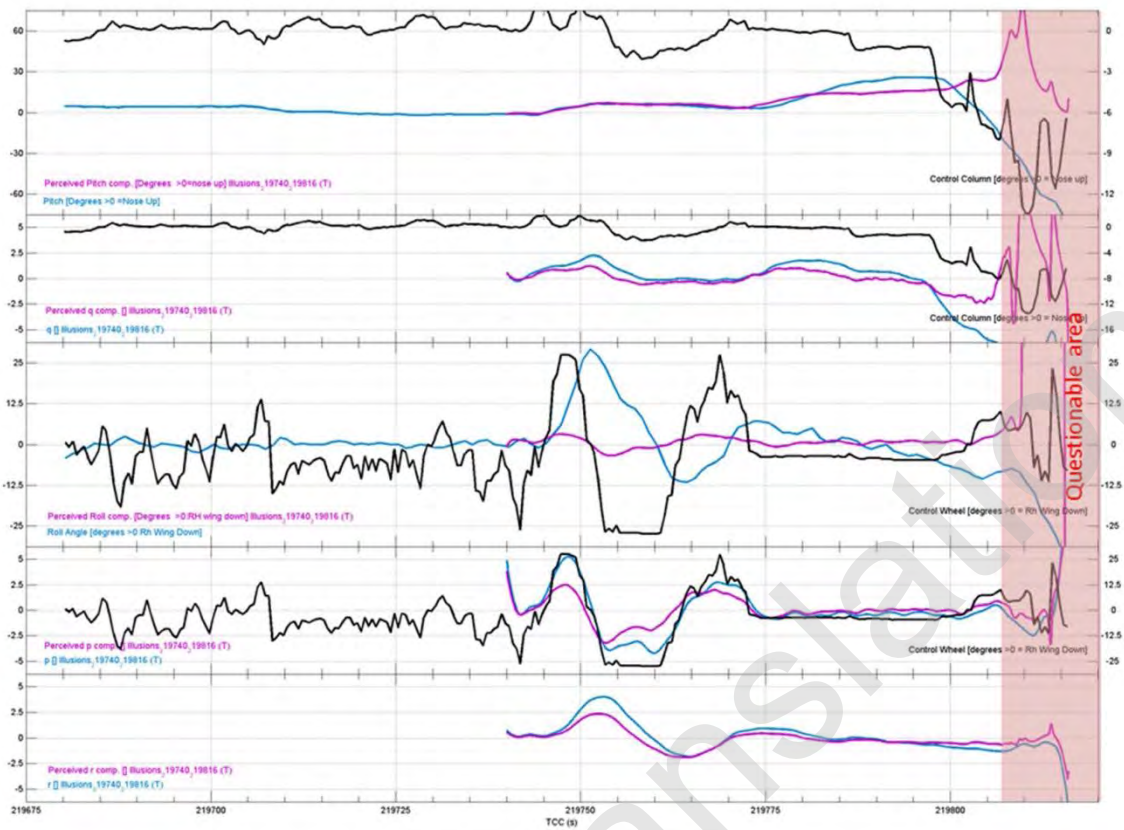
Figure 32 BEA Sensorial Modelling Results

The applied model has a number of limitations. The modelling results require verification when the actual pitch is greater than 25 degrees or lower than -15 degrees and could not be used when the normal acceleration is lower than 0 G (negative load factor). The abovementioned conditions are applicable to the 9 last seconds of the flight (Figure 32, see the red area)¹⁵.

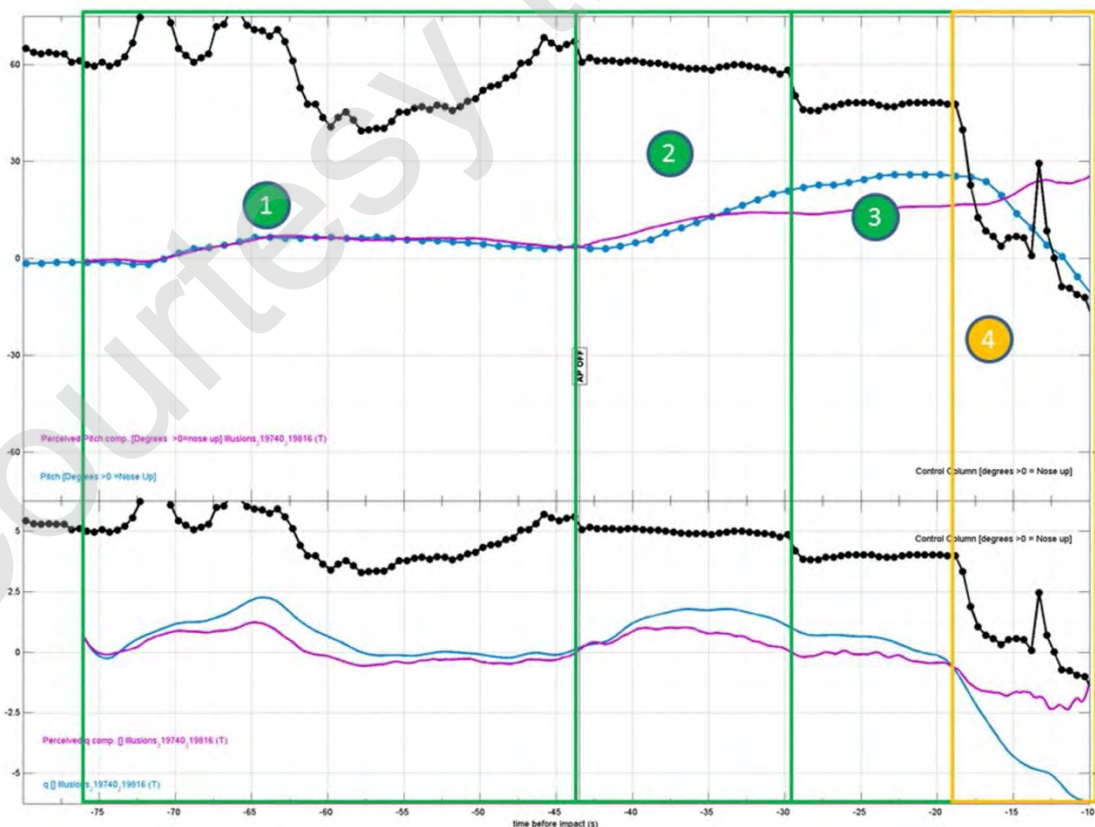
Figure 33 BEA Sensorial Modelling Results (cont.)

In zone 1 the actual and perceived pitch angles were quite similar. The autopilot was engaged during this segment.

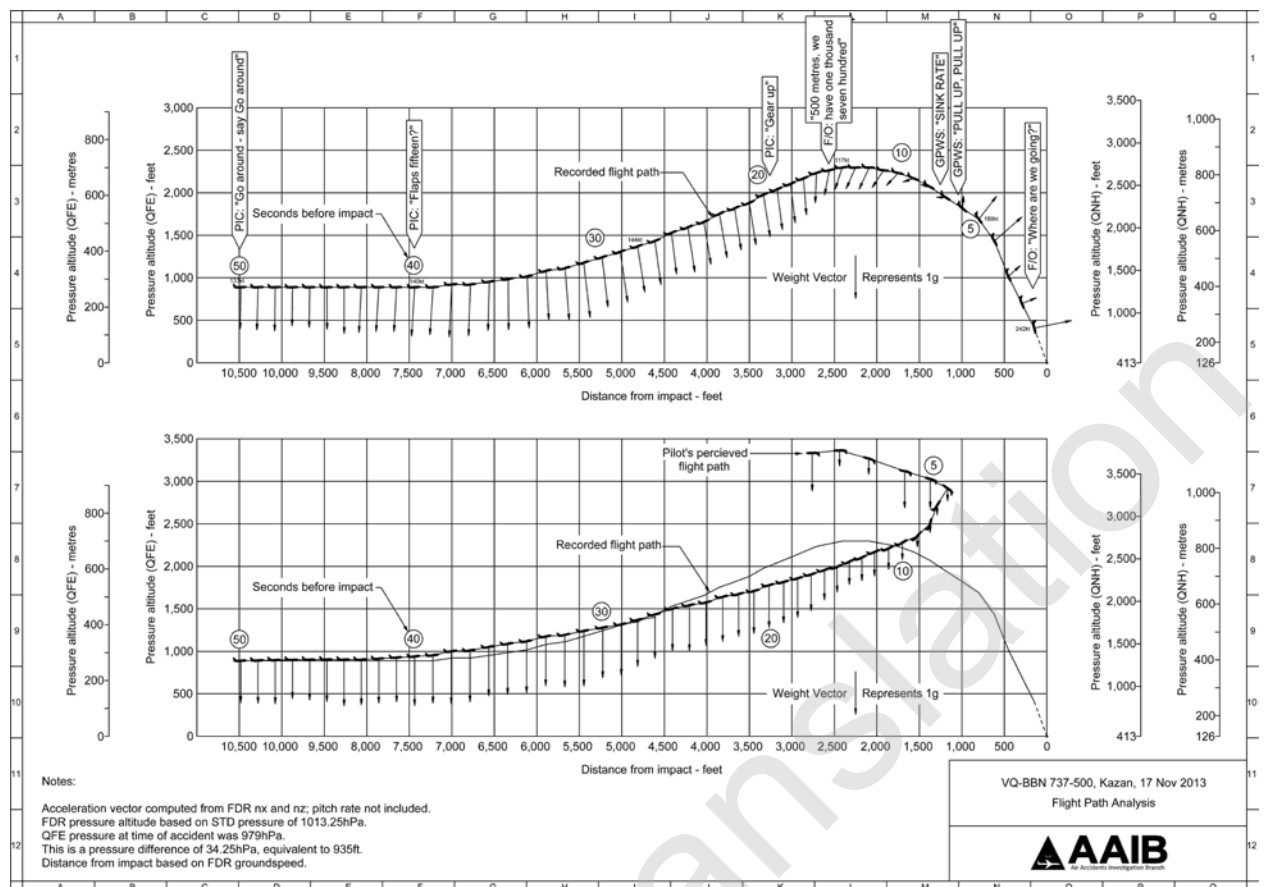
Figure 34 AAIB UK Sensorial Modelling Results

The AAIB UK also assessed the probability of somatogravic illusions effect on the pilots during the go-around. During the research they used a method successfully applied during some other investigations. Based on the calculations a chart was built (Figure 34) that shows the probable effect of the illusions.

The modelling led to a conclusion that provided the pilots did not monitor the flight instruments in due manner they could have experienced the so-called “inversion” illusion during a change from climb to descent and during descent, which could have forced the PIC to apply nose down pitch control to correct the perceived pitch angle increase (sensed “looping” flight path).
