INTERSTATE AVIATION COMMITTEE
AIR ACCIDENT INVESTIGATION COMMISSION

FINAL REPORT

Type of occurrence	Accident
Type of aircraft	Airplane, Boeing 737-500 (53A)
Registration	VQ-BBN (Bermuda)
Registered Charterer (according to the registration certificate)	AWAS (BERMUDA) LIMITED, Clarendon House, 2 Church Street, Hamilton HM 11, Bermuda
Operator	Tatarstan Airlines, JSC, Russia
Aviation Administration	Tatar ITO, FATA
Place of occurrence	Russian Federation, Kazan International Airdrome, coordinates: N 55° 36,5291' E 49°16,6111'
Date and Time	November 17, 2013, 15:24 UTC, 19:24 local time, night time

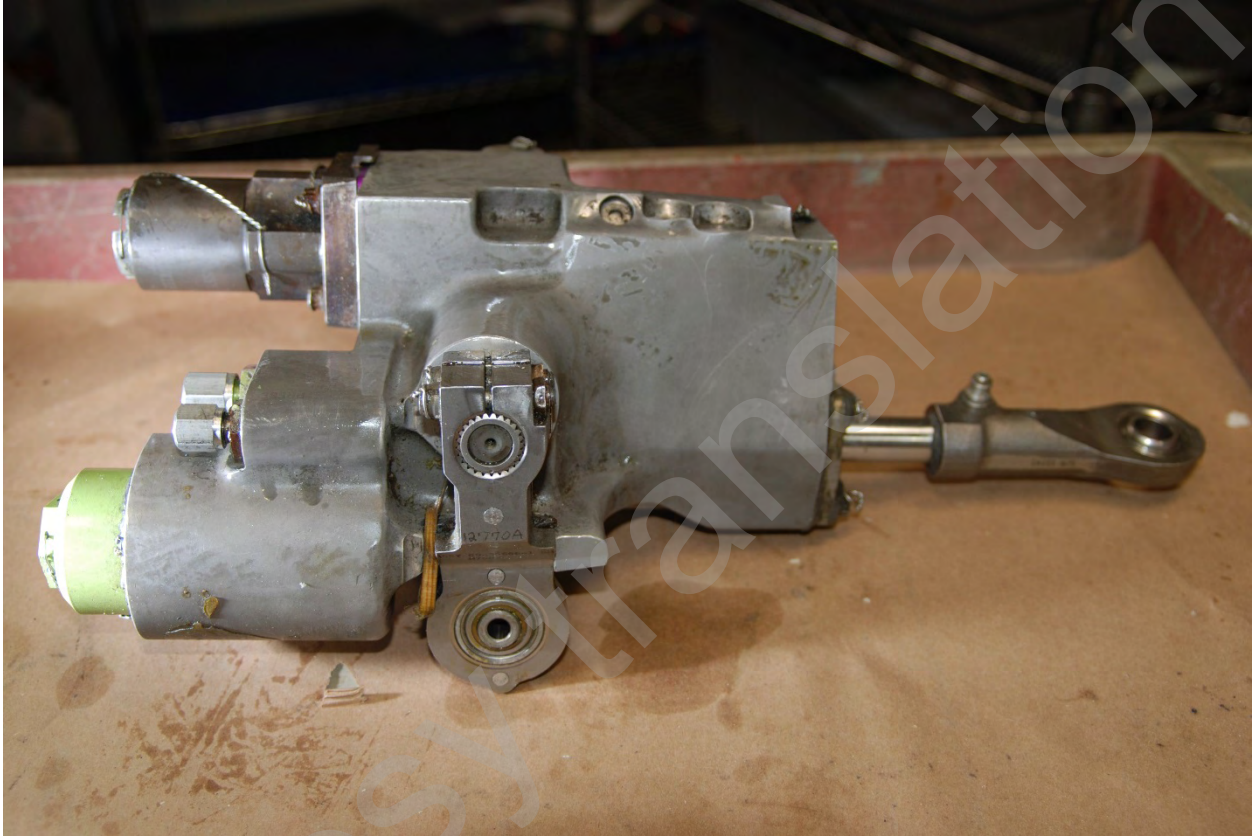
Figure 35 Left hand actuator

Taking into account the accident circumstances and FDR data readout (intense nose down pitching during the final phase of the flight and no nose up inputs) as well as earlier in-service occurrences related to PCU malfunctioning (Section 1.18.7) the investigation team decided to request an examination of the elevator power control units. Figures 35 and 36 below show the PCU as they arrived for the examination.

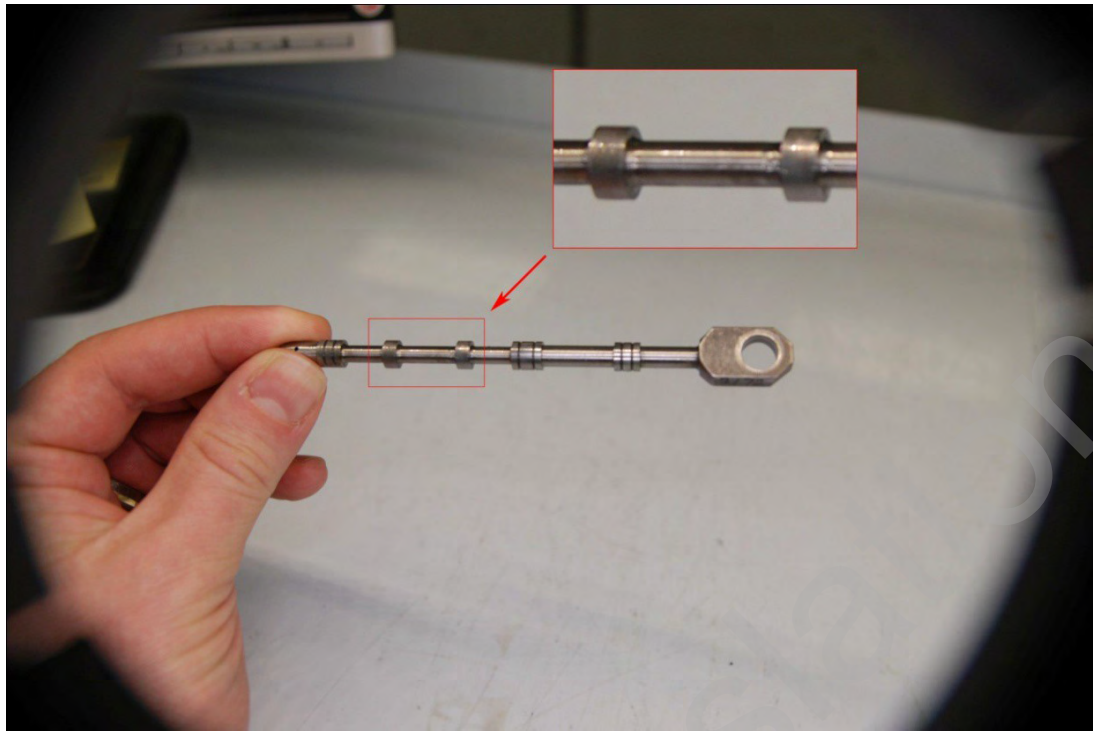
The first feature is different design of the RH and LH control valve primary slides. Two of the RH control valve primary slide lands have no balance grooves (Figure 66). While the LH control valve primary slide has those balance grooves (Figure 67).

Figure 66 RH control valve primary slide

Similar differences were revealed on the bypass valve slides. The absence of balance grooves may lead to increased friction forces and more extensive wear. According to the designer's explanation both types of slide design are acceptable. This is explained by the fact that balance grooves were added to slide design over time and are now considered the industry standard, though

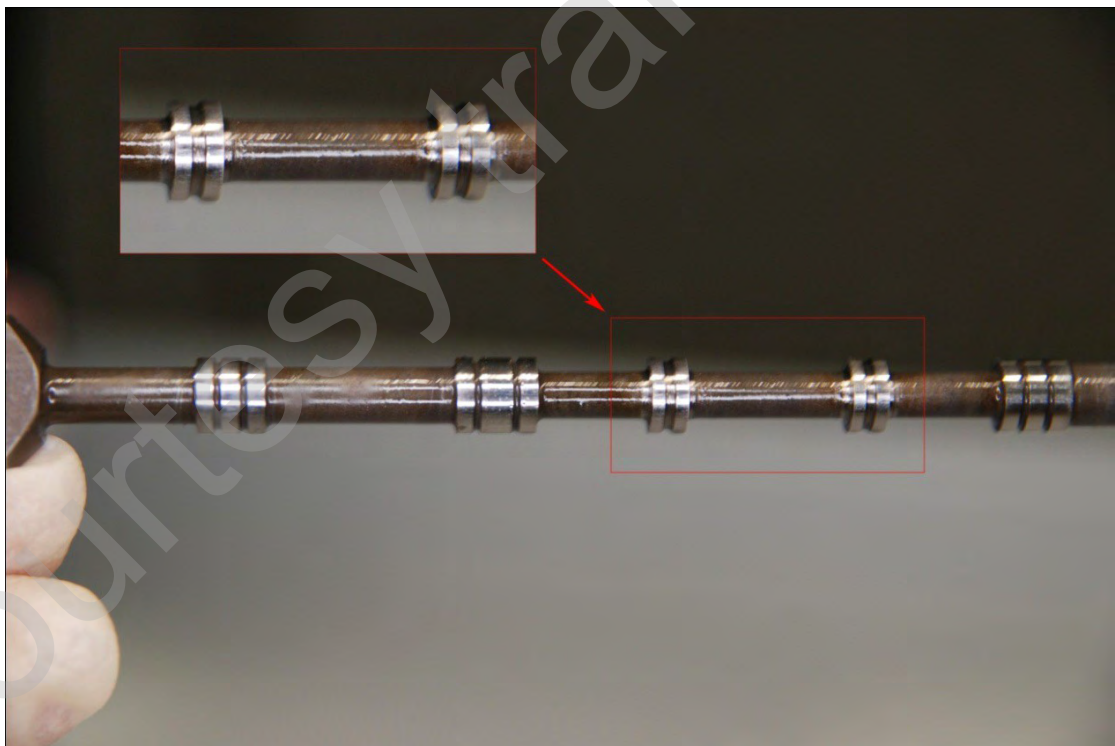
Figure 67 LH control valve primary slide

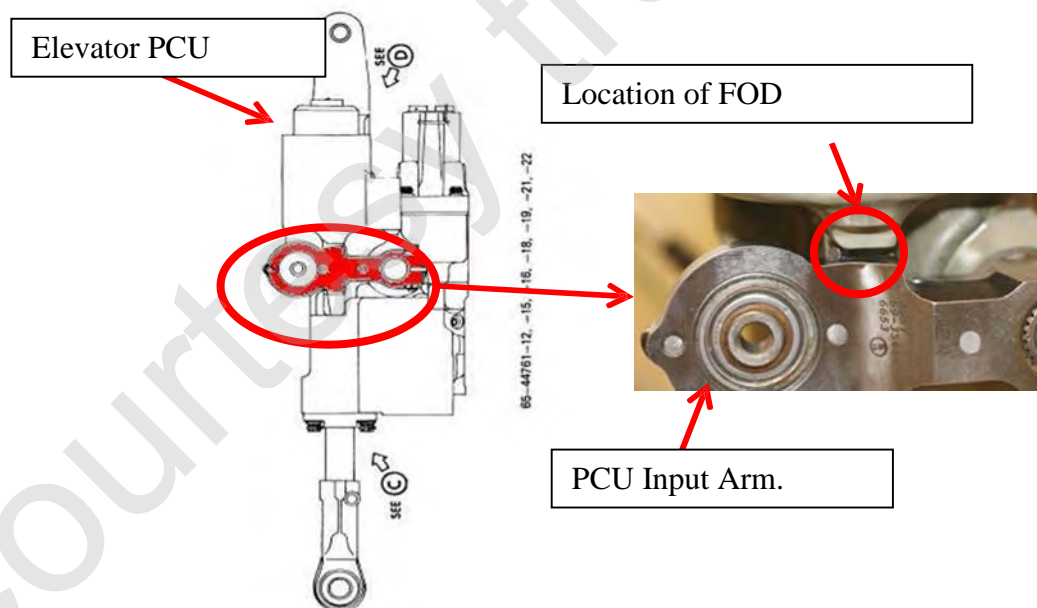
The incident investigation was conducted by the NTSB. The NTSB's investigation found that the incident was caused by an uncommanded elevator deflection as a result of a left elevator power control unit (PCU) input arm assembly jam due to foreign object debris (FOD). The FOD was a metal roller element (about 0.2 inches long and 0.14 inches in diameter) from an elevator bearing. As a result, the PCU would be commanded to move the elevator to a position that would pitch the aircraft nose up.

Figure 70 Location of FOD

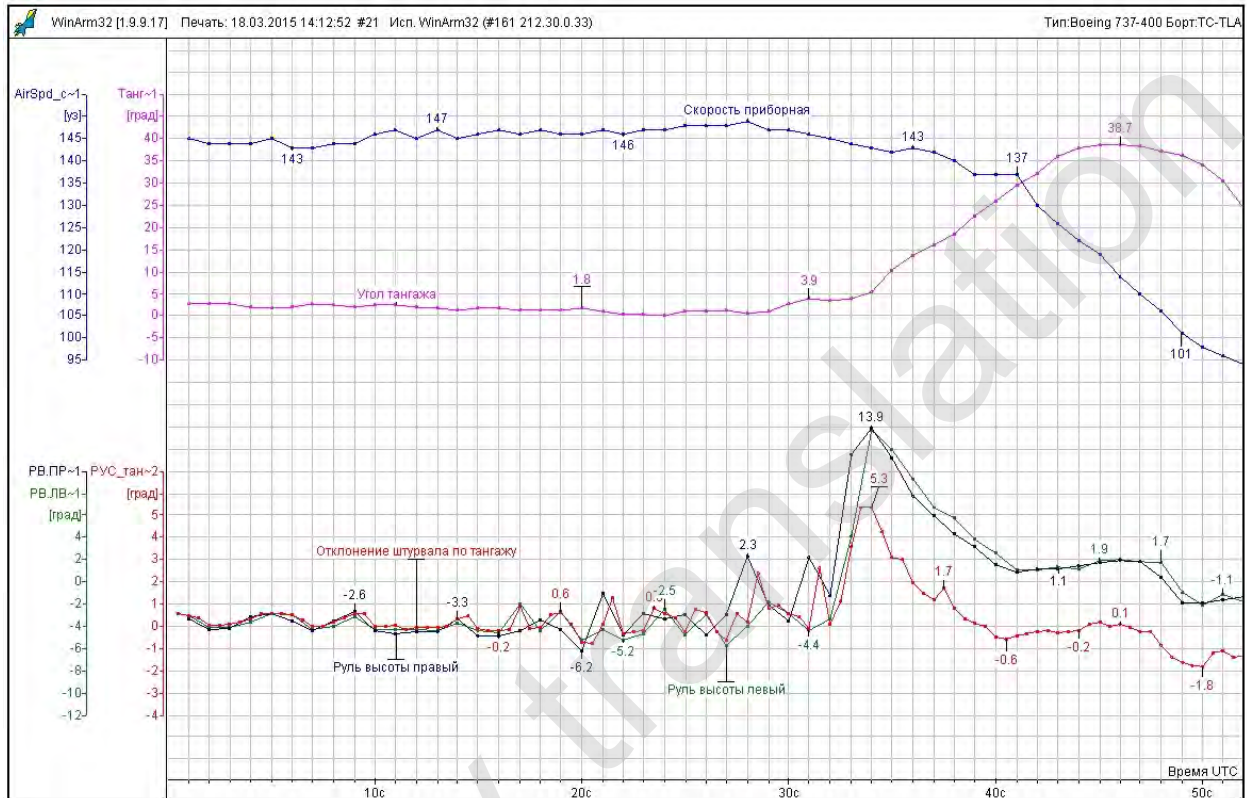
The FDR record analysis (Figure 71) revealed that the significant column input forces applied by the crew led to control linkage extension. This is revealed by comparing the column and elevator positions before and after the jam. The same column position corresponds to different elevator deflection angles.

Figure 71 Boeing 737-400 TC-TLA Flight Parameters

Figure 71 contains the FDR record for the Turkish event. Apparently the significant column input forces while the control linkage was jammed led to cable (control linkage) extension. This is revealed by comparing the column and elevator positions before and after the jam. The same column position refers to different elevator deflection angles.

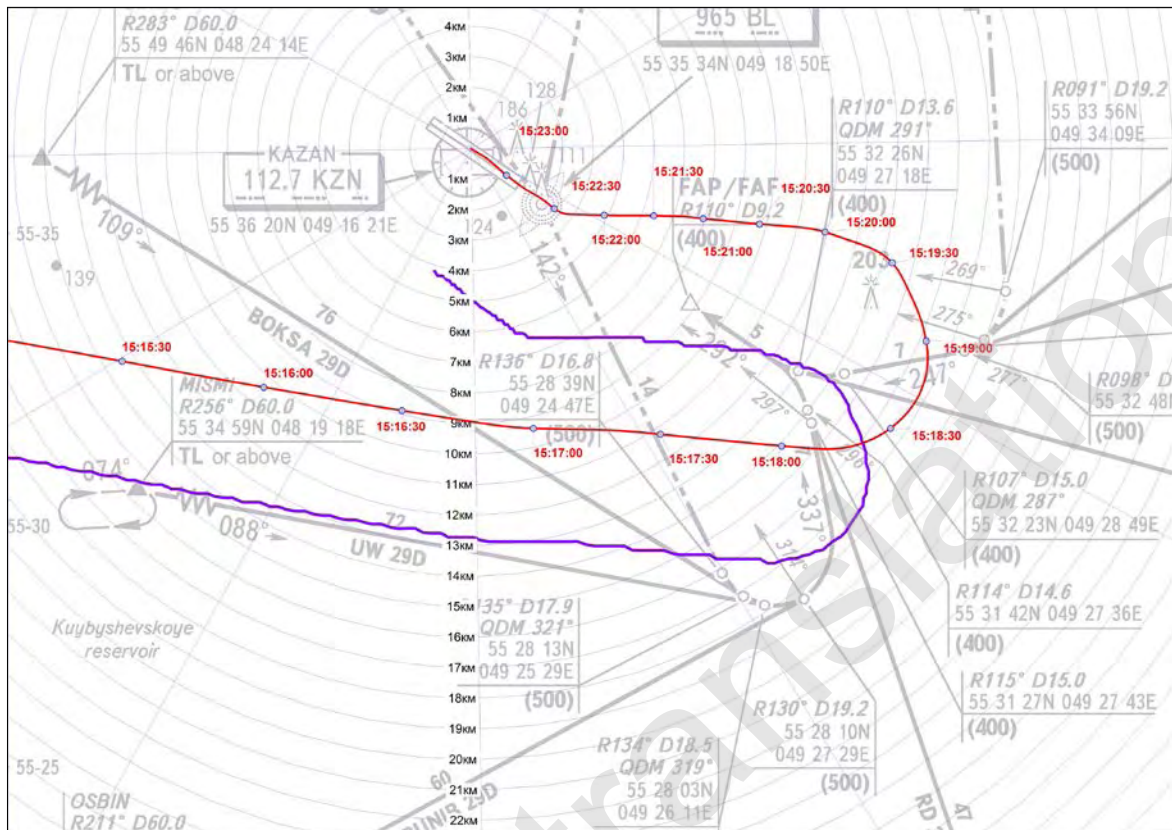
heading change was not enough either. The aircraft was approaching the base turn parallel to the standard approach pattern (Figure 15 and Figure 81).

Figure 81 Actual flight path (red) and FDR (IRS) flight path (blue). There is a gap between the base turn and MISMI waypoint, the location of MISMI WP is out of scale

After the crew informed the ATC on reaching the base turn point they were cleared for base and final turn. Actually the turn was initiated at 15:18 in the HDG SEL mode before the aircraft reached the altitude of 500 m with a significant deviation from the STAR pattern (Figure 15 and Figure 81), that the ATC could have seen on the radar, and the crew could have seen that using the VOR/DME.

The turn was completed with a significant “overtake” (Figure 15 and Figure 81). The cockpit communication analysis revealed that the crew was not completely aware of their position with regard to the approach pattern, which is confirmed by the following dialogue between the PIC and the FO at 15:18:46:

By the time the aircraft reached the approach pattern the map shift on the left IRS was approx. 4 km (Figure 81) southwards (i.e. the actual flight path was to the north of that recorded by the FDR)⁴⁰.

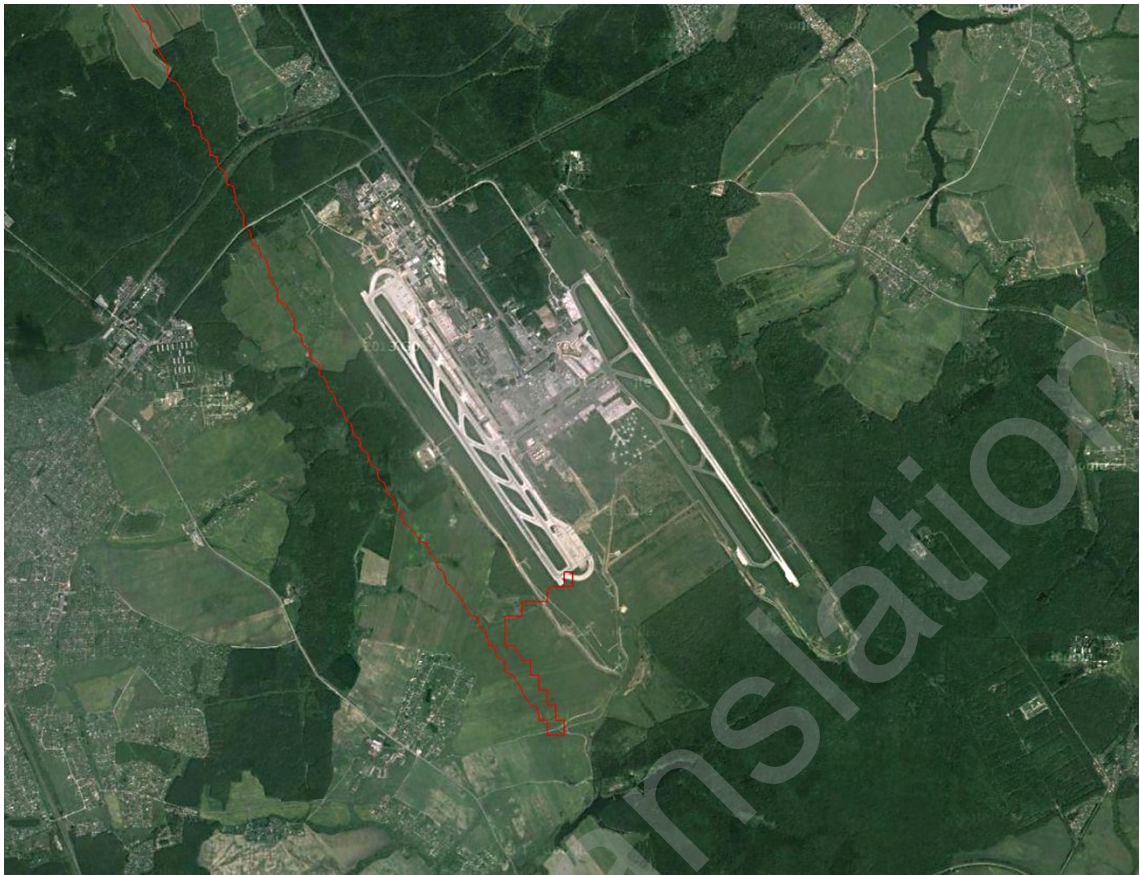
Comparison of the recorded aircraft position during taxiing and takeoff with the actual path can lead to a conclusion that during the takeoff a map shift of approx. 2 km southwards was also present (Figure 82). Thus, most probably when the crew aligned the IRS's before the flight they entered the current coordinates with some error (probably they entered the last position that remained in the FMS memory when it was switched off after the previous flight). The analysis showed (Section 1.18.10) that the same was true for the vast majority of other flights made by the airline crews.

Figure 82 Map-shift during the takeoff at Domodedovo Airport

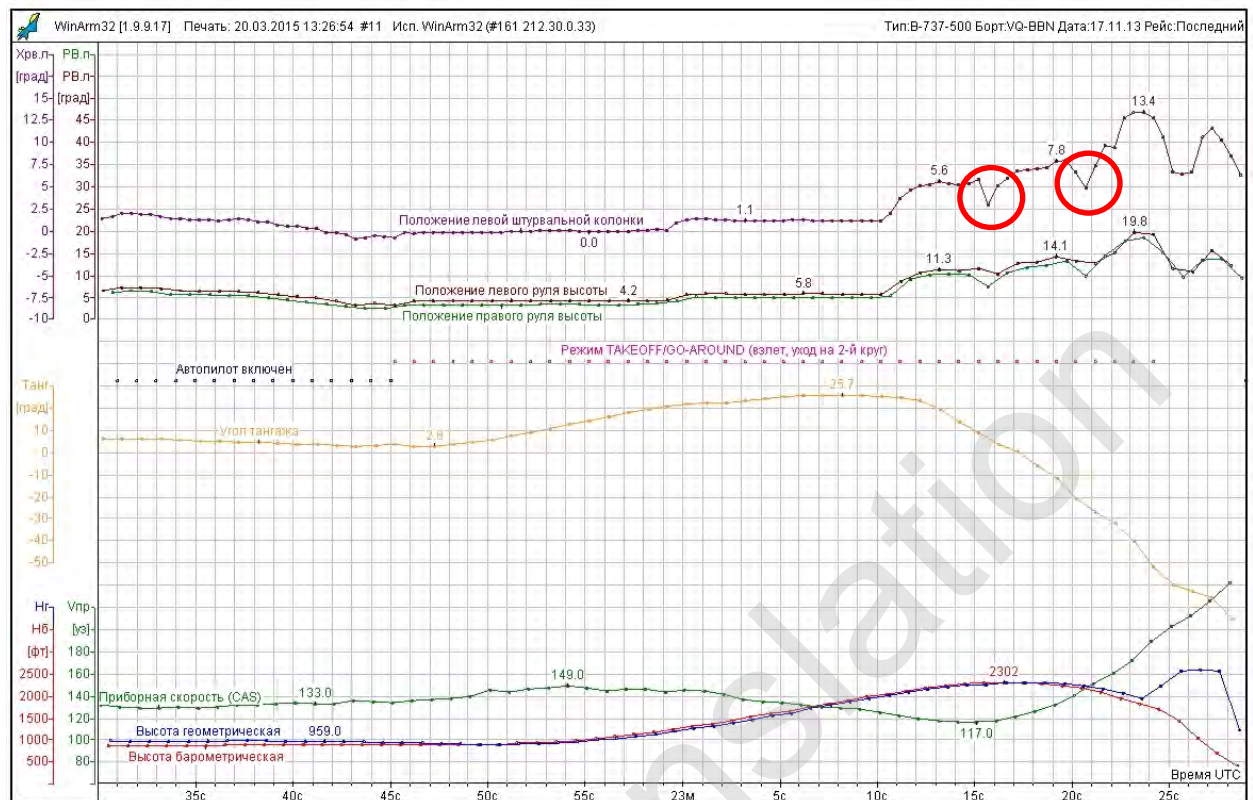
When analyzing the accident circumstances and recorded flight data (intensive nose up pitching during the final flight segment and no nose up control inputs) some of Rosaviatsyia experts that were involved in the investigation had an opinion that there could have been no nose up control inputs because the elevator control linkage has been jammed partly and could not be moved nose up. As an argument they pointed to some remarkable peaks on the column and elevator deflection records (Figure 83, circled).

Figure 83 Longitudinal parameters during the final segment of the accident flight

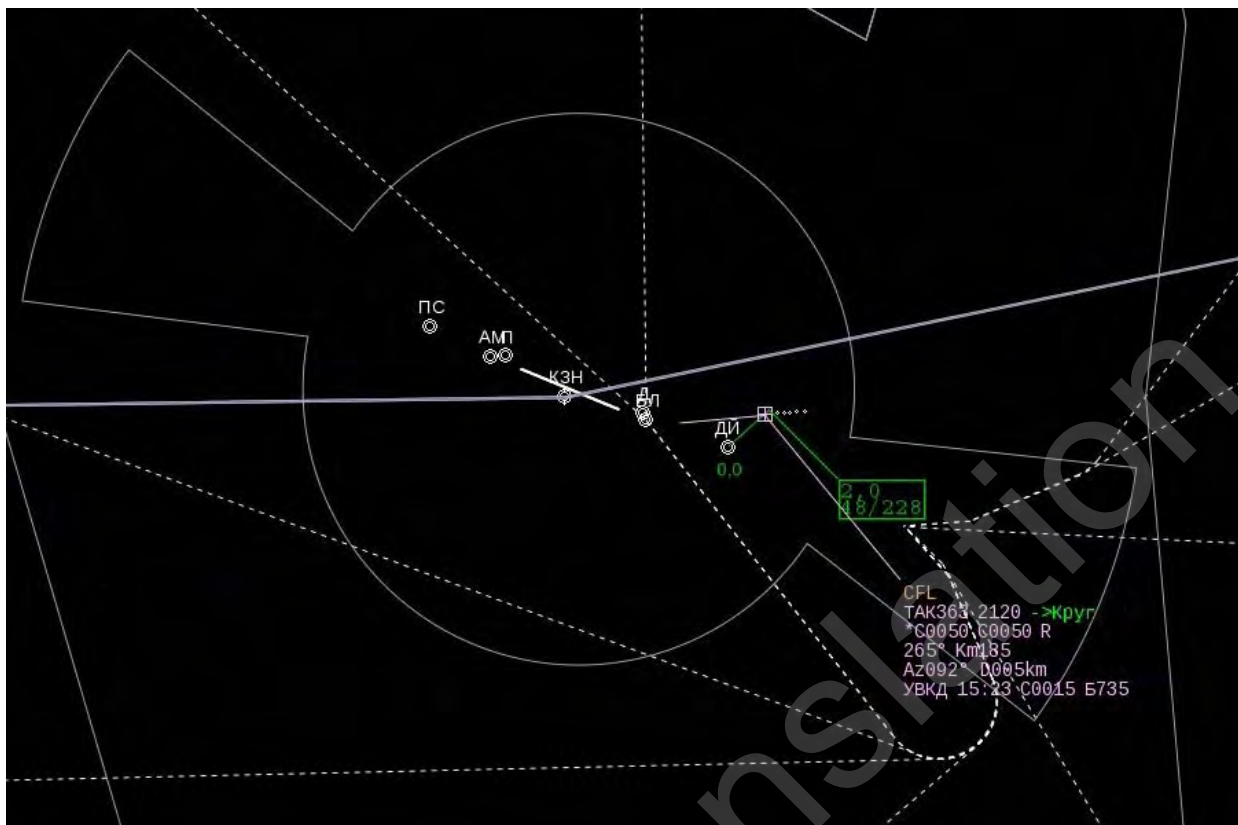
The ATC officer cleared them for landing, although he could see it on the radar that the aircraft was not stabilized (Figure 84): the distance from the localizer was about 5 km, according to Galaktika ATM automation complex, the altitude was 500 m according to the aircraft information tag without any tendency to descend (the descent symbol was not present in the tag) and the aircraft was offset to the right of the landing track. It would have been a more appropriate decision for the ATC officer to inform the crew on their actual position at least and recommend to go around.

Figure 84 Radar printscreen at the time of the landing clearance providing
