ATSB TRANSPORT SAFETY INVESTIGATION REPORT

Aviation Occurrence Report – 200503722

**In-flight upset event
240 km north-west of Perth, WA
Boeing Company 777-200, 9M-MRG
1 August 2005**

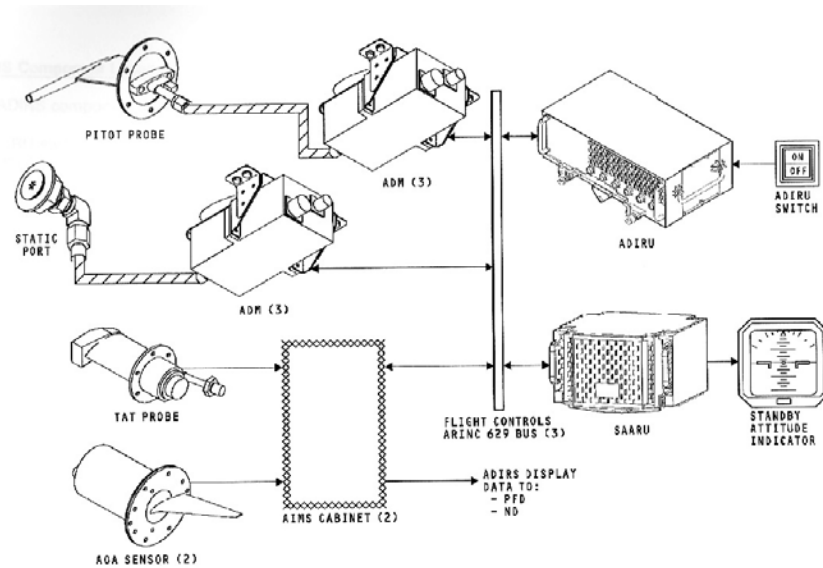
Figure 2: Air data inertial reference system

The ADM received air pressure from the pitot probes or static ports. The ADM then converted that air pressure into Aeronautical Radio, Incorporated (ARINC) 629¹¹ data. The ADM then sent that data to the ADIRU and SAARU. The ‘airplane information management system’ (AIMS) cabinets received TAT and AOA analog inputs, converted that data to digital and sent it to the ADIRU and SAARU.

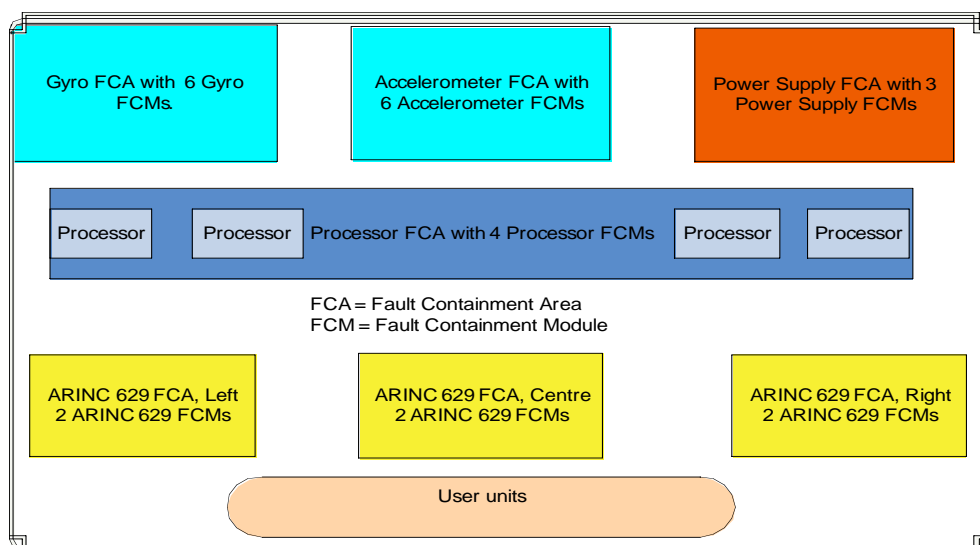
Figure 3: ADIRU diagram

The ADIRU could have an unserviceable item in any of the FCAs and the aircraft was still considered serviceable. That feature allowed operators to defer maintenance until the number of serviceable FCMs in any single area was less than that specified by the component manufacturer, and provided operators with lower maintenance costs and less disruption to aircraft scheduling.

Data from the accelerometers and gyros was sent to the processor FCA which produced navigation and flight control inputs. The processor FCA performed redundancy management on the gyro and accelerometer data by using fault detection and isolation software. The data was then checked by the software before it was sent to the ARINC 629 units for distribution to the aircraft user units. That design feature was to ensure that only data from serviceable sensors would be used in the ADIRU outputs.

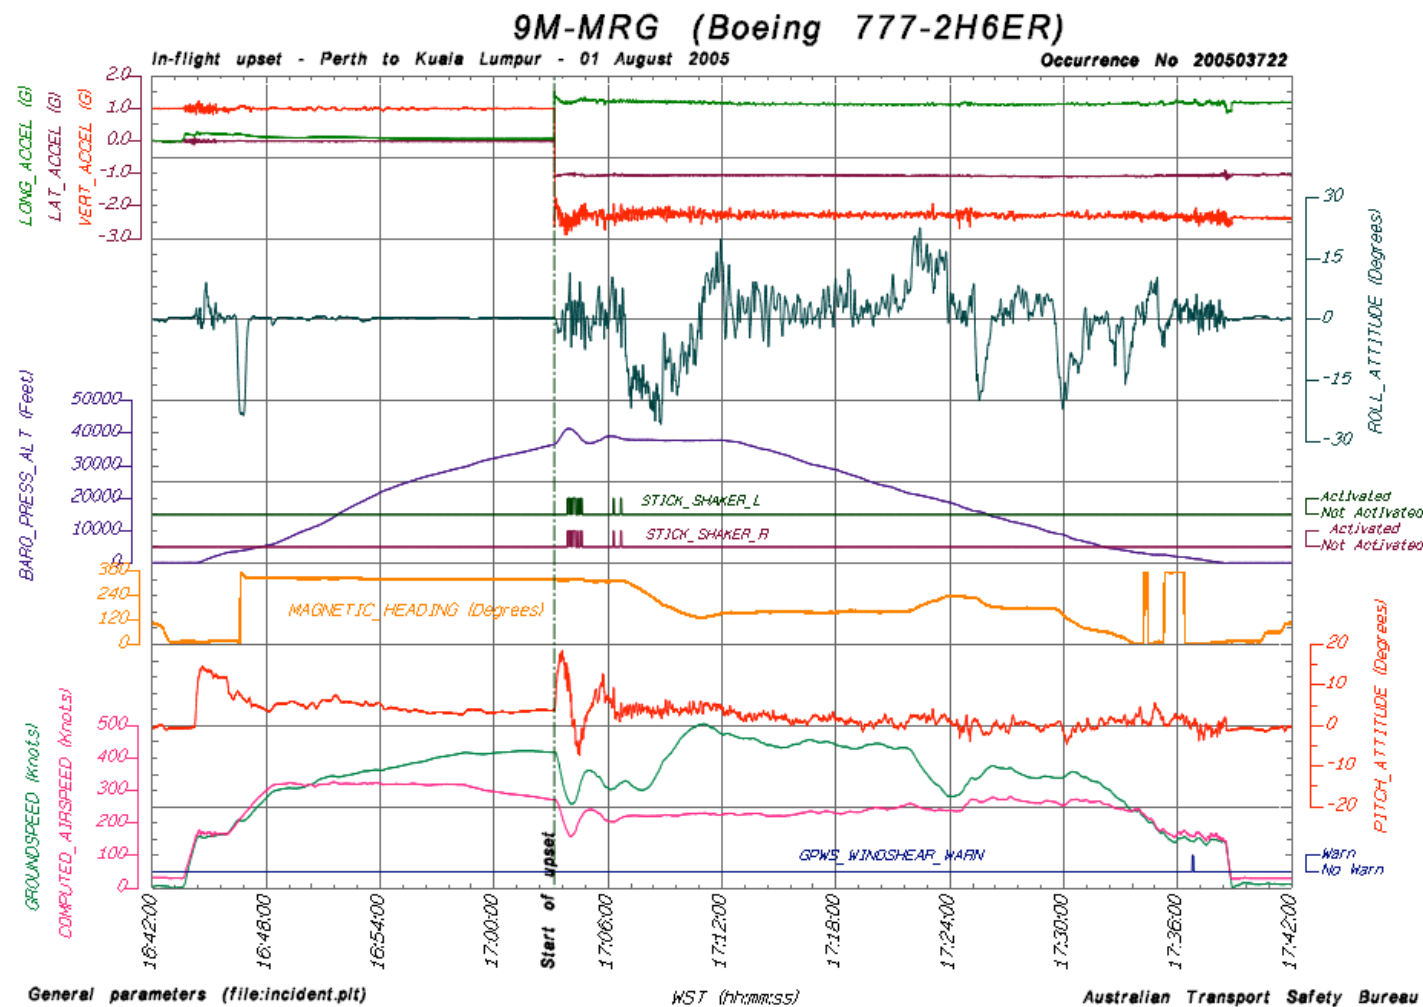
Figure 6: General parameters over sixty-minute period

General parameters over a 60-minute period containing the entire incident flight are displayed, see figure 6. Other relevant parameters are displayed over a 5-minute period incorporating the upset event, see figures 7-10.

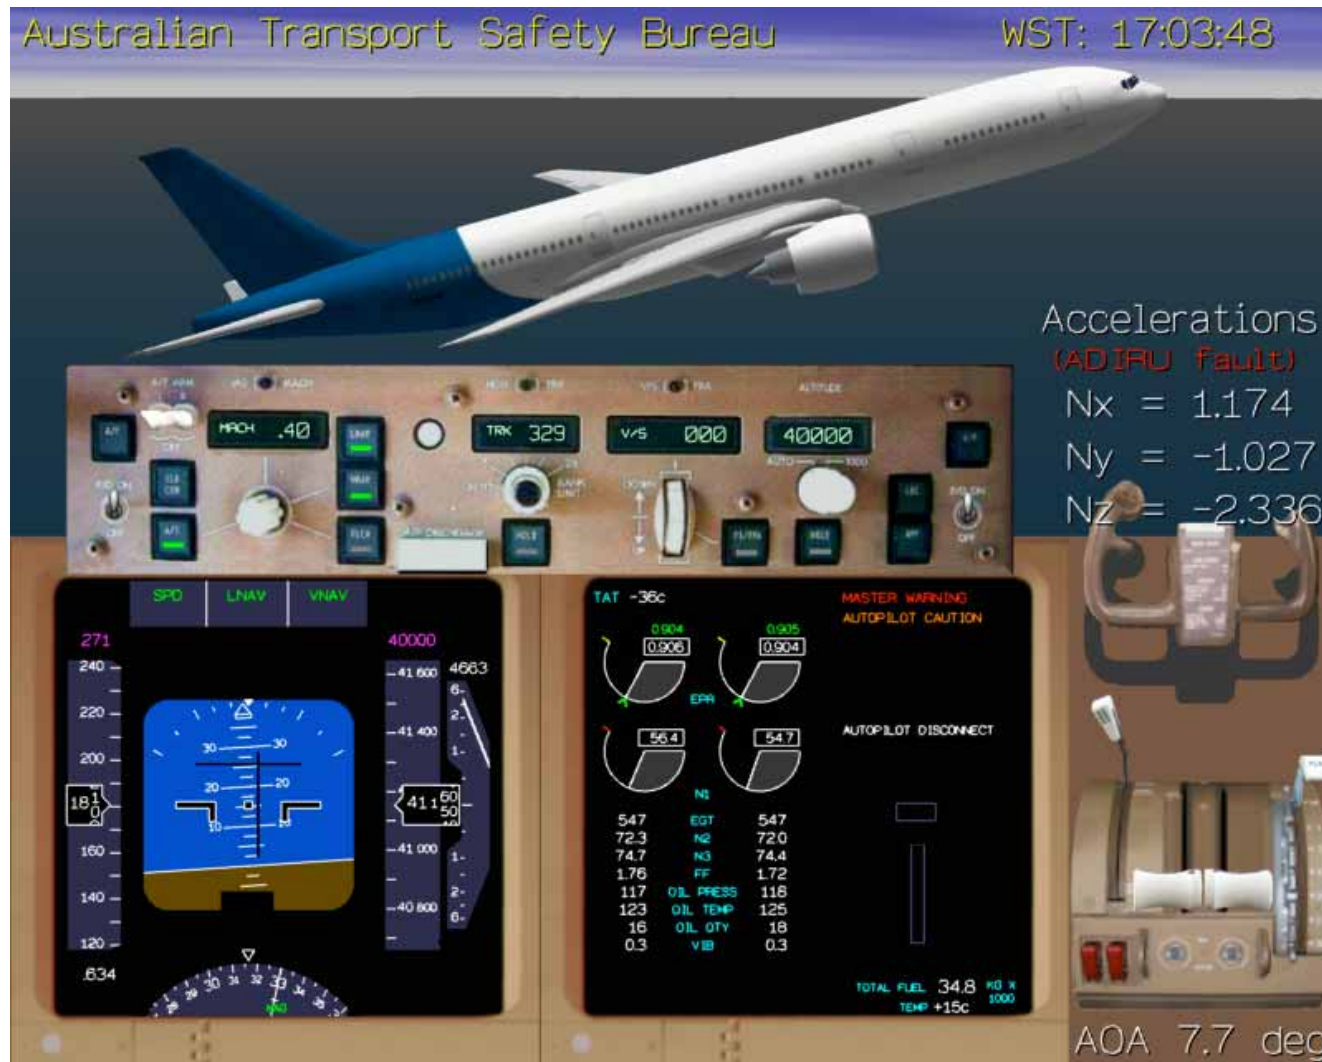
Figure 11: Screen capture of 9M-MRG animation

An animation of the incident was prepared using Insight Animation™ software and is part of this report. A file containing the animation in Insight View™ format (.isv) is available for download from the ATSB website. This file requires the installation of an Insight Viewer that can be downloaded from www.flightscape.com/products/view.php at no charge. A still screen capture of the animation is shown at figure 11.
