MINISTRY FOR  
INNOVATION AND TECHNOLOGY  
TRANSPORTATION SAFETY BUREAU

**FINAL REPORT**  
**2016-071-4P**  
**SERIOUS INCIDENT**  
**LHBP**  
**16/03/2016**  
**ATR 72-200**  
**YR-ATI**

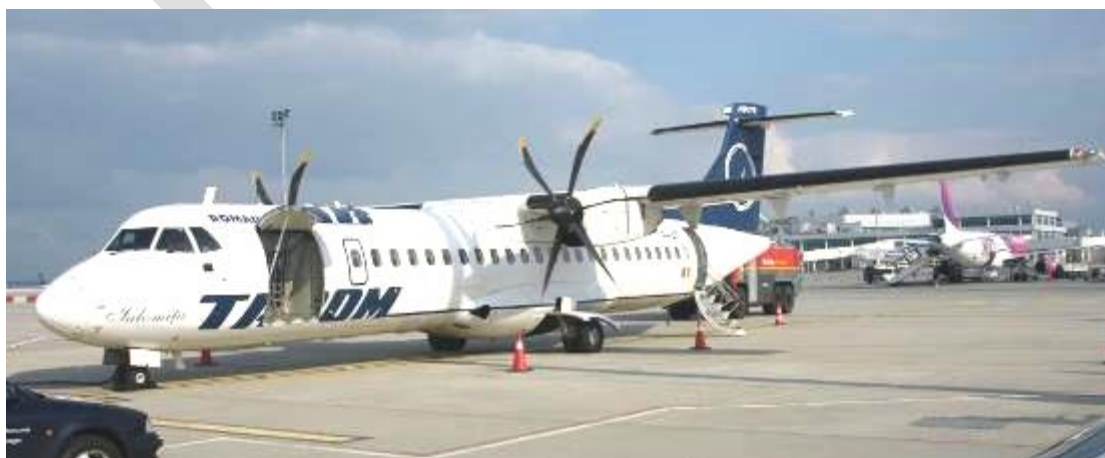
The №2 (right hand side) engine of the aircraft and its nacelle were significantly damaged in the occurrence.

**Figure 1:** The affected aircraft at Stand № 220 after the passengers disembarked

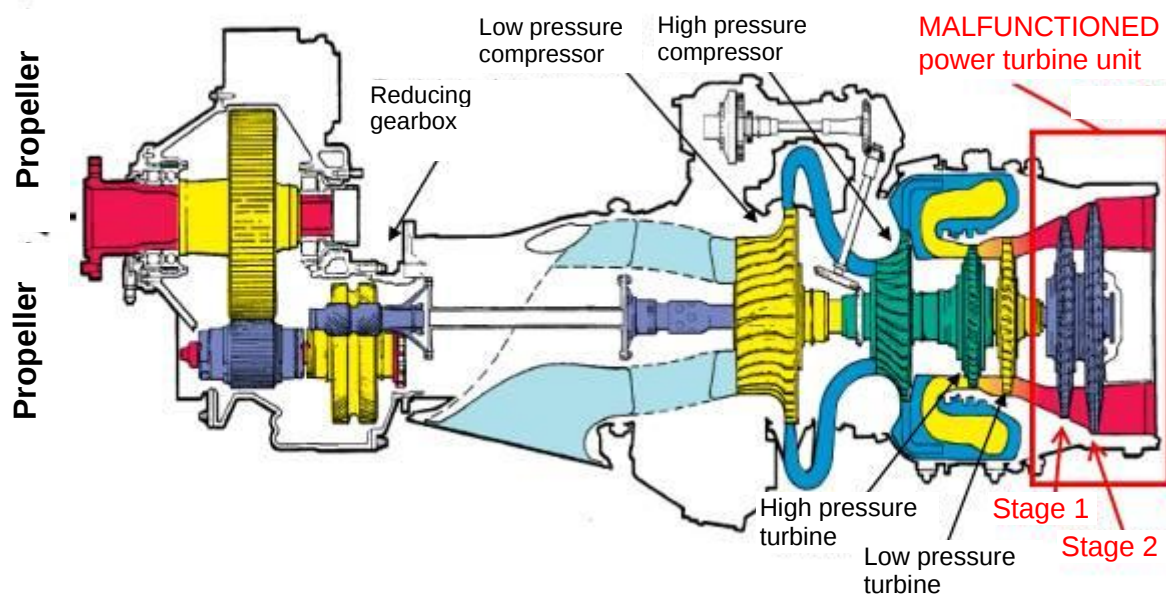
**Figure 6:** Principal layout of the Pratt & Whitney PW 127M turboprop engine

During the flight under investigation, a blade of the rotor assembly of 1<sup>st</sup> stage Power Turbine fractured in the course of the take-off run. The fractured blade badly damaged the blades of both the stator and the 2<sup>nd</sup> stage rotor assembly. The outblown debris damaged the tail pipe. The vibration caused by the imbalanced rotor assembly damaged the № 6 & 7 bearing housing and the connected lube oil pipes, and, consequently, also the low- and high-pressure rotor assemblies and shafts. The long-acting high temperature caused further severe damages to the low- and high-pressure turbines and their shafts.

The item number of the turbine blade which initiated the malfunction is 3078563-01, and its serial number is HWMM6651. It was installed in the engine during repair at the plant of Vector Aerospace France on 21 Oct 2014. Then it performed 2 491 hours (2 415 cycles) until the malfunction under investigation.

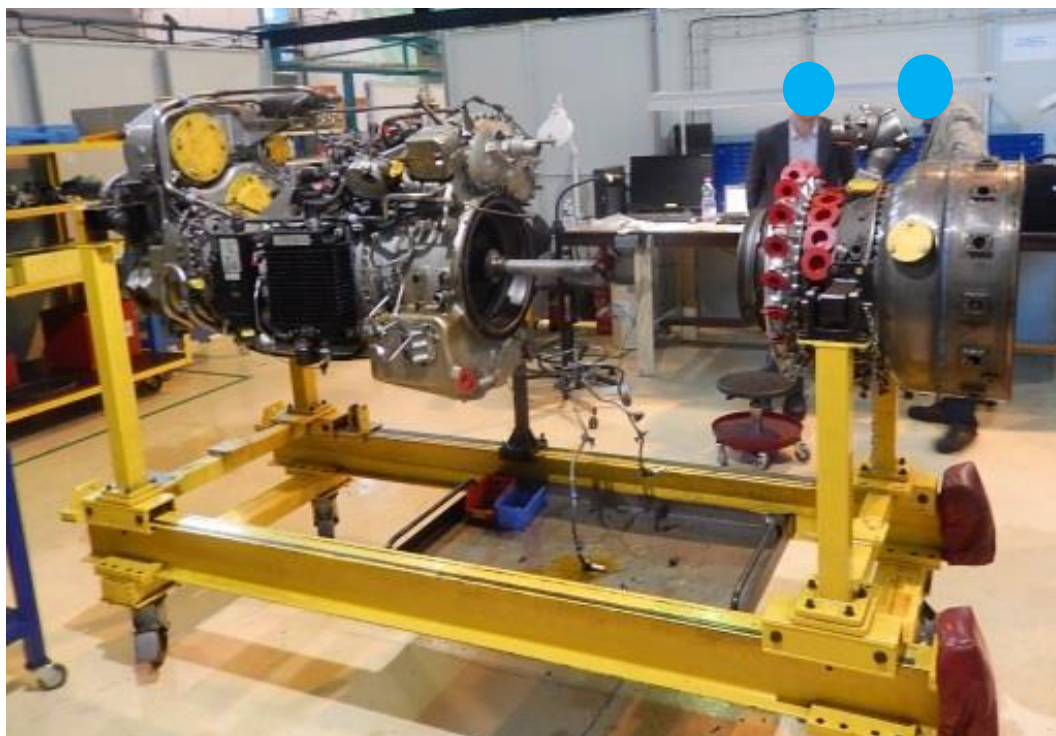
**Figure 12:** *Disassembly of the engine at the Paris plant of Vector Aerospace France*

It was found during the boroscope inspection and disassembly that

- The blades of the discs of both stages of the power turbine were badly damaged
- The low-pressure compressor showed no sign of damage caused by ingested foreign object.
- The outside of the engine showed the signs of effects of high temperatures.
- Significant quantity of metal debris was found in the oil system
- Both discs of the power turbine were badly damaged.

- 19 blades of 2<sup>nd</sup> stage PT were fractured and the rest of the blades were damaged.
- The tail pipe was damaged by partly molten metal debris flowing out.

- Each blade of the 2<sup>nd</sup> stage PT stator was damaged.
- Each blade of the 1<sup>st</sup> stage PT rotor assembly fractured. A blade of the rotor assembly broke off near its root, which may have been the point where the engine started to become inoperable.

- Several blades of the 1<sup>st</sup> stage PT stator were melted.
- The № 6 & 7 bearing housing disintegrated due to high temperature.
- The shafts of the low-pressure turbines and power turbines melted and fractured.

- Each blade of the rotor assembly of the low-pressure and high-pressure turbines fractured.
- The surface of the stator of the low-pressure turbine melted at the high temperature.

- The blades of the low- and high-pressure compressors were damaged when they reached inside the housing due to the failed turbines, bearings and shafts.

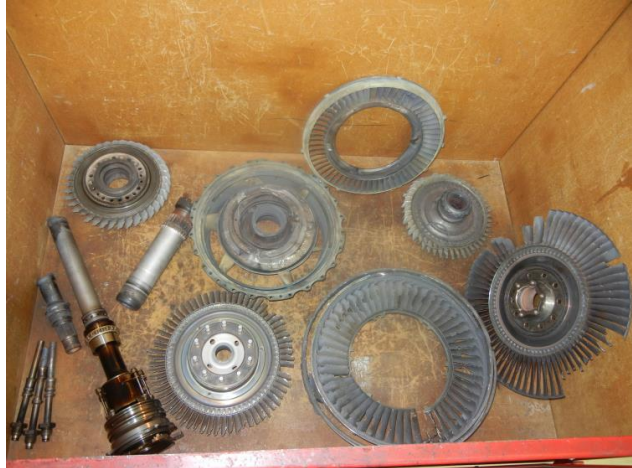
Following the disassembly of the engine in Paris, the following parts were sent to the lab of Pratt & Whitney Canada (PWC) for a more detailed examination:

- stator and rotor assembly of the power turbine
- power turbine shaft
- The common housing of the № 6 & № 7 bearings with the three oil pipes to it
- rotor assemblies of the low- and high-pressure turbines
- shaft of the low-pressure turbine

**Figure 17:** Parts sent to PWC (VAF)
